Principal Investigator Gene Roberson
Region Director R. M. Seeley
Date of Report 07/16/2013
Subject Failure Investigation Report – Enbridge Pipeline – Sump Pump Discharge Flex Hose Failure

Failure Investigation Report – CCPS Transportation, LLC – Sump Pump Hose Failure
12/14/2012

Executive Summary

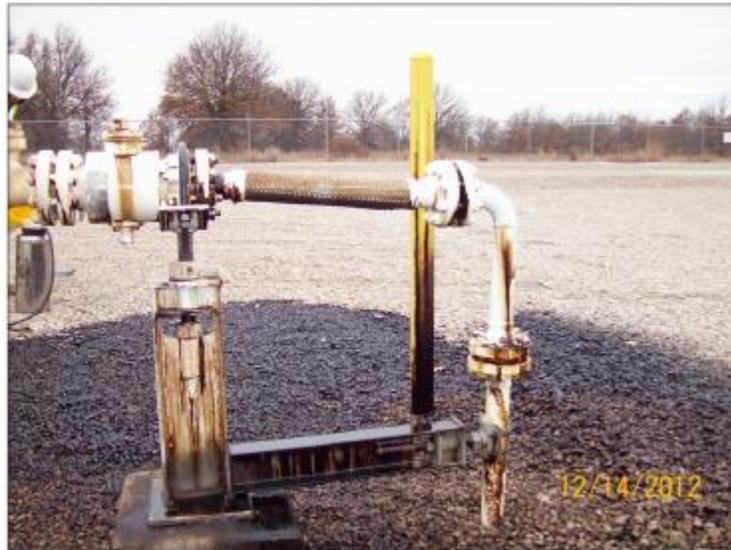
Figure 1 Flex Hose Installation

No pipe failed during this event. A flex hose was found to have failed on the discharge line of the sump injection pump. The flex hose was a certified ANSI 600 fitting. Enbridge installed the flexible hose in 2009 with the intent to isolate injection pump vibrations from the main line when reinjecting crude from the sump back into the pipeline.

The sump pump and all related piping was removed to allow soil removal for clean up. The flex hose was sent to a lab for analysis to determine the cause of failure. After soil removal was complete, the site was filled with new soil, the soil was compacted, and a new foundation was constructed to facilitate the re-installation of the pump and piping. Enbridge chose to install hard piping in the place of the flex hose.

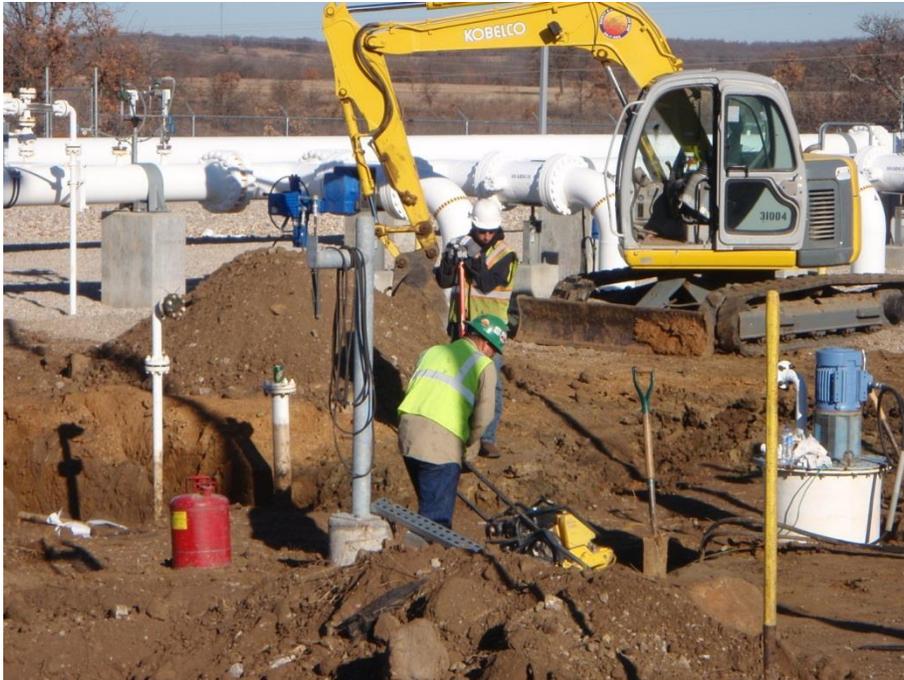
Figure 2 Site During Cleanup

When the technician returned to the station on Friday, December 14, 2012, crude oil was observed affecting an approximately 20-by-20-foot area on the ground in the station around the injection pump. The investigation indicated the release had been from the flex hose located on the pump* discharge. The volume of product in sump between the high level and low level switches is 38 barrels.

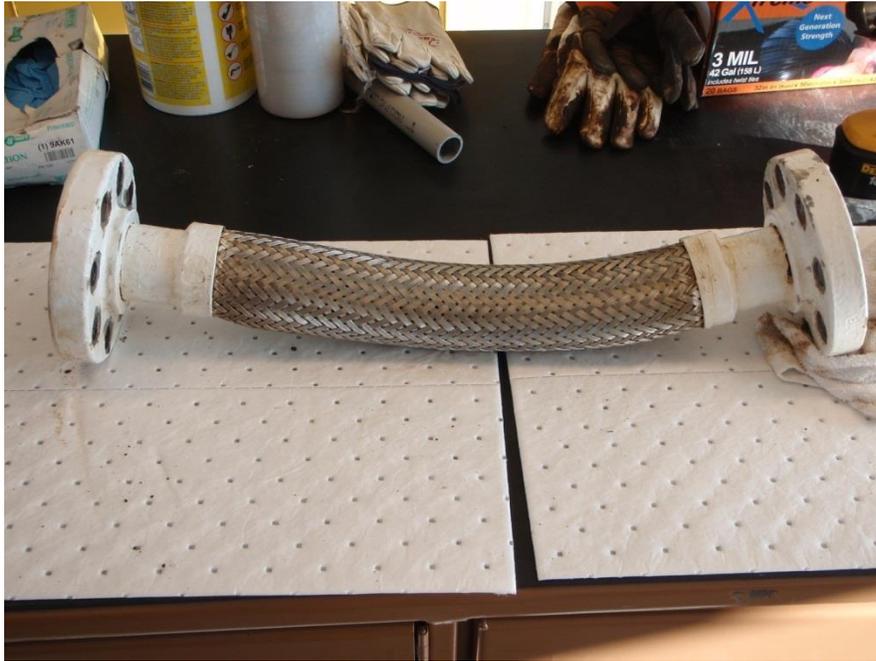
Figure 3 Failed Hose

operator. No cause for failure was apparent from a visual examination. Photos of the failed flex hose can be seen in Appendix C.

- The cause of the leak was the formation of a transverse crack along an internal convolution in approximately the middle of the hose's length.
- The failure mechanism was fatigue, and the failure cause was likely vibrations on the component resulting in high bending stresses on the convolutions.
- The uneven formation of the convolutions (with sharply bent internal convolutions) was likely a contributing factor in the failure.
- No evidence was found to suggest that material/microstructure was a factor in the failure.

The failure occurred in a flex hose. Per the metallurgical analysis, the cause of the leak was the formation of a transverse crack along an internal convolution of the hose. The failure mechanism was fatigue, and the failure cause was likely vibrations on the component resulting in high bending stresses on the convolutions.

The operator replaced two hoses (failed hose and another) downstream of the injection pump with hard pipe prior to returning the sump to service. The failed flex hose was sent to a metallurgical lab for testing.
