DOT US Department of Transportation
PHMSA Pipeline and Hazardous Materials Safety Administration
OPS Office of Pipeline Safety
Southwest Region

Principal Investigator Gene Roberson
Region Director R. M. Seeley
Date of Report 7/ 11/2011
Subject Failure Investigation Report – Mid-Valley Pipeline Internal Corrosion

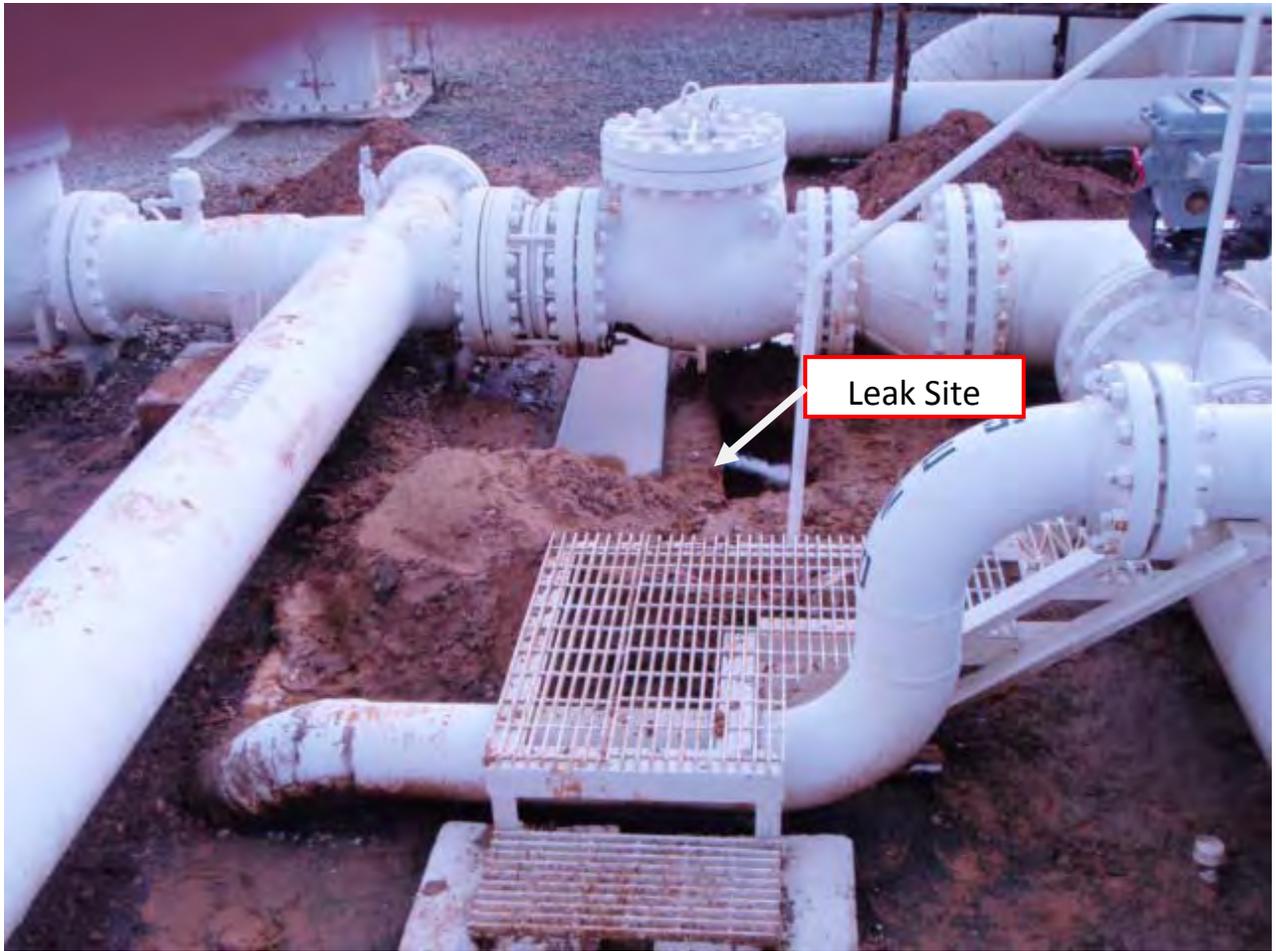
Figure 1 Leak site

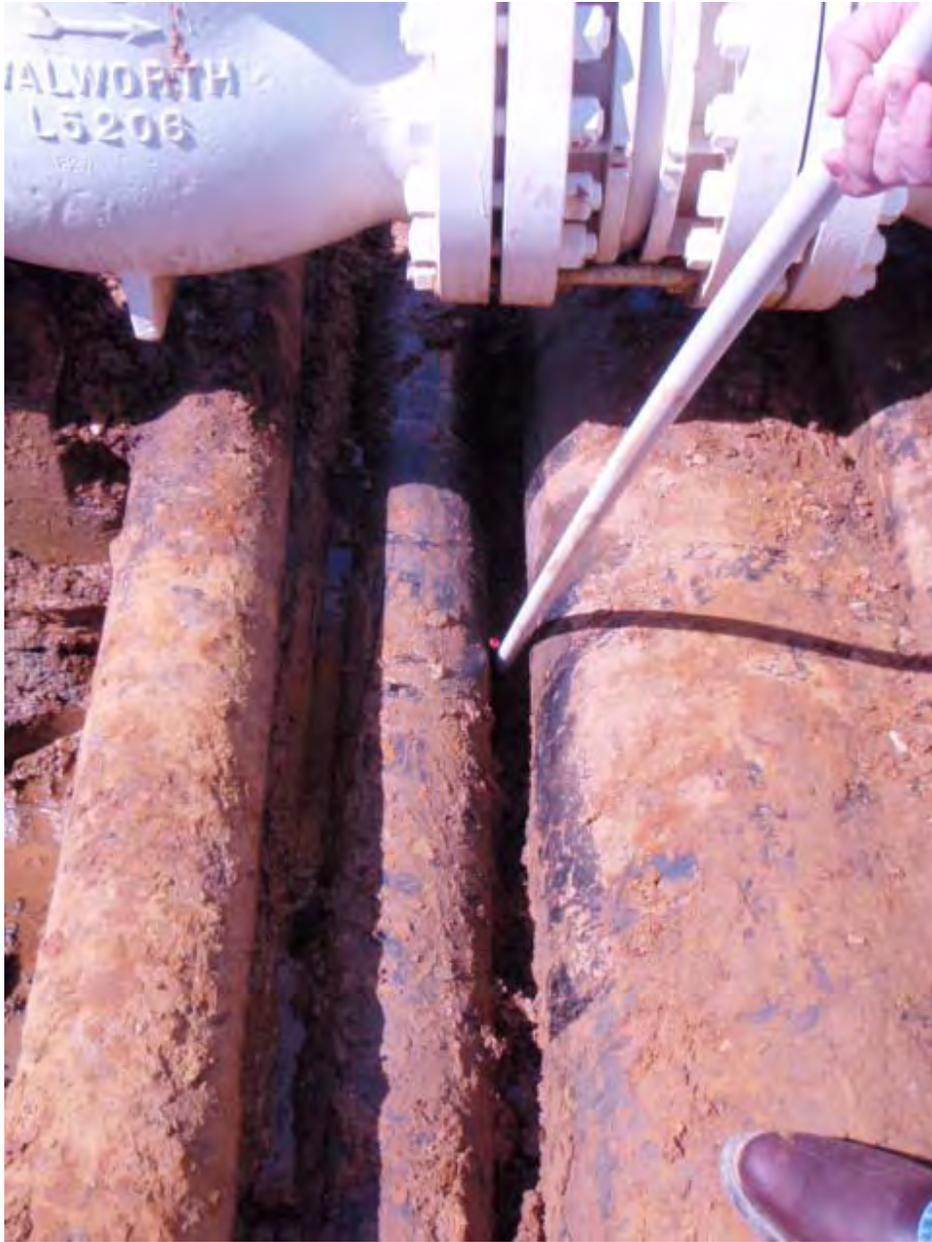
Figure 2 Exposed view of leak site

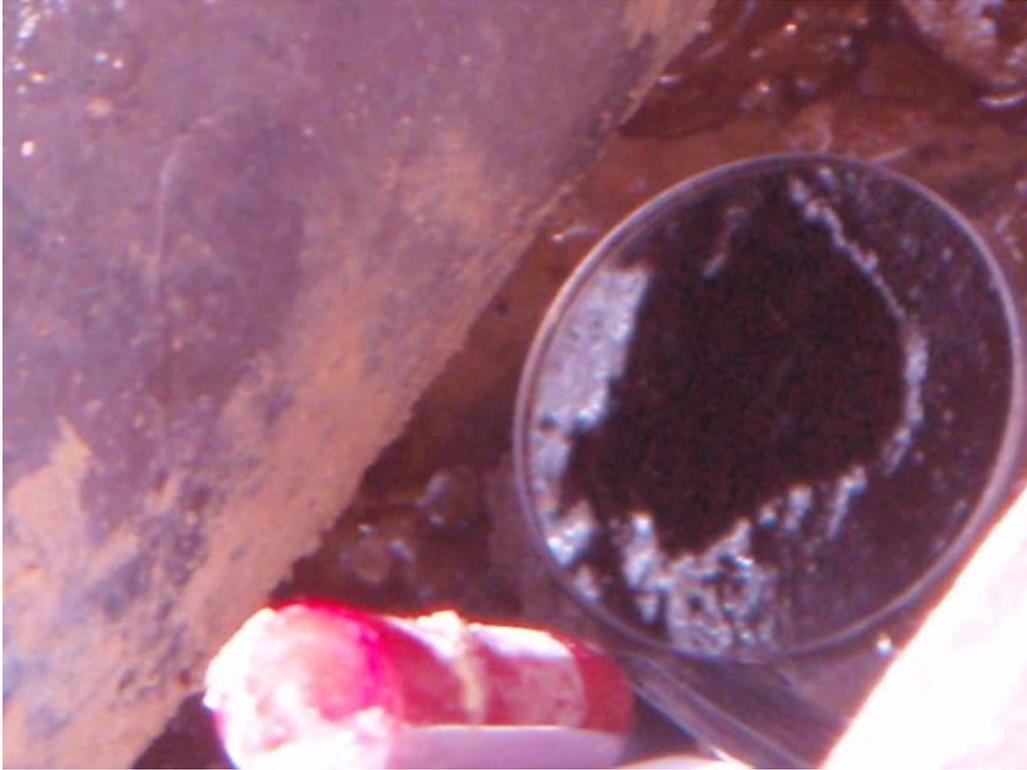
The section of pipe was not sent to a lab for analysis. Direct observation determined the failure was due to two localized spots of internal corrosion in the buried header. The failed section was a dead leg of pipe that was subject to pressure fluctuations with no flow during normal operations.

The failure initiated from 2 isolated incidences of internal spot corrosion, at the 6:00 o'clock position in the header. No other indications of internal corrosion were found in the header after it was removed and investigated.

Figure 3 Close up View of Internal Corrosion

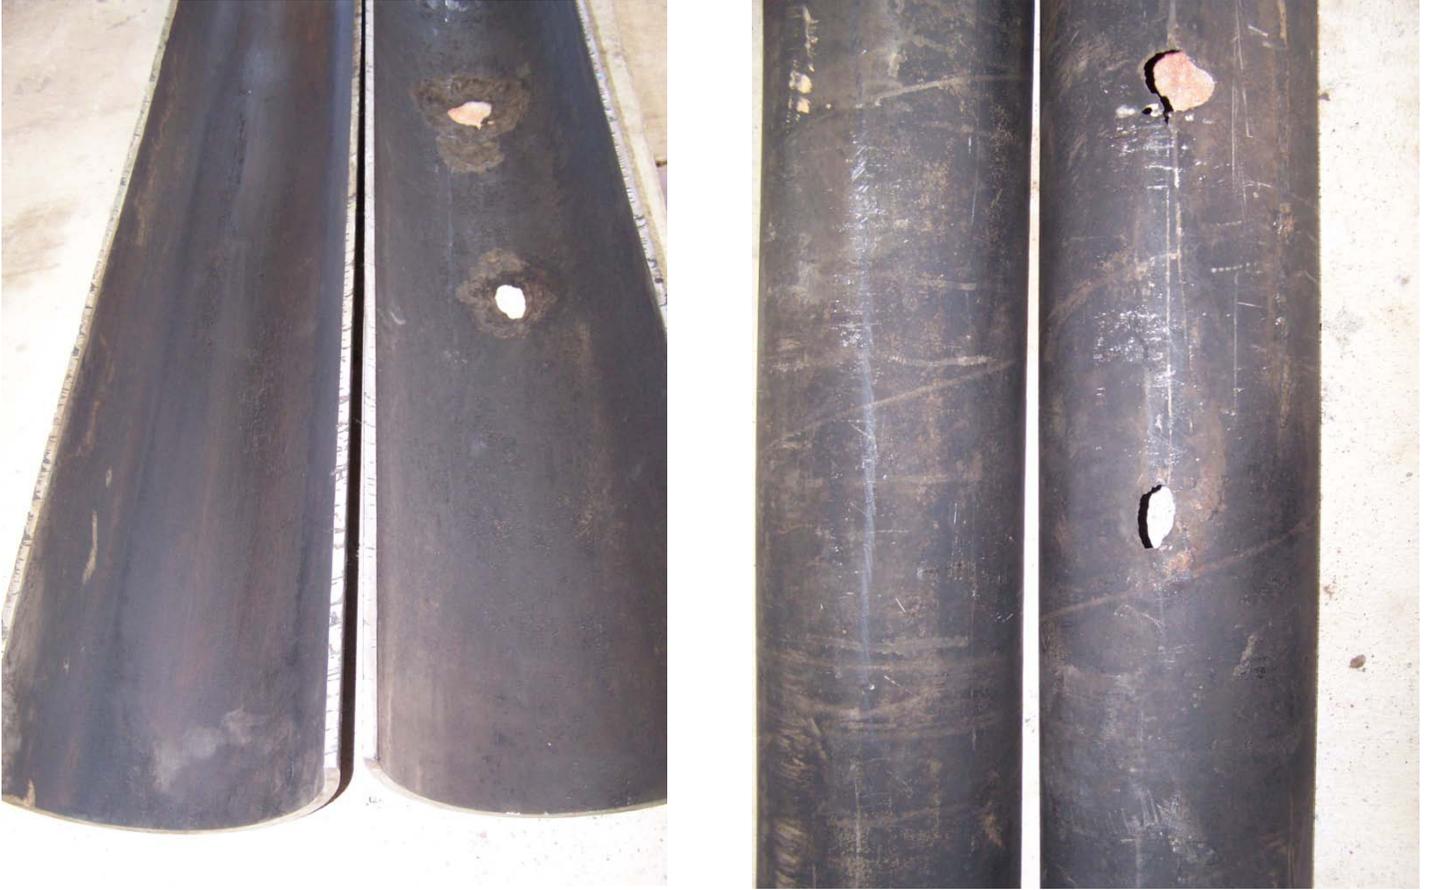
Figure 4 Removed pipe split open Internal and External Views
