FINAL REPORT

TGP MLV 205-4 + 11.28 Failure – Root-Cause Analysis

November 16, 2011 Failure

Tennessee Gas Pipeline Company LLC

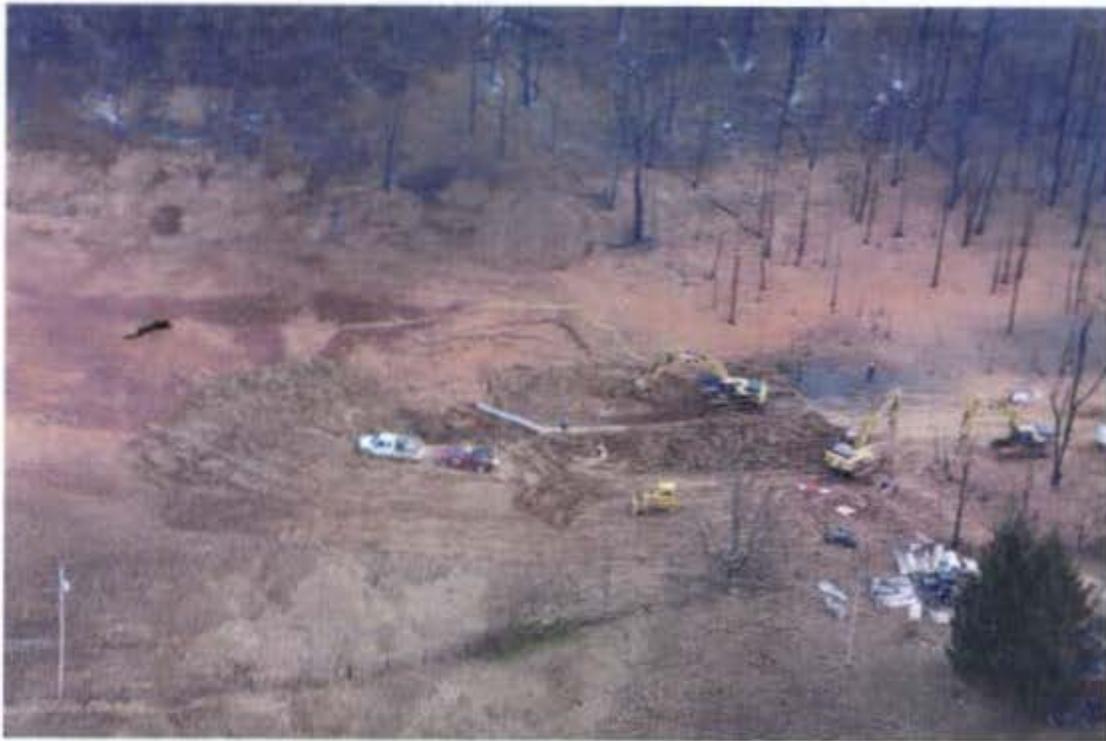
Figure 2. Aerial Photograph of Failure Site

An aerial photograph of the failure site is provided in Figure 2. The direction of flow in this photograph is from right to left and shows a section of pipe extending from the crater produced by the failure. A photograph of the soil located at an elevation higher than the crater produced by the failure is provided in Figure 3 and shows the fissures that developed near the crater. These fissures were not evident immediately after the failure but developed several days after the failure. The potential for soil movement is evident from this photograph taken a few days after the failure.

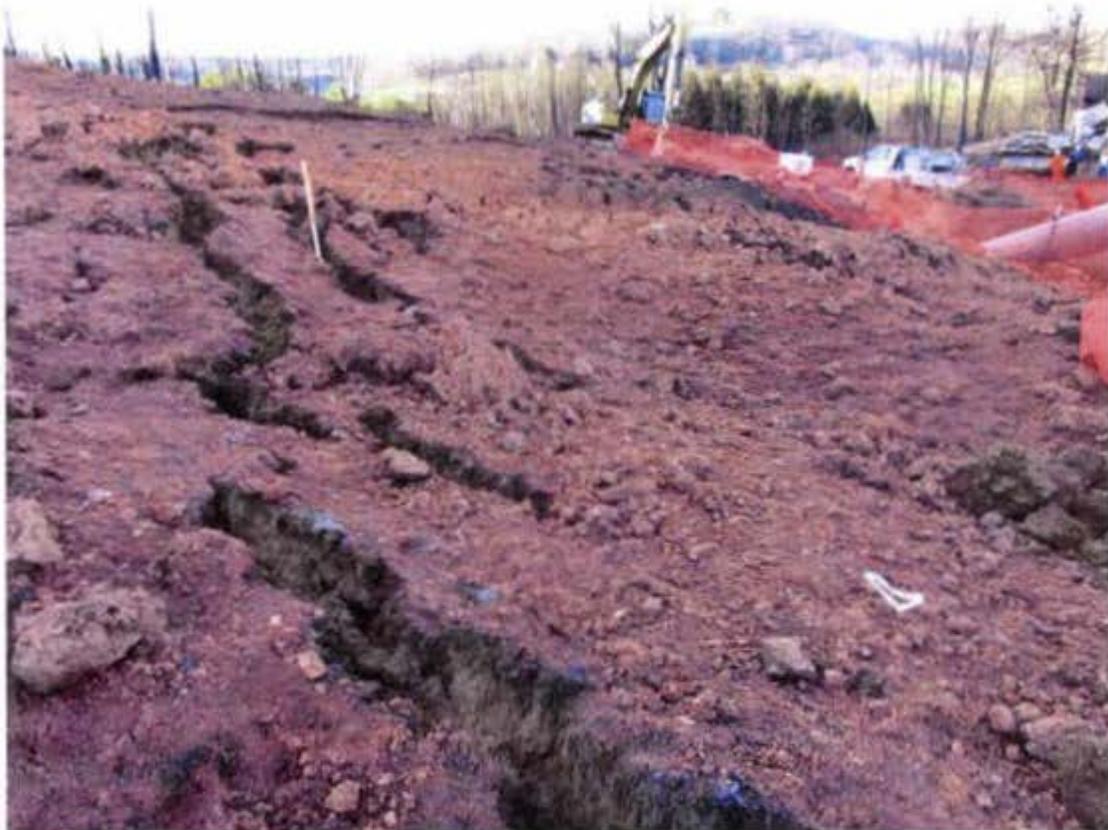
Figure 3. Photograph of Hillside Post-Failure and located above Pipeline Failure

‡ Based upon geomorphic evidence, the failure site is located within a complex landslide, spans approximately 1,000 feet along the pipeline length, and usually appears to have displaced 5 to 6 feet downslope from an as-built position.

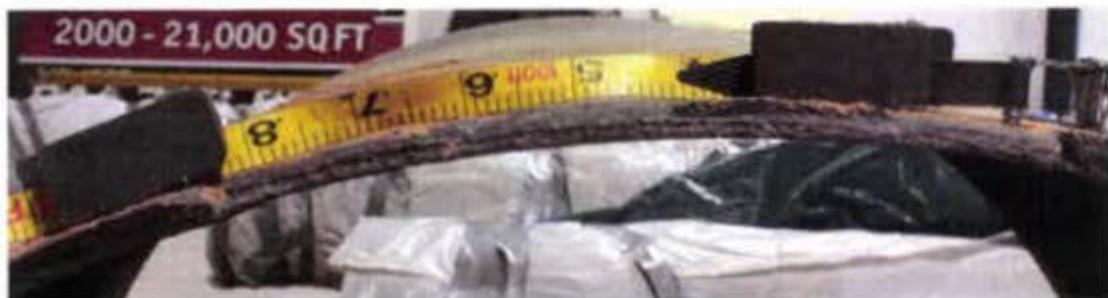
The contributing factors for this failure are best described by the conditions relative to the girth weld procedures and practices at the time of construction. These conditions resulted in the formation of a hydrogen-assisted cold crack at the toe of the root pass in the heat affected zone of the weld that was produced at the time of construction. The crack in the girth weld, as well as the girth weld itself, acted as a stress concentrator and the displacement (strain) of the pipeline occurred through the on-going progression of the landslide. Even in the absence of a crack in the girth weld, the landslide likely could have resulted in a pipeline failure at a later time if the landslide remained undetected and unmitigated.

The DNV metallurgical report¹⁴ concluded that rupture initiated at a pre-existing crack in the field girth weld. A photograph of the girth weld fracture surface is provided in Figure 4. The morphology of the crack is typical of hydrogen-assisted cold cracking and initiated at the toe of the root pass on the pipe ID.

Figure 4. Photograph of the fracture surface from Failed Girth Weld Section (U/S) from approximately 0 to 1 foot clockwise (looking D/S) of TDC.

- Continued Girth Weld Condition Assessment. Continue the development and implementation of methods to assess girth weld condition through in-line inspection and direct examination. This will be important when prioritizing the investigation of sites where landslides have been identified and for assessing girth welds exposed during strain relief excavations.

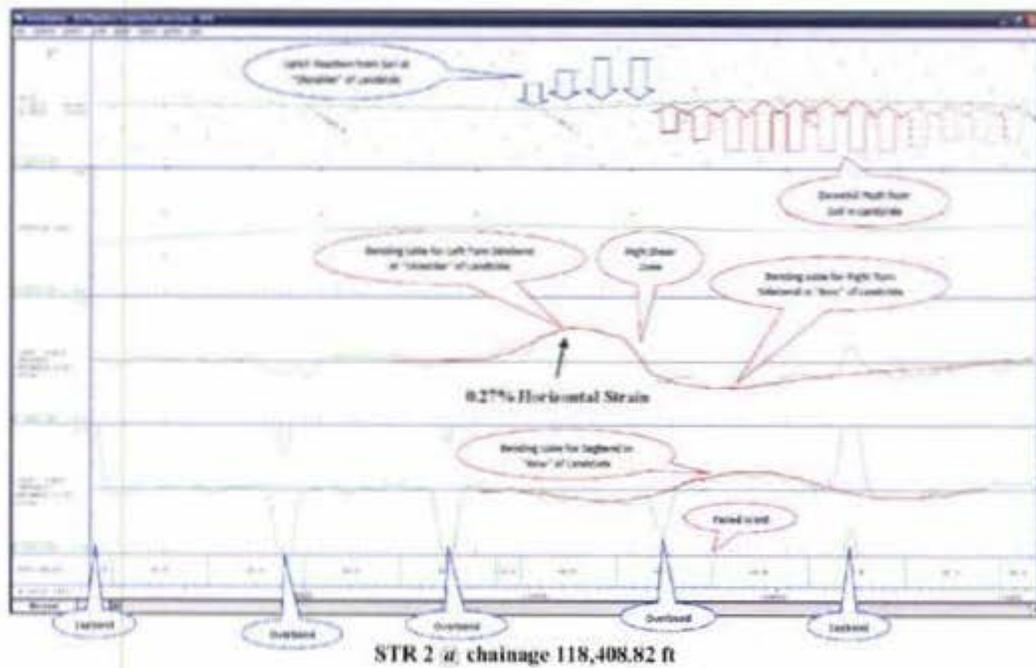
Figure 5. Preliminary Detailed Analysis of IMU Bending Strains in Proximity to MLV 205-4+11.28

An in-line inspection (ILI) was performed in June, 2011 using caliper, magnetic flux leakage (MFL), and inertial mapping unit (IMU) technologies. The original intent of the IMU was to obtain GPS centerline data for the pipeline. Post failure, TGP subjected the IMU data to a bending strain analysis³ and identified 9 locations between MLV 204-4 and 209-4 where the bending strains exceed 0.2%.

The location of highest bending strain was reported to be 0.28% and covered a length of 159 feet. The failed girth weld was located within this 159-foot long section. Detailed analysis of this location is underway²¹ and a schematic of the IMU data at the failure location is provided in Figure 5. Additional work is currently underway with regard to reviewing the IMU bending strain data and integrating these IMU bending strain data with field measurements.

- Continued validation from 205-4 + 11.28 Failure. Capitalize on the findings from this analysis to further validate ILI IMU bending straining results. Establish procedures for the assessment of loads and strains acting on pipelines including acceptance limits.
