EVALUATION OF RUPTURED DOT-E-7235 CYLINDER

Metallurgy Division

NIST

January 20, 1995

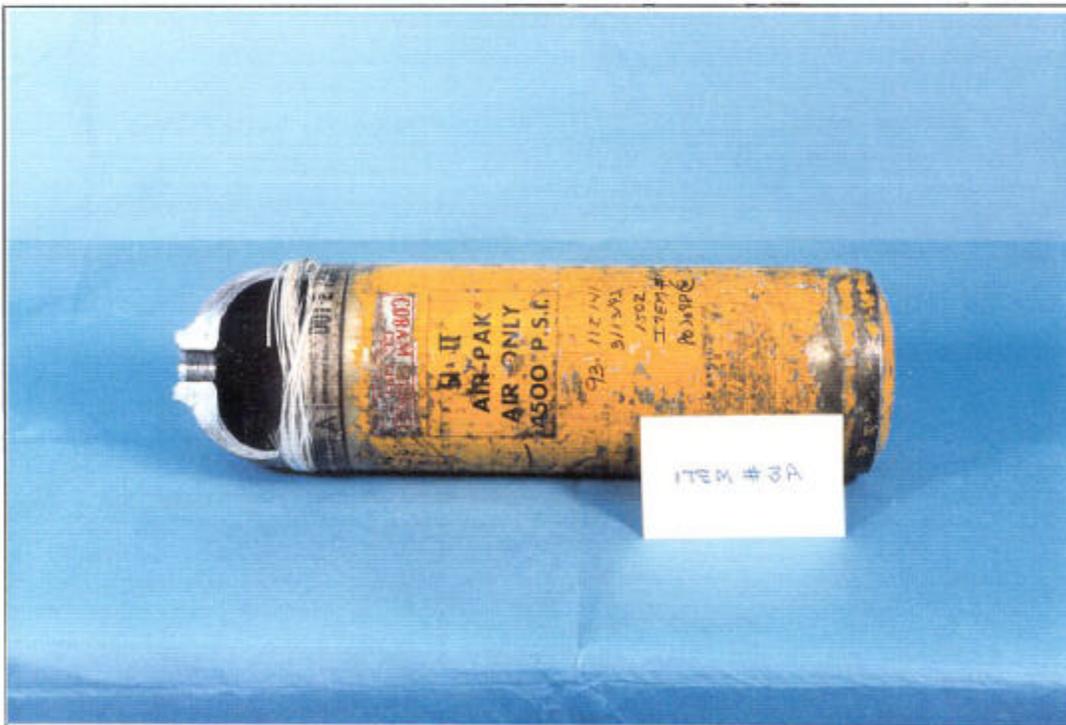
DOCUMENTATION OF THE Ruptured CYLINDER: The general condition of the ruptured cylinder received by NIST is shown in Figure 6 (Item 3A). The rupture of the cylinder resulted in the cylinder breaking into two pieces (Items 3A and 3B) as shown in Figures 6 and 7, respectively. A portion of the head of the cylinder (Item 3B) was removed as a result of the rupture. The rest of the

cylinder (Item 3A) remained intact (Fig. 6) with no significant secondary tearing or deformation of the cylinder.

DOT-E-7235 type cylinders are constructed of a seamless aluminum liner with hoop-wrapped fiberglass over-wrapping. The marked maximum service pressure of the cylinder that ruptured is 4500 psi. (Fig. 6).

FIGURE 6 SCOTT AIR PAK CYLINDER THAT RUPTURED AT NECK -- ITEM 3A

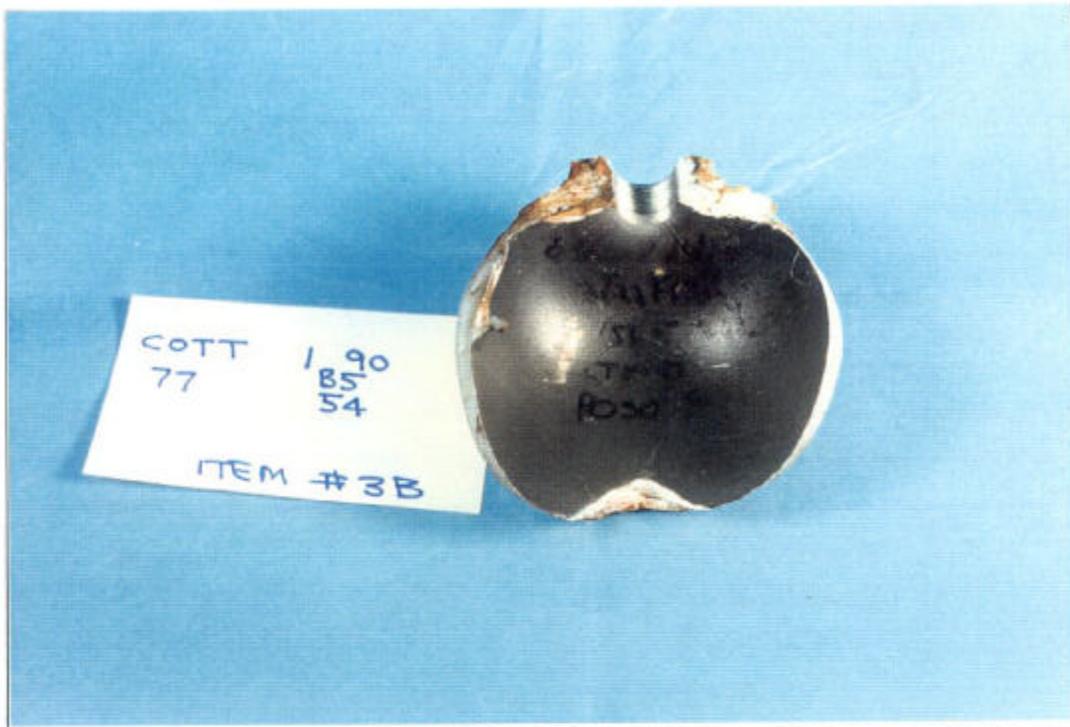
FIGURE 7 FRAGMENT OF SCOTT AIR PAK CYLINDER THAT RUPTURED --
ITEM 3A

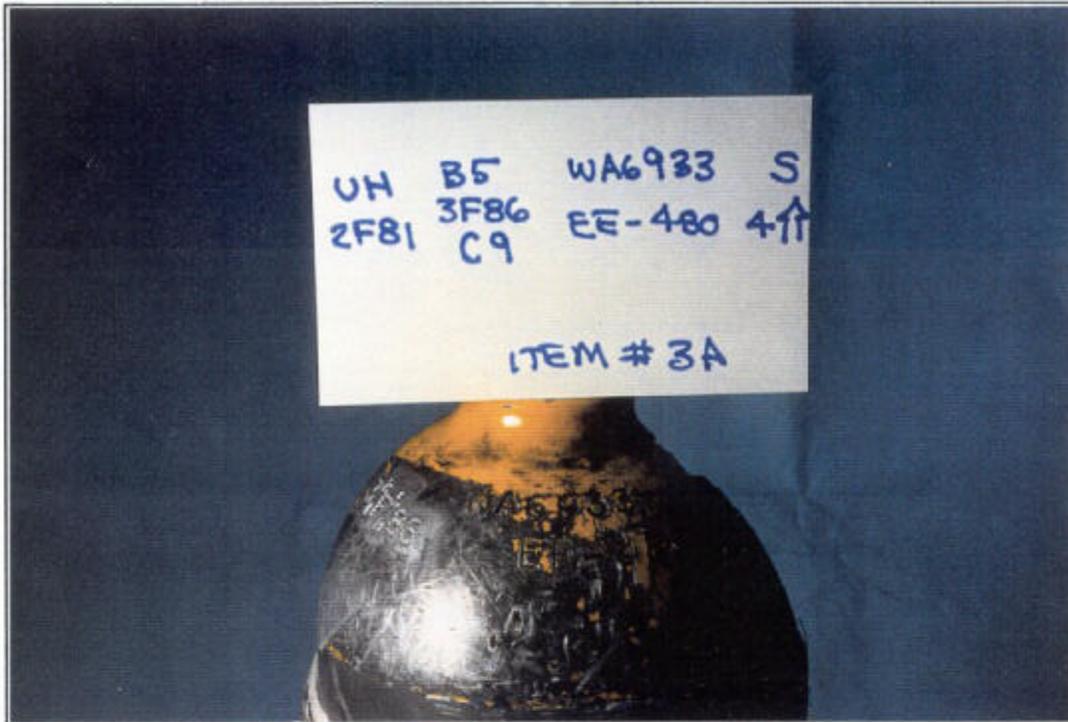
Markings on the head of the cylinder show that the serial number for this cylinder is WA 6933 (Fig.15). Other markings on the head of this cylinder show that the elastic expansion value at the time of manufacture was EE-480 (this value is referred to during the hydrostatic retest). The number "4" next to an upright arrow on the head of the cylinder is the first part of the marking showing the date of the first hydrostatic test which is taken as the date of manufacture of the cylinder (the other part of the date of first hydrostatic test is on part 3B). The "4" indicates the month as April. The upright arrow is the symbol for Authorized Testing Inc. which is the DOT independent inspector for Luxfer U.S.A. Ltd. The other marking on this section of the head is an "S" which is part of the name Scott who was the ordinal purchaser of the cylinder. Figure 16 shows more details of the markings on the head of the Item 3A part of the cylinder. These markings show that the cylinder was retested, as required by DOT, in 1981 and 1986.

In addition to the markings on the head of the cylinder, Figure 15 shows that the cylinder that ruptured had not been fitted with a steel neck ring as required by the DOT notice of August 15, 1985 (Ref. 2). The absence of a neck ring is seen by the yellow paint to the very end of the neck on the cylinder and by the lack of any machining on the neck that would be required before a neck ring could be fitted (Fig. 15). There was no physical evidence that the cylinder which ruptured had ever had a neck ring or had been machined in preparation for fitting a neck ring.

FIGURE 15 MARKINGS ON THE HEAD OF THE RUPTURED CYLINDER SHOWING THE SERIAL NUMBER -- ITEM 3A

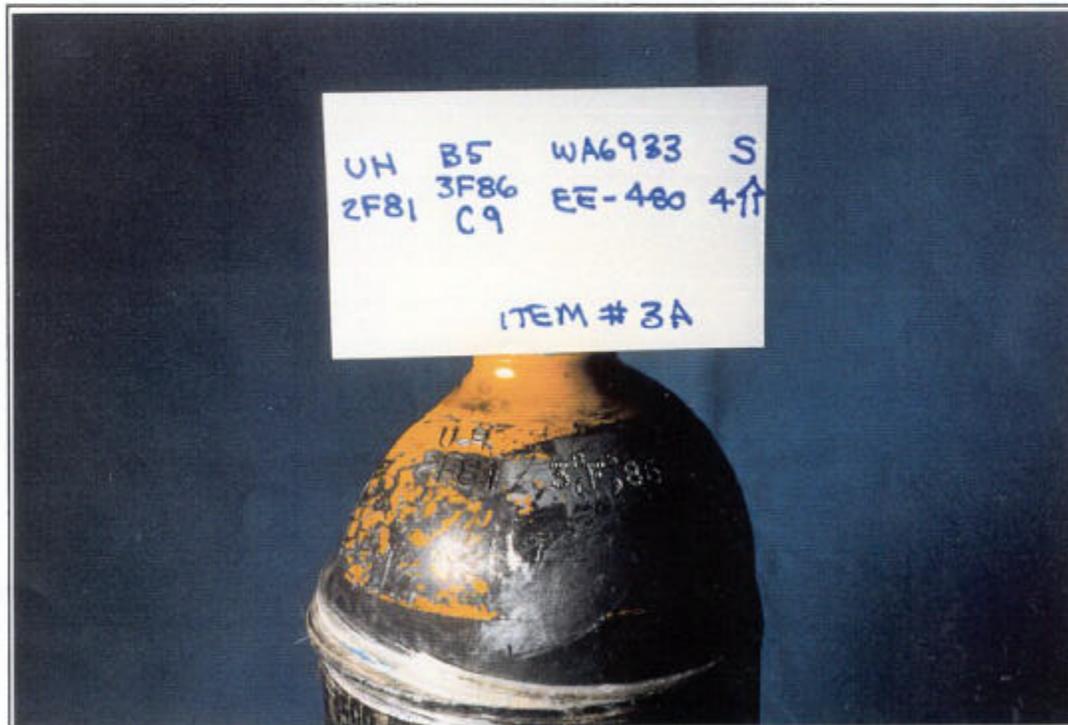
FIGURE 16 MARKINGS ON THE HEAD OF THE RUPTURED CYLINDER SHOWING THE DATE OF RETESTS -- ITEM 3A

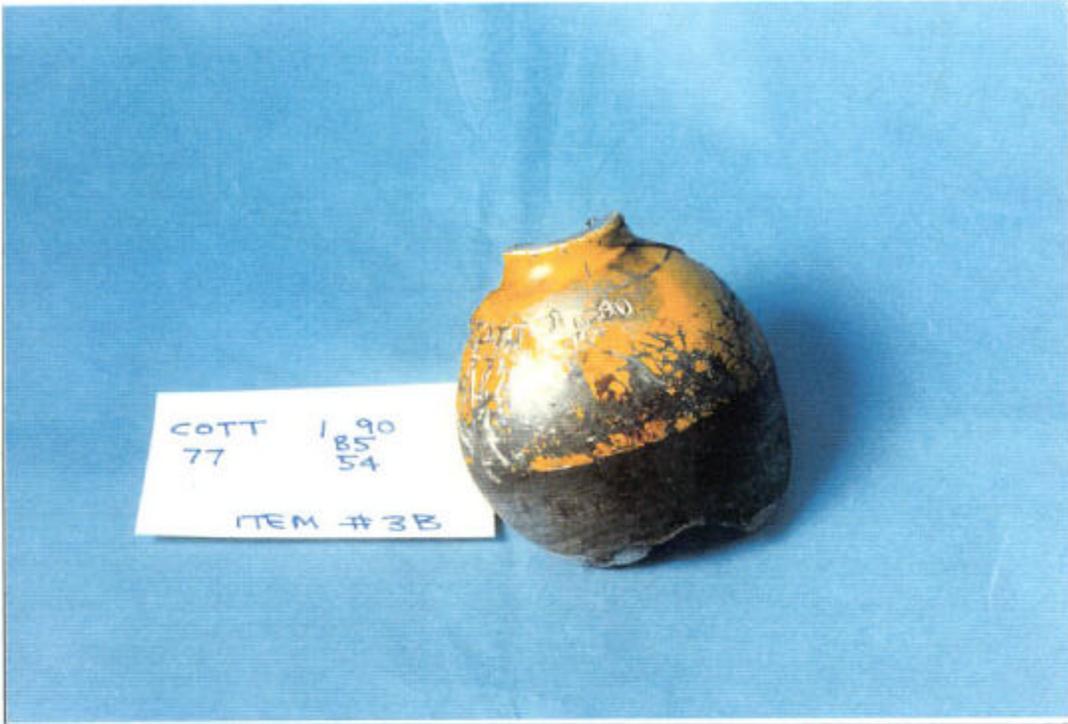
The rest of the markings on the head of the cylinder are shown on the section of the cylinder head that came off during the rupture (Item 3B) that is shown in Figure 17. The markings on this section of the head show the markings "COTT" which is the rest of the name of the ordinal purchaser, i.e., SCOTT and the year of manufacture, which is "77" for 1977. This section also shows the date of the last retest which is 1990.

FIGURE 17 MARKINGS ON THE HEAD OF THE CYLINDER THAT RUPTURED SHOWING THE YEAR OF MANUFACTURE -- ITEM 3B

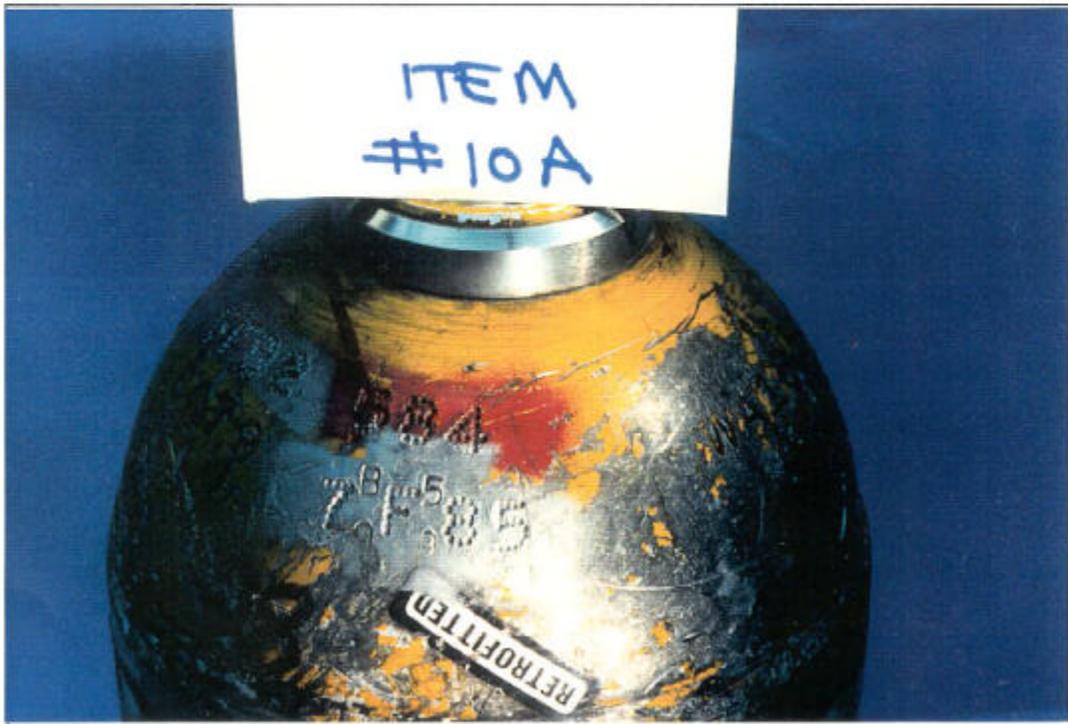
For comparison, a typical DOT-E-7235 cylinder of the same design which had been retrofitted with a steel neck ring is shown in Figure 18. In Figure 18, the neck ring is visible as the shiny silver colored attachment on the neck of the cylinder. The purpose of the steel neck ring is to prevent rupture of the cylinder when cracking occurs in the shoulder of the cylinder. When cracking occurs in the shoulder of cylinders manufactured according to DOT exemption E-7235, the cylinders have been shown to only leak when they are fitted with a neck ring but to rupture when the neck ring is not present.

FIGURE 18 EXEMPLAR CYLINDER FITTED WITH STEEL NECK RING -- ITEM 10A

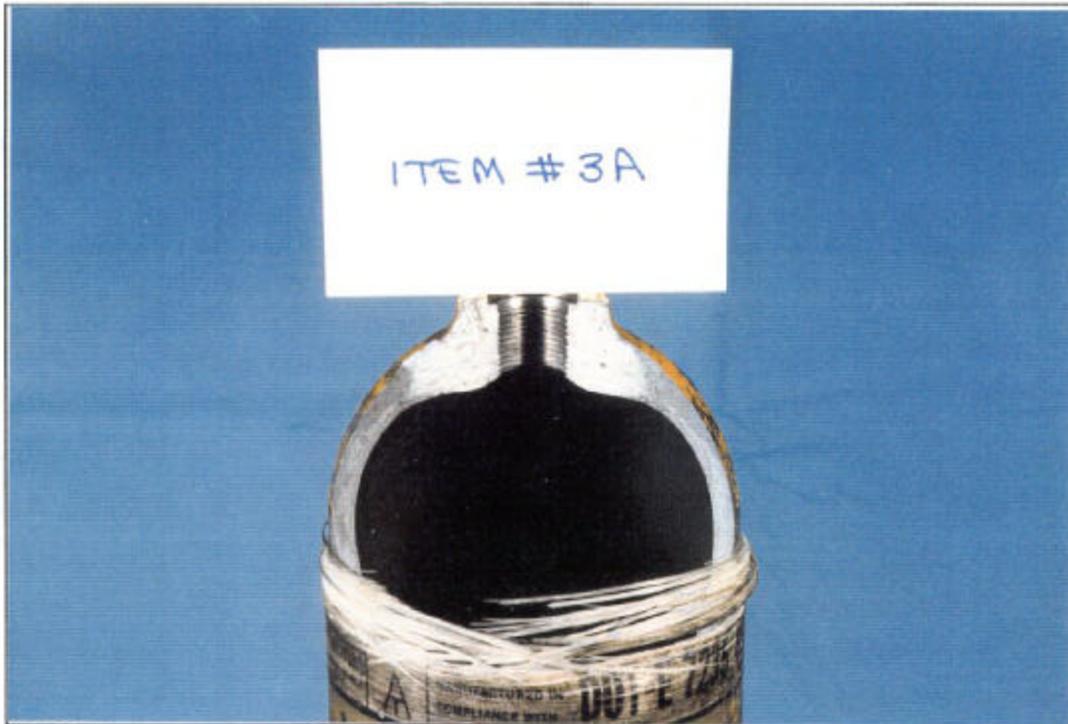
GENERAL CHARACTERIZATION OF THE RUPTURED CYLINDER: Photographs were taken of the ruptured part of the cylinder to identify the size, shape, and fracture appearance of the origin of the rupture. As shown in Figure 19, the rupture appears to initiate at the shoulder of the cylinder and propagate around cylinder head and cause the cylinder head to tear off. On closer examination of the shoulder of the cylinder, as shown in Figure 20, there appears to be shoulder cracks on each side of the threaded region of the cylinder. These shoulder cracks are believed to be the origin of the rupture which then propagated around the head of the cylinder and down to the region of the cylinder body that was wrapped with fiberglass. Figure 21 shows that the region of the cylinder shoulder at the base of the threaded region has a different, more shiny, appearance than the remainder of the fracture surface. This shiny region is believed to be the preexisting cracked region that led to the final rupture.

FIGURE 19 FRACTURE APPEARANCE OF THE HEAD OF THE RUPTURED CYLINDER -- ITEM 3A

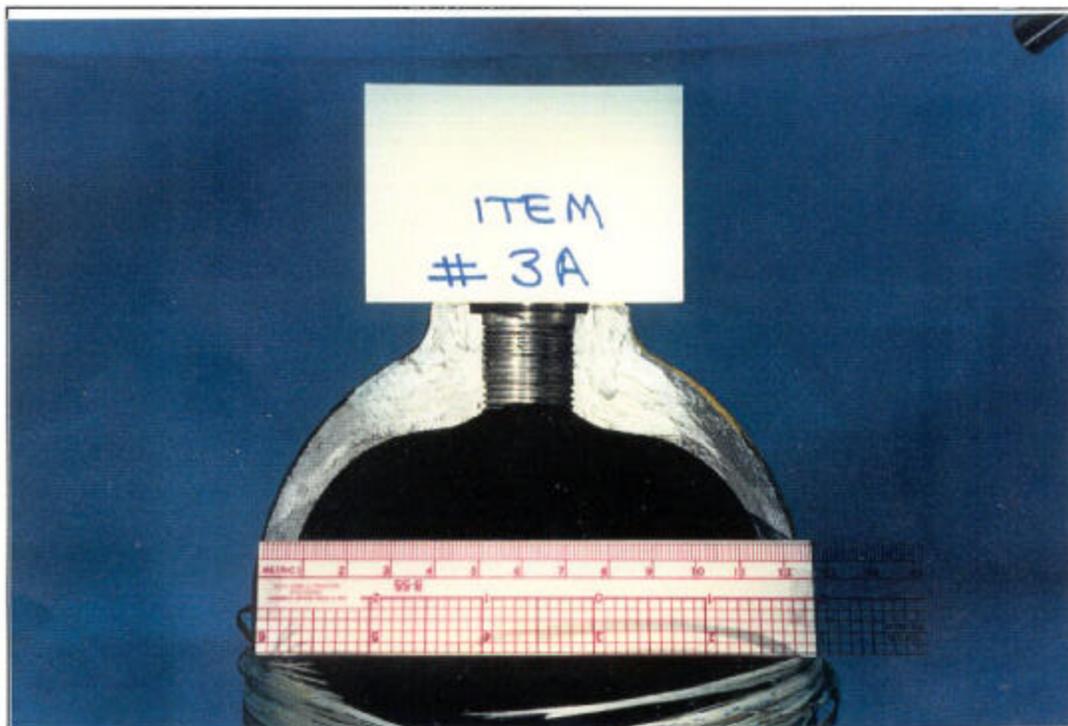
FIGURE 20 HEAD OF THE RUPTURED CYLINDER SHOWING LOCATION OF CRACKS IN THE SHOULDER OF THE CYLINDER HEAD -- ITEM 3A

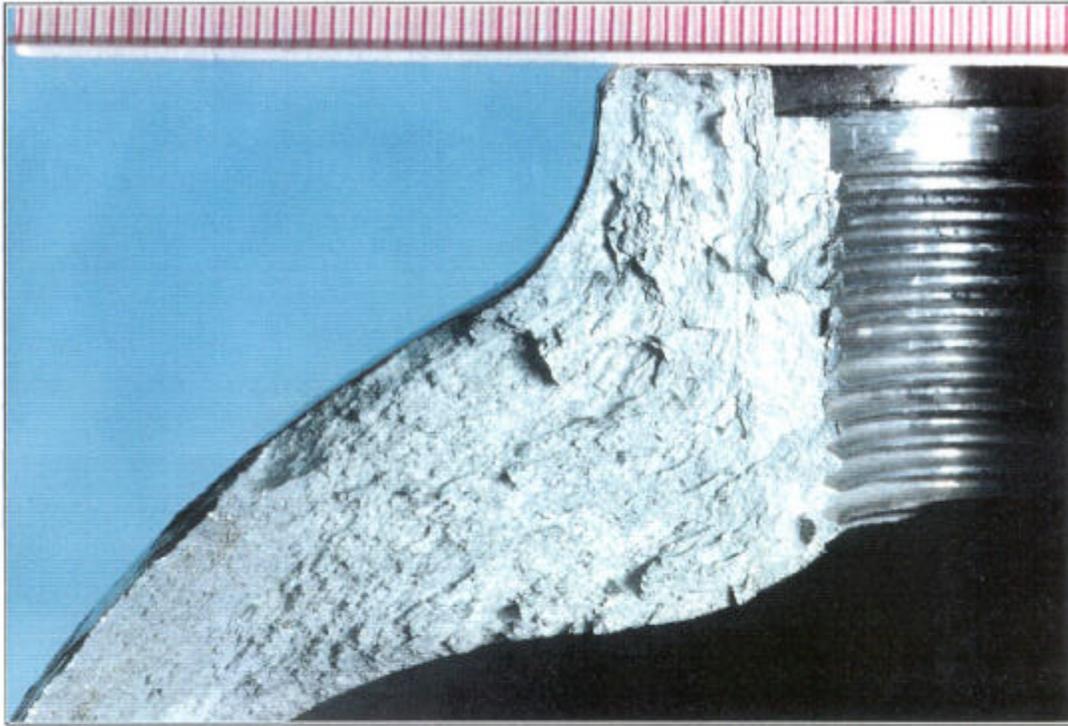
FIGURE 21 CLOSE UP PHOTOGRAPH OF THE CRACKED REGION OF THE CYLINDER HEAD -- ITEM 3A

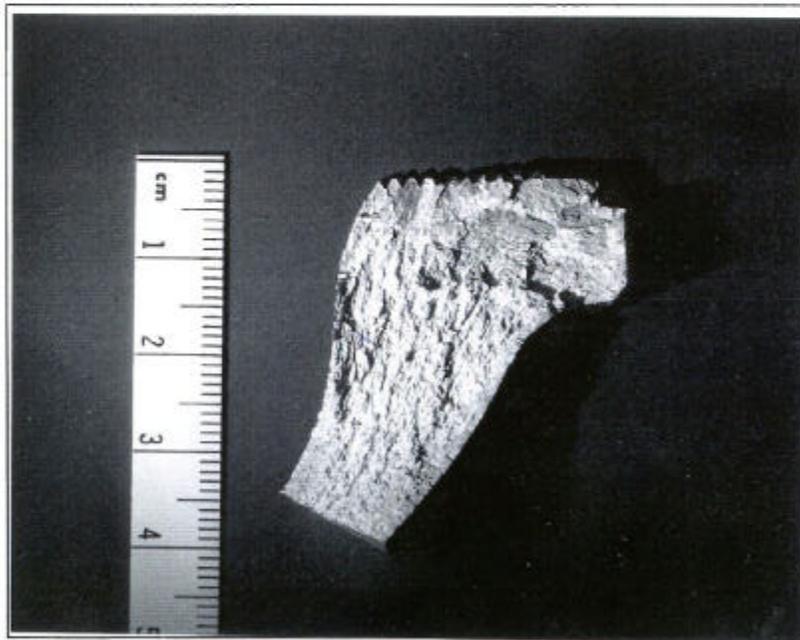
A specimen was cut from the cylinder shoulder, as shown in Figure 22, for examination in the scanning electron microscope. The entire surface of this specimen was examined to characterize the type of fracture that occurred. The fracture surface of this specimen in the lower left corner (Fig. 22) near the bottom end of the threads is shown in Figure 23. At this location, the fracture surface was characteristic of a type of intergranular, ductile fracture known as sustained-load-cracking (SLC) that has been found to occur in type AA6351 aluminum alloy (Ref. 5). This type of cracking occurs over time when the metal is stressed at a high level as it is in these type of cylinders. This region of the cylinder shoulder is believed to be the origin of the final rupture of the cylinder.

FIGURE 22 SPECIMEN FROM THE SHOULDER OF THE RUPTURED CYLINDER USED FOR MICROSCOPIC EXAMINATION
