Principal Investigator Joe Elmer
Senior Accident Investigator Karen Butler
Region Director David Barrett / Allan Beshore
Date of Report 8/10/2015
Subject Failure Investigation Report – Magellan Pipeline Company, LP – Other Accident Cause

Date of Failure 11/22/2012
Commodity Released Gasoline
City/County & State Coralville / Johnson, Iowa
OpID & Operator Name 22610 Magellan Pipeline Company, LP
Unit # & Unit Name 3953 (WPL) CHICAGO UNIT
SMART Activity # 144161
Milepost / Location 0+00, Iowa City Station & Terminal
Type of Failure Leak
Fatalities 0
Injuries 0
Description of area impacted Terminal Facility (HCA)
Total Costs \$158,100

Failure Investigation Report – Magellan Pipeline Company L.P. Breakout Tank Leak

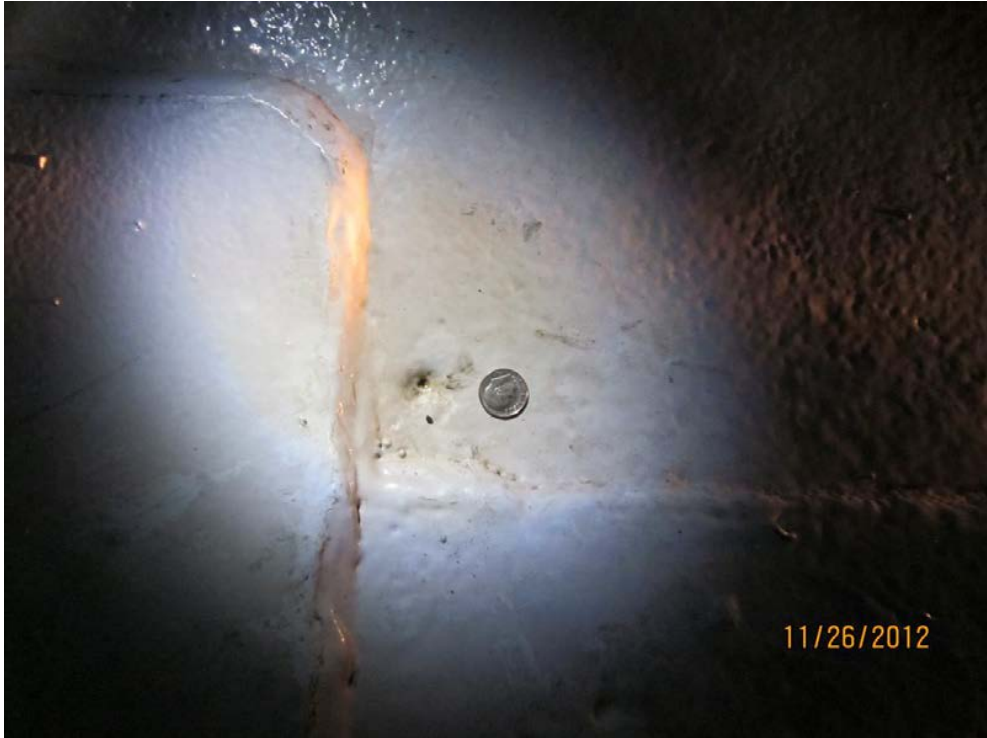
On November 24, 2014 the tank floor was cleaned and a through wall hole was discovered in the bottom of the tank. The hole was located near the south entrance .

The failure analysis performed by Kiefner and Associates did not identify a specific cause of the hole in the bottom of the tank. While conclusive evidence does not exist to determine the exact cause of the hole, it is strongly suspected that a leak at the coupling joint in the abrasive blasting equipment hose caused grooving in the floor in three areas and created the hole that caused the leak.

Visual indication of the through-bottom hole, 11/26/2012
(Magellan provided the photograph)

On November 29, 2012, HMT Inc. performed a vacuum test on all bottom and corner welds. No additional through bottom holes were identified. A 20-inch by 20-inch section was cutout that contained the hole in the floor and the section was sent to Kiefner and Associates for analysis. The damaged section of floor was repaired in accordance with API 653 and inspected by an API 653 inspector.

Corrective action taken: The internal epoxy lining specification has been updated to include wording that requires a protective sleeve be installed over all blast hose connections that come in contact with the blast surface. The specification requires that the fittings and protective sleeve be inspected before and after blasting activities to ensure the connection(s) are intact. If damage is found to the protective sleeve or hose connections that would be indicative of an abrasive leak, the blast surface will be visually inspected for damage.

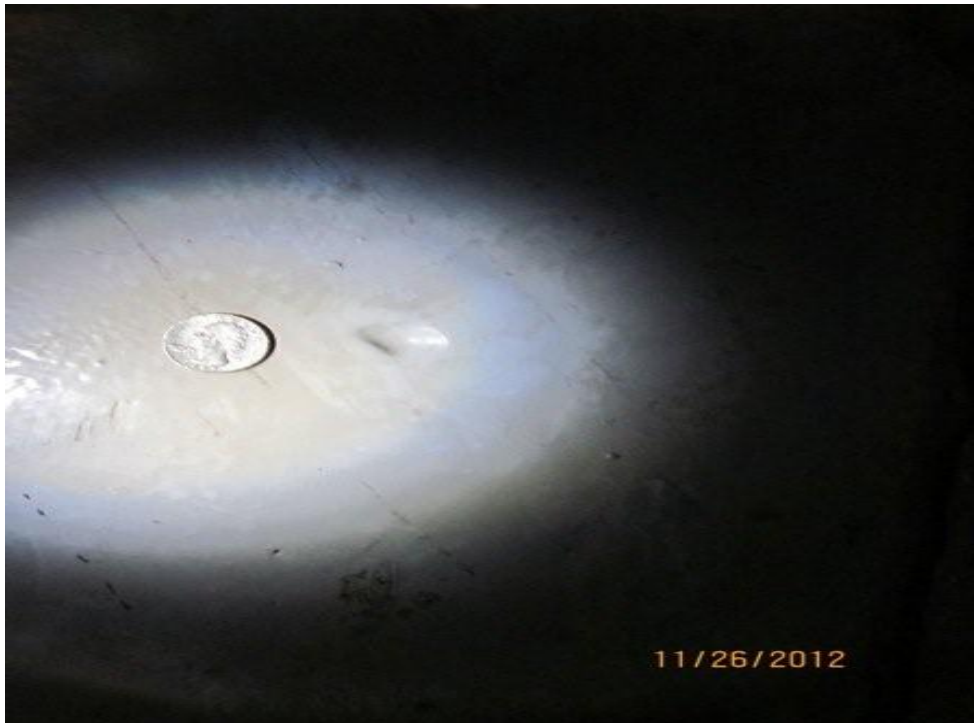
Visual indication of defect in close proximity to the hole, 11/26/2012
(Magellan provided the photograph)

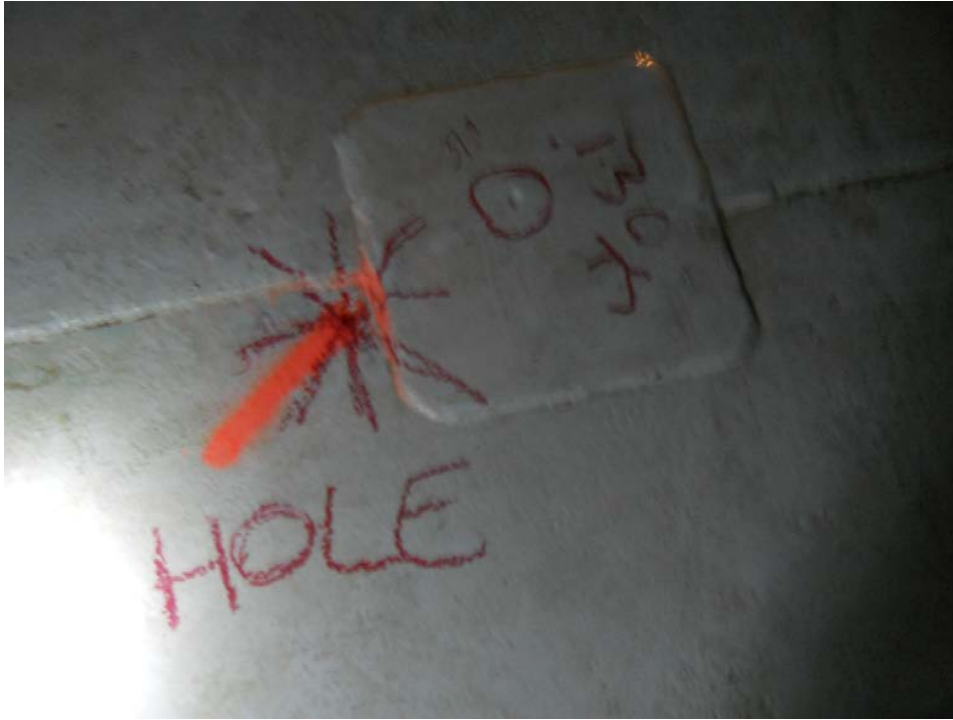
Visual indication of hole and the defect in close proximity to the hole, 11/29/2012. The patch was installed as part of an OOS inspection in 1997.

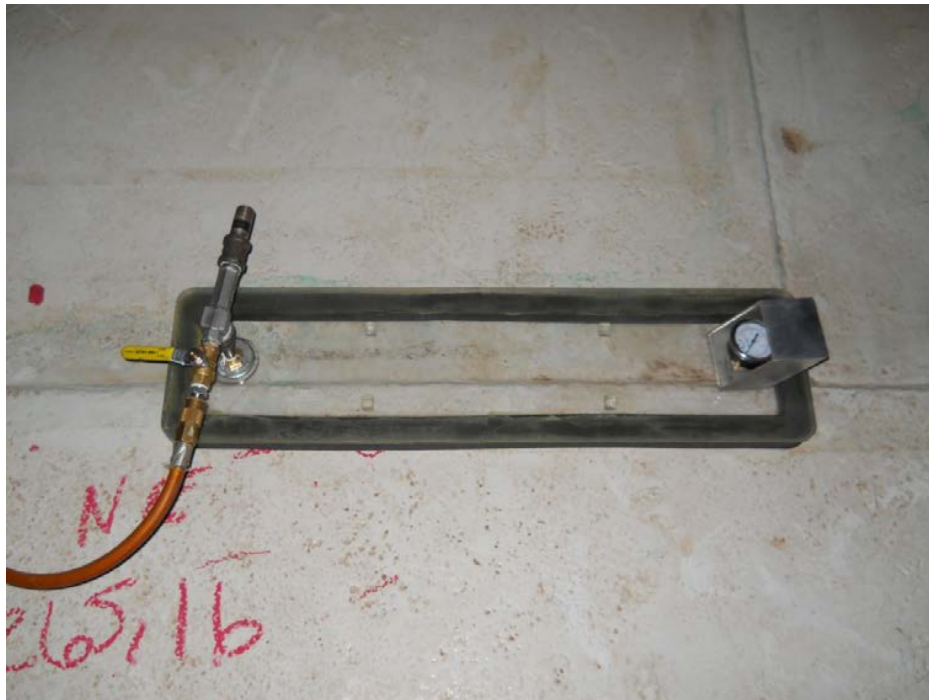
Example of vacuum box testing of the bottom welds conducted on 11/28/2012.

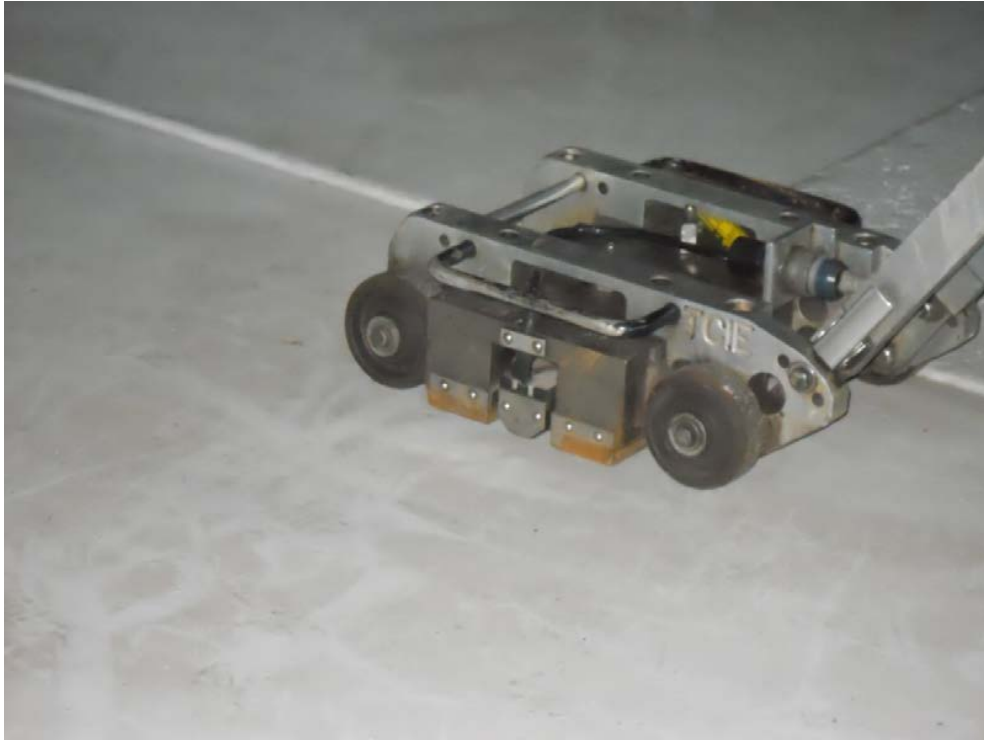
On November 28, 2012, Tank Consultants, Inc. performed a magnetic flux exclusion (MFE) scan on the entire floor. No additional through bottom holes were identified.

Example of MFE scanning on 11/28/2012.
(Magellan provided the photograph)
