Investigators Richard Lopez and Joseph Elmer
Region Director R. M. Seeley
Date of Report April 19, 2012
Subject Failure Investigation Report – Chevron Coahoma LPG Loop

Failure Investigation Report – Chevron Coahoma LPG Loop

Failure Date 9/8/2011

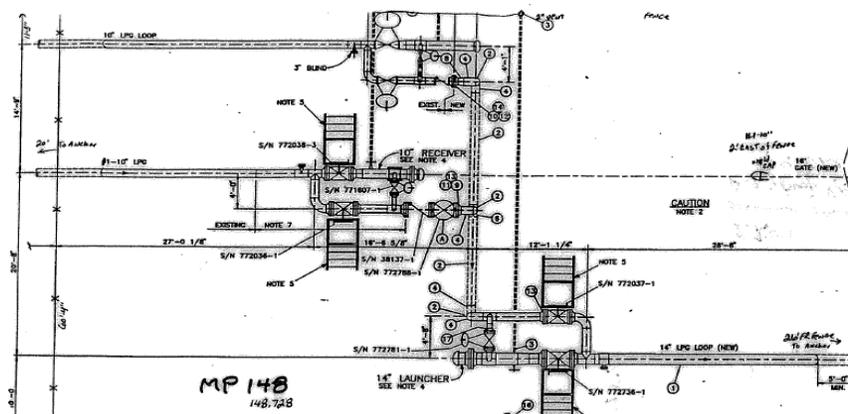
Sketch 1 – Pig Trap upstream of failure site (flow is from left to right)

The leak site is approx. 17.2 miles east CPL’s Coahoma pump station (Howard Co. TX.) and approx. 40-feet west of the MP 148.8 pig trap (Mitchell Co. TX). The area where the leak occurred is remote, isolated ranch land. The terrain is generally flat with arid soil conditions typical of the West Texas region.

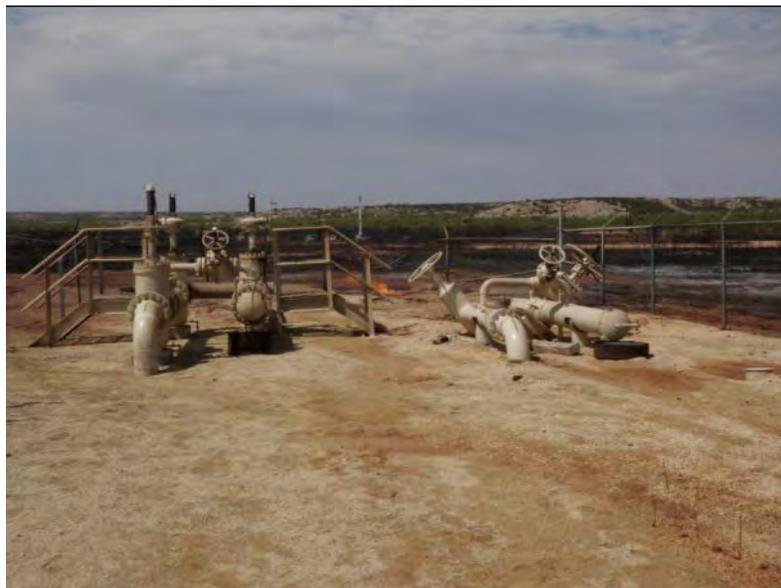
Photo 2 – Pig trap area facing upstream

The photo is an upstream view of the two 10-inch pipelines within the trap area. The line on the right hand side is the 10-inch Loop line – the line that failed. The line in the middle was not affected. The line on the left is the 14-inch line that continues to Mt. Belvieu. Fire during the accident engulfed both 10-inch pipelines in the trap area. Product from the failure site that is still burning can be seen in the background. Temporary flares can also be seen in the background.

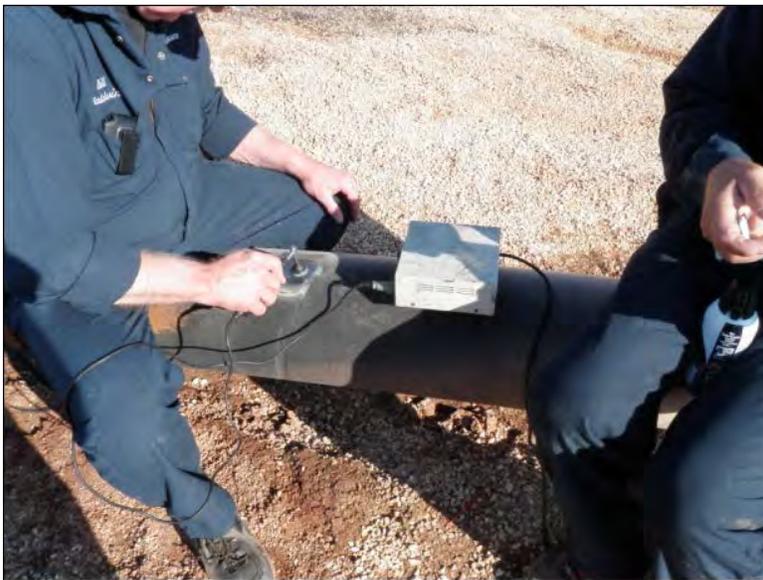
Photo 3 – Chevron specialists performing integrity tests

Both of the aboveground segments of the 10-inch pipelines and their respective main line valves located at the MP 148 valve site were engulfed in the fire. The aboveground pipe was tested for integrity by Chevron material specialists. They conducted both the Brinnell and Rockwell hardness tests and concluded that both lines were safe to operate.

The valves on the inside 10-inch line (Line 2) in the scraper trap were evaluated by Chevron personnel after purging the LPG from the line. The valves internals on the line were then removed and replaced by a contractor. With the valves rebuilt, Line No. 2 was returned to service. No upstream service disruptions to Gas Processing Plants were caused by this accident.

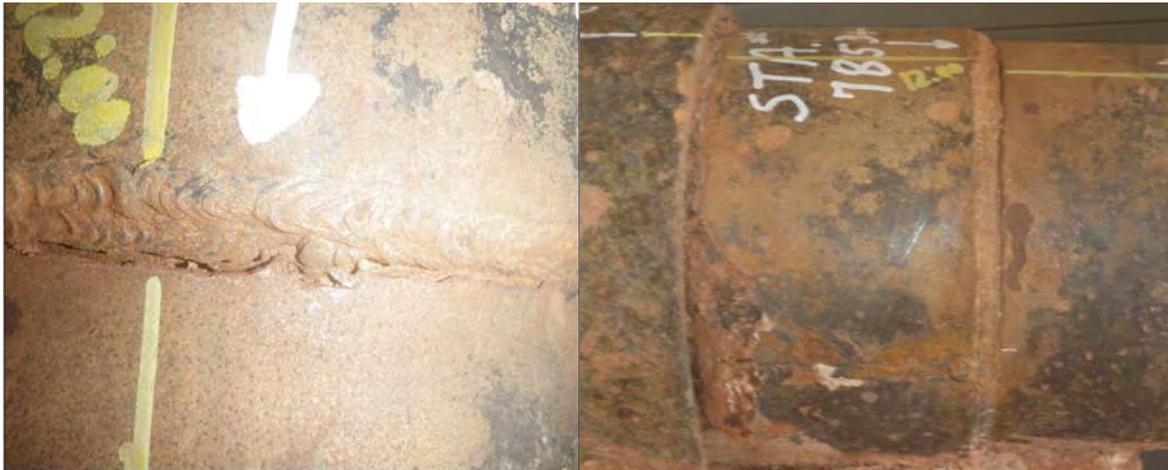
Photos 4 and 5 – Showing the failure and the location of the failure

Subsequent initial visual inspection of the failed section of pipeline showed the failure likely initiated at an anchor on the 10-inch Loop line. It is not known when or why the anchor was installed. The failure appeared to have occurred near the fillet weld where a reinforcing sleeve had been welded to the pipeline at an anchor.

The damaged segment was transported to Stress Engineering Services (SES) in Houston, TX for analysis. The probable cause of the failure was determined to be a crack in the 10-inch diameter pipe located at the upstream fillet weld of the external sleeve. The crack was the result of a combination of bending loads and excessive hardness in the heat affected zone (HAZ) of the weld.

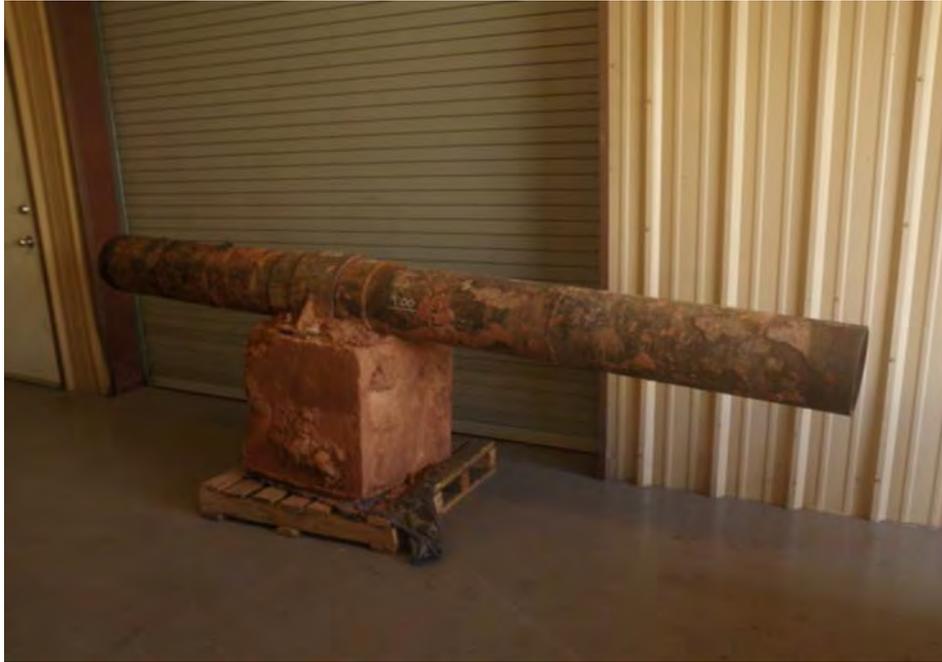
Photo 6 – Segment removed for metallurgical testing

The pipeline segments involved in the incident were shipped to SES in Houston, TX for metallurgical analysis. SES's analysis (Appendix D) identifies that:

1. The failure occurred near the fillet weld of sleeve on an anchor near a pig trap.
2. The controller's actions were appropriate and the incident location was isolated promptly.
