TC Oil

RCFA for the Keystone Milepost 14 Release

April 21, 2023

Final Report

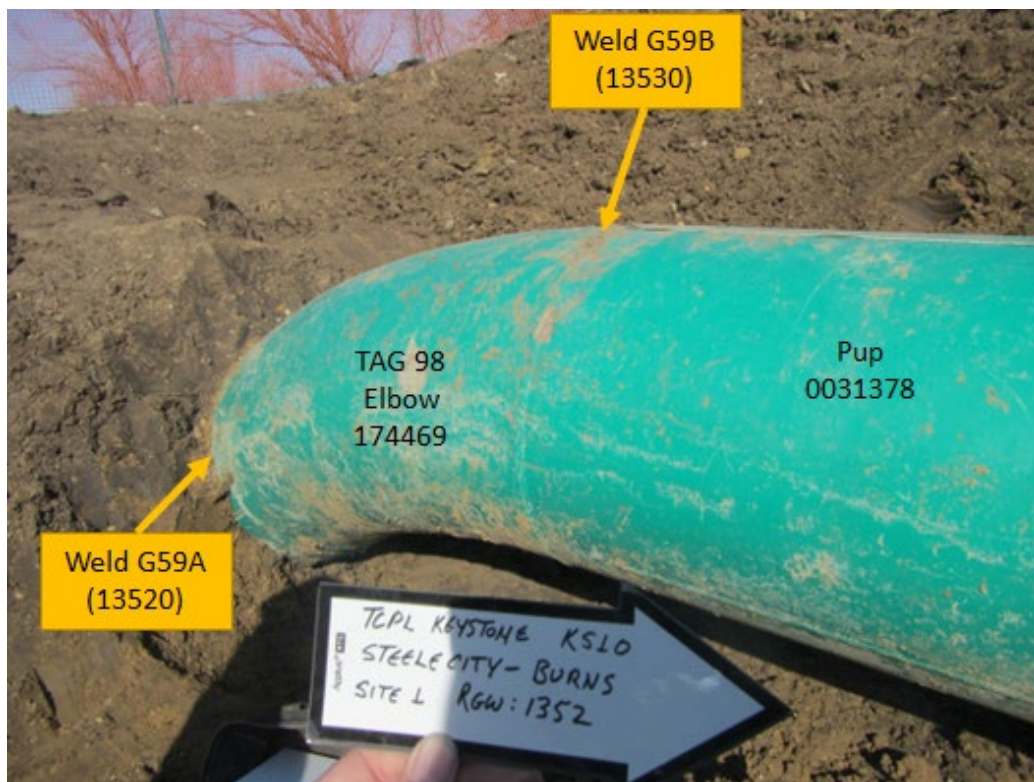
Figure 11. TAG 98 Bend Assembly (BND 350) During March 2013 Excavation to Investigate ILI-Called ID Restriction (March 1, 2013)

The 2012 profile caliper ILI tool identified a [REDACTED] ID restriction (due to ovality) in the TAG 98 bend assembly that had damaged the cleaner and gauge tools run prior to the caliper tool. An excavation was performed in March 2013 to evaluate the restriction. A [REDACTED] ovality was measured in the field and ultrasonic wall thickness measurements were taken. The ovality was determined not to be an integrity concern at the time as it pertained to future ILI runs and the bend assembly was backfilled without any further interventions. While the excavation was still open, discussions occurred between the Pipe Integrity team and ILI vendor about how best to proceed. Several possible options were evaluated including (1) having the ILI vendor modify their tool so that it would pass through the elbow, (2) using a multi-diameter tool, or (3) cutting out the ID restriction. The option to cut out the feature was determined not to be the most favorable option at the time. Instead, the vendor agreed that they could navigate the feature with a tool redesign. Subsequent ILI runs have successfully navigated the ID restriction without any significant issues.

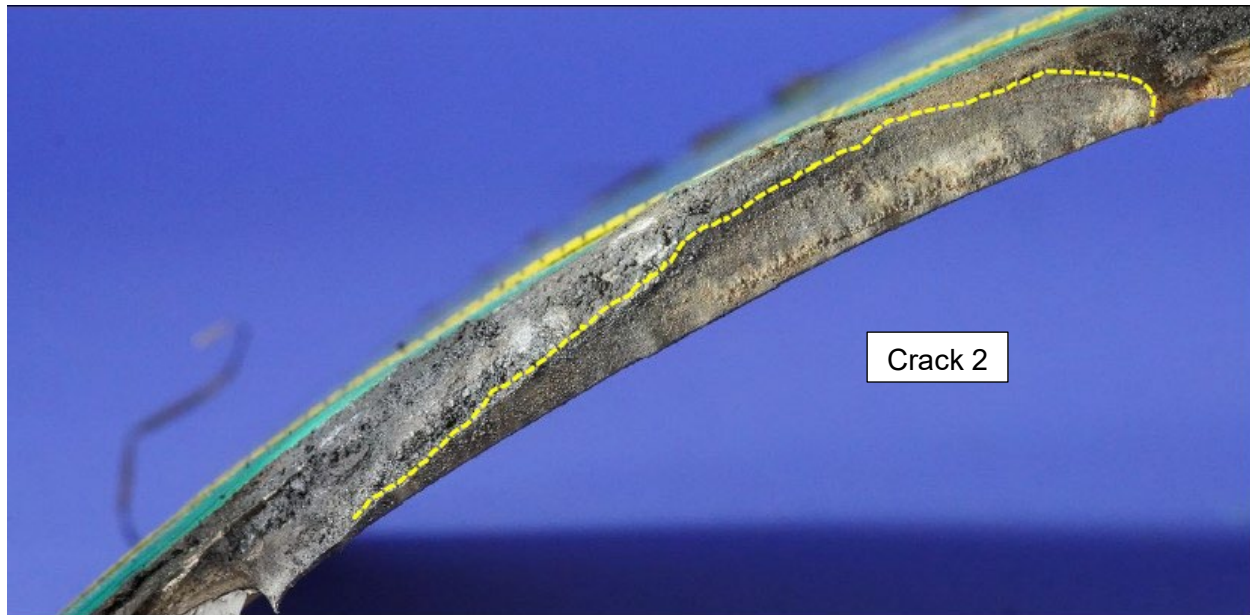
Figure 16. Magnified View of Crack 2 in GWD 13530 (G59B)

The three crack features were identified as originating at or near the inner diameter (ID) toe of the GWD 13530 and had multiple, radially oriented crack initiation features (ratchet marks). Each crack showed evidence of progressive cracking in the form of multiple crack arrest features. Crack 1 and Crack 2 exhibited 10 to 15 distinct "beach marks" or macroscopic features marking the position of the crack front over time, characteristic of a progressive or fatigue cracking mechanism from the ID surface.

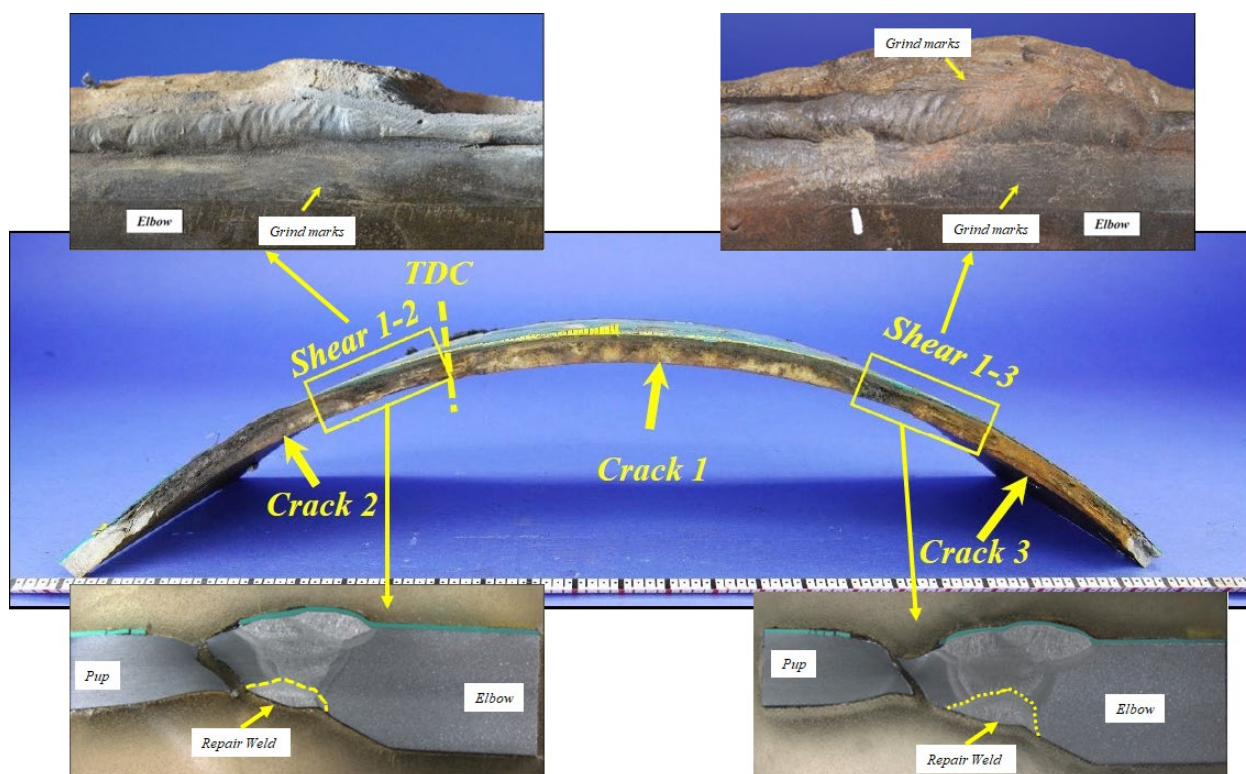
Figure 18. Images and Metallographic Sections Showing the Location of Repairs in GWD 13530 (G59B) Between Fatigue Crack Locations

As shown in Figure 18, separating Crack 2 and Crack 3 from Crack 1 were two regions exhibiting a shear morphology (fracture surfaces oriented at approximately 45°). Examination of the upstream portion of these regions (weld side) showed that they coincided with weld repairs as confirmed by grind marks and a thicker weld bead.

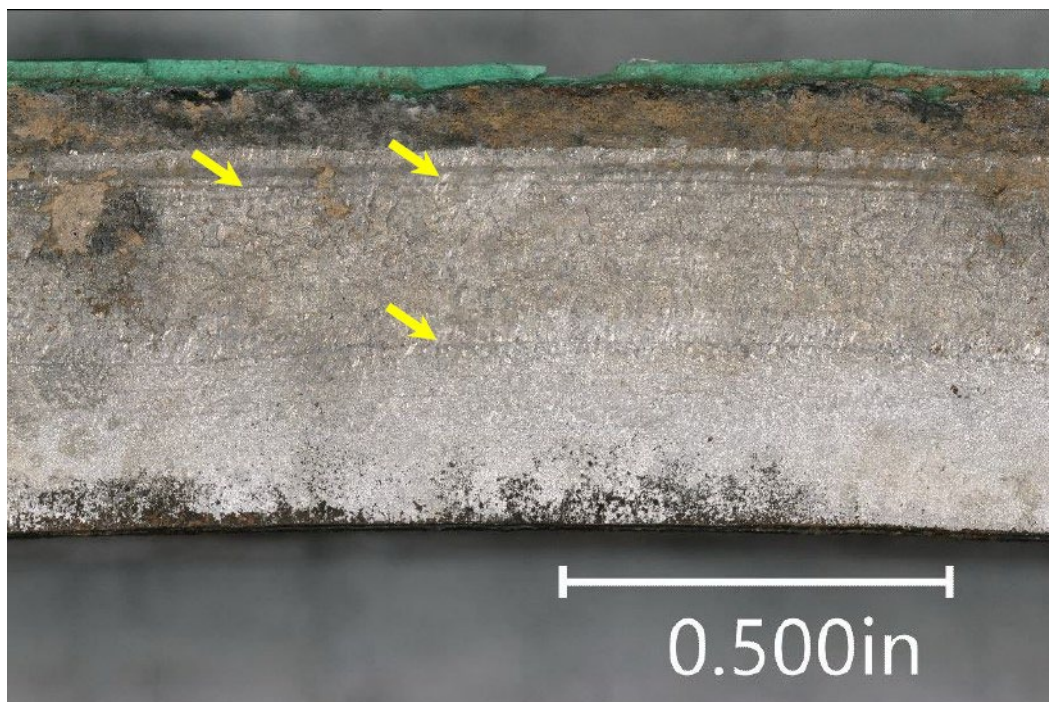
Figure 21. Low Magnification SEM Showing the Center Region of Crack 1 (most prominent crack arrest lines identified with yellow arrows)

The fracture surfaces of the three cracks were examined at low and high magnification by SEM. An SEM image of Crack 1 is presented in Figure 21. Common features to the three elliptical cracks are (1) each crack appeared to initiate at or near the ID surface and had multiple, radially oriented crack initiation features (also known as "ratchet marks"); and (2) each showed evidence of progressive cracking in the form of multiple crack arrest features. Crack 1 and Crack 2 each contained 10 to 15 distinguishable arrest lines or "beach marks".

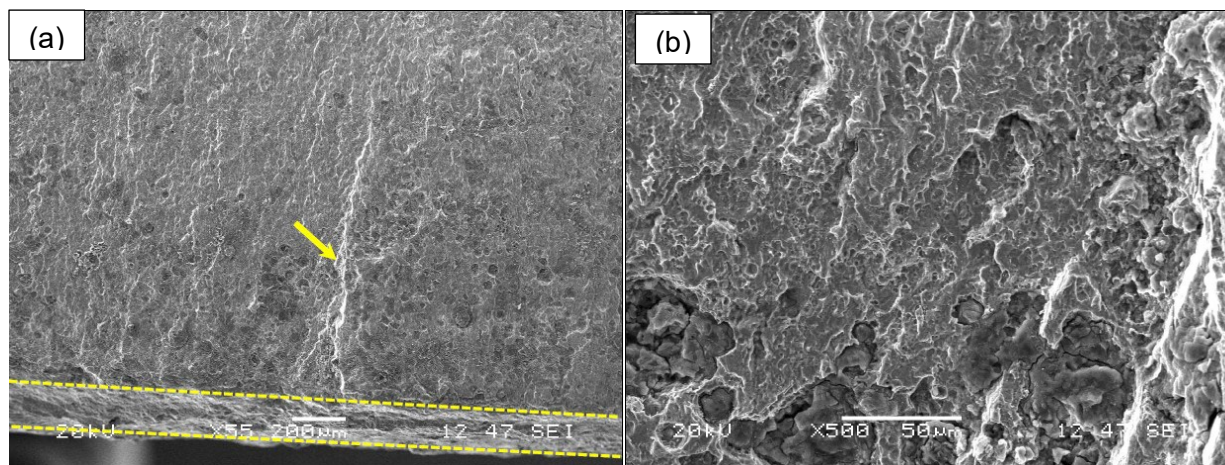
Figure 22. (a) Low Magnification SEM Fractograph Showing the ID Region of GWD 13530, Crack 1 and (b) Higher Magnification SEM Fractograph Showing that the Fracture Surface near the ID of GWD 13530, Crack 1 had been Consumed by Oxidation

A “ratchet mark” identified by the yellow arrow in Figure 22(a) is emanating radially from the edge of the LOF (the region between the dashed yellow lines) onto the fracture surface. Ratchet marks occur where a fracture initiates at multiple sites that are not quite coplanar. They disappear where the individually initiated crack surfaces merge to a common plane. Figure 22 (b) shows the fracture morphology near the ID of GWD 13530, Crack 1 to have been consumed by oxidation.

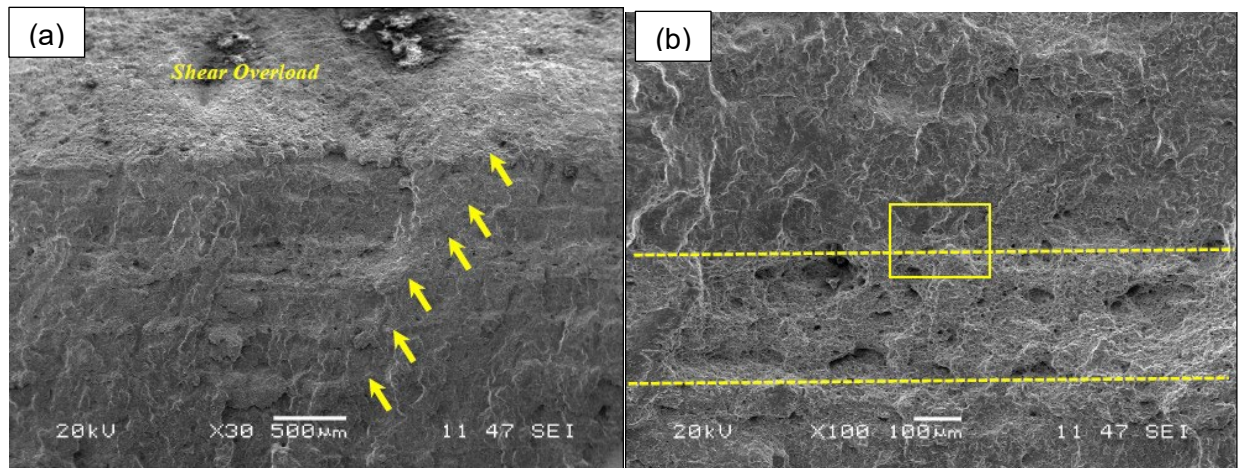
The fracture surface near the mid-wall to OD surface of Crack 1 showed several distinct crack arrest lines near the transition to shear overload (denoted by the yellow arrows in Figure 23(a)) with thin bands of micro-void coalescence (MVC) or dimpled rupture between some of the crack arrest lines (region between the dashed yellow lines in Figure 23(b)). According to Anderson, the space between the crack arrest lines appeared to be brittle with no evidence of striations (incremental cyclical crack growth). The shear overload region consisted of MVC which is consistent with ductile overload. RSI considers that the featureless fracture surfaces between the arrest marks are inconclusive as to mode of fracture due to corrosion. The surfaces do not entirely resemble the one region of cleavage fracture identified. The mechanism for stable but brittle crack advance defined by periodic ductile arrest marks is also not obvious. The arrest marks are spaced approximately 0.040-inch on average (0.500-inch / 12 marks), while the estimated plastic zone size assuming a fracture toughness derived from the average weld metal CTOD values (which were lower than the HAZ values), even assuming a constrained plain-strain condition is four times larger. Stable incremental non-ductile crack advance might occur if the crack is forced to extend into a compressive residual stress zone in the weld by periodic high loadings, but this is speculation. The Anderson metallurgical report (see Figure 33 of the Anderson report) identified a single, narrow band of cleavage fracture surface 0.040-inch in radial dimension on Crack 2. No similar feature was observed anywhere else on Crack 2 or any other crack. Its cause is unknown but could have occurred in a zone affected by a transient, nonoptimal welding condition over a short arc length of weld deposit. There is no evidence in the weld CVN or CTOD test results that would suggest a tendency for brittle fracture at the construction or operating temperatures. Since no similar feature was observed on the other fractures and it was very small in radial extent it was concluded to not have significantly influenced the formation or growth of the crack.

Figure 23. (a) Low Magnification SEM Fractograph of GWD 13530, Crack 1 Showing Multiple Crack Arrest Lines (crack arrest lines identified with the yellow arrows) and (b) Higher Magnification SEM Fractograph of GWD 13530, Crack 1 Showing a Band of Dimpled Rupture Associated with a Crack Arrest Line Near the Shear Overload Region

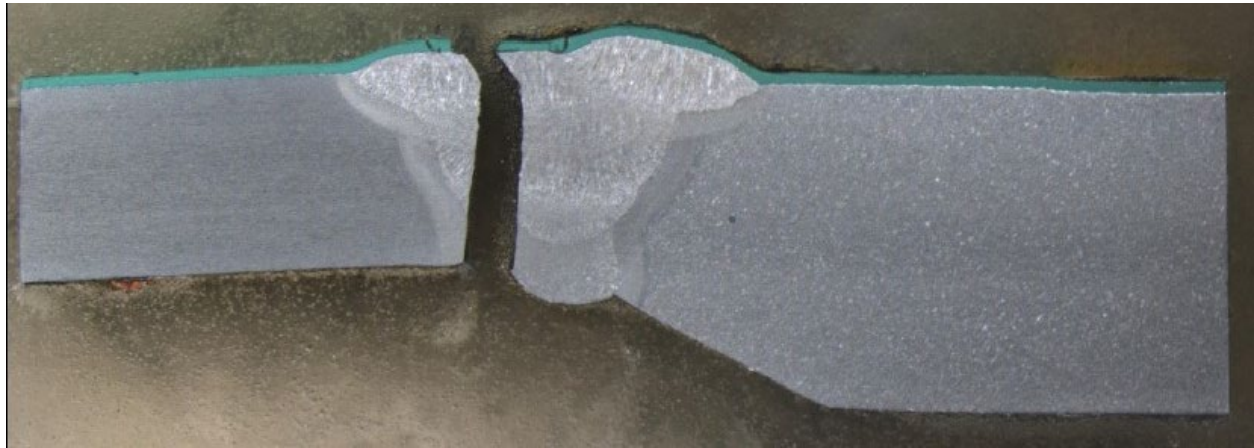
Figure 24. Metallographic Cross Section Through GWD 13530, Crack 1

Metallographic cross sections were prepared across the fractured and intact portions of GWD 13530 (G59B) and the intact GWD 13520 (G59A). Figure 24 is a section across the fractured weld at Crack 1. Figure 25 is a montage of the fracture at higher optical magnification. The crack grew from a small angular feature (lip) in the root pass at the inner toe of the girth weld. The prominent lip was observed at the ID intersection of the crack and appeared to parallel the fusion line. The lip feature was approximately 0.008-inch (200 µm) in length. The crack enlarged in a single radial plane which is typical of fatigue cracks enlarged by cyclic loading conditions. The final fracture occurred by ductile shear represented by the slanted fracture in the outer portion of the weld cap.

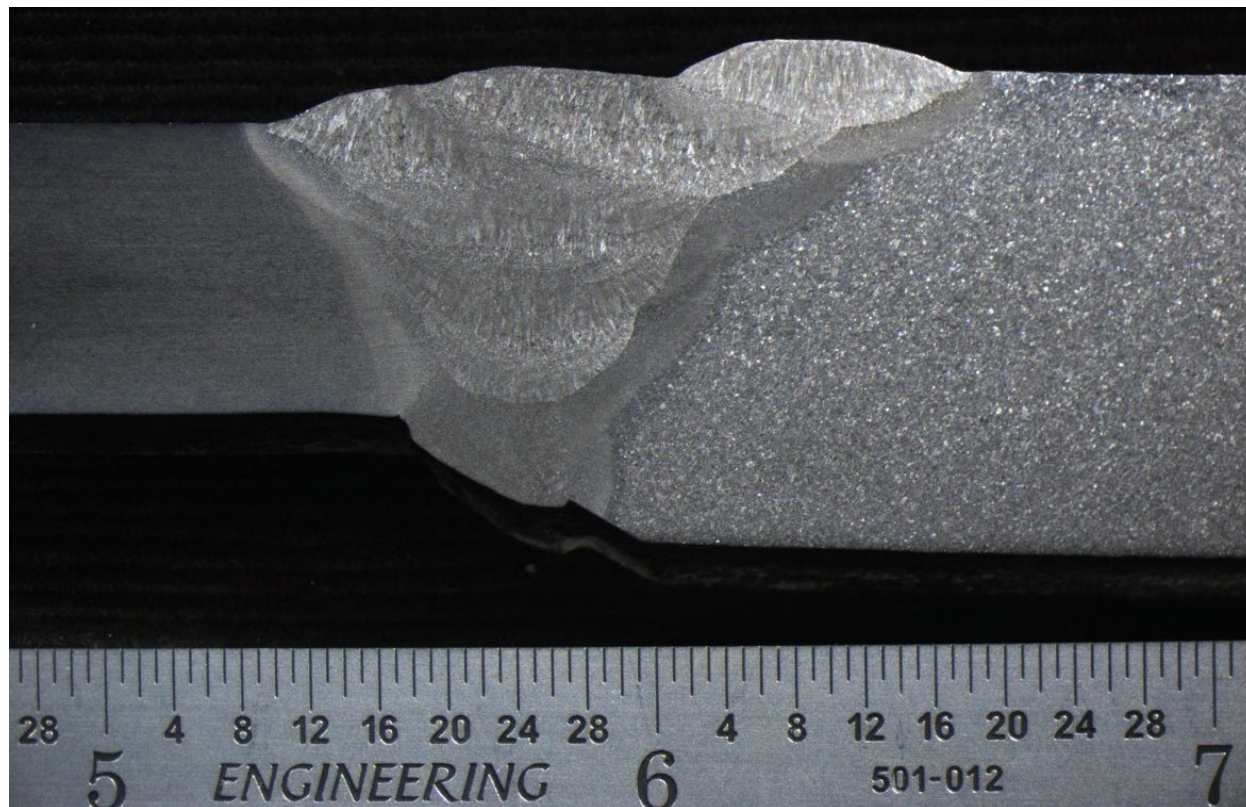
Figure 26. Metallographic Section of an Intact Portion of GWD 13530 at 139° from TDC Consistent with PAUT Indication 2

Figure 26 presents a metallographic section of an intact portion of GWD 13530 (G59B) at 139° from TDC which was coincident with a PAUT indicated feature. As shown in Figure 27(a), there was an indication consistent with a LOF defect identified at the toe of the girth weld on the pup side of GWD 13530. Figure 27(b), shows a magnified view at the upward curvature of the defect at the terminal end which may be due to the onset of fatigue cracking. The higher magnification micrograph shows dense, tightly adhered oxide scale lining the surfaces of the LOF which is consistent with formation at the time of welding. Similar LOF defects (which also showed evidence of fatigue) and repairs of the ID weld root pass were also noted in GWD 13520, which did not fail.

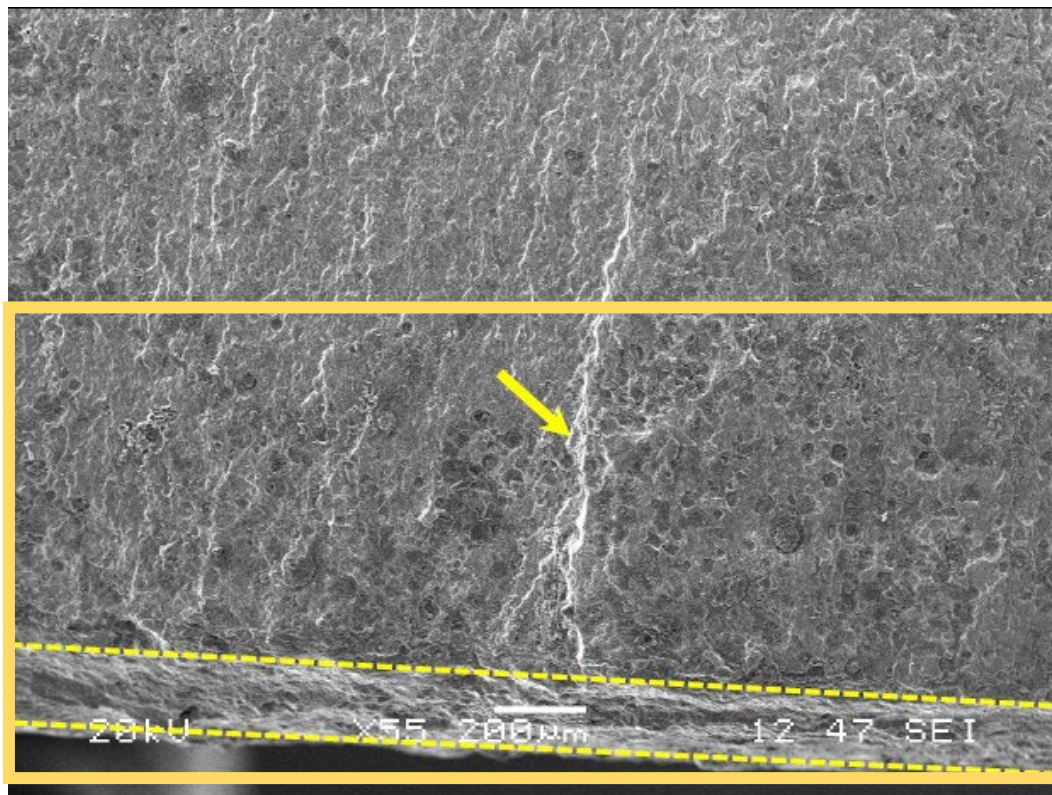
Figure 37. Region on the Crack 1 Fracture Surface with Corrosion Indicating Crack Initiation Early in the Life of the Crack

Although the surface has been altered by corrosion, the initial 0.040-inches of the fracture surface has a greater concentration of pitting than the remaining 0.500-inch (see areas highlighted by the yellow box in Figure 37). These corrosion pits indicate an 'older' surface that had been exposed to a corrosive environment (e.g., water and product). As discussed previously, the bending load that was applied during construction was sufficiently high to cause permanent plastic deformation of the TAG 98 (BND 350) bend assembly. This load likely exceeded the crack initiation threshold from the LOF already present and initiated the crack at that time (or at a minimum opened the root bead LOF allowing a crack to start sooner). Once a crack initiated, the subsequent thermal and pressure cycles caused the crack-front to progress over the 12-years of operation.
