Date: 6 January 2023
From: **Redacted by TC Energy**
To: **File**
CC: **Redacted by TC Energy**
RE: STL CB MP14 Review of Prior ILI Results
Revision: 0

The purpose of this memo is to document the review of prior in-line inspection (ILI) results following the MP 14 incident as per CPF No. 3-2022-074-CAO (“CAO”), Required Correction Action number 3 – Review of Prior ILI Results.

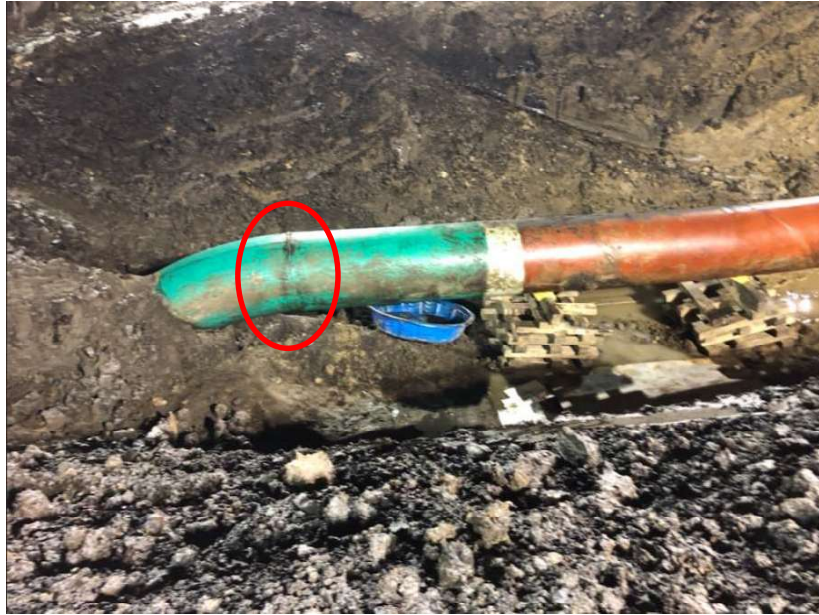
Investigation on site has revealed that the failure feature was located in the vicinity of GWD 13530, which is a circumferential weld which connects a 3D elbow fitting to the pup that came from the fabrication shop. Photos of the failure feature are shown in Figure 3 and Figure 4.

Figure 3: Failure Feature Location Circled in Red

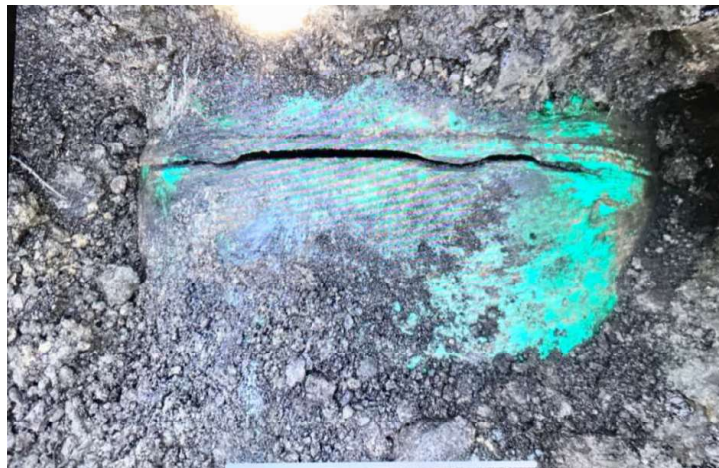
Figure 4: Photo of Failure Feature. Note that the feature is on the pup side of GWD 13530

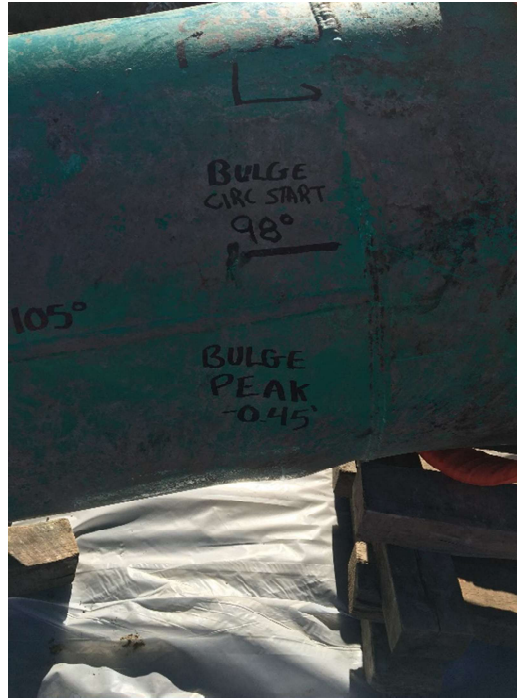
In addition to the circumferentially oriented failure, during excavation, a bulge was also noted upstream of the elbow. This bulge is shown in Figure 5.

Figure 5: Photo of Bulge Upstream of Elbow

In consideration of the bulge identified in the field, Baker Hughes also reviewed the raw caliper data in the vicinity of the failure and identified a possible wrinkle (with an approximate peak to trough height of

(OD) immediately upstream of GWD 13520 (the location of the bulge identified in the field). A screenshot of the MFL4 caliper data is shown in Figure 7.

The difference in the caliper signal from the 2018 inspection when compared to the 2013 inspection was that there was an inward and outward geometry movement in the caliper data in addition to a minor signal response in the MFL sensor data indicative of mechanical sensor movement, which could indicate a possible deformation, though which was not considered to meet all criteria such that it would be characterized and reported as a wrinkle.
