U.S. Department  
of Transportation

**Pipeline and Hazardous  
Materials Safety  
Administration**

Reference No. 23-0041

**R N A Consulting, Incorporated**  
*Specializing in forensic materials engineering and sciences*

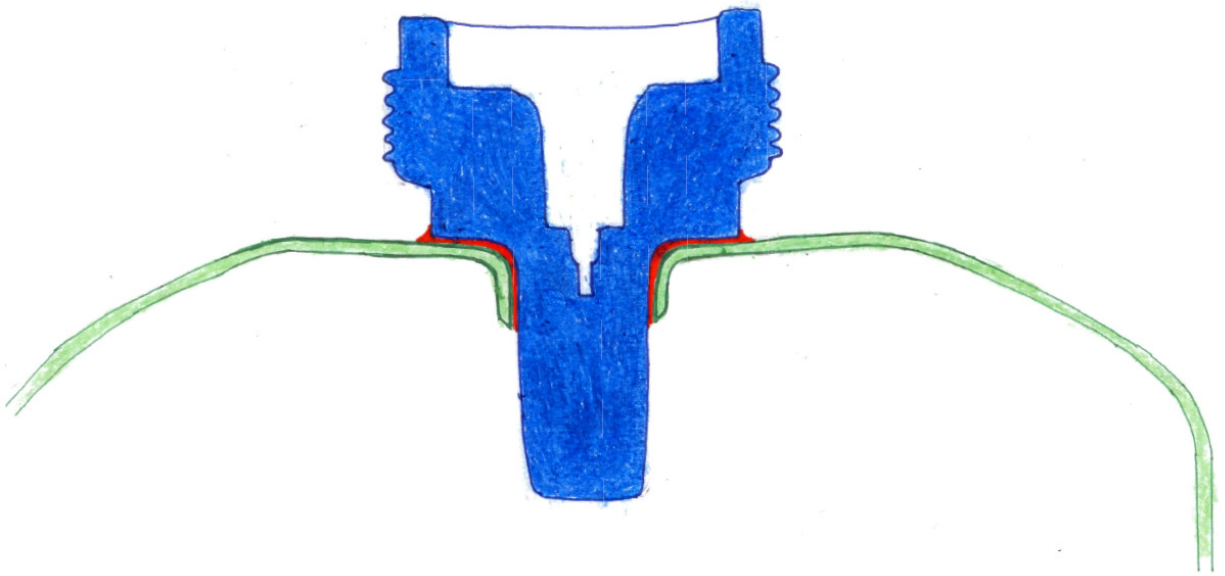
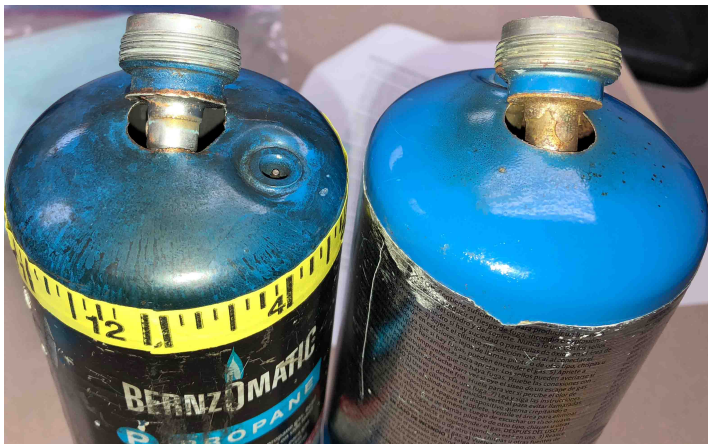
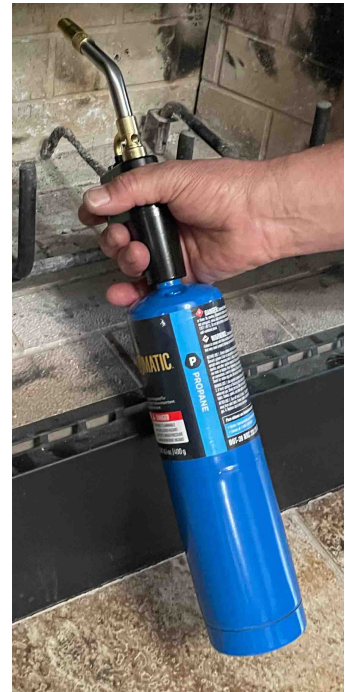
The subject fuel cylinders have failed many times at the neck area, also called the “main valve housing,” shown in the photo provided by Worthington’s engineer, Steve Gentry several years ago:

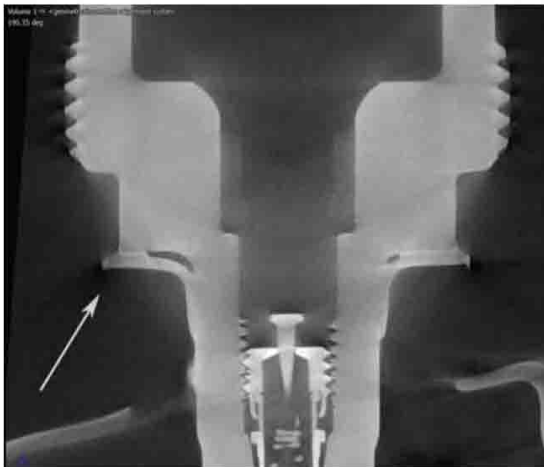
JPV-1

Worthington Cylinder Corporation took x-ray and scan images of the two failed cylinders shown in the photo above in 2018. Both cylinders contained the large voids and gaps shown on Worthington's images:

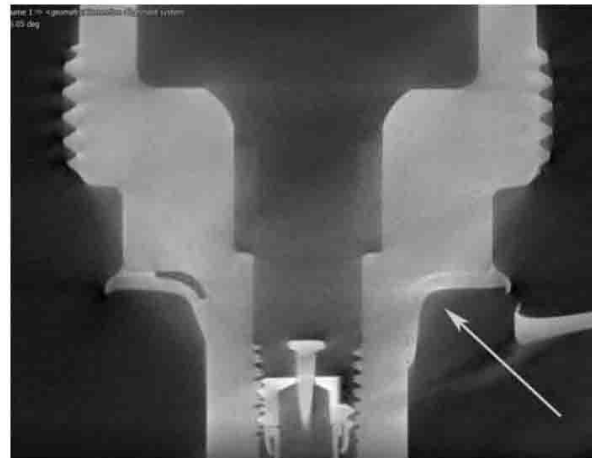
JPV-2

- Peralta cylinder, large voids

\*voids do not go 360° around as stated by Dr. Pfaendtner.

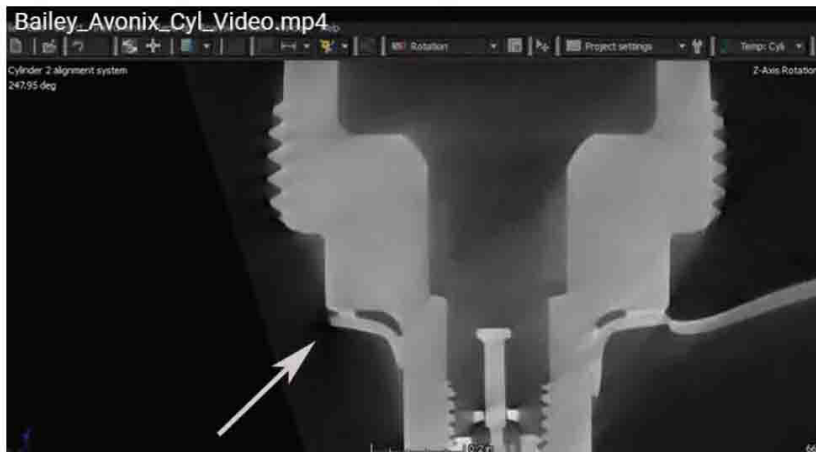
KBV-1

(braz compound is minimal, void quite large)

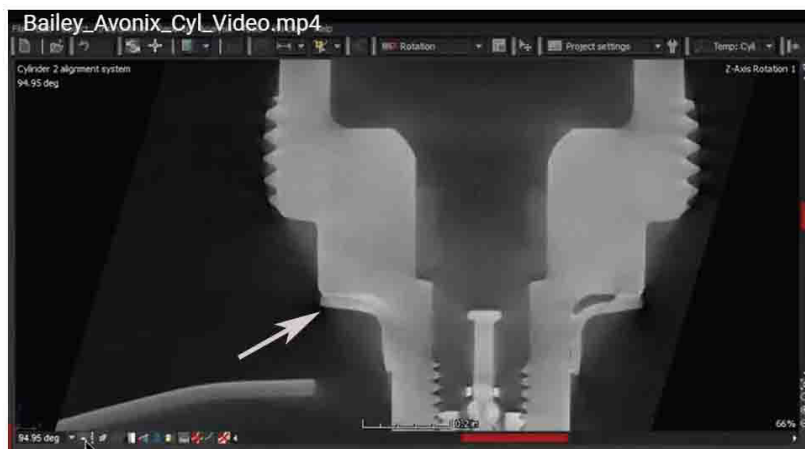
KBV-2

\*voids do not go 360° around as stated by Dr. Pfaendtner

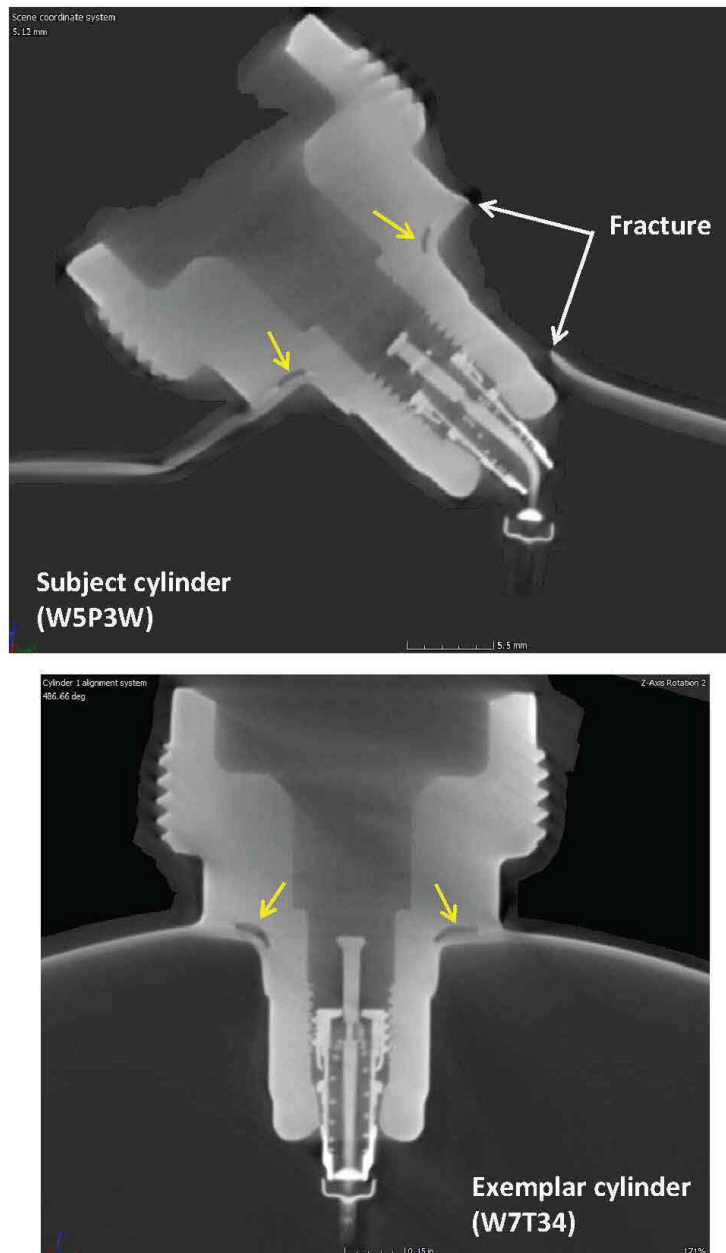
Figure 17. Computed Tomography (CT) X-ray images of dome area of subject (top image) and exemplar (bottom image) propane cylinders. Yellow arrows indicate voids in braze.

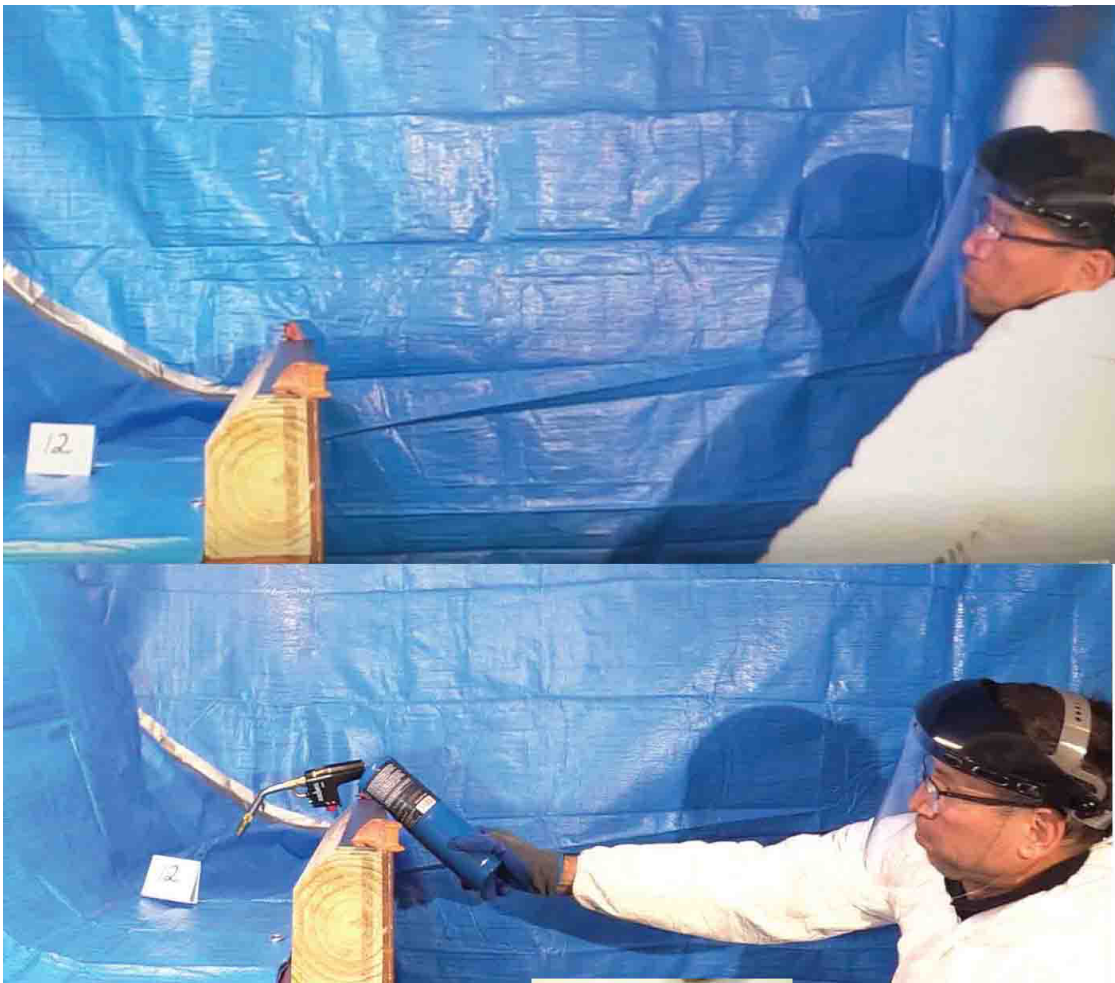
We have also personally spoken with five of the victims of cylinders which failed at the neck as shown in the photo above: (1) Kurtis M. Bailey, *Bailey v. Worthington*, 1:17-cv-7548-PGR (Northern District of Illinois); (2) Jason Peralta, *Peralta v. Bernzomatic/Worthington*, 2:17-cv-3195-JJT (Arizona); (3) Andrew Shalaby, *Shalaby v. Bernzomatic*, 3:11-cv-00068-AJB (S. Dist. CA); (4) Murray Shadbolt (Canada); and Jacob Avery (Massachusetts). The injury victims all reported failure of the cylinder at the neck without application of any unusual or unforeseeable forces. The manufacturer filed expert witness reports that in essence stated that the injury victims were lying about the manner with which they used the torches, and that the victims had to have exerted a very strong amount of force. Their expert performed duplication tests to try to show the types of forces they had to have subjected the cylinders to, and took videos and photographs, such as shown here:

Worthington's engineer stated that he tested six non-defective cylinders. He struck five of them on a solid sharp edge of a workbench as hard as he could, but could not get them to fail. He then created a raised edge as shown above, and struck it as hard as he could to cause one cylinder, the sixth tested, to fail as shown. He also stated that the torches in the two cases he was assigned to, Bailey and Peralta, could not have possibly failed under the use described by Mr. Bailey and Peralta, because such a failure would be impossible if they were not defective. Mr. Bailey and Peralta have given sworn statements that the cylinders did indeed fail under normal use and without application of any such forces. Mr. Shalaby also stated that he was just using his torch in a normal manner, without application of any such forces, and it failed at the neck as well. All of the victims suffered severe permanent burn injuries. Other victims, whose families filed cases in different states, have died from their injuries.

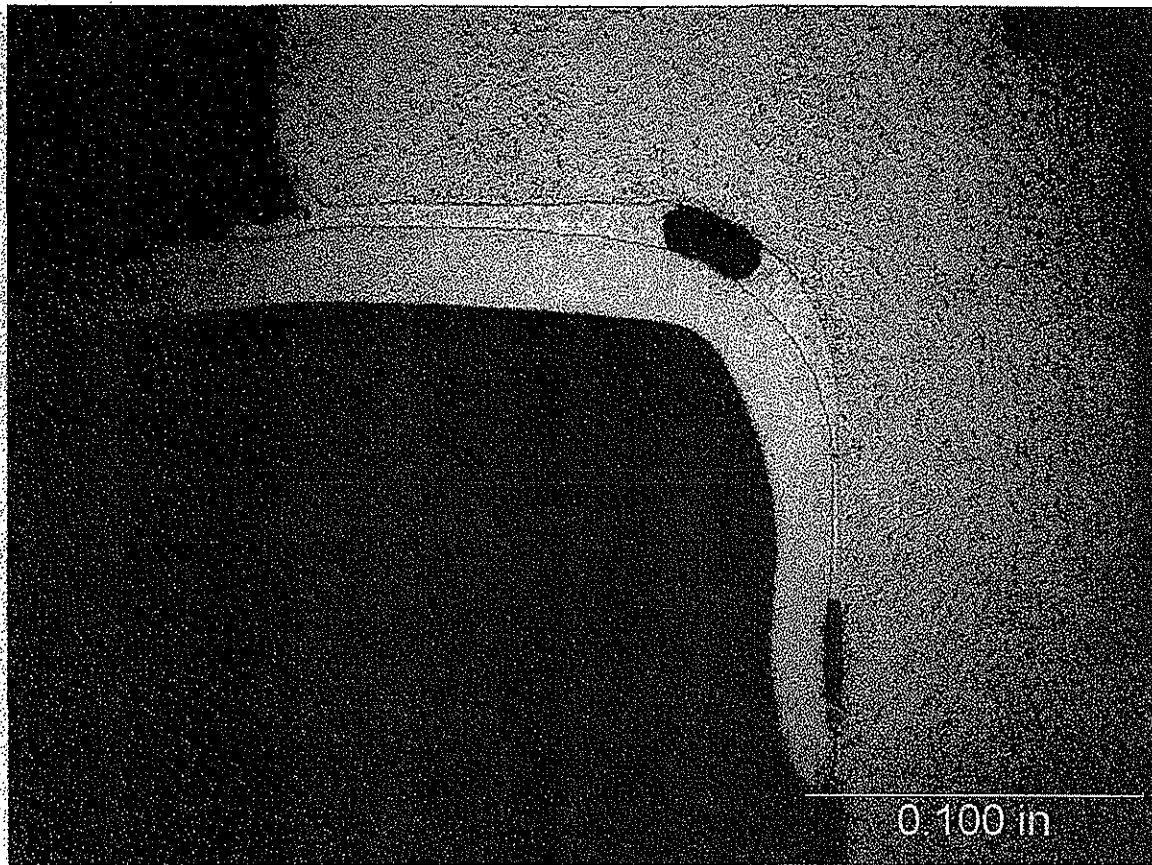
The cylinders have been sectioned in half and four sections have been cut from each cylinder to show a portion of the neck piece and cylinder wall and the brazing material between. These sections have been mounted in plastic and polished and photographically documented. Representative examples of the microphotographs from each cylinder are shown in **Photographs 3, 4, and 5**. **The brazing materials have large voids in the bulk and smaller voids in the interface between the cylinder walls and the center valve housing as shown in Microphotographs 6, 7, and 8.** The brazing on the outer surface of the cylinder is undercut in all three cylinders rather than forming a meniscus. The undercutting is a sign of **lack of wetting and penetration of the brazing material with the cylinder and valve.** A good meniscus shows that wetting has occurred. **The brazing defects shown in photographs 3-8 reduce the strength of the joint and make it more likely that the valve will partially separate from the cylinder and release gas when the torch is used as intended.**

The outside surface of the brazing material that is undercut represents a lack of wetting and penetration of the brazing material with the cylinder and valve housing. This flaw is sufficient to reject the cylinder. This flaw should have been picked up by the manufacturer with a simple visual inspection of the cylinders.

The Bernzomatic one pound MAPP gas cylinder is manufactured per Federal specification published in 49 CFR 178.65 (D.O.T. 39). The specification for non-reusable (non-refillable) cylinders states "brazed seams must be assembled with proper fit to ensure complete penetration of the brazing material throughout the brazed joint." The brazed joints shown in microphotographs 6, 7, and 8 lack complete penetration.

**Photo 3: W10G57E. @ 13X. Valve housing on the top and cylinder on the bottom with brazing material inbetween.**
