Final Summary Report

Metallurgical Analysis of 42-Inch MVP Line H600 Hydrotest Elbow Fitting Failure (05/01/2024)

Mountain Valley Pipeline, LLC
Canonsburg, Pennsylvania

Report No: E-AD-LI / GTQU (10513119)
August 1, 2024

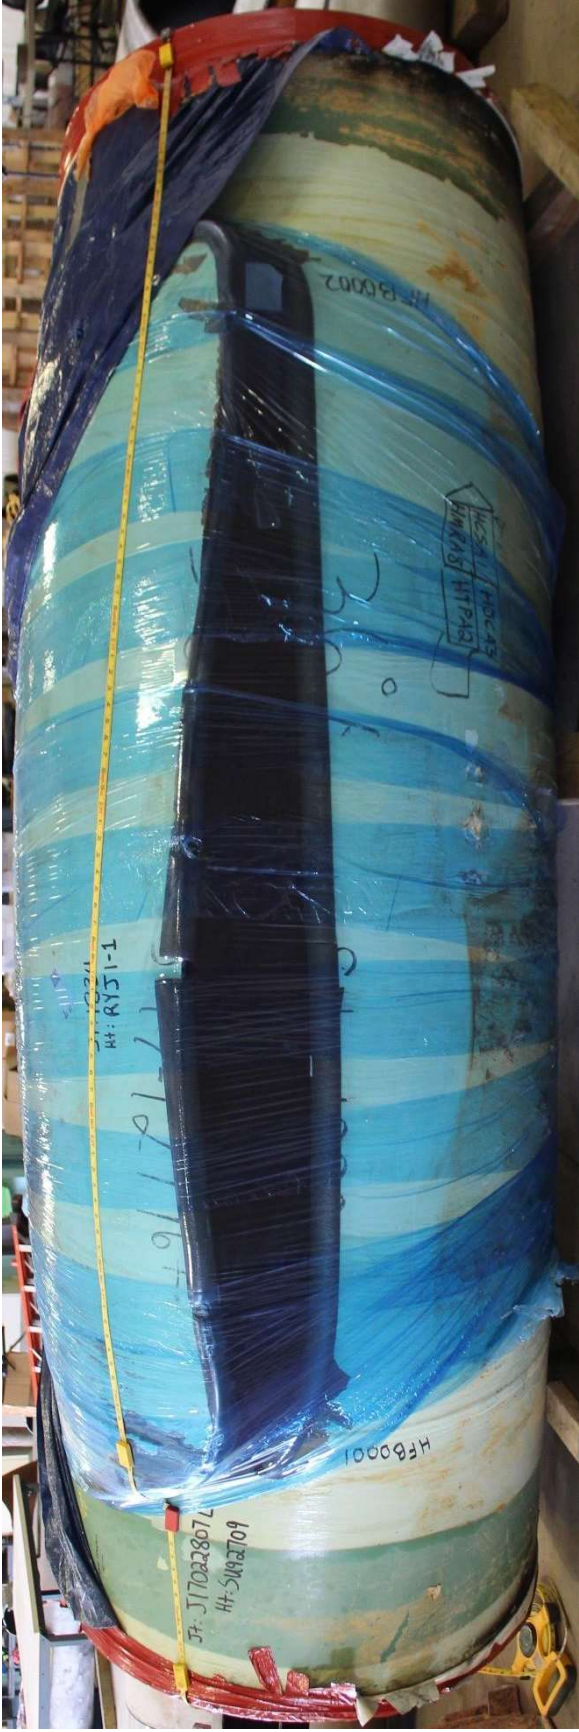
Figure 1. Photograph of the pipe section as received at DNV, after unloading. The pipe section was wrapped with plastic and tarps, with the ends sealed. The fracture surfaces were protected with foam tubing construction, various labels were written on the external pipe surface, such as "Jt: J17022807H Ht: SU92709, upstream, HFB0002, HCSA1, HJCA3, HMRA8, HTPA2, 36°, Jt: 1834 Ht: RYJ1-1, HFB0001, Jt: J17022807L Ht: SU92709, downstream, TDC, Jeeped 7-17-18, 2 of 3 JT sec. 740 36°".

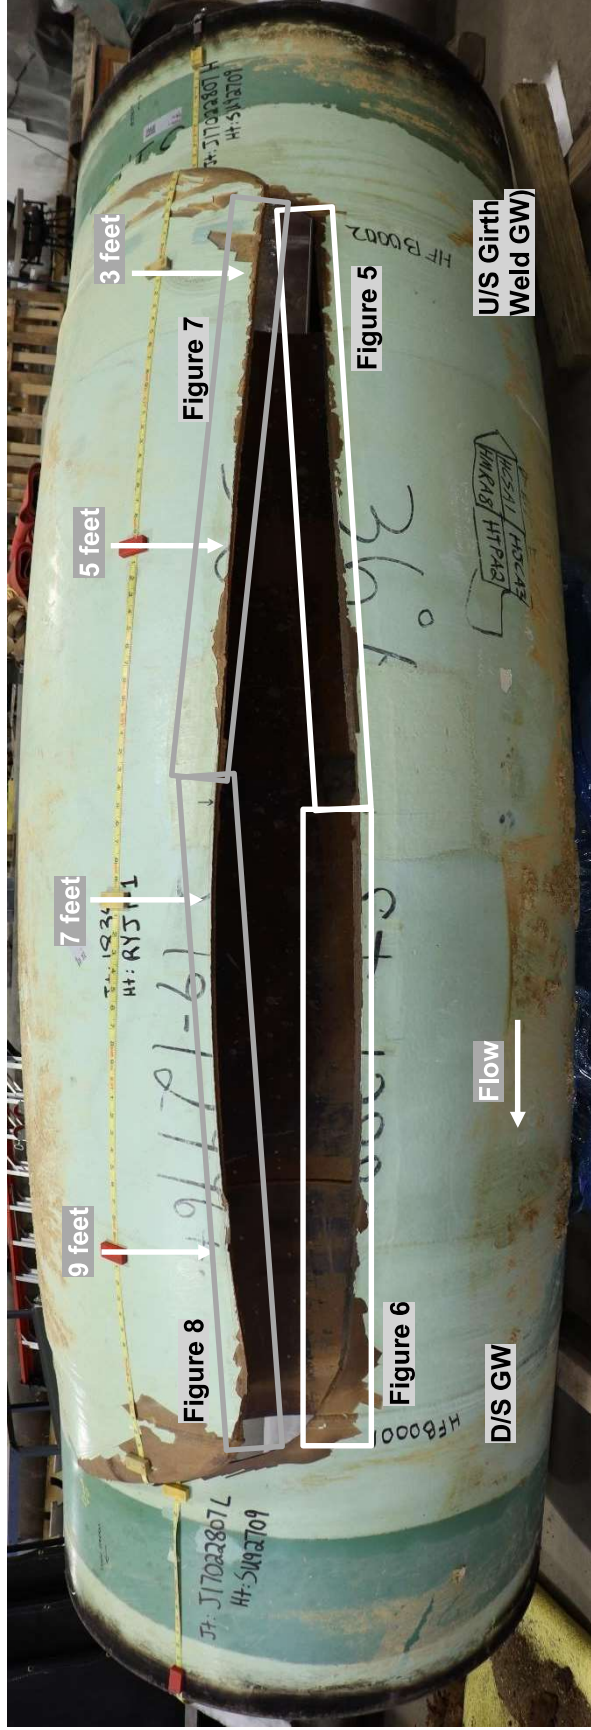
Figure 2.

Photograph of the pipe section at DNV, following removal of the protective coverings. The tape measure indicates the distance, in feet, from the U/S end of the pipe section. The portion that was removed from the pipeline (*pipe section*) consists of an elbow fitting and two PUP sections. The pipe section ruptured along the seam weld of the elbow fitting and terminated in the PUP sections. The rupture opening was located between 1.55 and 11.22 feet (116 inches long) from the upstream (U/S) end of the pipe section, with a maximum opening of 10.9 inches at a distance of 7.42 feet from the U/S end of the pipe section or 4.97 feet from the U/S girth weld (GW). Measured near the fracture surface, close to the extrados, the pipe section was approximately 12.6 feet long, the U/S PUP was 2.45 feet long, and the elbow fitting was 7.65 feet long. The seam weld that failed on the elbow fitting was at the 9:06 orientation. The seam welds on the U/S and downstream (D/S) PUPs were at the 6:00 orientations and appeared to be submerged arc welds (SAWs). There was no evidence of external or internal corrosion. The external coating was adhered except for some portions adjacent to the fracture surfaces that disbonded due to the rupture. Portions of the pipe in the white and grey boxes were removed for further fractographic and metallographic analyses.

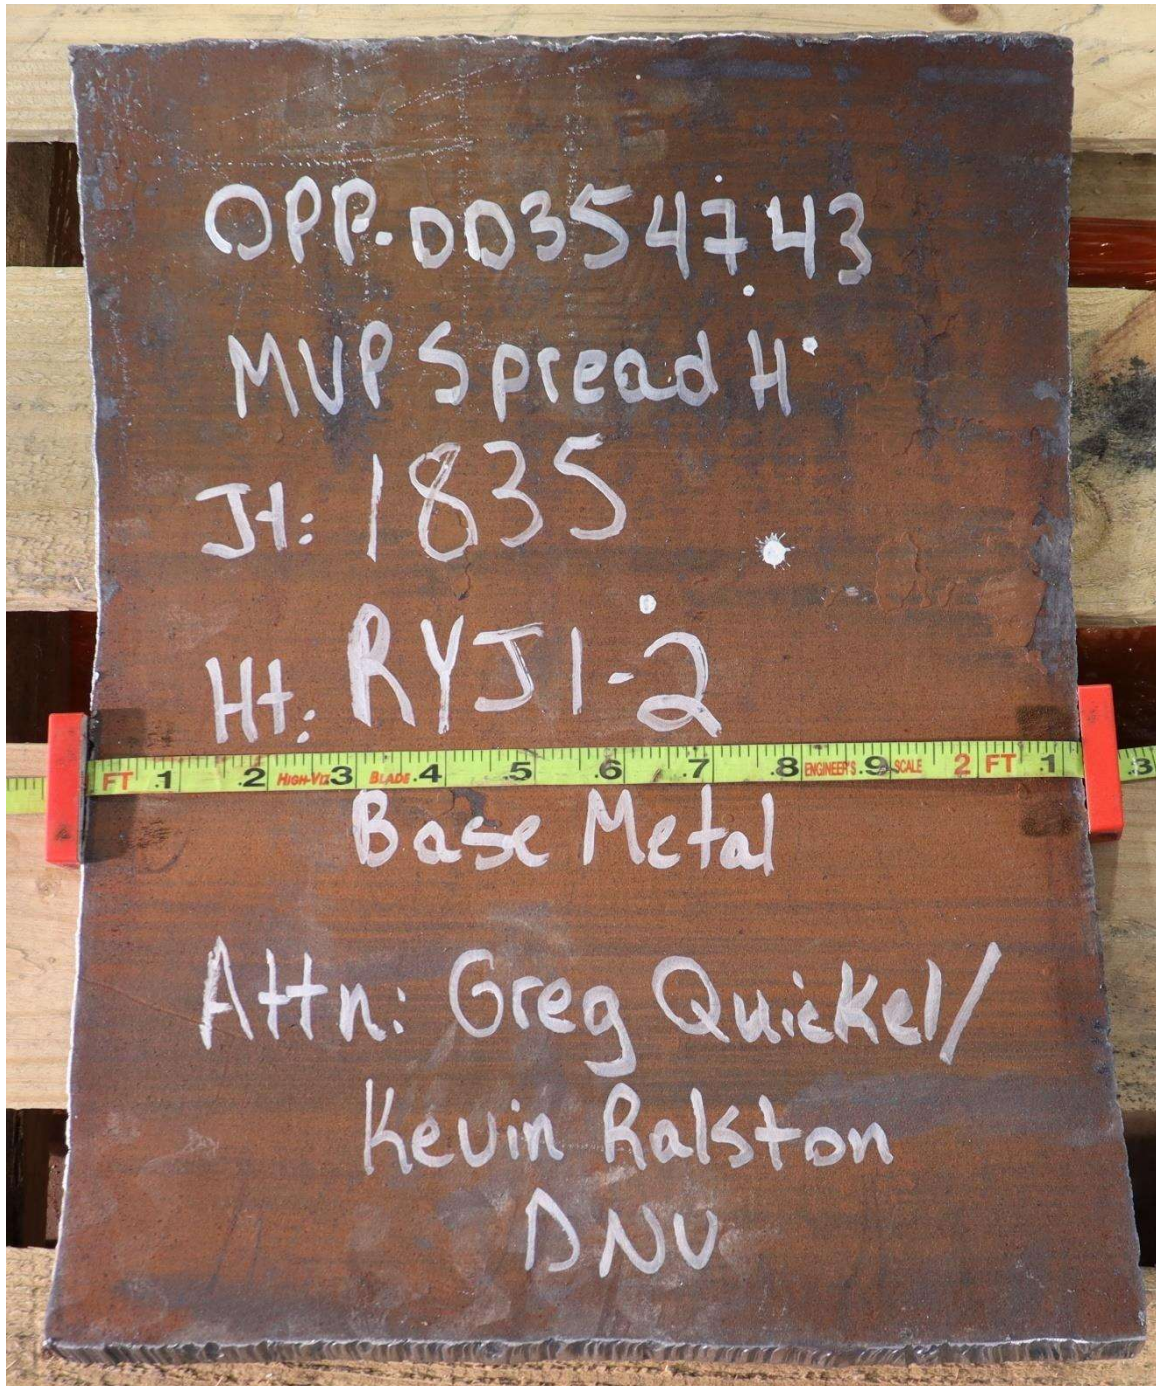
Figure 3. Photograph of the base metal coupon from the sister elbow fitting that was used for base metal tensile testing and Charpy V-notch (CVN) impact testing. The tape measure indicates dimensions in feet.

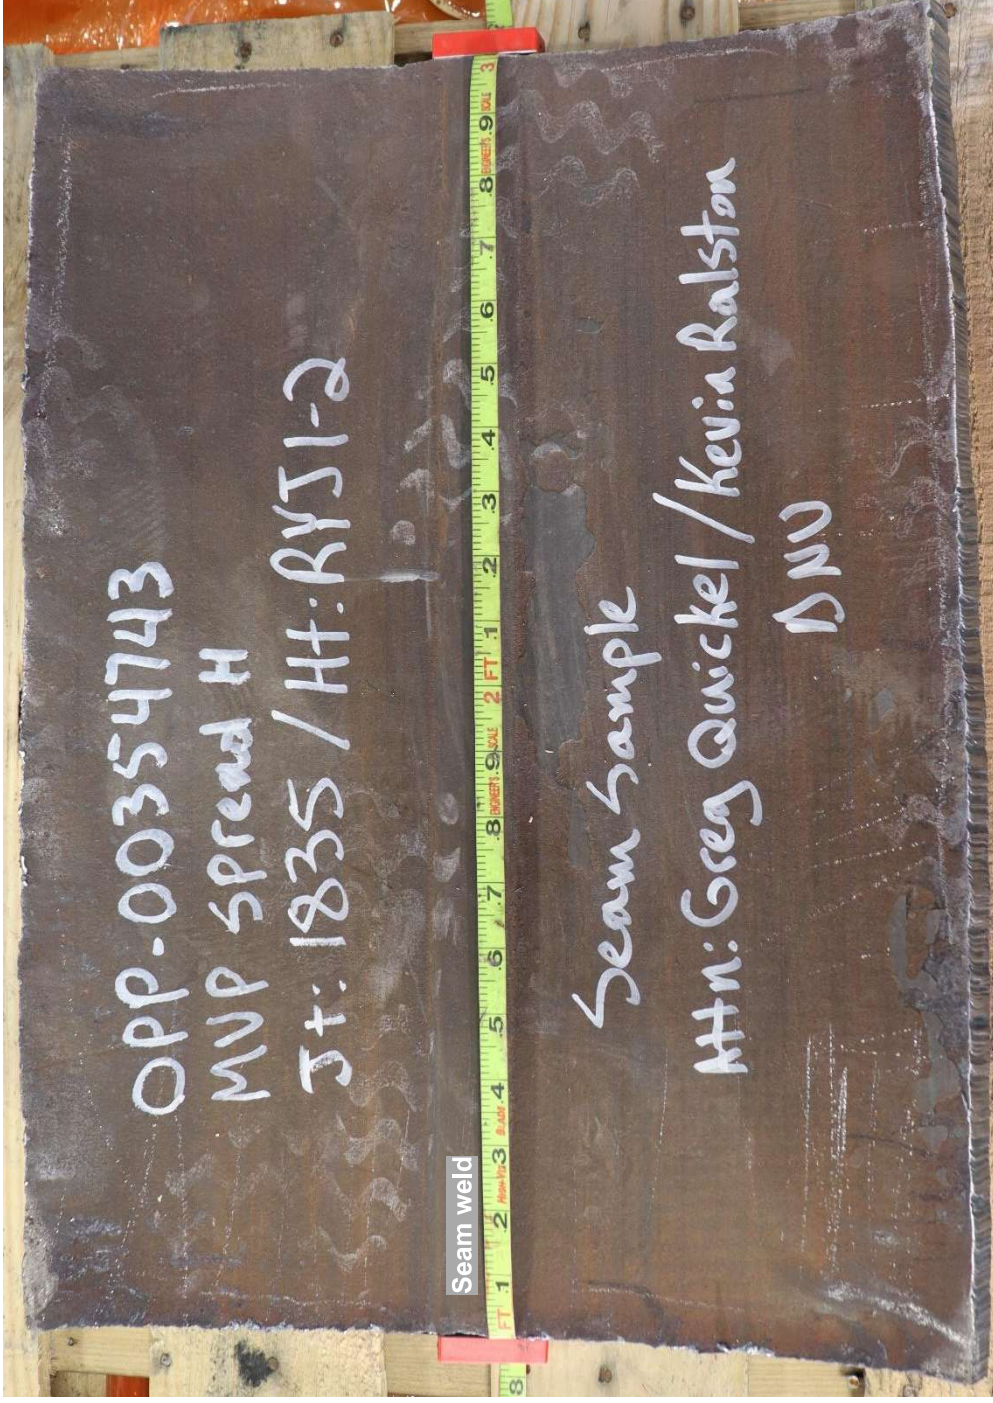
Figure 4. Photograph of the seam weld coupon from the sister elbow fitting that was used for seam weld tensile testing, Charpy V-notch (CVN) impact testing, base metal steel chemistry testing, and metallography of the seam weld. The tape measure indicates dimensions in feet.

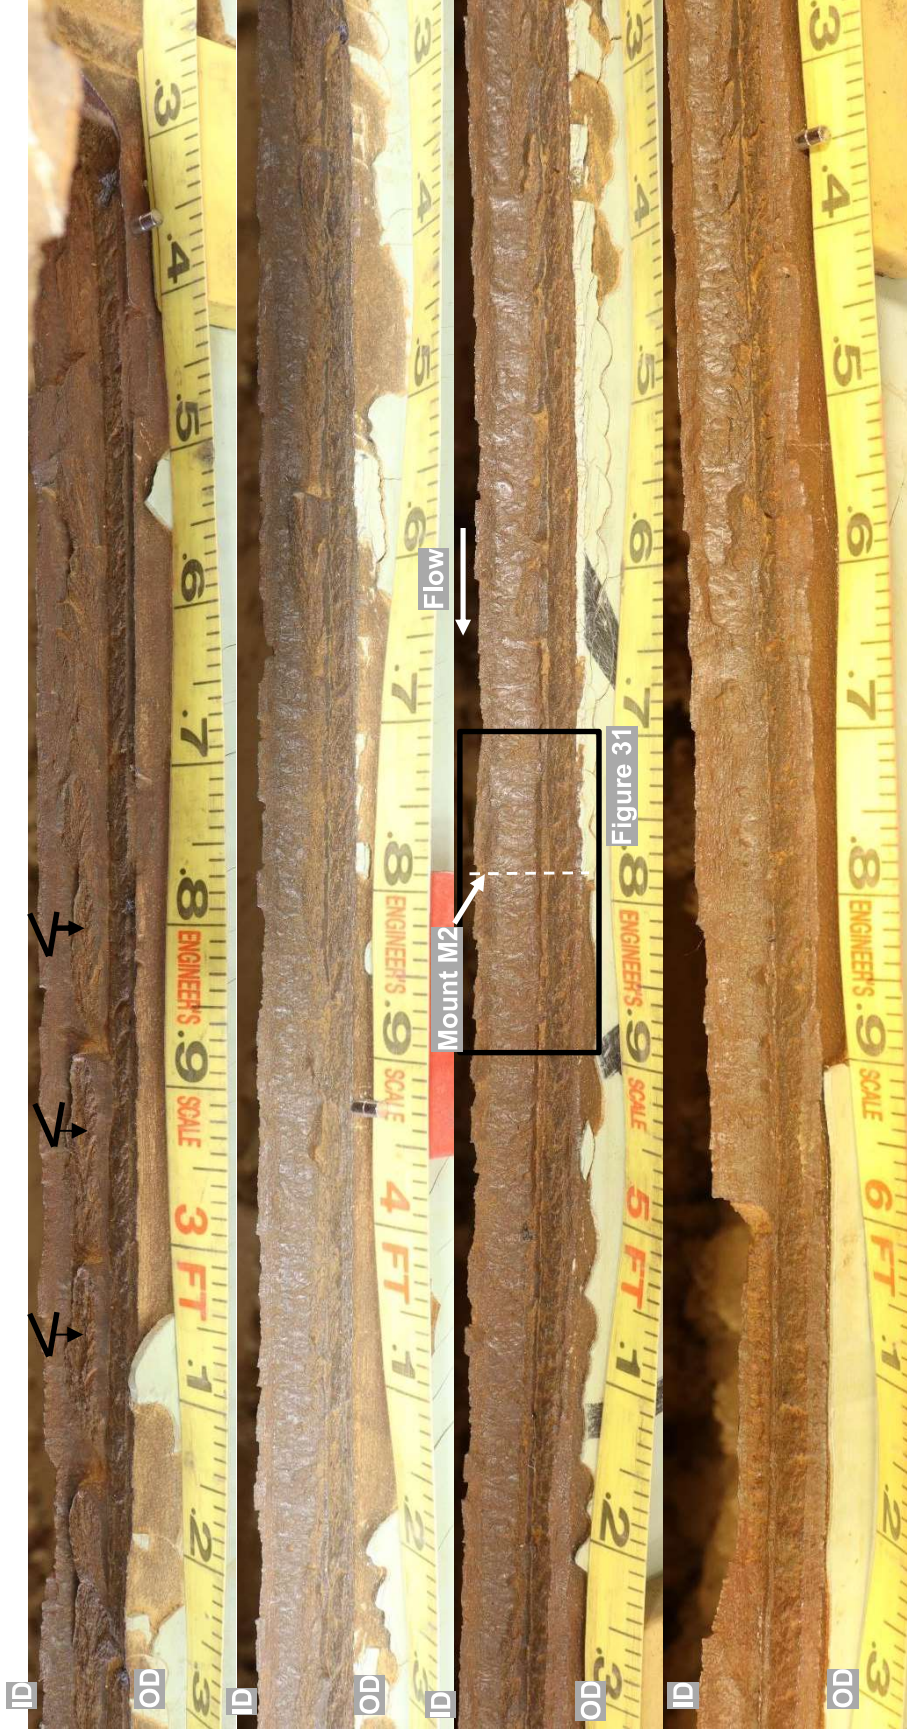
Figure 5. Photographs (4) of the fracture surface counter clockwise (CCW) of the rupture opening from 2.3 to 6.3 feet from the U/S end of the pipe section; area indicated in Figure 2. The tape measure indicates the distance from the U/S end of the pipe section. Chevrons are located on the top photograph indicating that the origin was D/S of that location (3.1 feet D/S from the U/S end of the pipe section). No obvious pre-existing flaws were observed on the fracture surface.

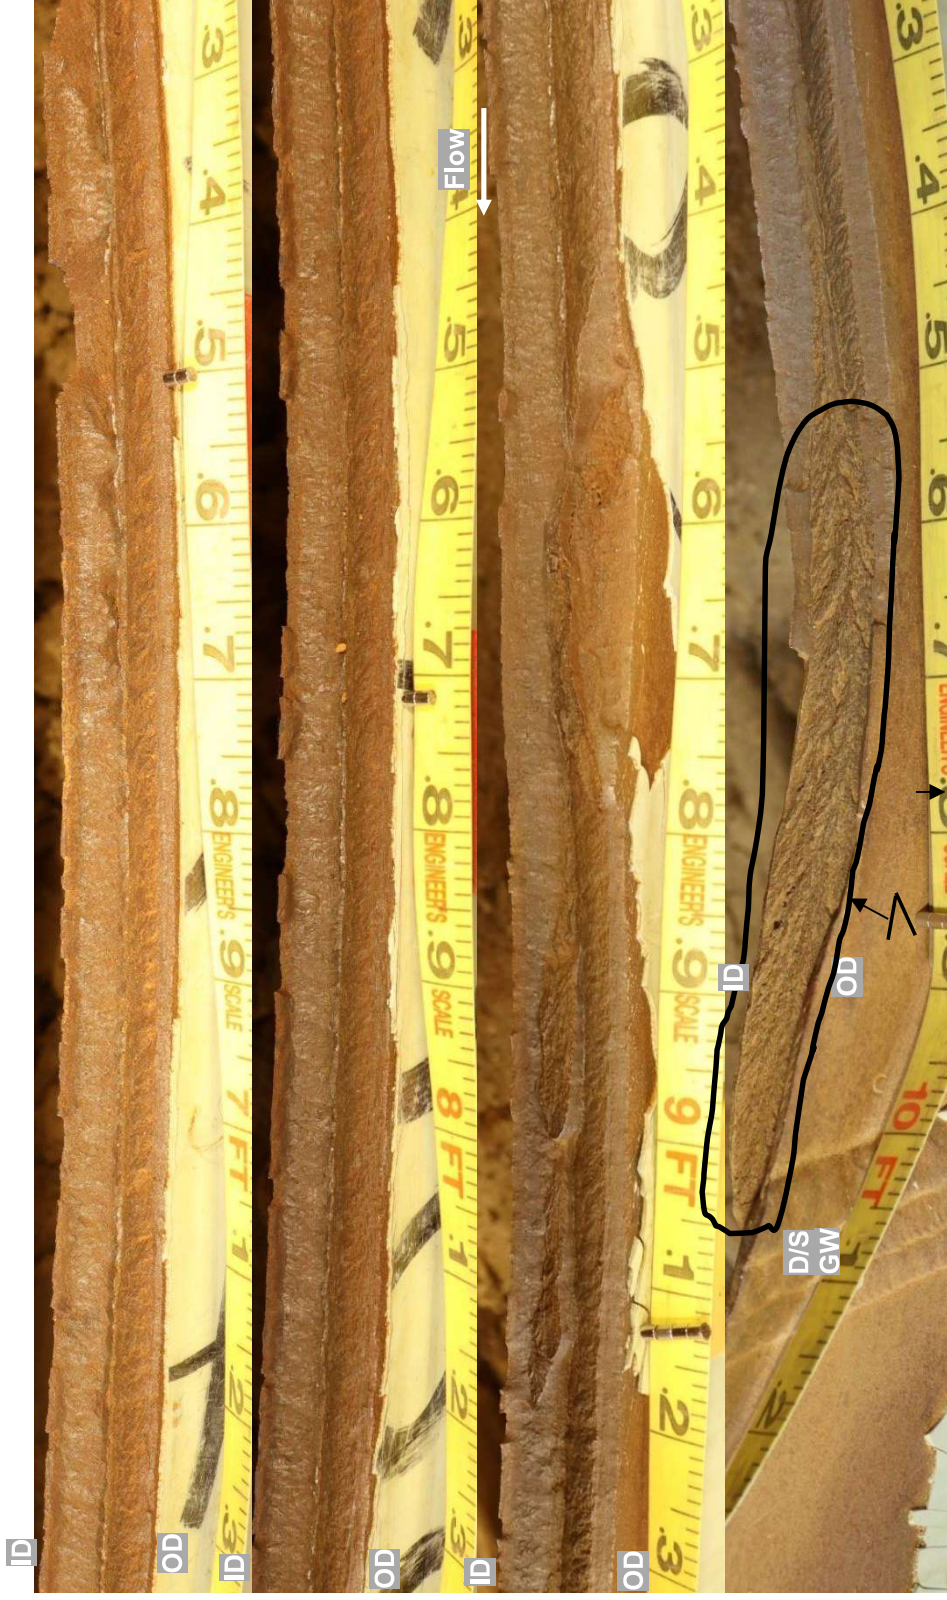
Figure 6. Photographs of the fracture surface CCW of the rupture opening from 6.3 to 10.1 feet from the U/S end of the pipe section; area indicated in Figure 2. The tape measure indicates the distance from the U/S end of the pipe section. Chevrons are located in the bottom two photographs indicating that the origin was U/S of 8.9 feet from the U/S end of the pipe section, indicating the origin is between 3.1 and 8.9 feet from the U/S end of the pipe section, near the middle of the elbow fitting. No obvious pre-existing flaws were observed on the fracture surface. Overall, the fracture surfaces had a similar profile for the entire length where midwall was further away from the camera compared to the OD and ID surfaces. Additionally, the fracture surfaces are slightly rough to macroscopically smooth, except for a few places near the ends of the fracture surfaces.

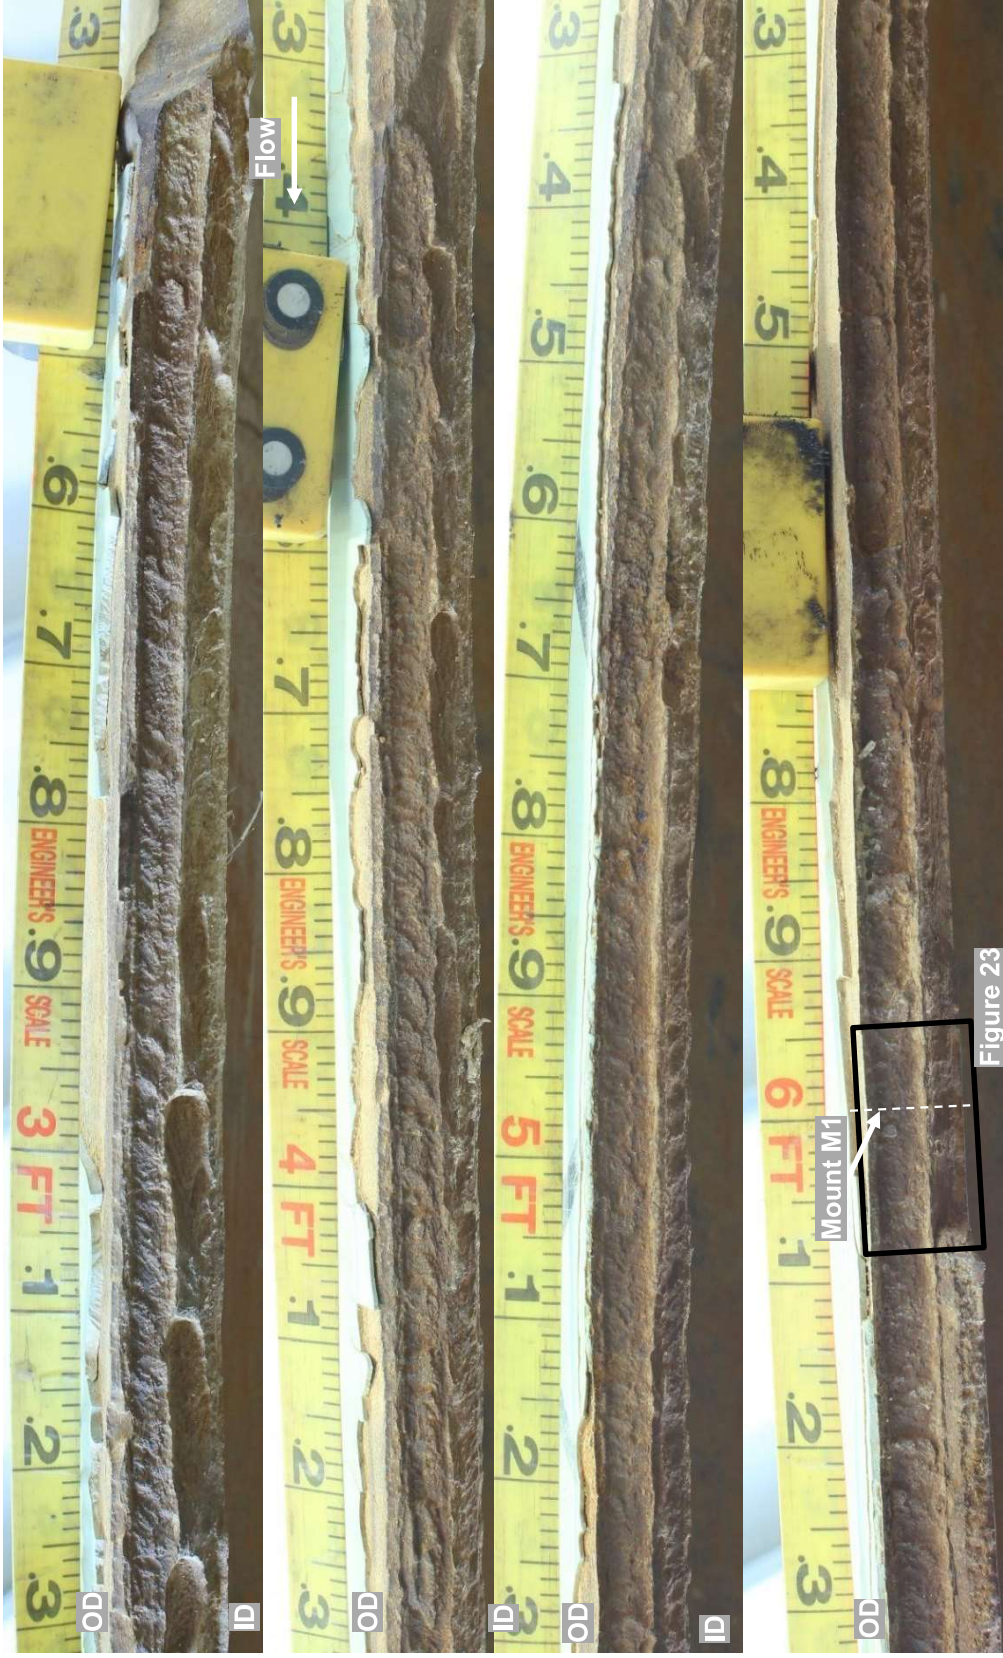
Figure 7. Photographs of the fracture surface clockwise (CW) of the rupture opening from 2.3 to 6.3 feet from the U/S end of the pipe section. The tape measure indicates the distance from the U/S end of the pipe section. The fracture morphology is similar to the CCW fracture surface expect more topography is visible due to the lighting.

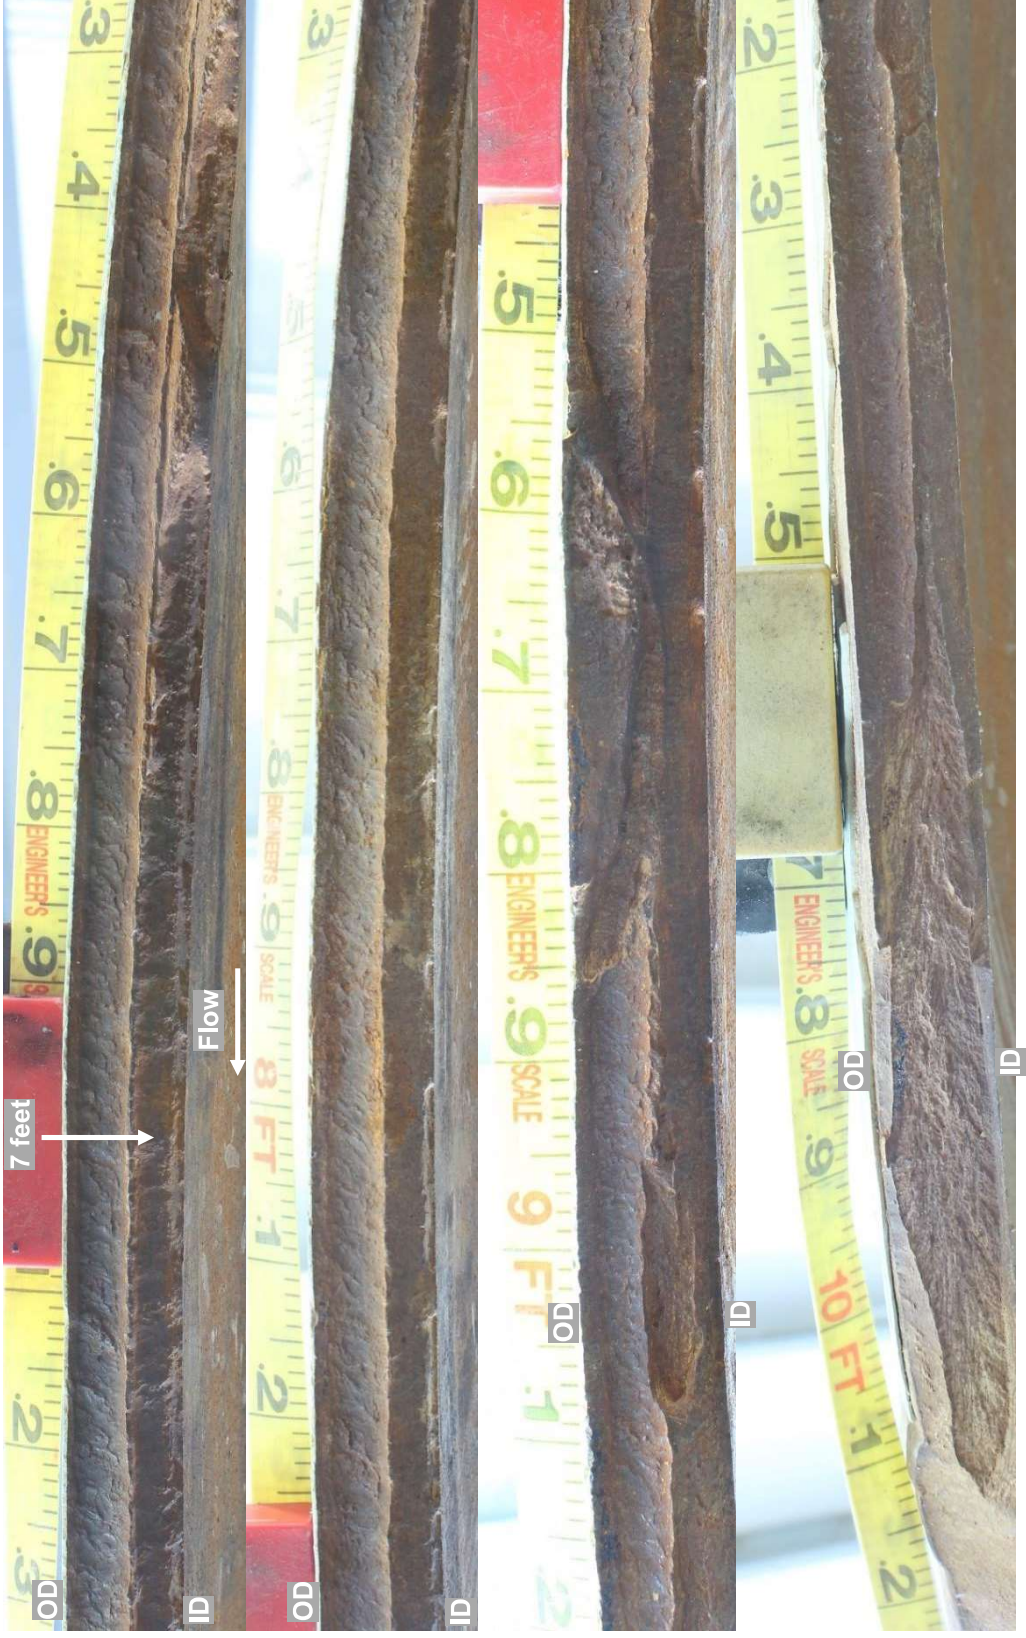
Figure 8. Photographs of the fracture surface CW of the rupture opening from 6.3 to 10.2 feet from the U/S end of the pipe section. The tape measure indicates the distance from the U/S end of the pipe section. The fracture morphology is similar to the CW fracture surface expect more topography is visible due to the lighting.

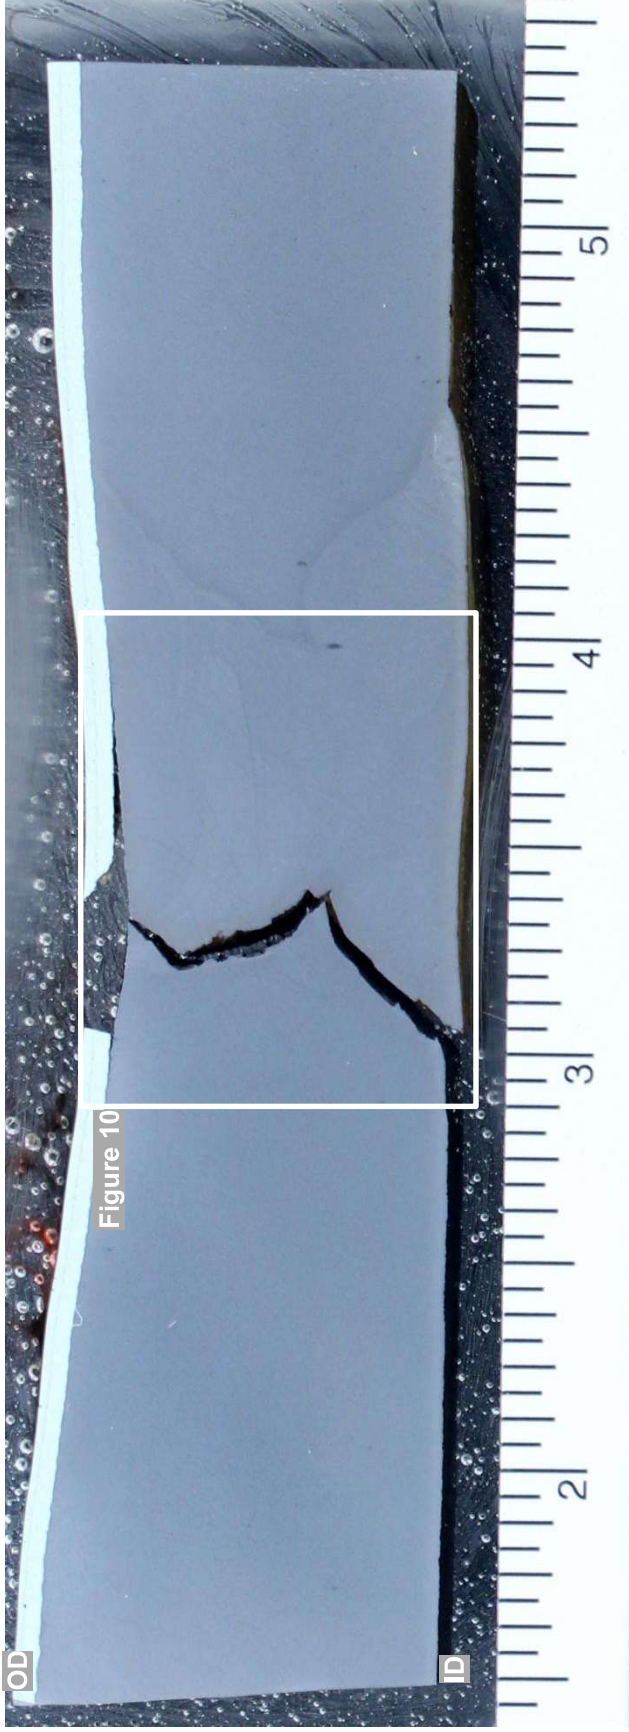
Figure 9.

Photograph of the transverse metallographic section (Mount M1) that was removed across the rupture opening, approximately 5.99 feet from the U/S end of the pipe section, near the middle of the elbow fitting. The scale is in inches. See Figure 7 for the mount location. The middle of the fitting was 6.27 feet from the U/S end of the pipe section, near this location. The fracture path appears to be located at or near the fusion line between the weld metal and base metal. The wall thickness at the far left of the cross-section, at the rupture opening, and far right of the cross-section are approximately 0.965 inches, 0.790 inches, and 0.904 inches, respectively. The significant wall reduction/necking is evident in the cross-section and maximum at the rupture opening, consistent with a ductile overload failure. The weld metal on the ID surface is approximately 1.5 inches wide (in the circumferential direction). This cross-section (and adjacent SEM sample) was removed at this location since it appeared to be the thinnest region of the fracture surfaces, due to the necking.

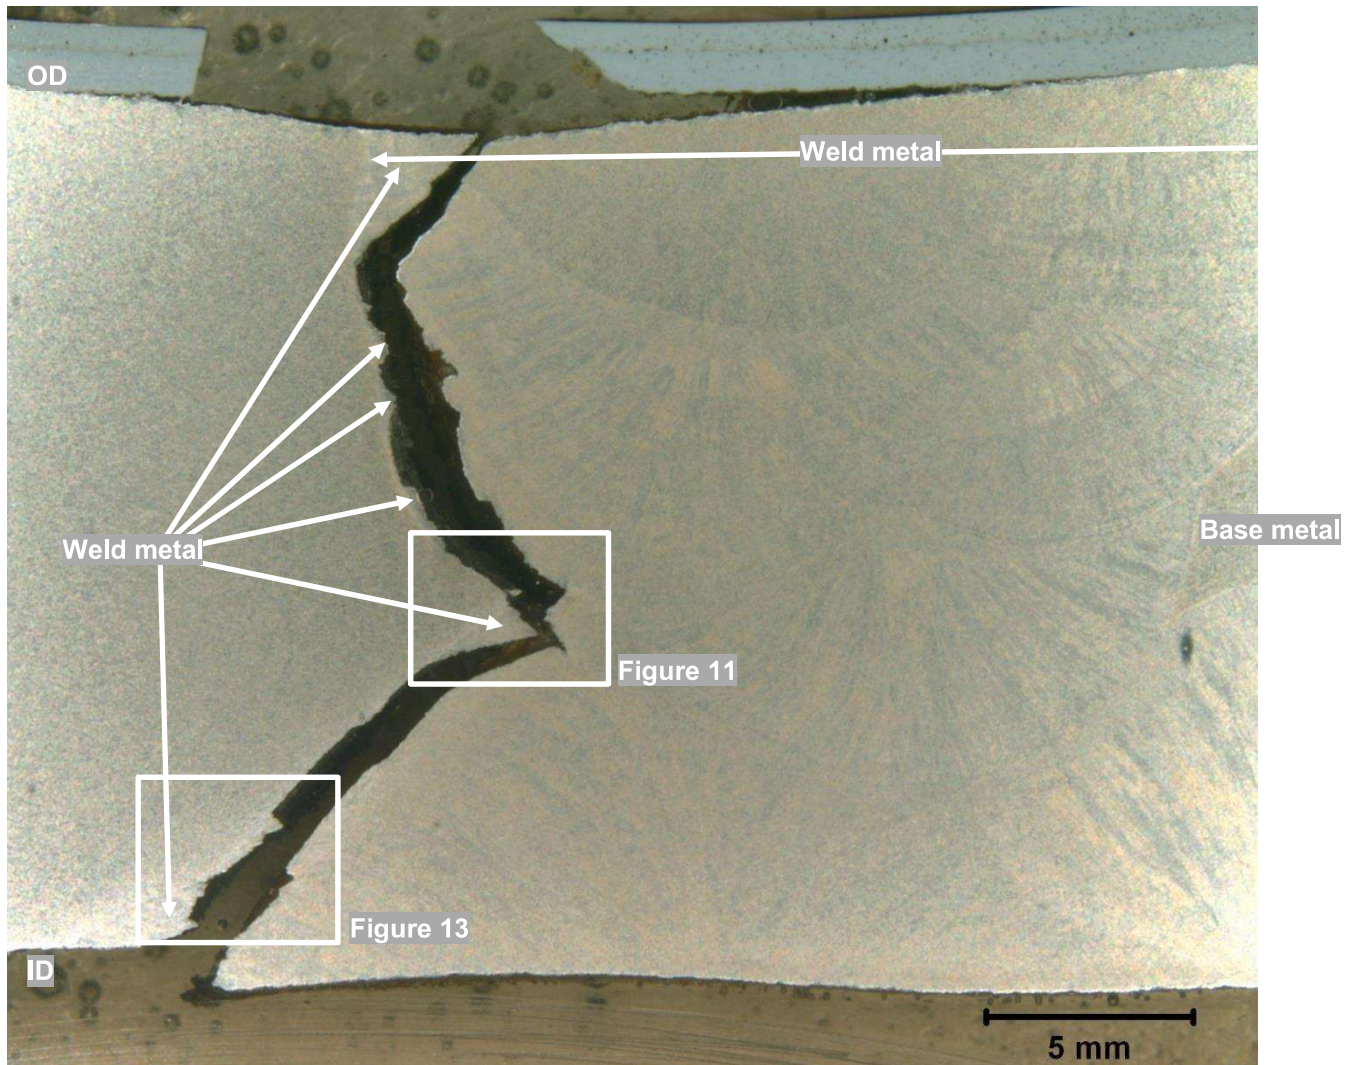
Figure 10. Light photomicrograph of transverse Mount M1 showing the fractures surfaces in cross-section (2% Nital Etchant); area indicated in Figure 9. There appears to be 5 (or 6) weld passes made from the OD surface and 2 from the ID surface with the ID passes being deposited first. The figure shows that the crack path is through the weld metal at the OD surface, ID surface, and midwall, and located at or near the fusion boundary elsewhere. Most of the material is base metal left of the fracture path and weld metal right of the fracture path.

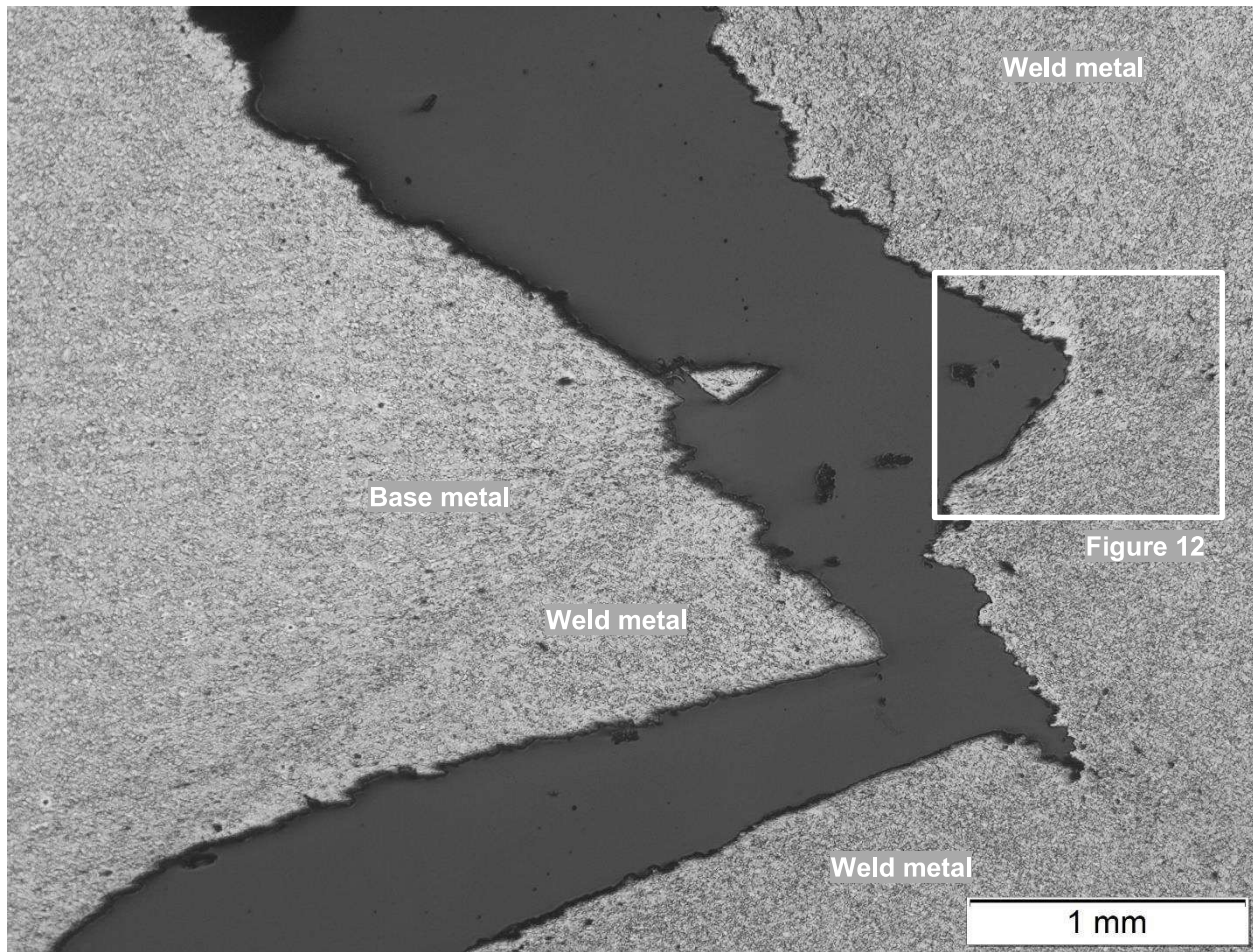
Figure 11. Light photomicrograph of Mount M1 midwall (2% Nital Etchant); area indicated in Figure 10. The figure shows where a portion of the path is through the weld metal and the remainder is at or near the fusion boundary.

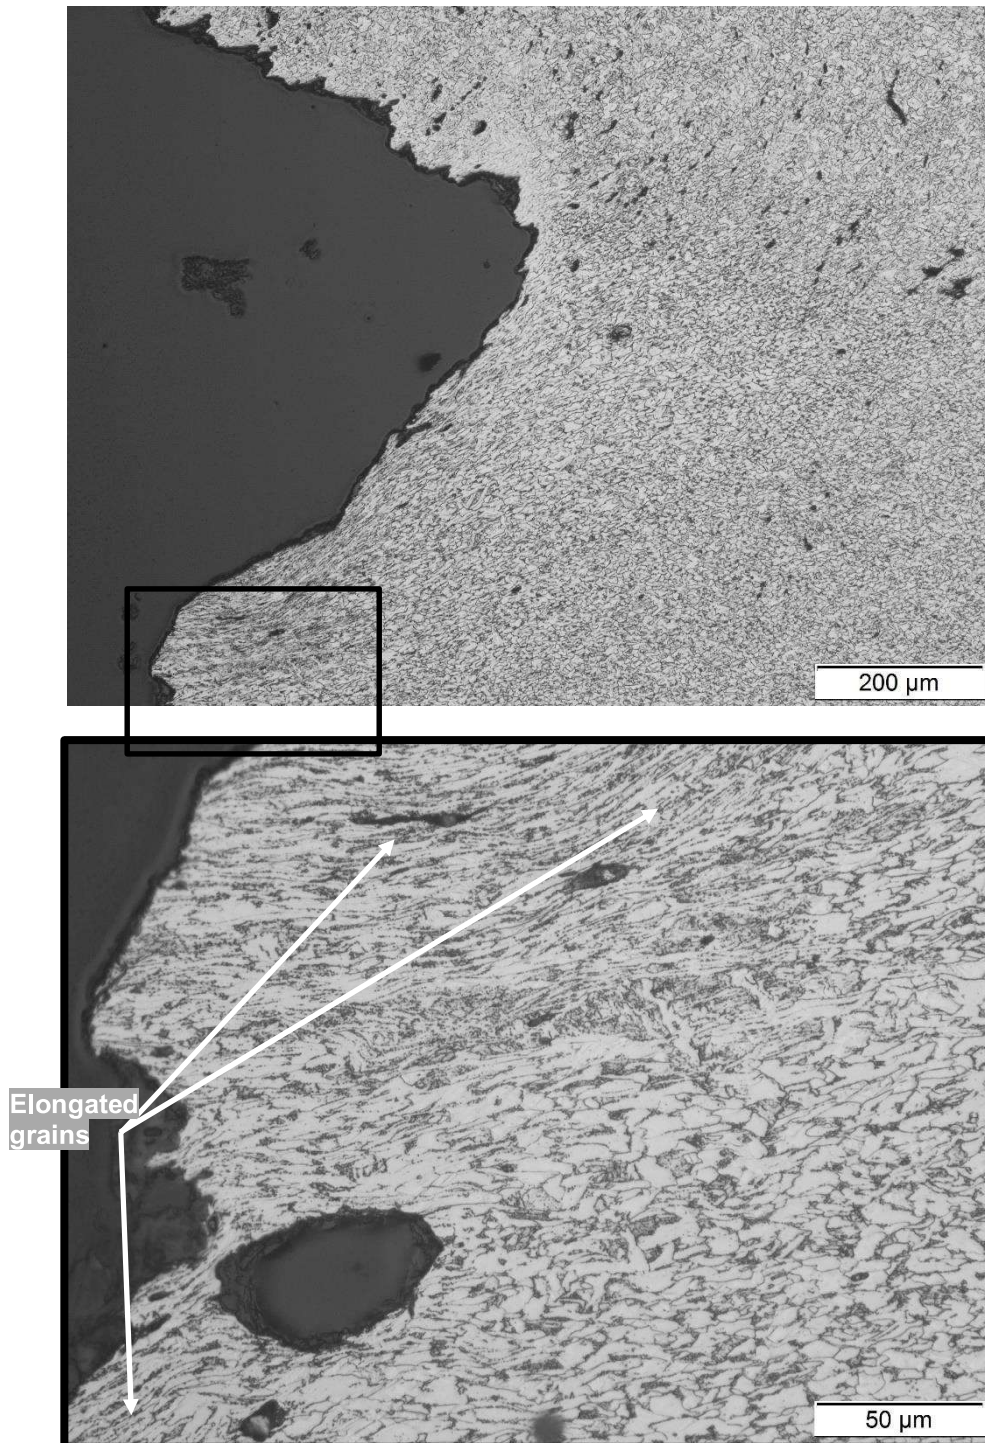
Figure 12. Low and high magnification light photomicrographs of Mount M1 midwall (2% Nital Etchant); area indicated in Figure 11. The figures shows elongated grains adjacent to the fracture surface, which is consistent with ductile overload.

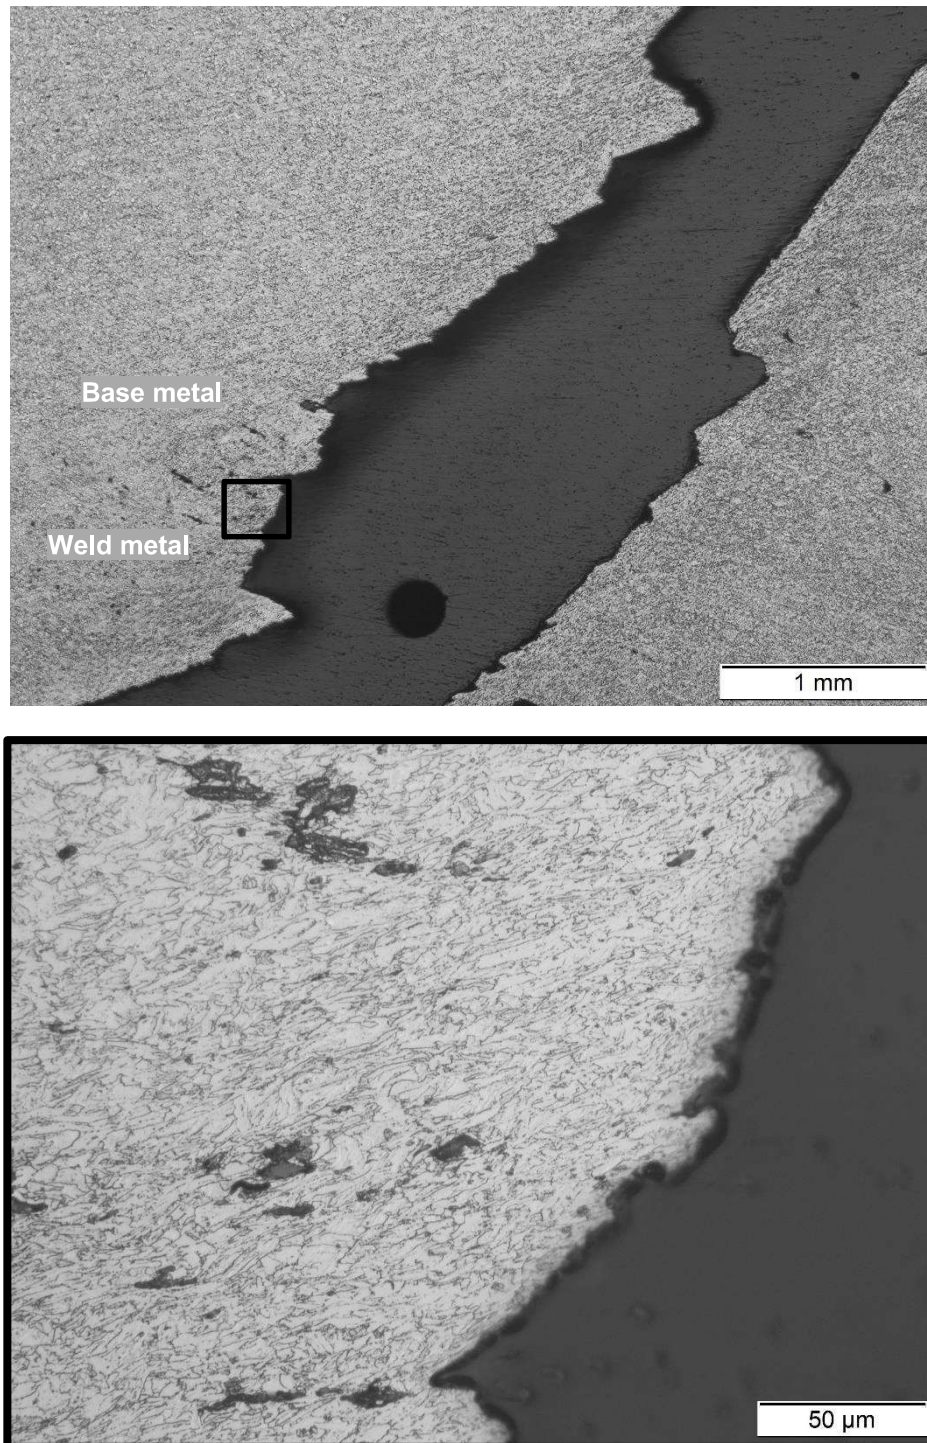
Figure 13. Low and high magnification light photomicrograph of Mount M1 near the ID surface (2% Nital Etchant); area indicated in Figure 10. The bottom photomicrograph shows elongated grains in the weld metal.

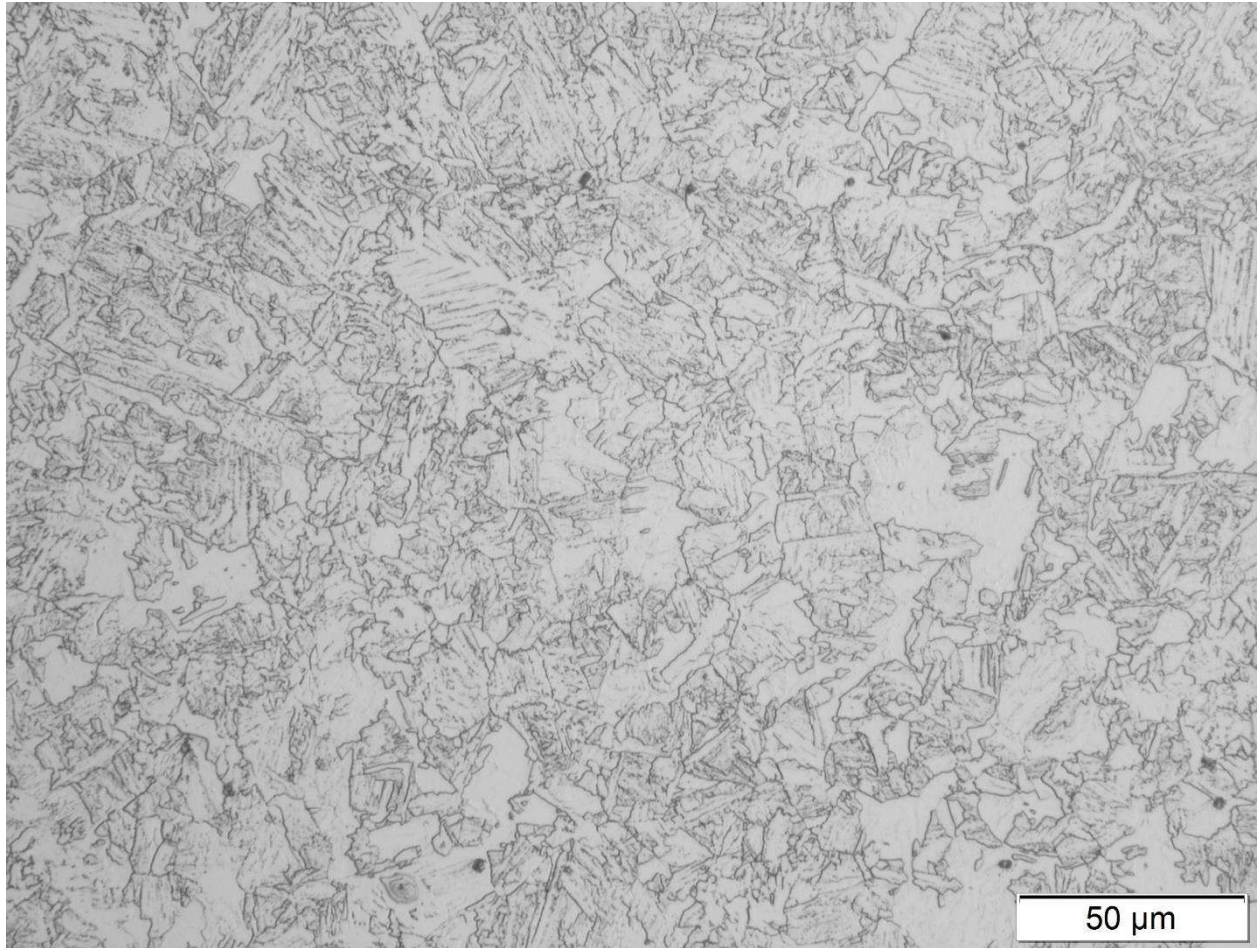
Figure 14. Light photomicrographs of Mount M1 showing the typical base metal microstructure of the fitting (2% Nital Etchant). The microstructure is consistent with a quench & temper (Q&T) microstructure and consistent with that reported in the MTR.

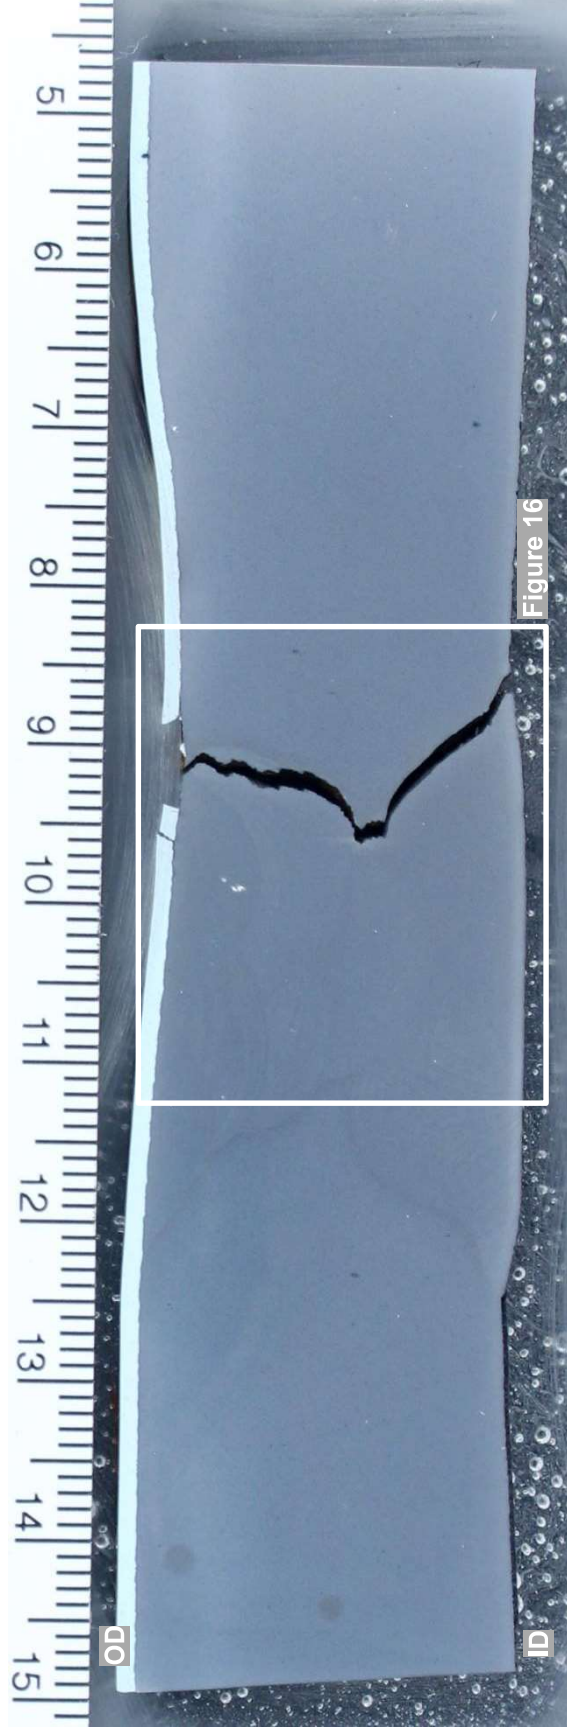
Figure 15.

Photograph of the transverse metallographic section (Mount M2) that was removed across the rupture opening, approximately 4.78 feet from the U/S end of the pipe section. The scale is in millimeters. See Figure 5 for the mount location. The fracture path appears to be located at or near the fusion line between the weld metal and base metal. The wall thickness at the far left of the cross-section, at the rupture opening, and far right of the cross-section are approximately 0.926 inches, 0.823 inches, and 0.943 inches, respectively. The significant wall reduction/necking is evident in the cross-section and the necking is maximum at the rupture opening, consistent with a ductile overload failure. The weld metal on the ID surface is approximately 1.5 inches wide (in the circumferential direction). The morphology of the weld and the fracture path are similar at this location compared to in Mount M1. The cross-section (and adjacent SEM sample) was removed from this location along the fracture surface in order to examine the midwall vertical portion.
