Final Summary Report

Metallurgical Analysis of 42-Inch MVP Line H600 Hydrotest Elbow Fitting Failure (05/01/2024)

Mountain Valley Pipeline, LLC
Canonsburg, Pennsylvania

Report No: E-AD-LI / GTQU (10513119)
August 1, 2024

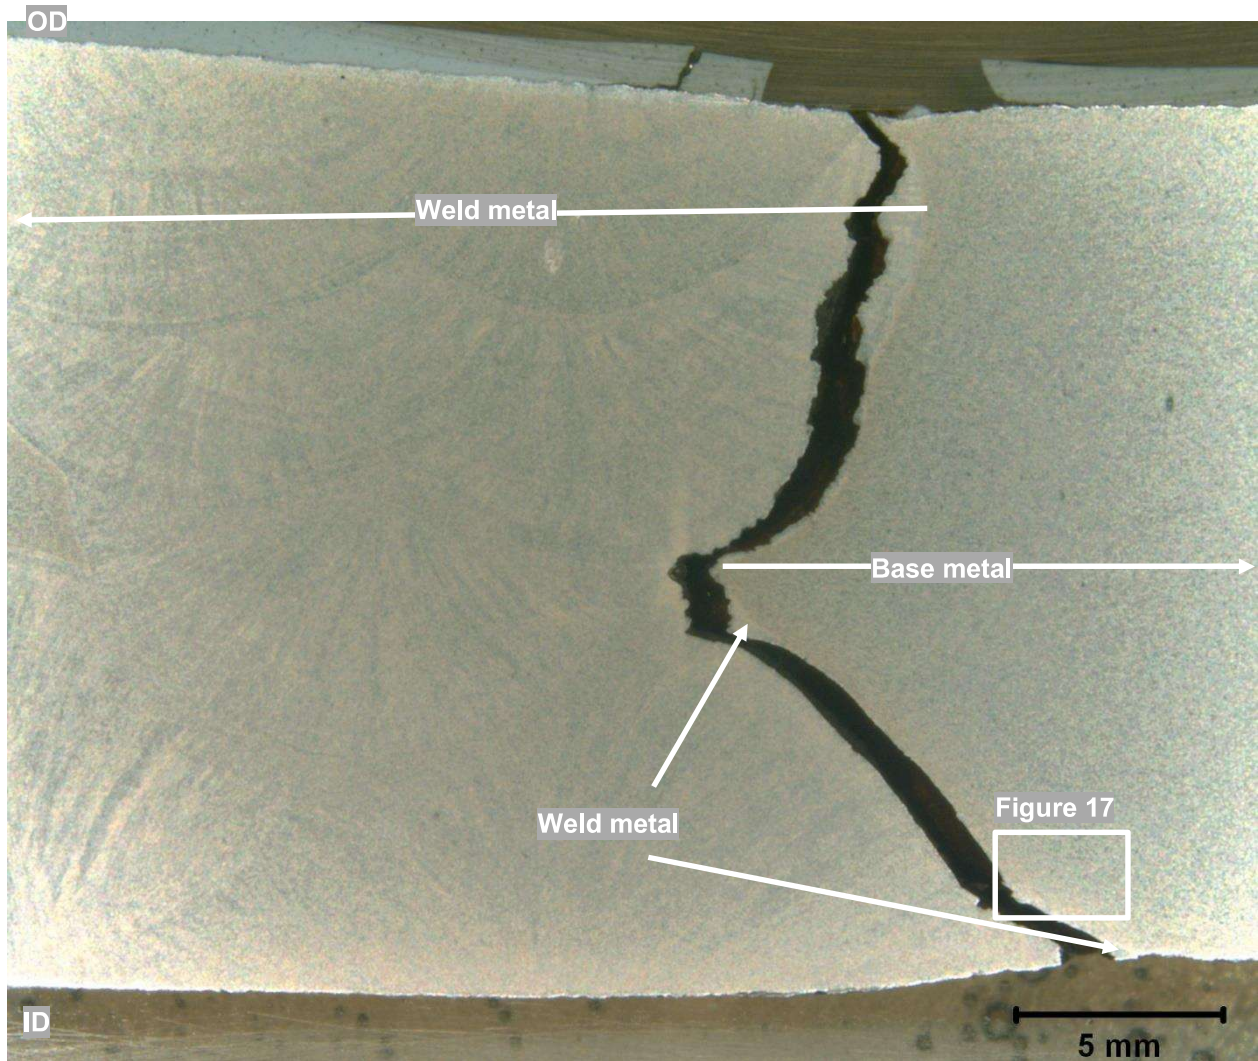
Figure 16. Light photomicrograph of transverse Mount M2 showing the fractures surfaces in cross-section (2% Nital Etchant); area indicated in Figure 15. There appears to be 5 weld passes made from the OD surface and 2 from the ID surface with the ID passes being deposited first. The figure shows that the crack path is through the weld metal at the OD surface, ID surface, and midwall, and located at or near the fusion boundary elsewhere. Most of the material is weld metal left of the fracture path and base metal right of the fracture path.

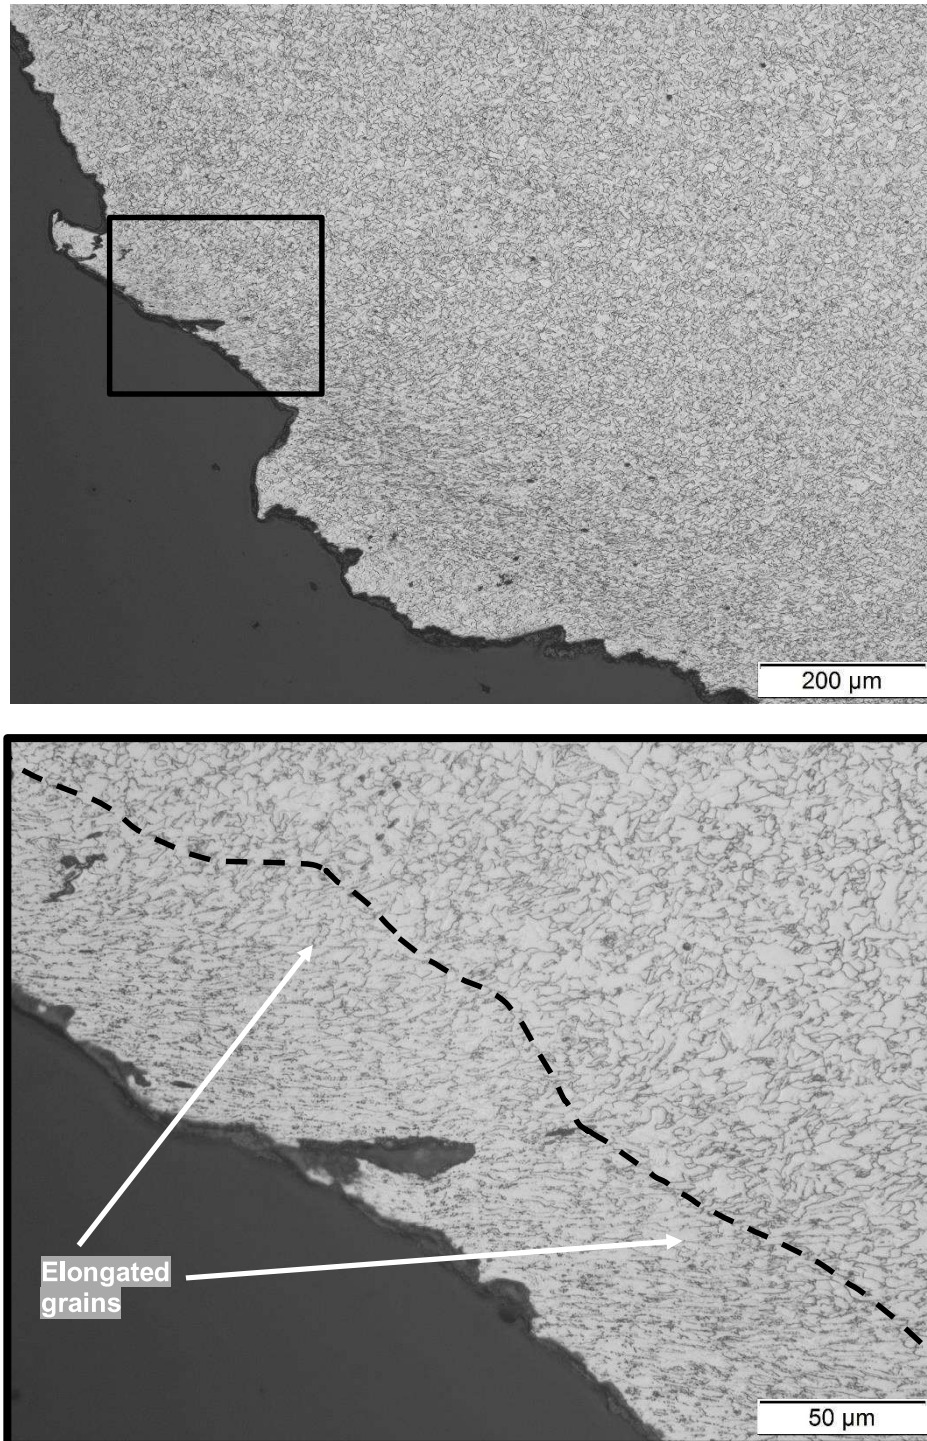
Figure 17. Low and high magnification light photomicrographs of Mount M2 near the ID surface (2% Nital Etchant); area indicated in Figure 16. The figure shows elongated grains at the fracture surface and unaffected grains away. The elongated grains are consistent with ductile overload.

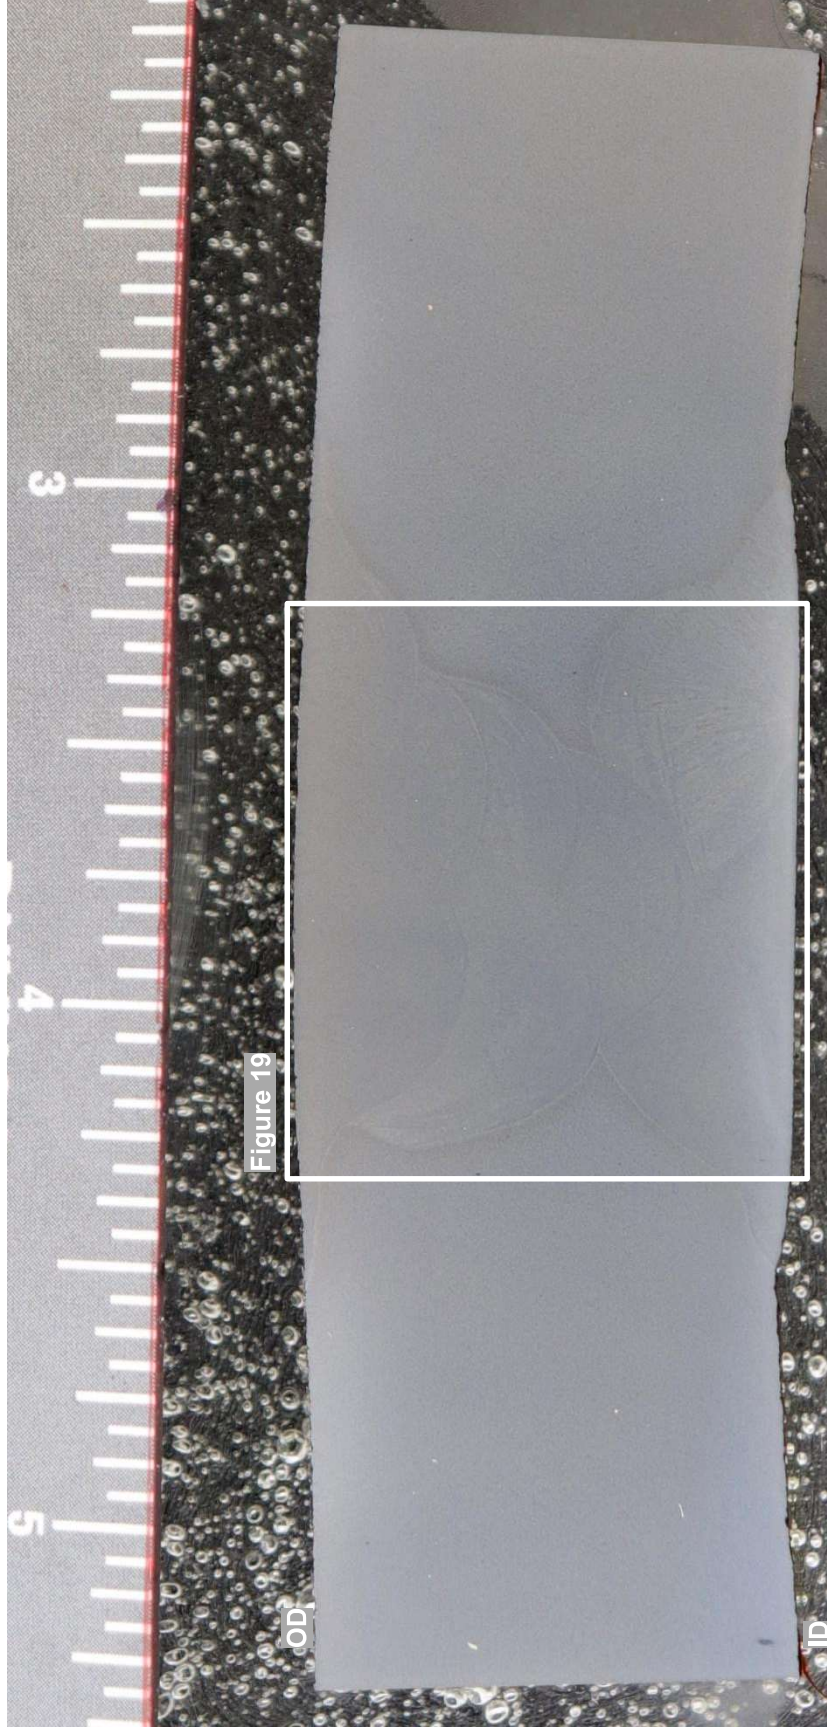
Figure 18. Photograph of the transverse metallographic section (Mount M3) that was removed across the seam weld of the sister elbow fitting. The scale is in inches. The morphology of the weld is similar to that in Mounts M1 and M2. The wall thickness at the far left of the cross-section, at the middle of the weld, and far right of the cross-section are approximately 0.925 inches, 0.959 inches, and 0.921 inches, respectively. Compared to Mounts M1 and M2, the fitting at this location does not show any evidence of wall reduction. The weld metal on the ID surface is approximately 1.5 inches wide (in the circumferential direction), similar to the failed elbow fitting.

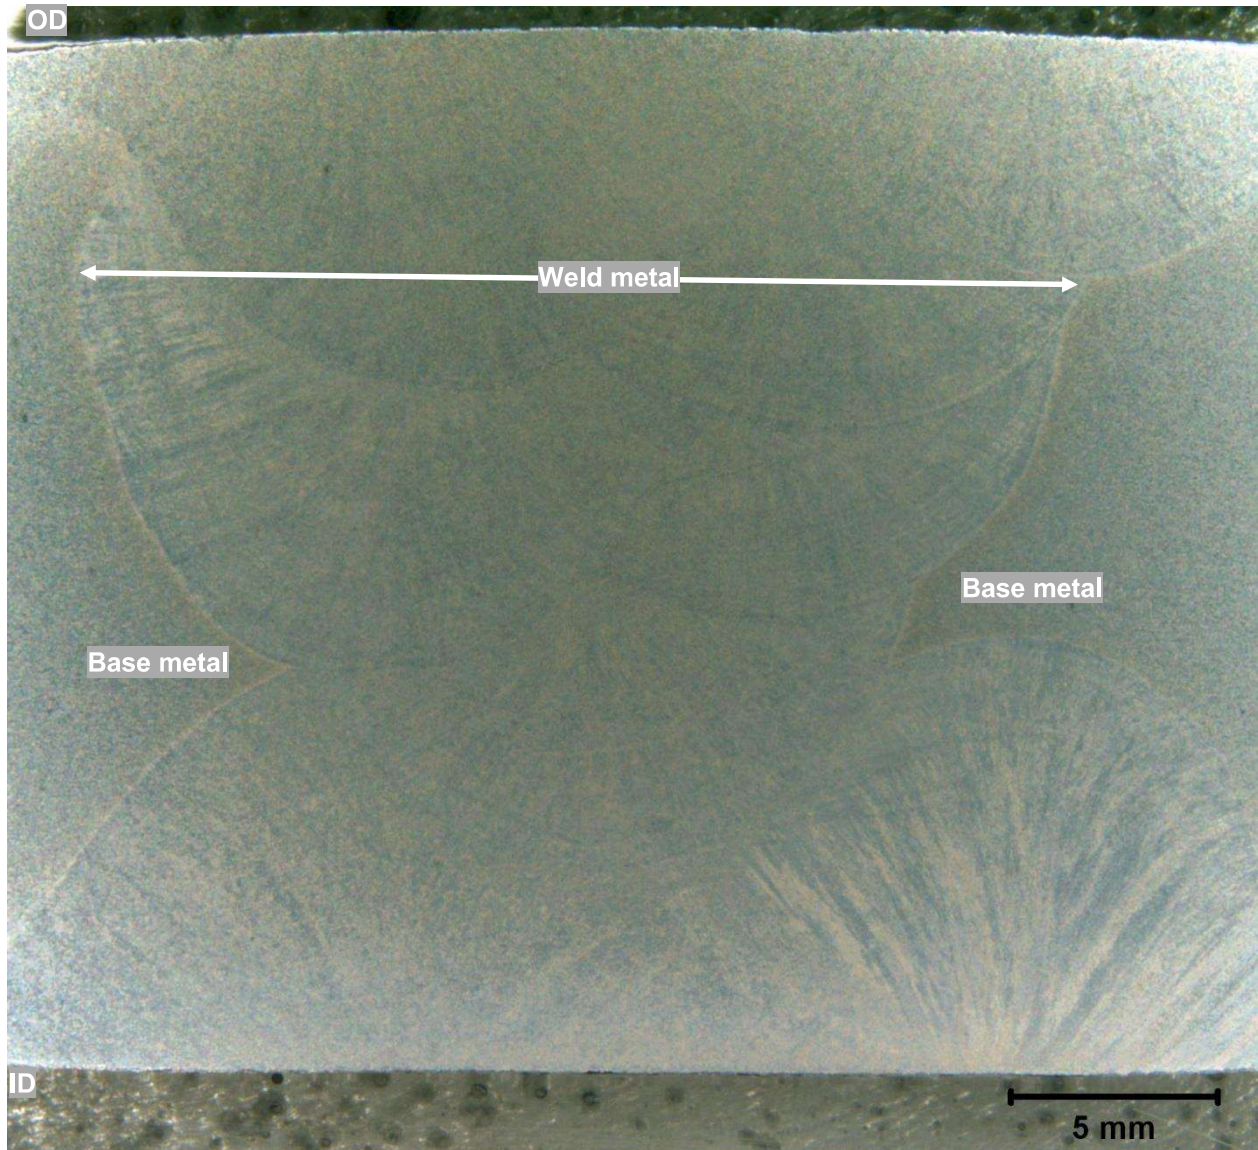
Figure 19. Light photomicrograph of Mount M3 showing the morphology of the weld (2% Nital Etchant); area indicated in Figure 18. There appears to be 6 weld passes made from the OD surface and 2 from the ID surface with the ID passes being deposited first. No pre-existing flaws are visible.

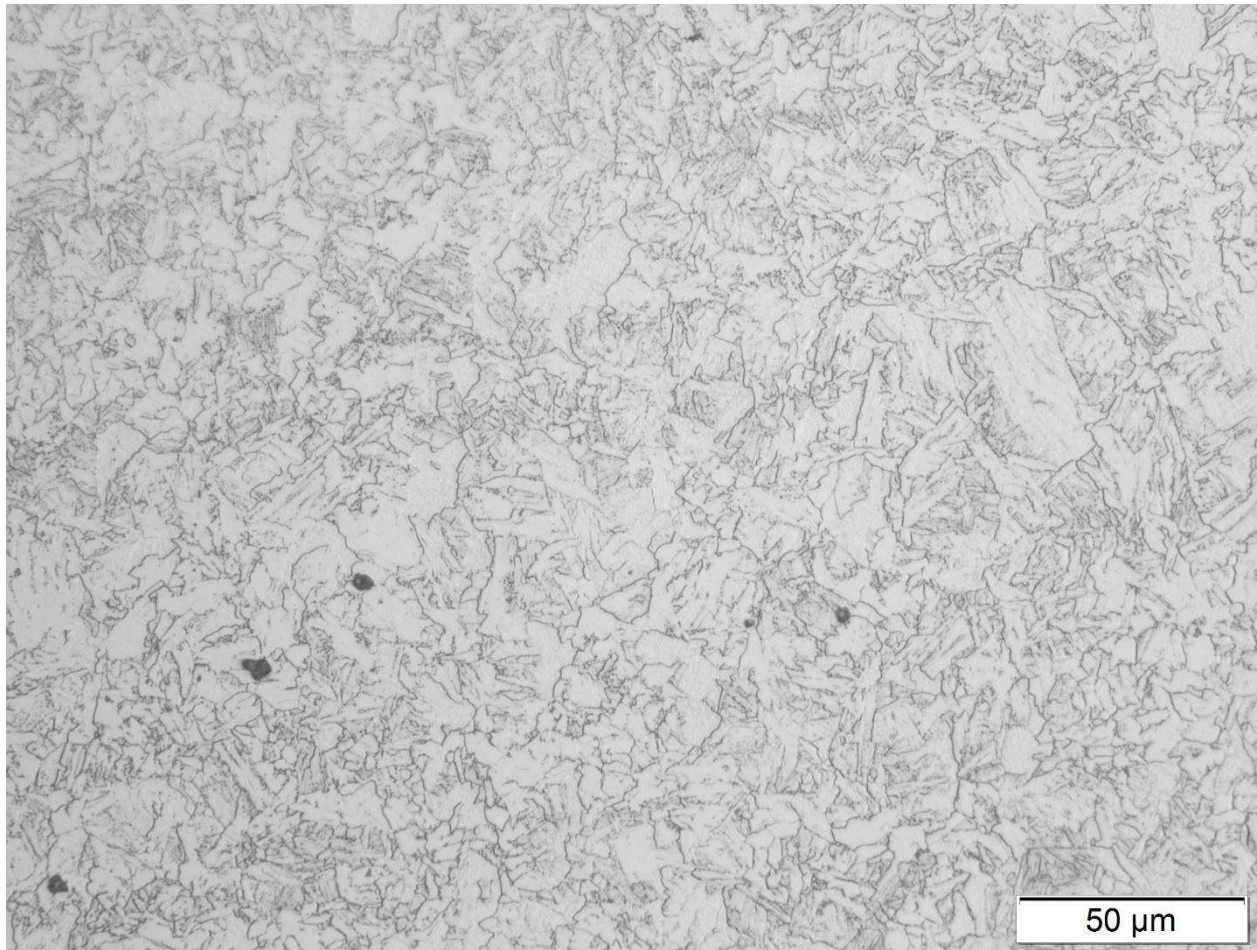
Figure 20. Light photomicrographs of Mount M3 showing the typical base metal microstructure of the sister elbow fitting (2% Nital Etchant). The microstructure is similar to that in the failed elbow fitting, consistent with a Q&T microstructure, and consistent with that reported in the MTR.

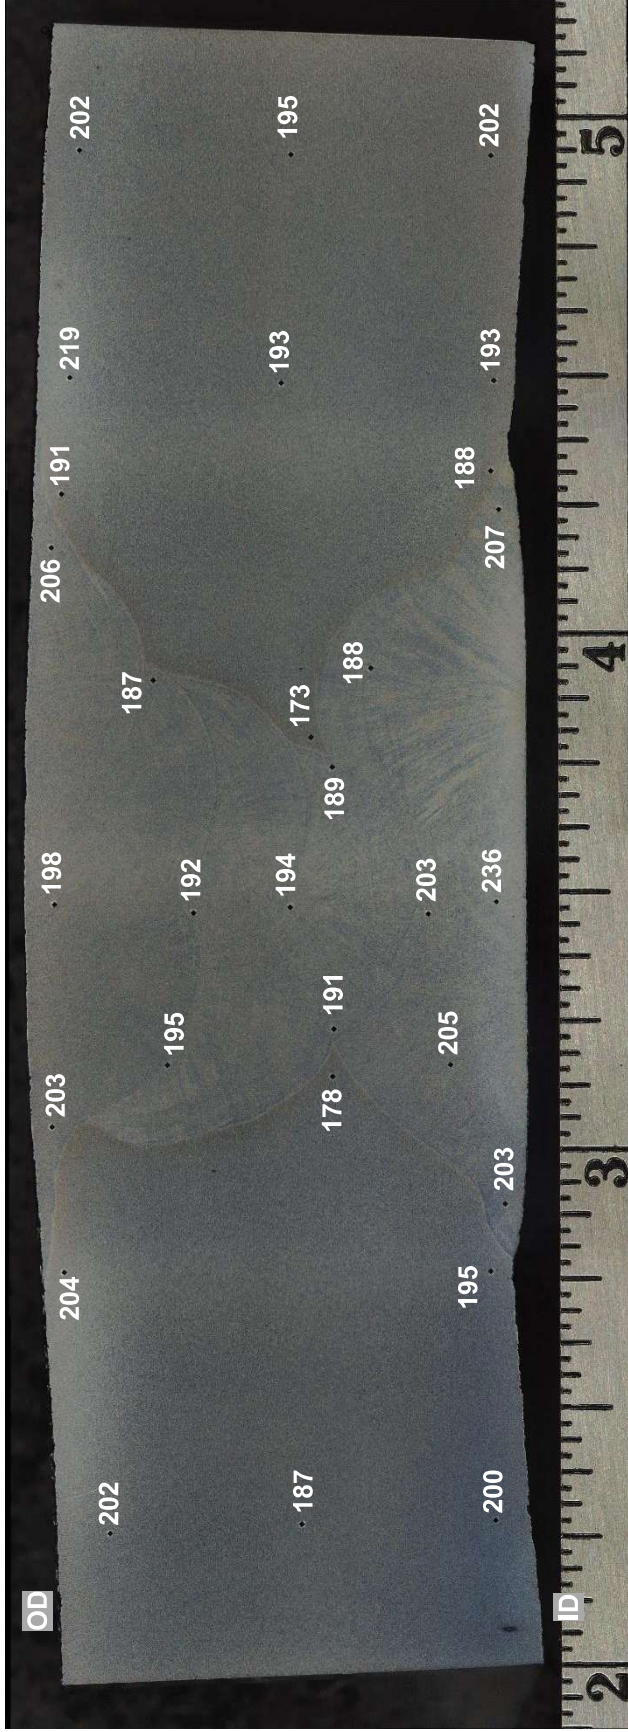
Figure 22. Light photomicrograph of Mount M3 from the sister elbow fitting following hardness testing (Vickers 10 kg load) showing the indents and corresponding hardness values (2% Nital Etchant). The hardness values are between 173 HV and 236 HV, with an average value of 197HV. A similar trend is present at this cross-section when comparing to Mount M2. The mid-thickness of the sample is slightly softer than the outer edges. The softest portion of the base metal is mid thickness near the weld metal (173 and 178 HV), near the intersection of OD and ID weld passes, compared to the next highest base metal value of 187 HV. Overall, there appears to be a softening of the base metal mid-thickness adjacent to the weld metal, where the weld metal is also somewhat softer compared to the outer edges of the weld metal.

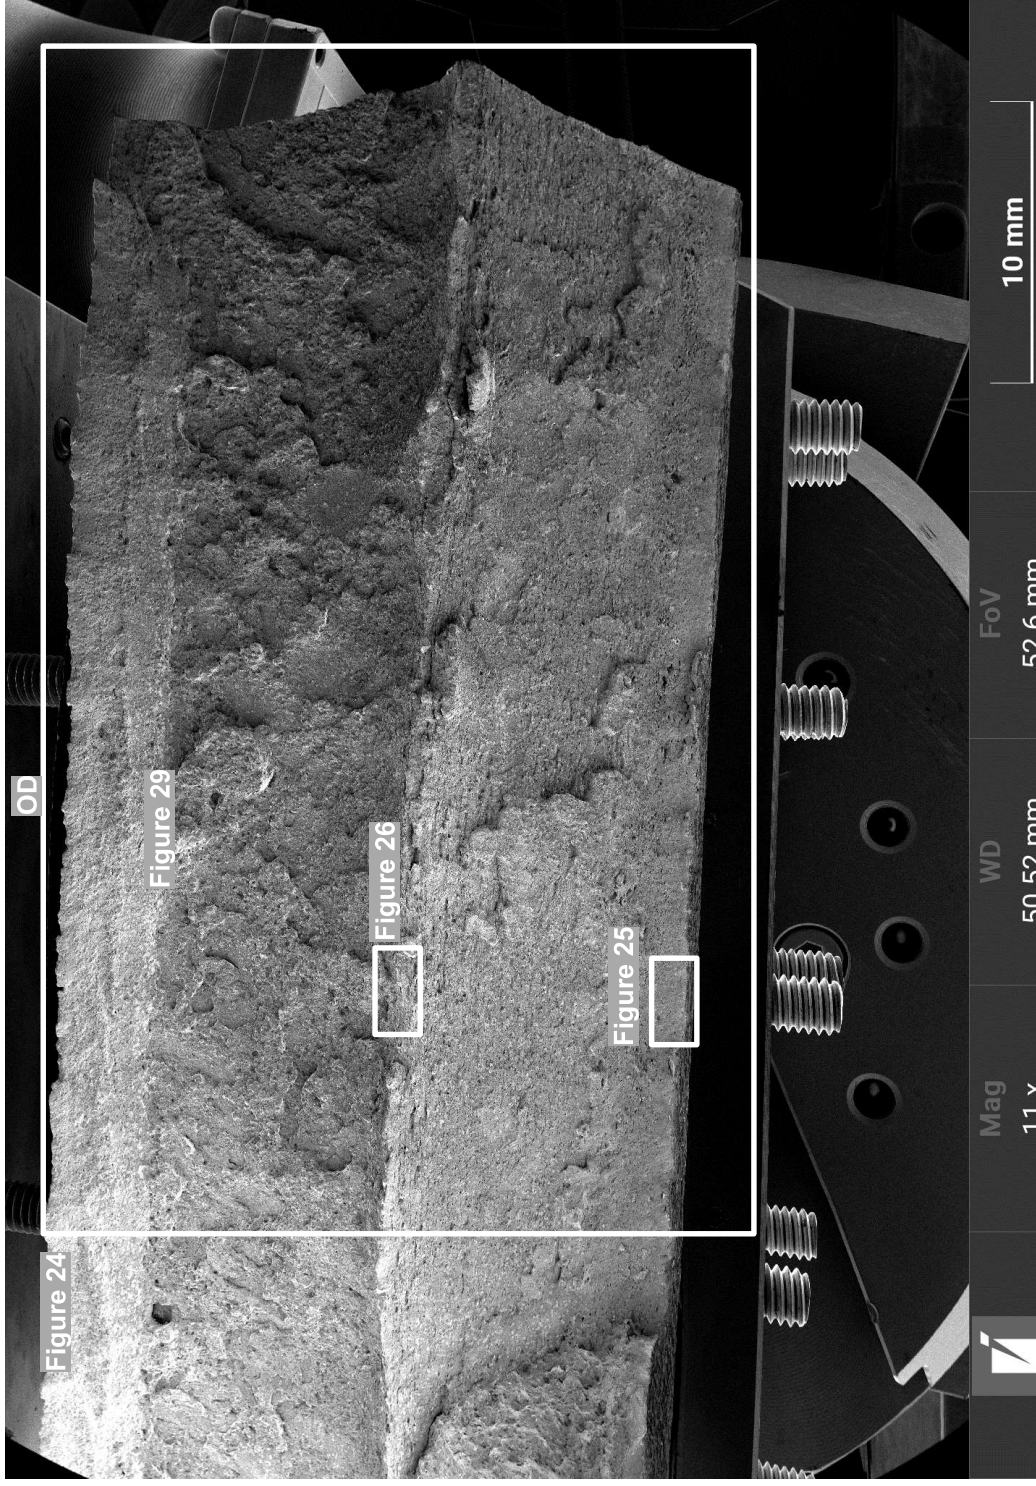
Figure 23. SEM image of Sample S1 showing the fracture surface, following cleaning in ENPREP®214; area indicated in Figure 7. The figure shows where higher magnification SEM images were taken. As mentioned above, the sample was removed at this location since it appeared to be the thinnest region of the fracture surface.

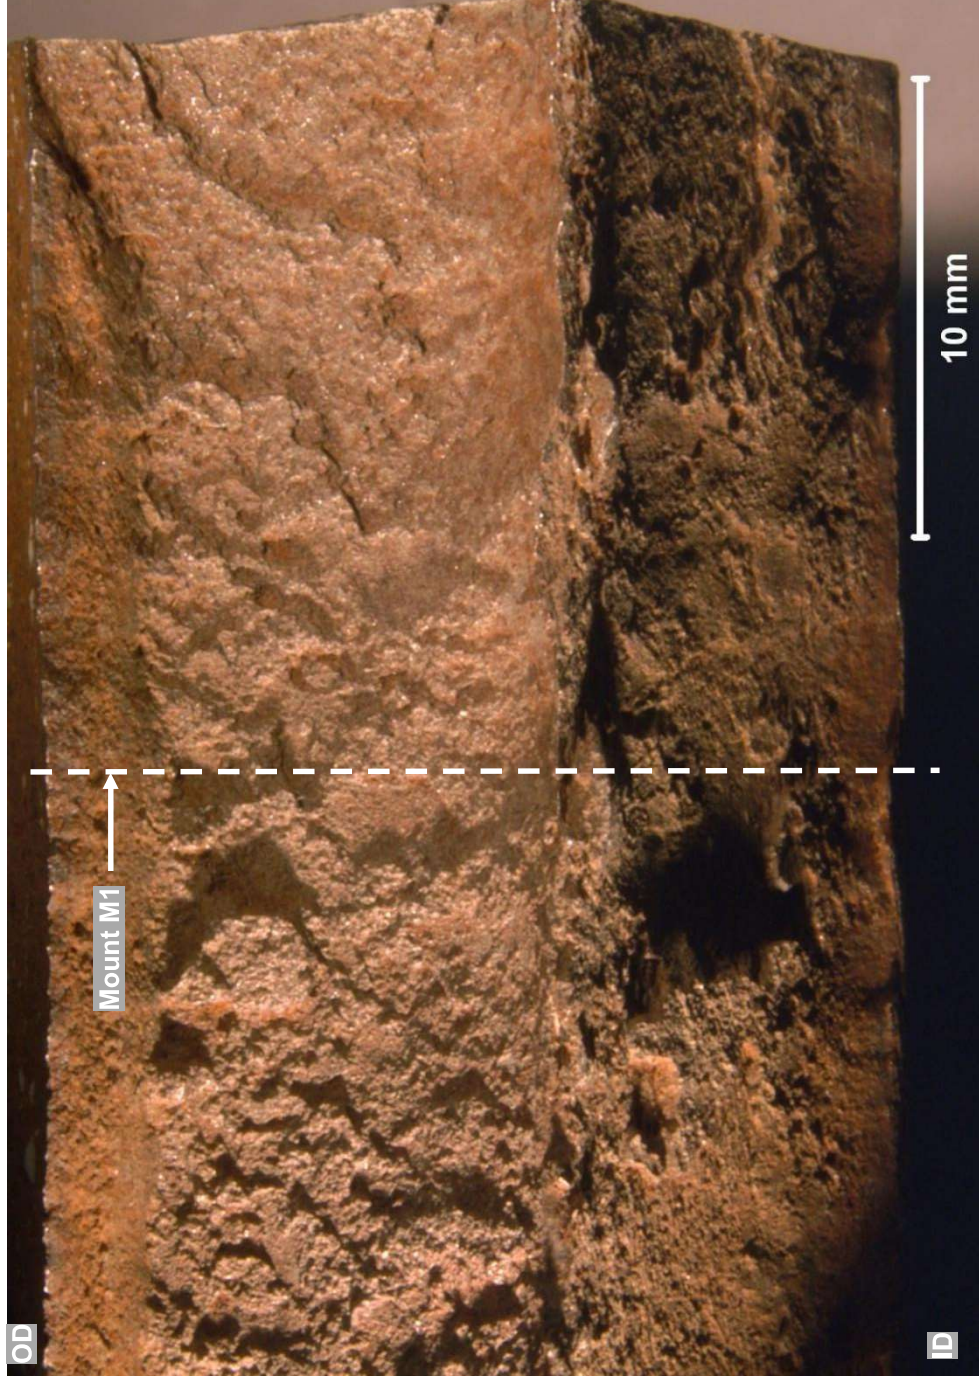
Figure 24. Light photomicrograph of Sample S1 showing the fracture surface; area indicated in Figure 23. The figure shows where Mount M1 was removed. The fracture surface is somewhat smooth from the ID surface to midwall, transitions to a rougher portion from midwall to just below the OD surface, and then the remaining portion adjacent to the OD surface is similar to the portion adjacent to the ID surface.

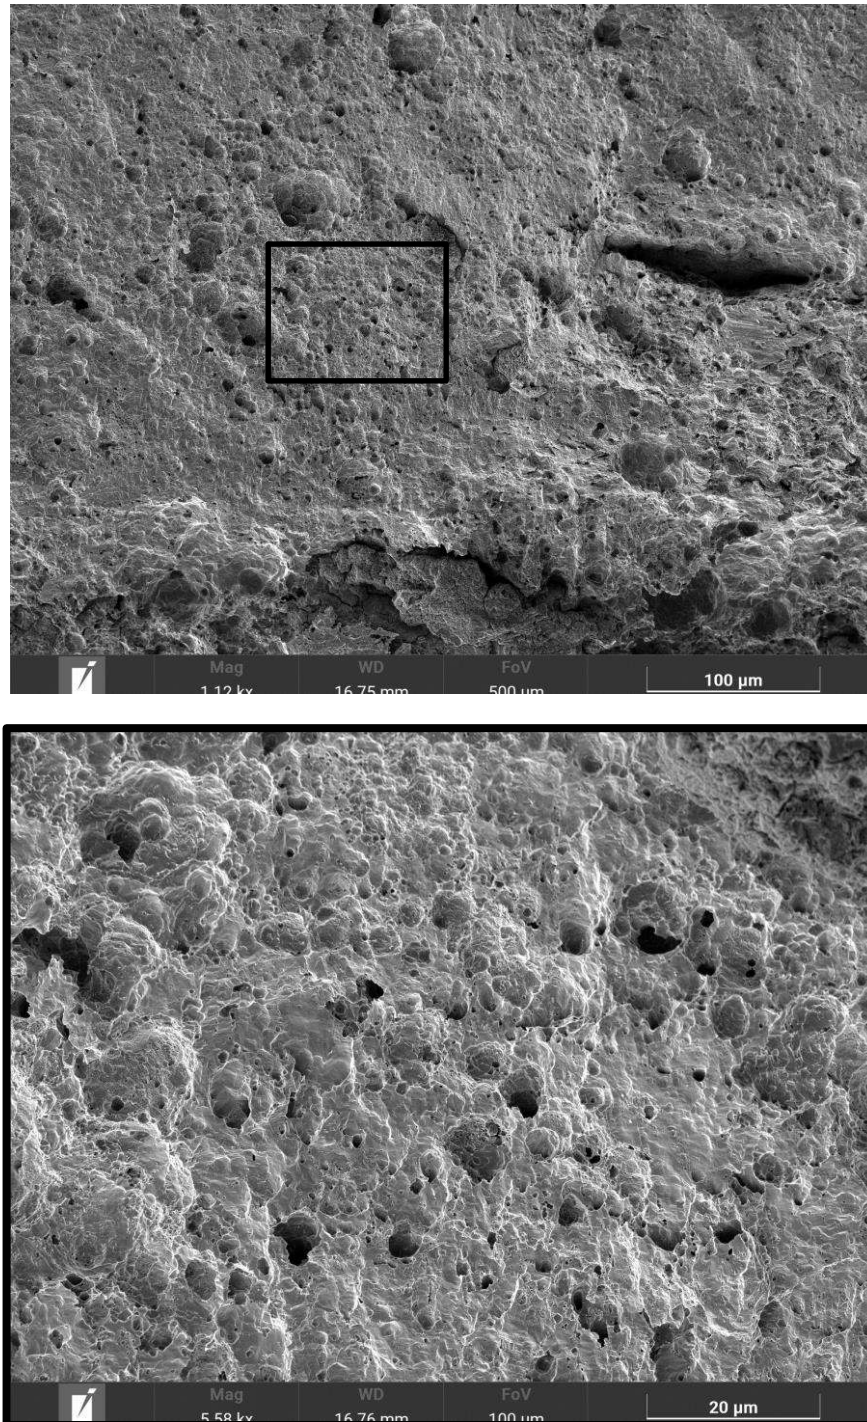
Figure 25. Low and high magnification SEM images of Sample S1 near the ID surface showing the fracture surface in Region 1; area indicated in Figure 23. The fracture surface consists of dimples, consistent with ductile fracture overload. This morphology is consistent with the metallographic cross-section.

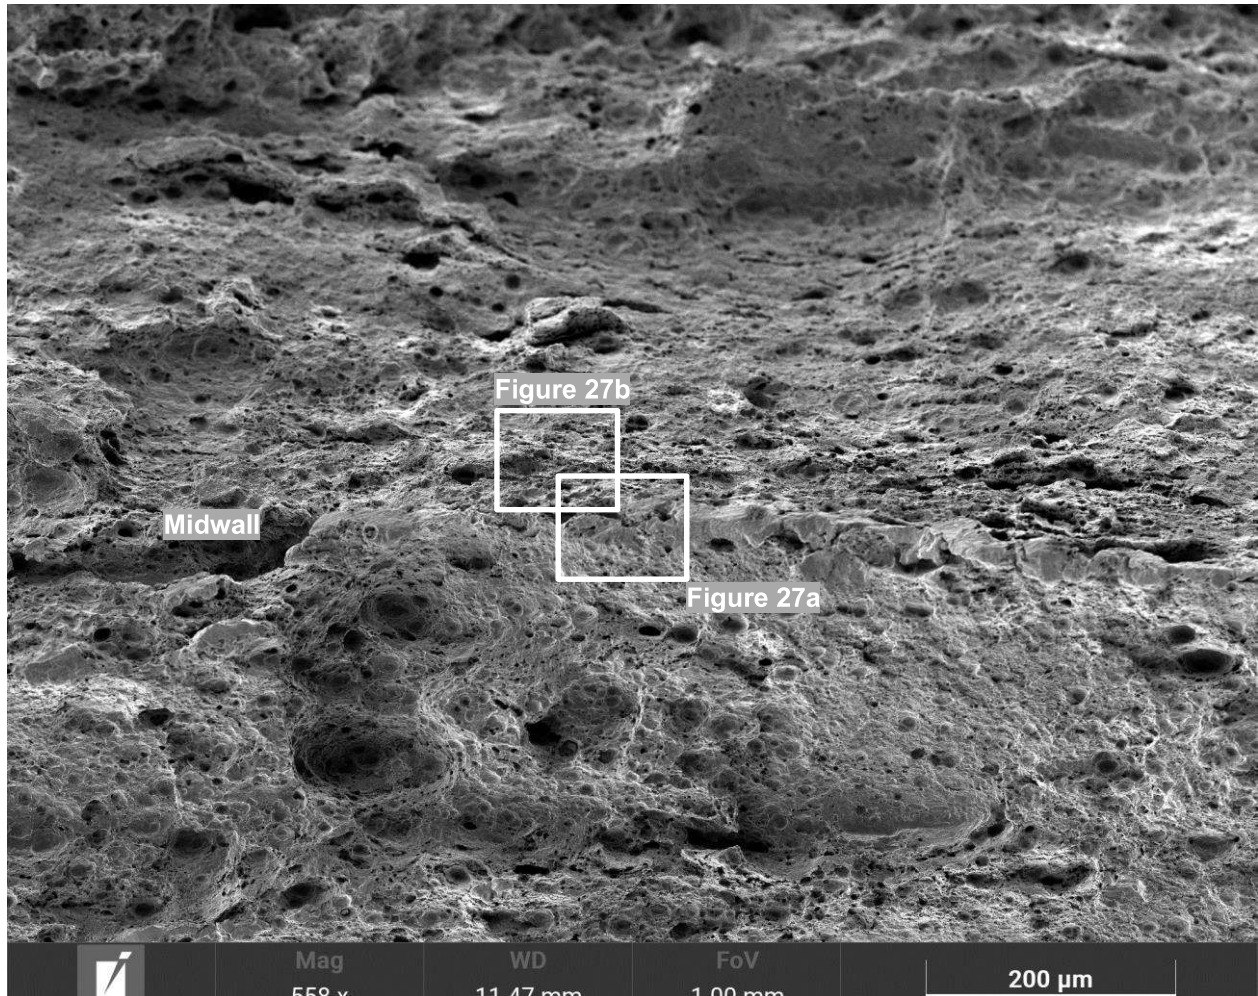
Figure 26. SEM image of Sample S1 midwall showing the fracture surface near midwall; area indicated in Figure 23. The fracture surface at this location also contains dimples, consistent with ductile overload.

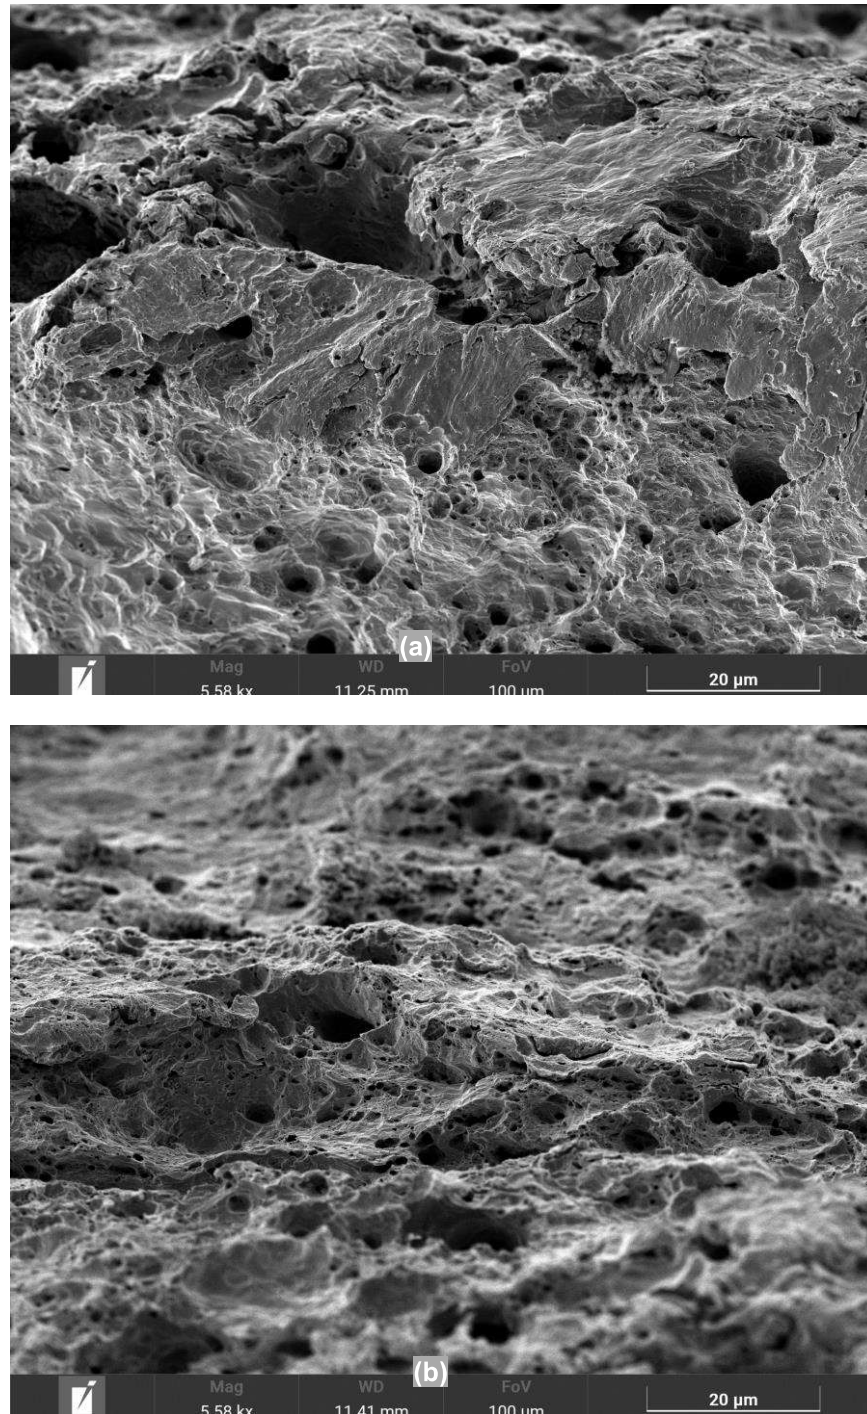
Figure 27. SEM images of Sample S1 at/below midwall (a) and above (b) showing the fracture surface; area indicated in Figure 26. The fracture surface appears smooth and smeared midwall as shown in (a) above and dimples are located above and below it.

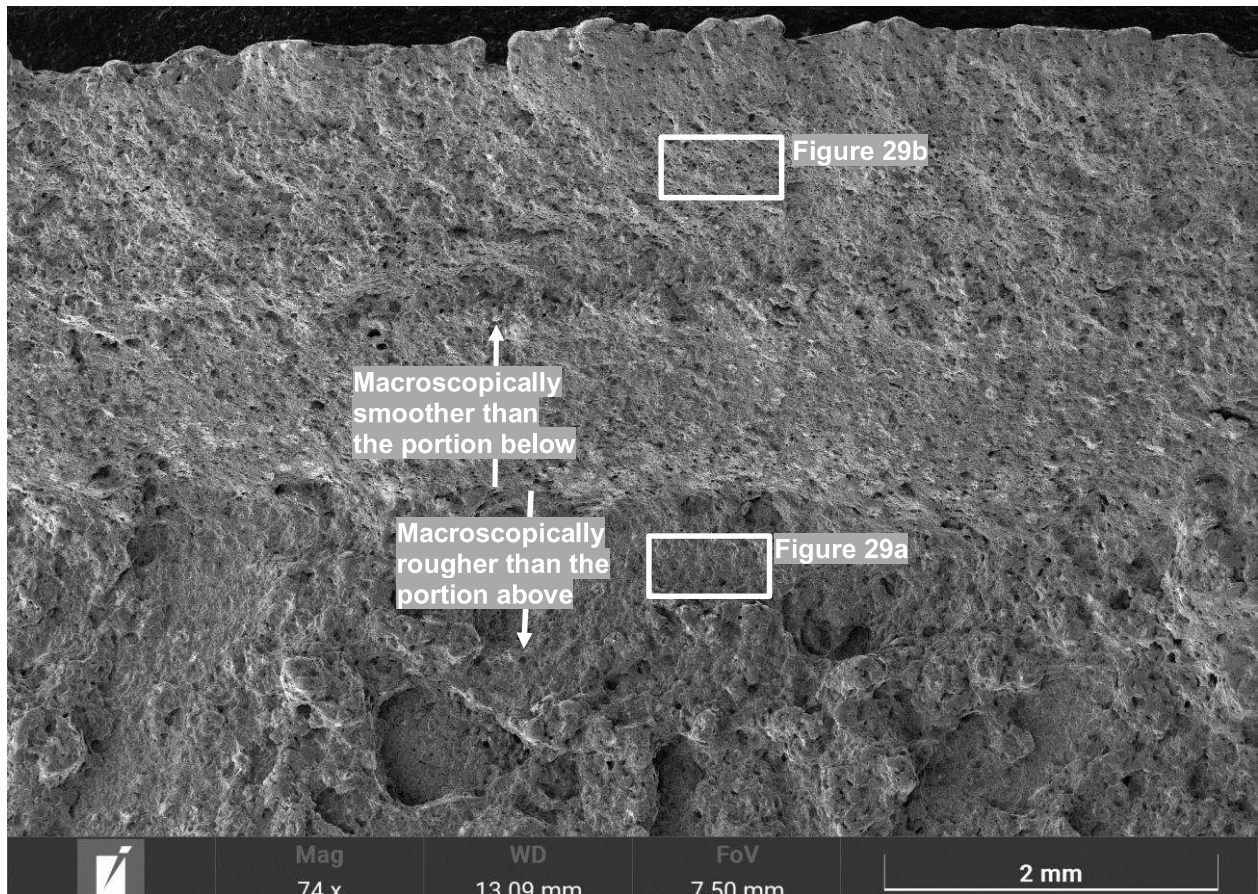
Figure 28. SEM image of Sample S1 showing the fracture surfaces near the OD surface; area indicated in Figure 23. The figure shows the difference in the topography of the fracture surface and where higher magnification SEM images were taken.

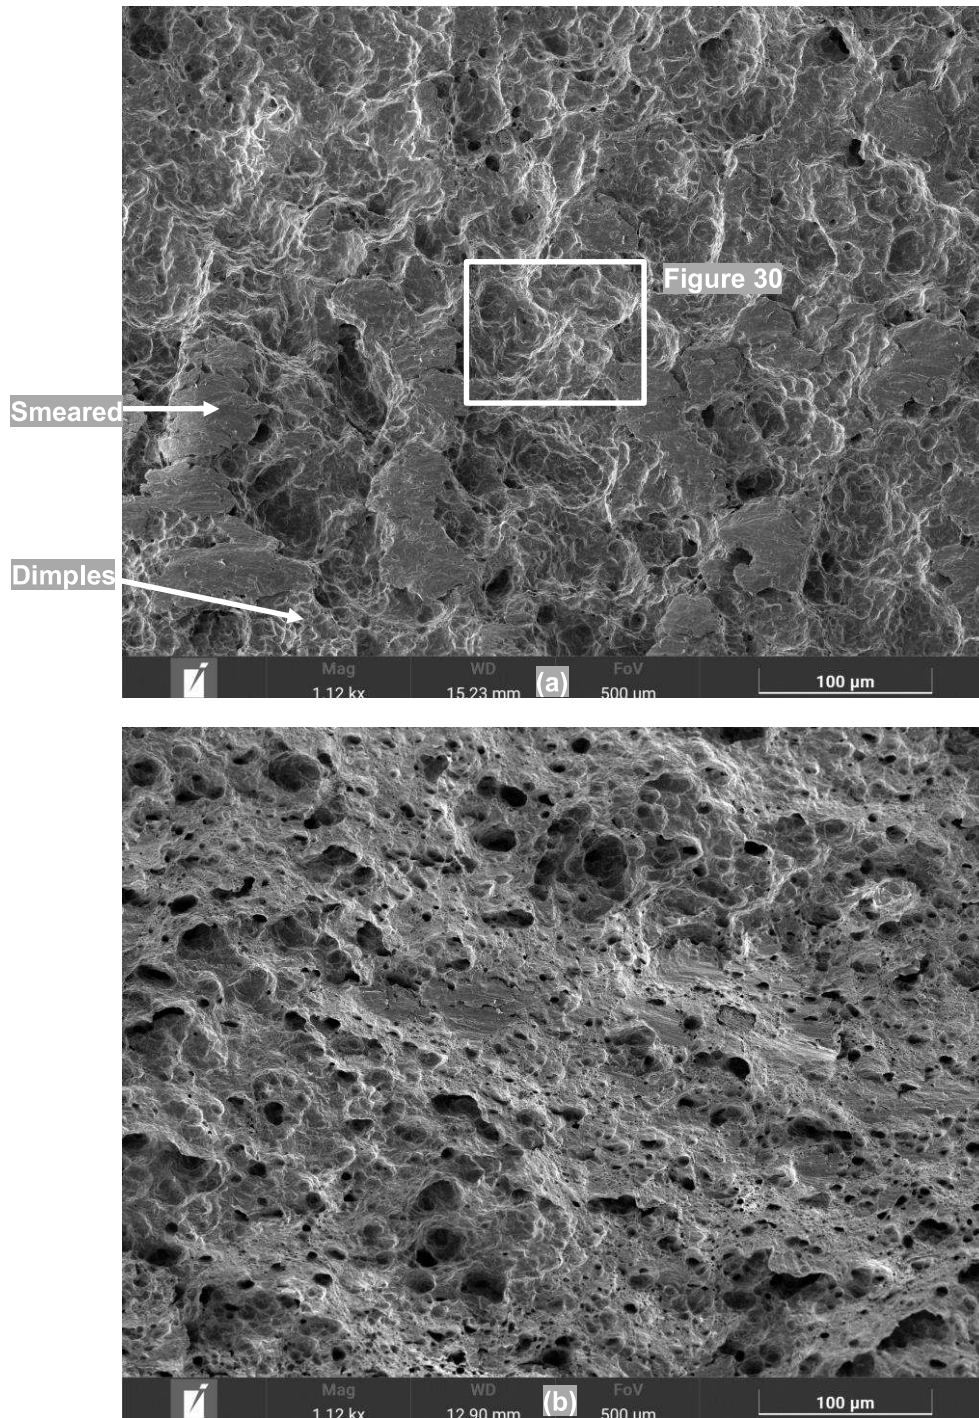
Figure 29. High magnification SEM images of Sample S1 showing the fracture surfaces at the areas described in Figure 28; areas indicated in Figure 28. The fracture surface contains in (a) above contains some dimples and smeared metal, less evidence of ductility compared to the other portions of the fracture surface. The fracture surface in (b) contains dimples. The dimples are consistent with ductile fracture.

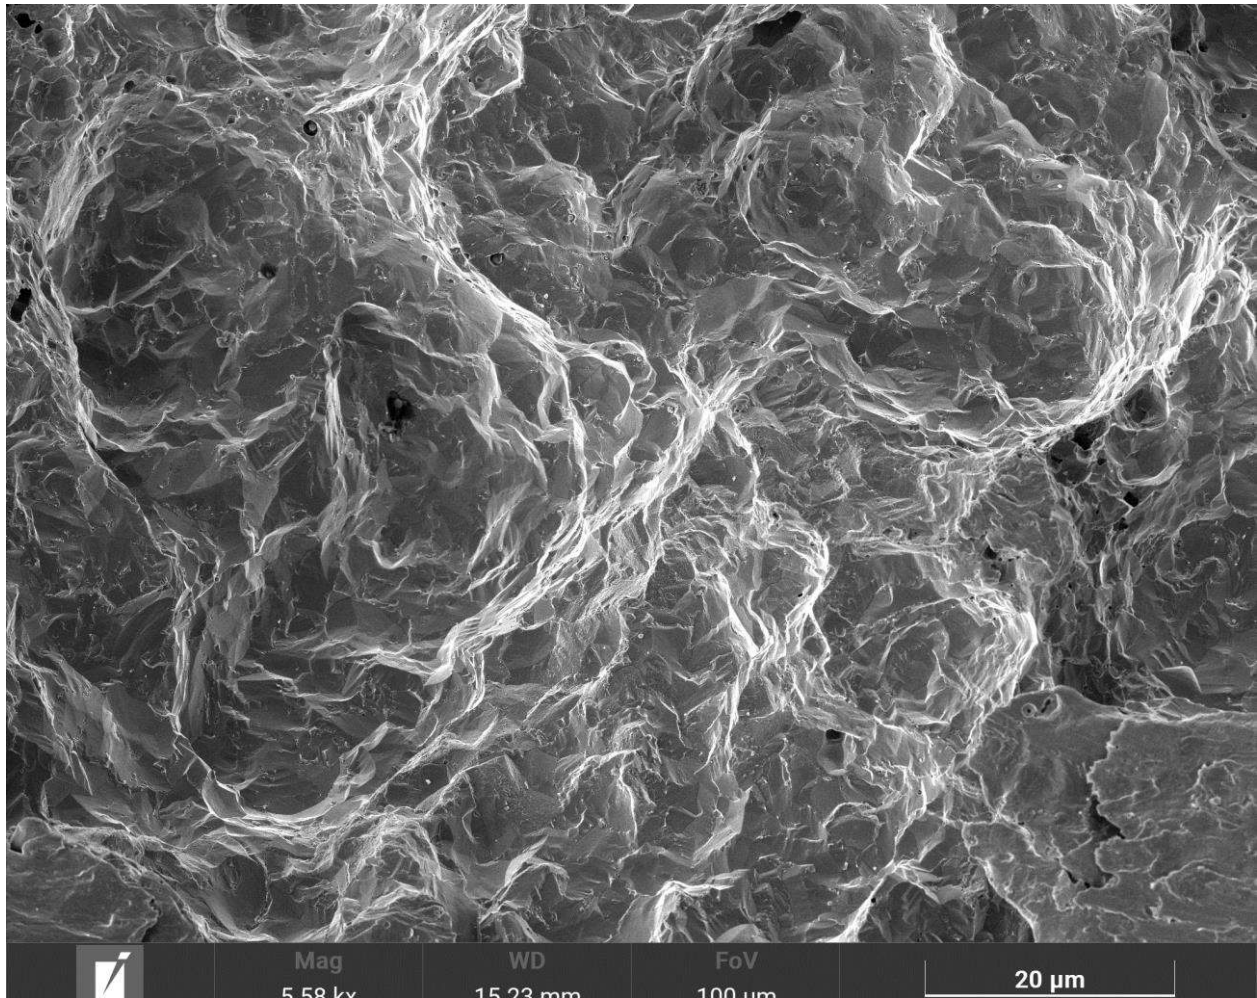
Figure 30. High magnification SEM images of Sample S1 showing the fracture surfaces where there was less evidence of ductility; area indicated in Figure 29. The fracture surface has a “glassy” appearance and appears to be quasi cleavage, and thus is likely more brittle compared to the other areas of the fracture surface that just contain dimples.

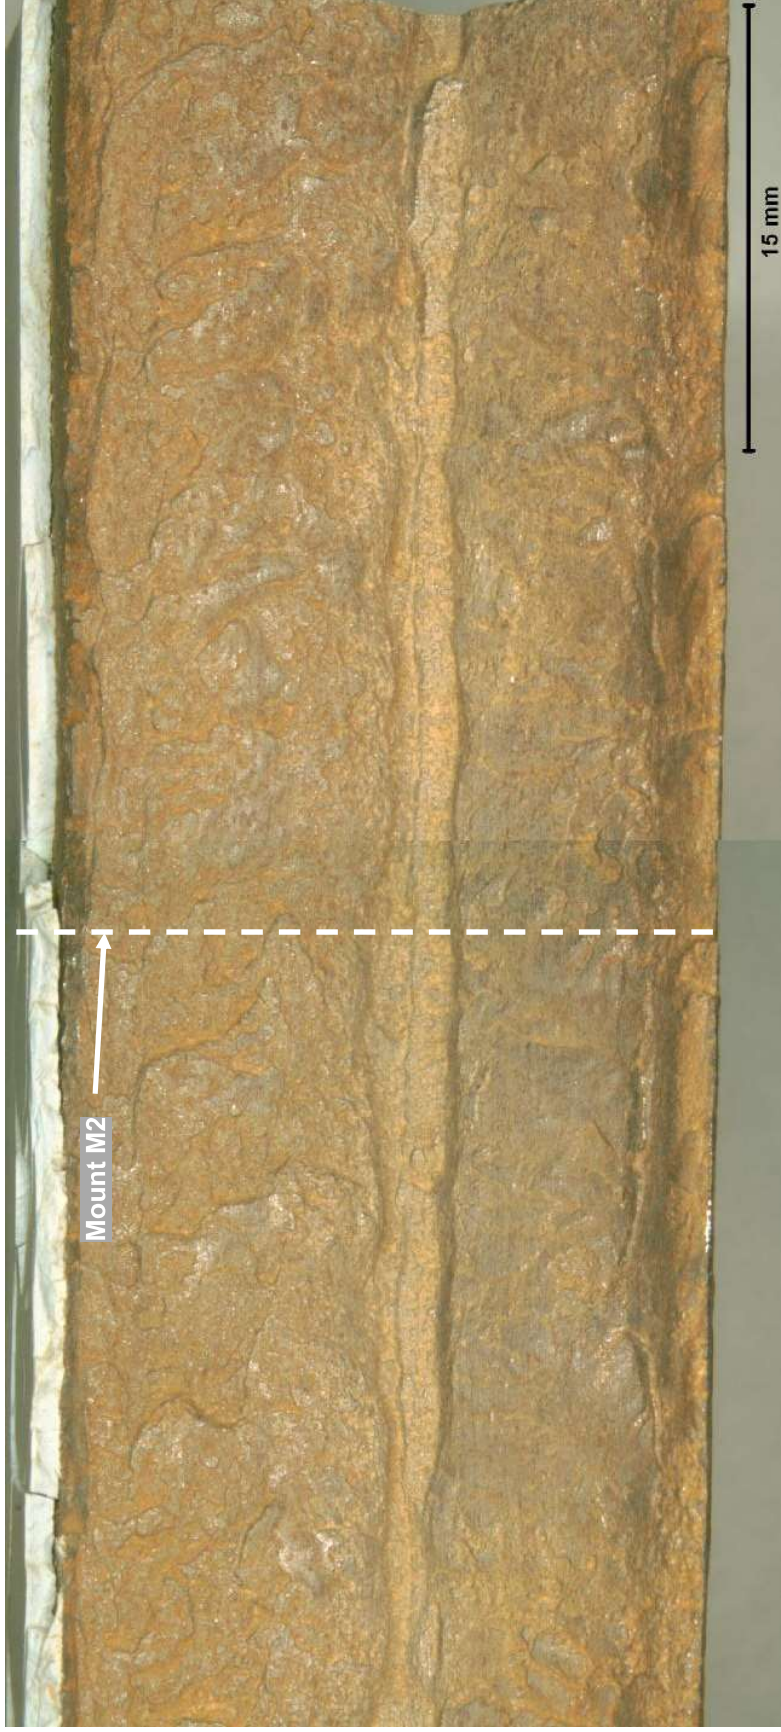
Figure 31. Light photomicrograph of Sample S2 showing the fracture surface; area indicated in Figure 5. The figure shows where Mount M2 was removed. Examination in the SEM showed similar features as Sample S1, with areas of smearing and areas of dimples. There was no evidence of pre-existing flaws. The slight difference in this fracture surface from Sample S1 is that midwall is flatter in the thickness direction, which is obvious when looking at the fracture surface in cross-section in Mount M2 in Figure 16. As mentioned above, this sample was removed from this location along the fracture surface in order to examine the midwall vertical portion.

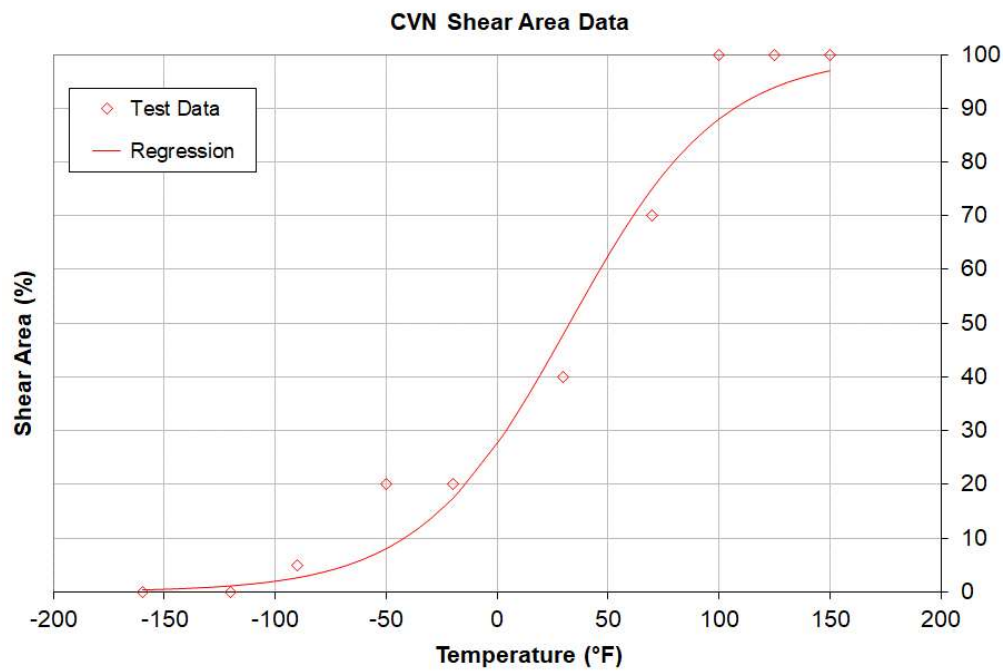
Table 8. Results of analyses of the Charpy V-notch impact energy and percent shear plots for transverse seam weld (HAZ notch) specimens removed from the sister elbow fitting. When comparing to line pipe steel for a 2018 vintage, the upper shelf impact energy value is typical and the 85% fracture appearance transition temperature (FATT) value is higher (poorer) than typical.

Figure 32. Percent shear from Charpy V-notch tests as a function of temperature for transverse seam weld (HAZ notch) specimens removed from the sister elbow fitting.

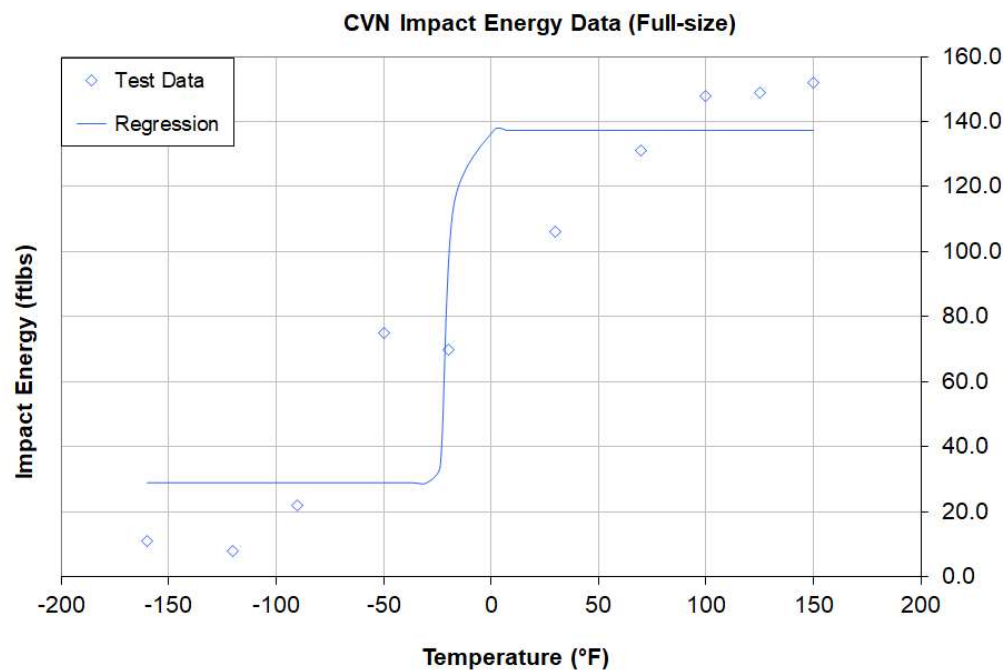
Figure 33. Charpy V-notch impact energy as a function of temperature for transverse seam weld (HAZ notch) specimens removed from the sister elbow fitting.
