# Failure Investigation Report

## TC Oil Pipeline Operations Inc.

Rupture – Circumferential Girth Weld Failure

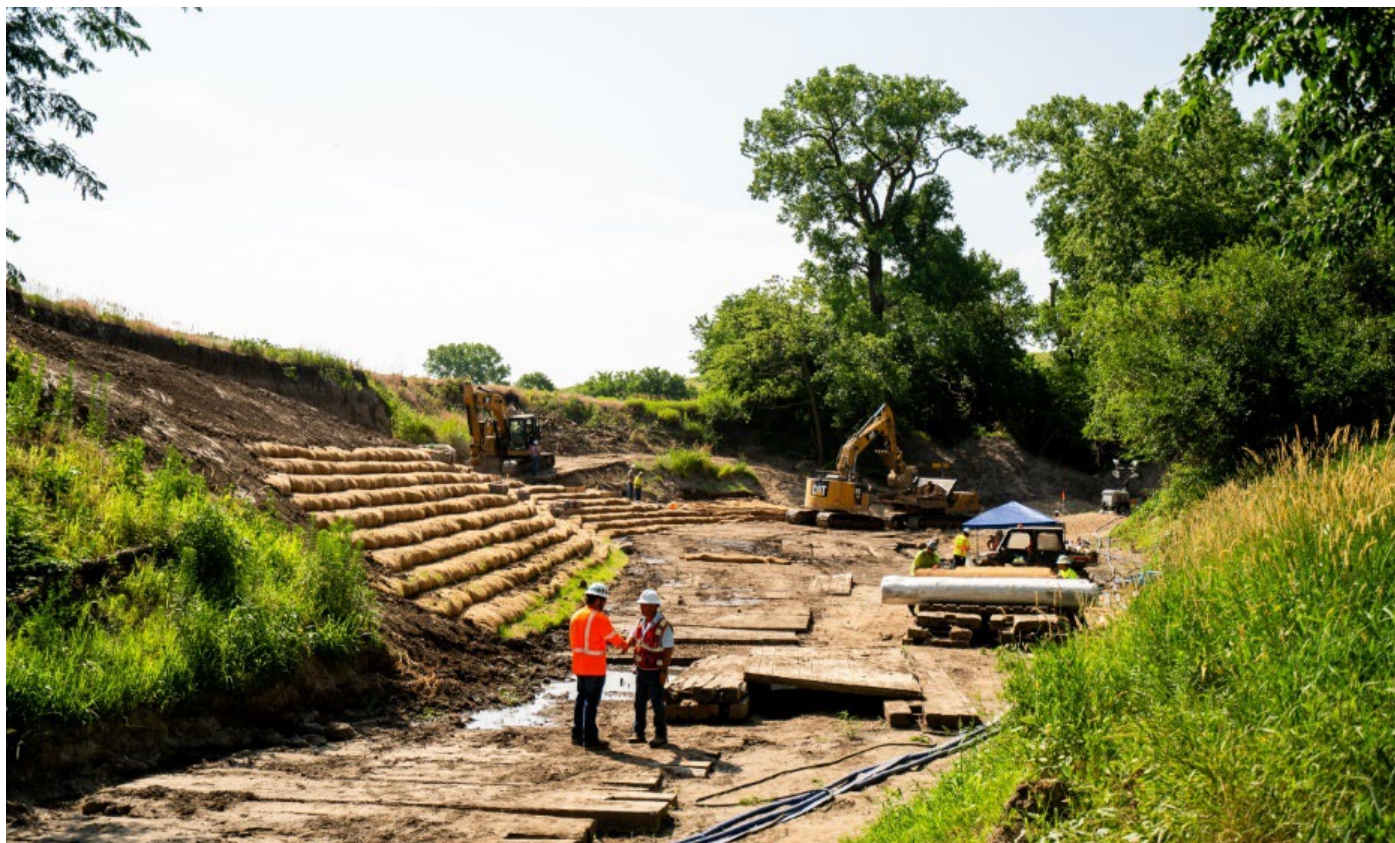
**Figure 3.** Keystone Cushing Extension Pipeline Crossing of Mill Creek Near the Failure. Dry Creek Bed and Clean-up After River Diversion (South is to the Left), Provided by TC.

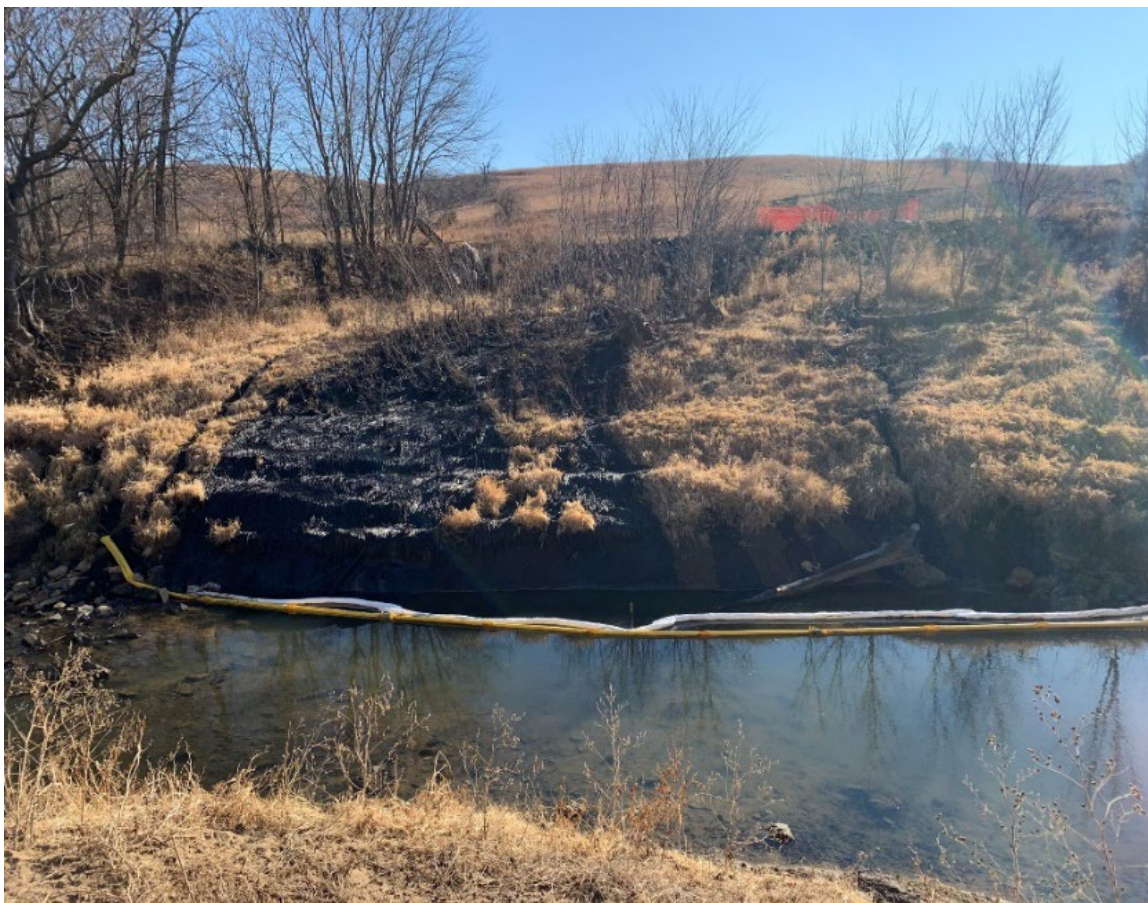
**Figure 6.** South Creek Bank Showing Shallow Soil Slippage, Pipeline Runs from Creek Uphill to Orange Fencing.

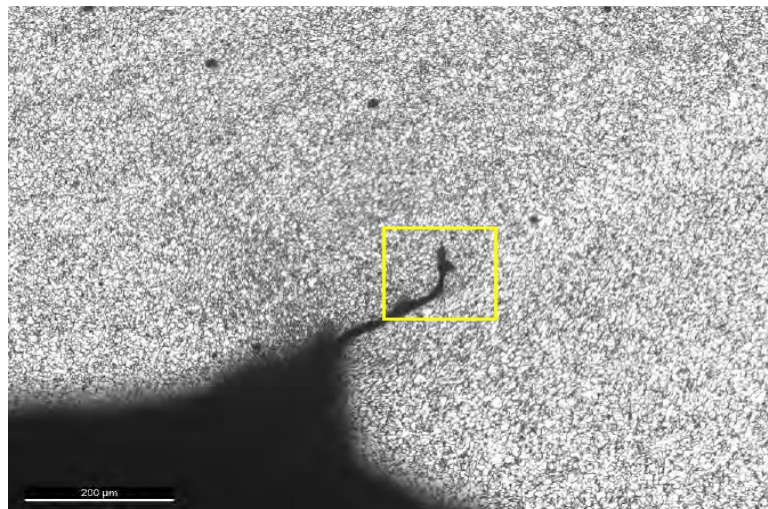
Metallurgical testing of the metal and weld for GWD 13520 confirmed their properties met the API Specification 5L, 43rd Edition. The metallurgical analysis and PHMSA's observation of the metallurgy testing conclude the girth weld failed as a result of cyclic fatigue of the cracks which initiated at points of LOF in the root pass (**Figure 14** and **Figure 15**). The cracks grew to the point that

**Figure 14.** GWD 13520 LOF in Root Pass, Photo from AA.

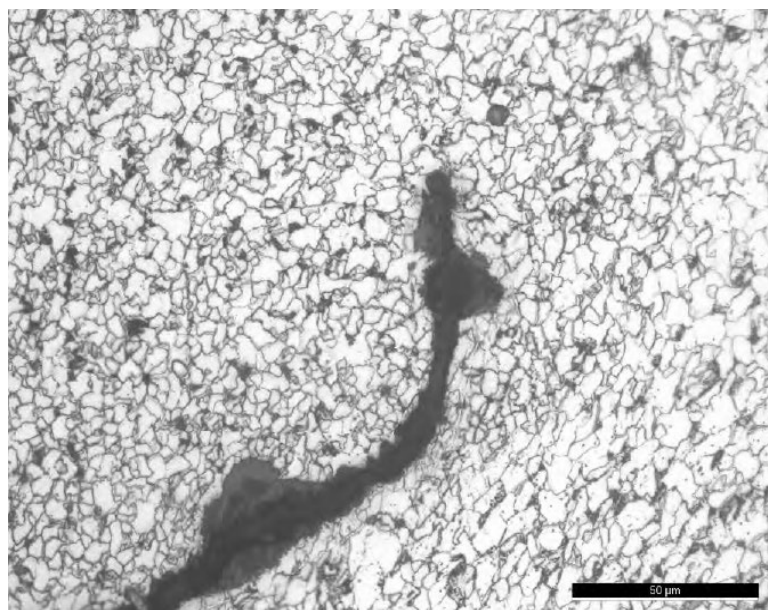
**Figure 15.** Zoomed-in View of GWD 13520 LOF, Photo from AA.

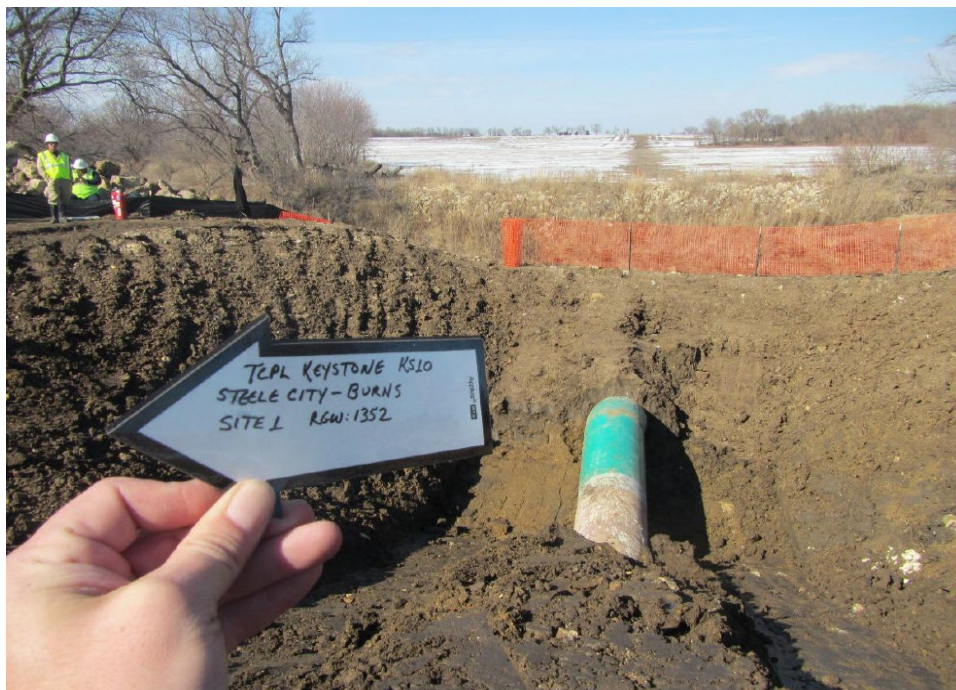
**Figure 17.** Photo of TAG 98 Fitting Assembly During the 2013 Ovality Inspection Showing the Extent of Excavation. The Excavation Did Not Add or Decrease Any Stress on the Pipeline, Photo from TC.

While the excavation was still open in March 2013, (**Figure 17**), the integrity team worked with the ILI vendor on options to address the restriction in the pipeline. Three options were identified; 1) modify the tool to pass through the restriction, 2) use a dual diameter tool, or 3) cut out a segment of pipe containing the ovality. The options were provided to TC senior leadership, who chose not to cutout and replace the ovality but instead opted for tool modification option. Post incident, during PHMSA interviews with TC integrity personnel, it was stated that the cause of the ovality was not considered a stress-related integrity threat.
