Failure Investigation Report

TC Oil Pipeline Operations Inc.

Rupture – Circumferential Girth Weld Failure

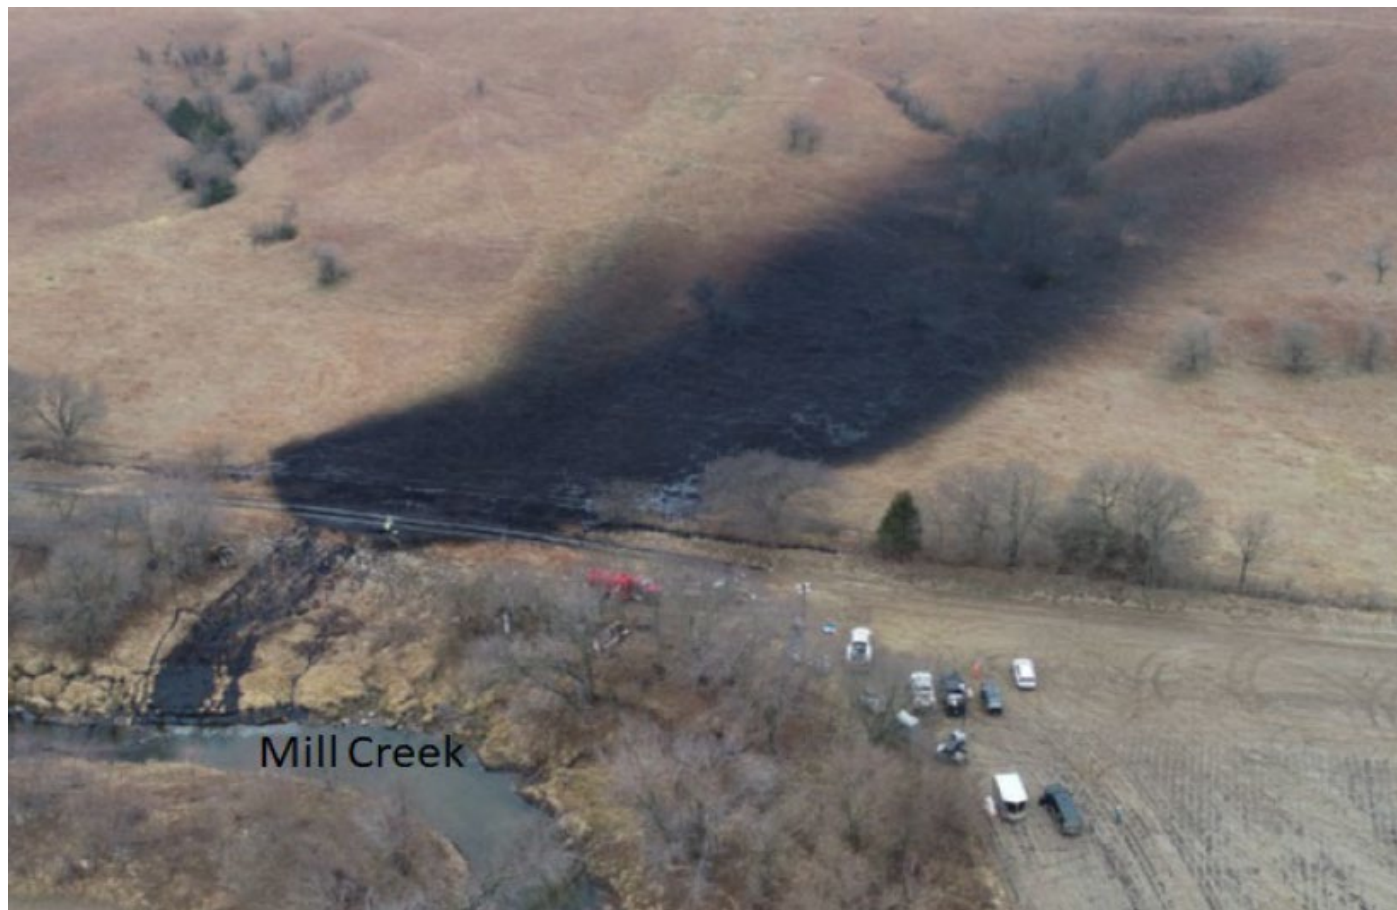
Figure 2. Drone Photo of Release Site, Provided by TC.

Most of the crude oil flowed about 75-feet downhill into Mill Creek.¹¹ Crude oil also sprayed south of the rupture, impacting an agricultural area approximately 1/4-mile in length and 600-feet wide (**Figure 2**). Containment booms were installed at several locations on Mill Creek and an underflow dam was installed about 3.5-miles downstream from the pipeline crossing to contain the

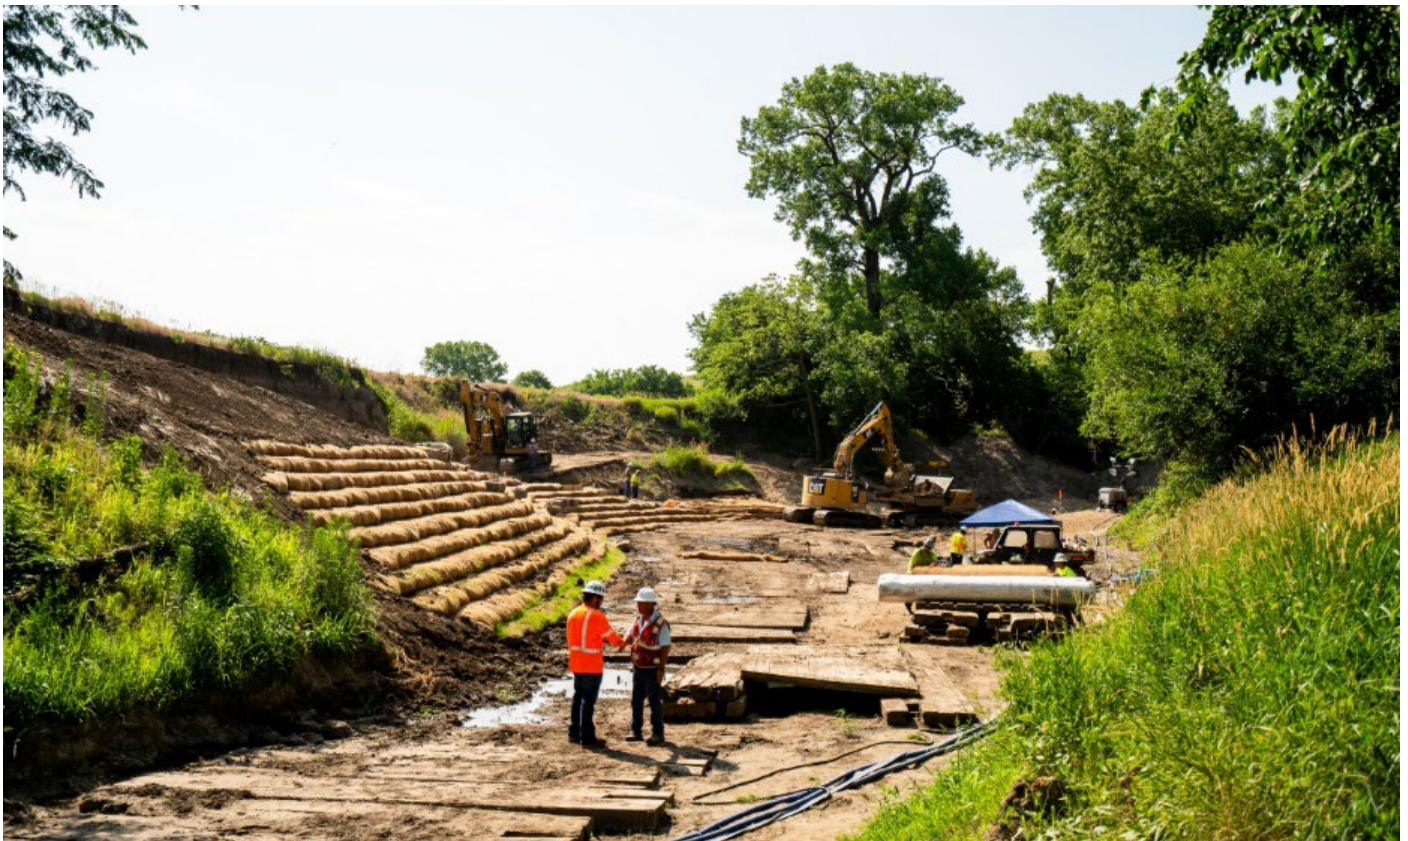
Figure 3. Keystone Cushing Extension Pipeline Crossing of Mill Creek Near the Failure. Dry Creek Bed and Clean-up After River Diversion (South is to the Left), Provided by TC.

Clean-up of the oil contaminated sediment and debris within Mill Creek began on January 30, 2023, and was completed on May 9, 2023. A dam was installed upstream of the pipeline crossing and the creek was diverted to the downstream side of the underflow dam (**Figure 3**). All contaminated soil and woody debris within Mill Creek were excavated and replaced with clean soil. The creek bed was then reflooded above the creek's water level at the time of the failure to assess for the presence of any oil sheen. No oil sheen was identified, which concluded the clean-up of Mill Creek. All waste was disposed of at the Pheasant Point Landfill in Bennington, Nebraska. A total of 12,973 barrels of crude oil were either recovered, disposed of, or evaporated.

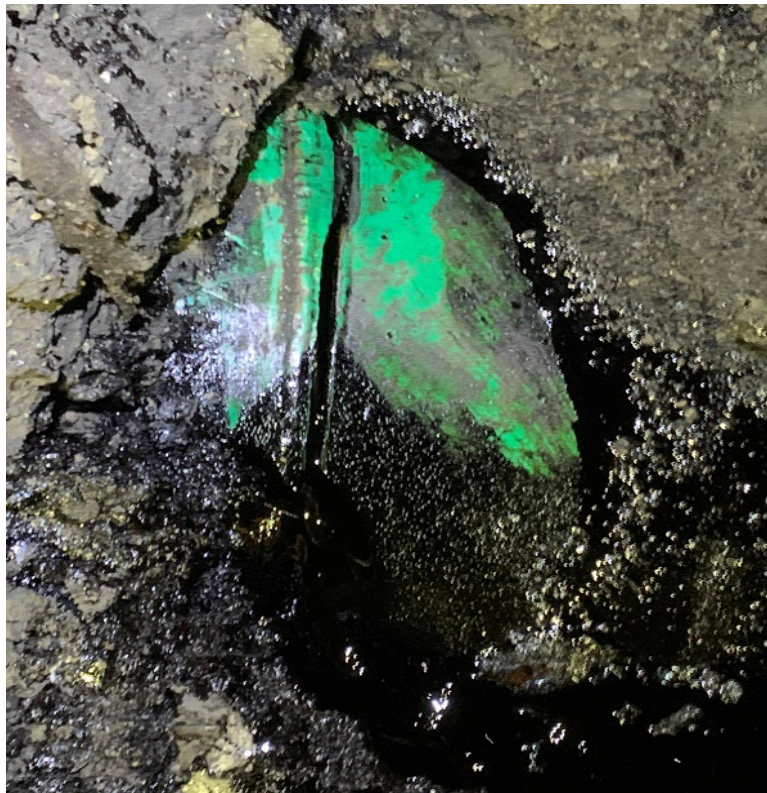
On December 13, 2022, the failure was excavated and exposed (**Figure 4**). A circumferential crack was identified in the girth weld. The crack was open about a 1.5-inches wide at the widest point. The crack spanned 26.5 inches from 333° to 54° along the girth welds circumference. A bulge (**Figure 5**) was observed at the 6:00 position upstream of the failed girth weld. TC's geotechnical expert was on site to determine if soil slippage contributed to the failure. The expert concluded that there was evidence of shallow surface soil slippage on the south creek slope over the pipeline, however the slippage was determined to be not deep enough to affect the pipeline and did not contribute to the failure. Furthermore, the soil slippage was on the upstream side (north) of the fitting. (**Figure 6**).

Figure 4. Initial View of Failed Girth Weld Exposed.

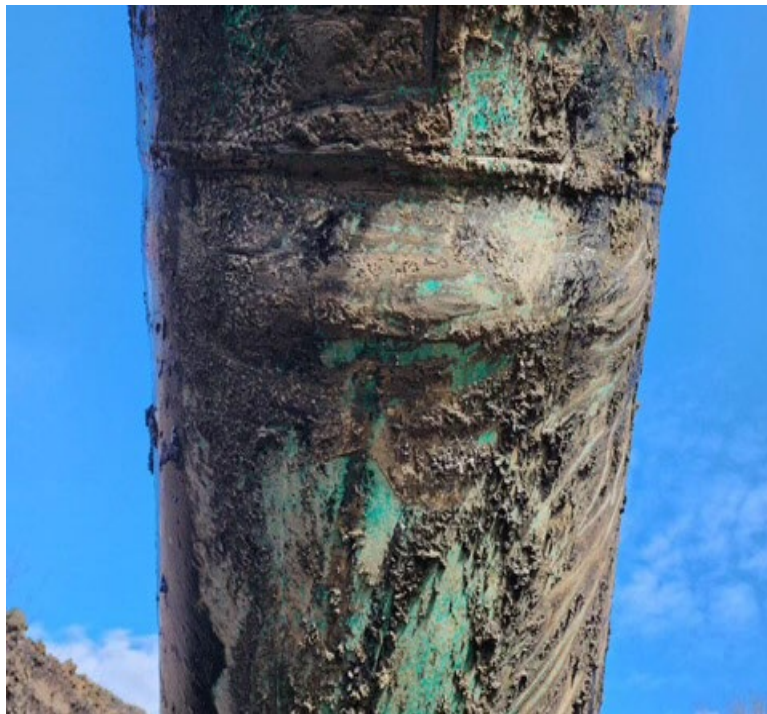
In the area of the December 7, 2022, failure, the pipeline flows from north to south. During PHMSA's on site investigation, a bulge⁴ on the bottom of the pipe located upstream (north side) of the elbow was identified. The downstream portion of the pipeline, approximately 30-feet south of the ruptured girth weld, was observed to have raised up 6 to 8 inches from its original position while it was being excavated after the rupture. The observed ovality, the bulge, and the pipe rising indicate excessive stress was present on the pipeline as a result of external loading. This stress has been determined sufficient to initiate cracking of the failed girth weld. PHMSA attributes the primary source of external loading, and therefore bending stress, was due to inadequate soil compaction during the backfill process following the fitting replacement in 2010.

Figure 5. The Compression Stress Bulge in the 6:00 Position. This Single Compression Point Caused the Pipeline to Bulge out About 1/2-Inch from the Normal Plane of the Pipeline. This Photo Was Taken After the Failure in December 2022 Looking Up.

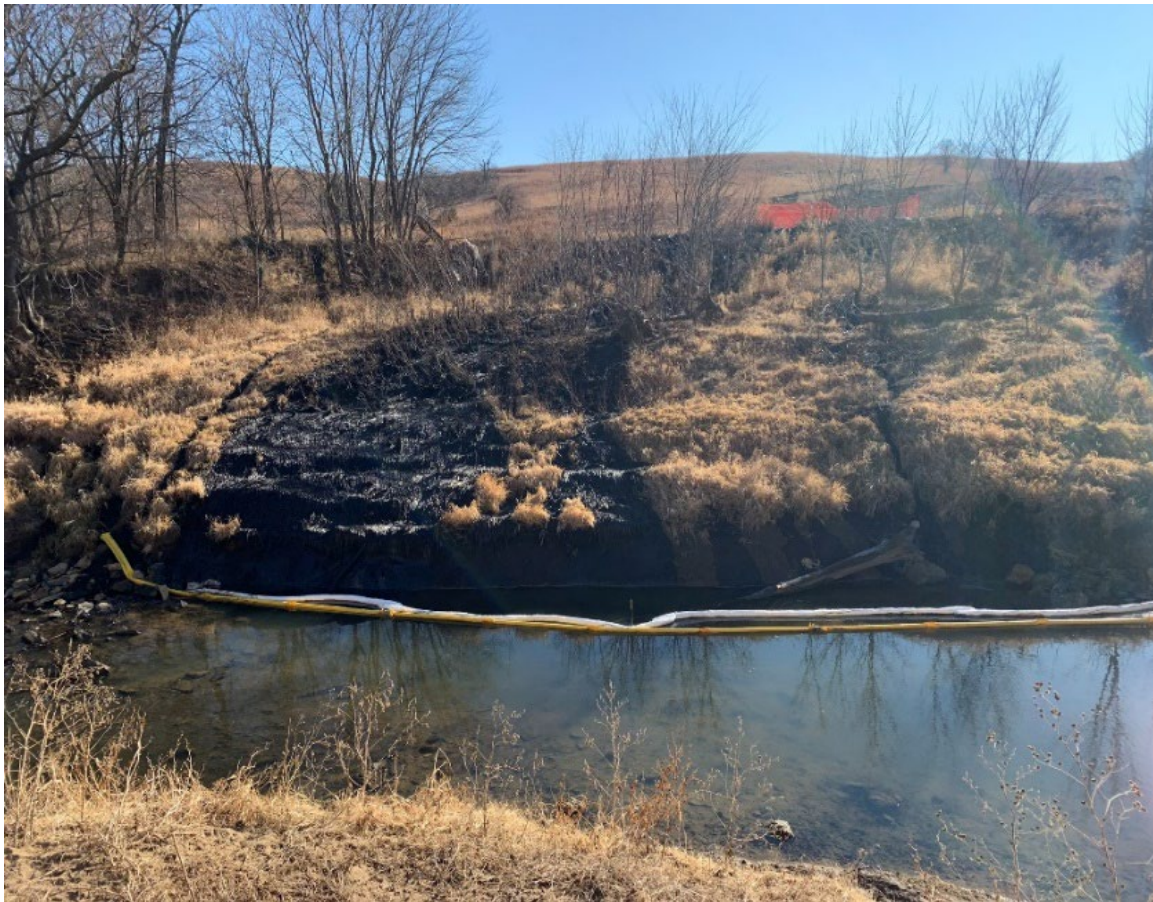
Figure 6. South Creek Bank Showing Shallow Soil Slippage, Pipeline Runs from Creek Uphill to Orange Fencing.

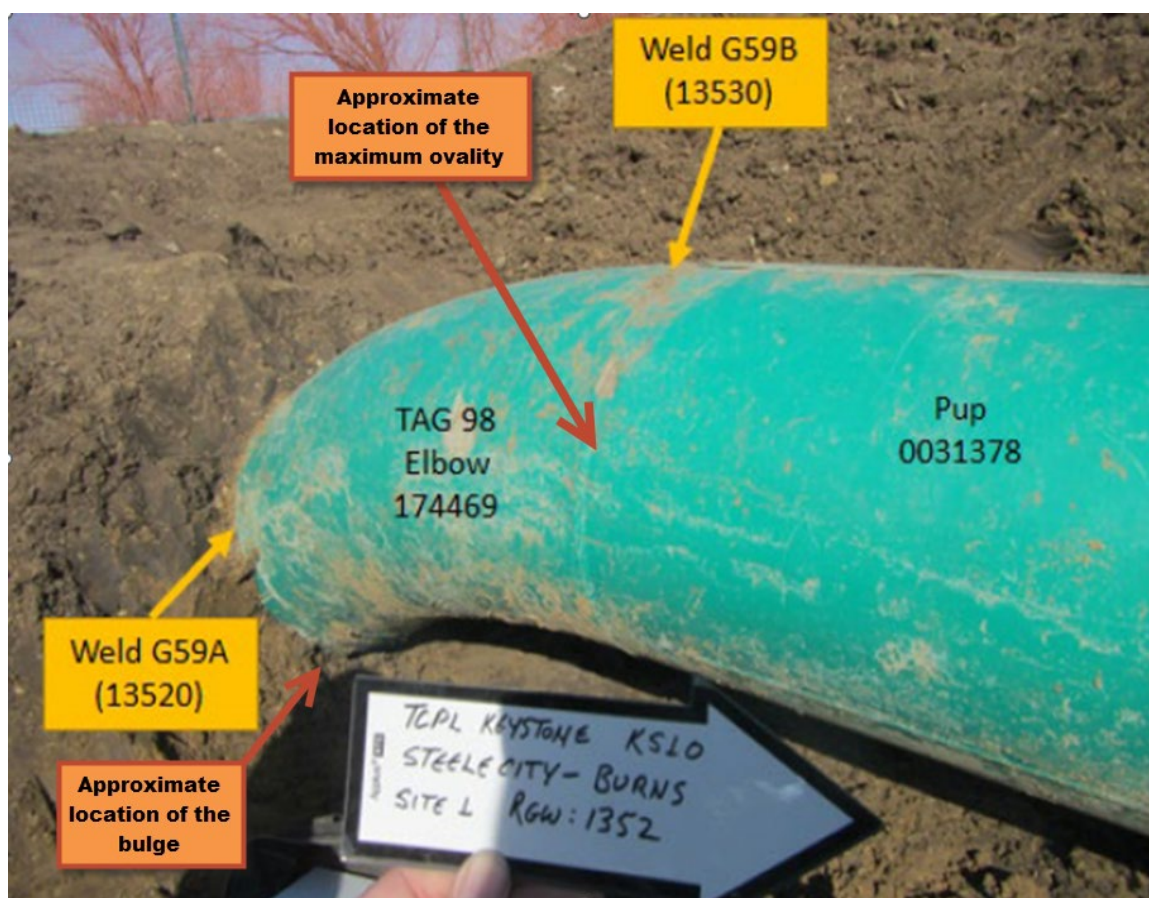
The failed fitting assembly, known as TAG 98, (**Figure 7**) was fabricated in 2010. It had the 30° elbow manufactured by Canadoil in Becancour, Quebec and was then sent to Texas, where RC Fabrication attached an 8-foot-long pup to each end of the elbow. The pipe pups were 0.515-inches thickness thick and were welded to the 30° elbow. The elbow was specified to have a minimum wall thickness of 0.515 inches, and was stamped 0.515 inches, however it had an actual wall thickness of 0.890 inches. The two girth welds were welded in the shop following the TransCanada qualified welding procedure (QWP) TES-WELD-AS-US and RC Fabrication's welding procedure. RC Fabrication's procedure complement the QWP. The QWP used GMAW with 100% CO₂ and ER80S-Ni wire for the first pass and E81T1-Ni Flux core on the following passes.

The weld joint design of TAG 98 consisted of a 30° bevel and a 30° taper transition. The length of the taper transition was measured at 0.78 inches (**Figure 7**). The minimum taper transition according to MSS SP-75-2008 is 1 inch. The shorter taper transition increased the stress at the weld. In the welding procedure TES-WELD-AS-US section 8.20 it states that the preferred transition when the wall thicknesses exceed 0.100 inches is a counterbore and taper transition.

Figure 7. Photo of TAG 98 Fitting Assembly During 2013 Ovality Investigation, Weld G59B (13530) (GWD 13530) Contained the Failure, the White Arrow Represents the Flow Direction of The Crude Oil. AID Added the Approximate Location of the Bulge and the Ovality to the Photo Provided by TC.

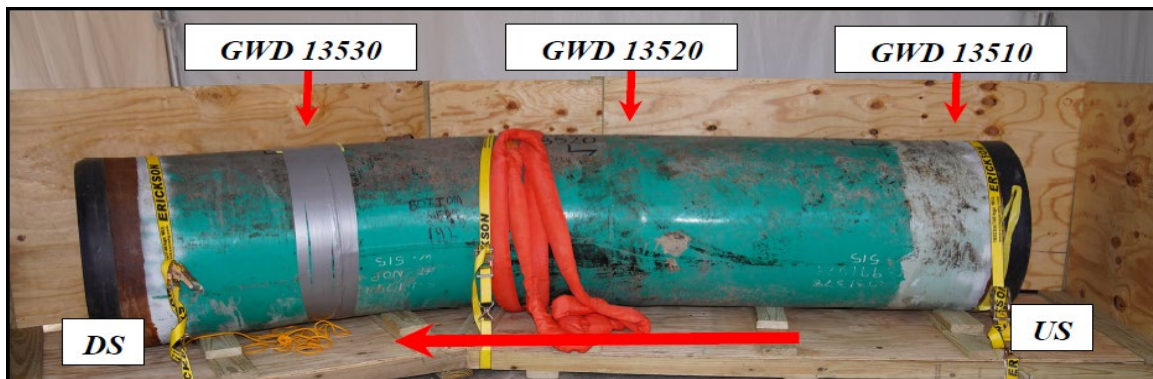
Figure 8. Failed TAG 98 Fitting Assembly Received at Anderson Lan, Duct Tape is Covering the Failed Girth Weld GWD 13530, Photo from AA.

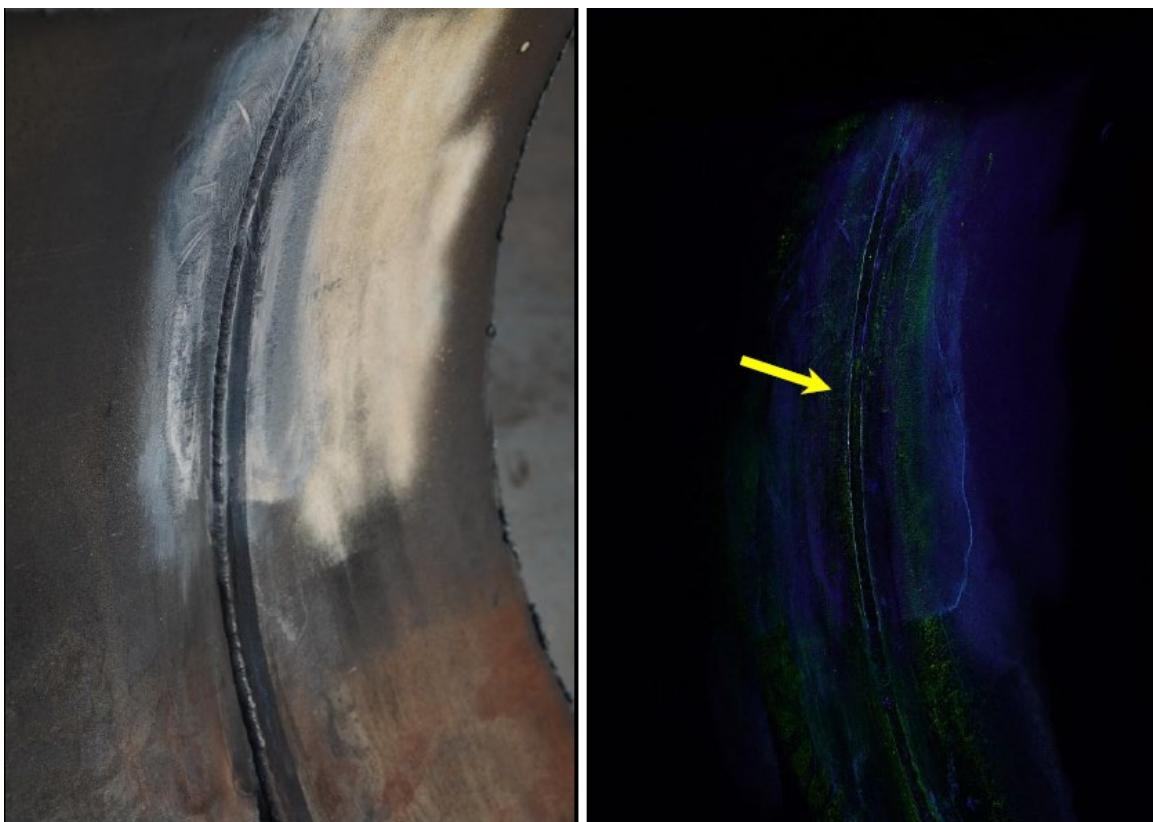
Figure 9. GWD 13520 Internal Girth Weld Showing LOF Defects in the Root Pass, Photo from AA.

NDT of the intact portion of the pup-to-fitting girth weld identified lengthy crack-like indications in the hot pass weld deposit and the base metal. The metallurgical testing identified these indications LOF of the filler metal and the initiation point of the failure (**Figure 9**).

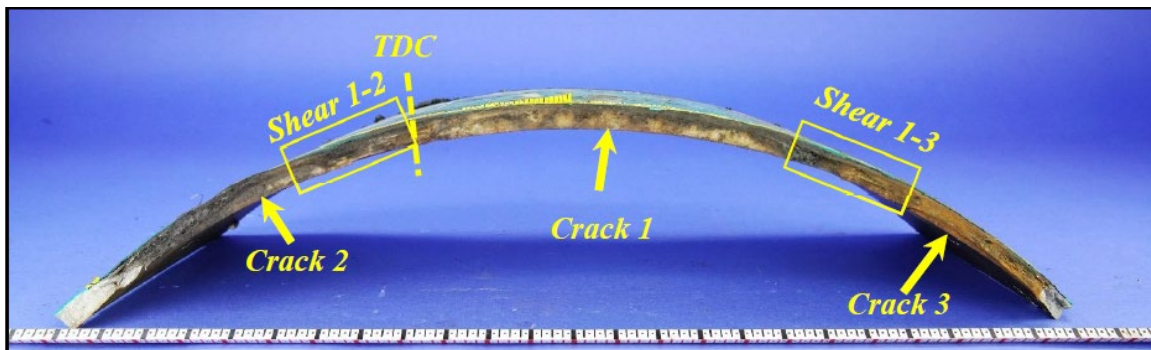
Figure 10. GWD 13520 Failed Girth Weld Show 3 Elliptical Crack Regions, Photo from AA.

The fracture consisted of five distinct regions (**Figure 10**). There were three elliptical fatigue cracks that initiated from the inside diameter (ID) of the pipe, separated by two shear areas. The shear areas are locations where the root pass was repaired from the inside. The repairs interrupted the LOF defects which eliminated the crack initiation stress riser. There existed three elliptical crack regions. Each showed initiation points at the LOF between the pup and the girth weld. A straight edge was placed at the apex of the bulge (**Figure 11**). Within the three elliptical crack regions, beach marks are illustrated with the yellow arrows (**Figure 12**). The beach marks align with the weld passes that exist in the girth weld. The red arrow in **Figure 12** points to a dark ledge that is the crack initiating stress riser. This was created during the welding process. The darkness of the ledge is a result of a dense, tightly adhered oxide scale consistent with magnetite, which can only be created at temps during welding. This material is formed at temperatures higher than 600°C.

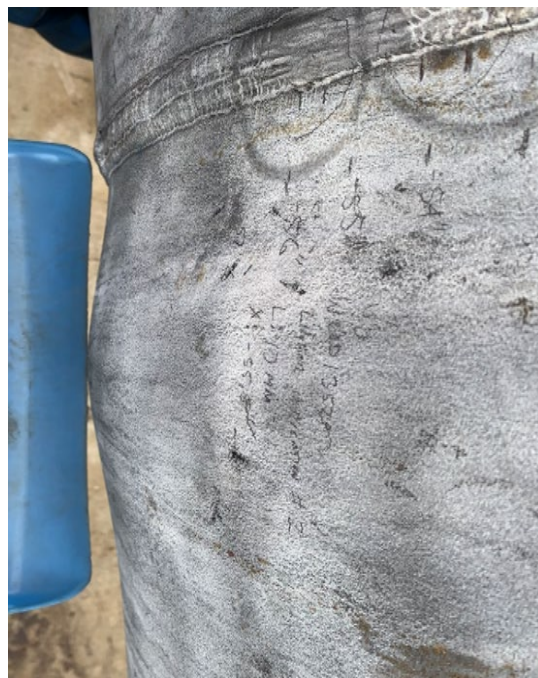
Figure 11. Sandblasted Pipe with Mag Particle Contrast Paint Applied. The Bulge is Located at the 6:00 Position.

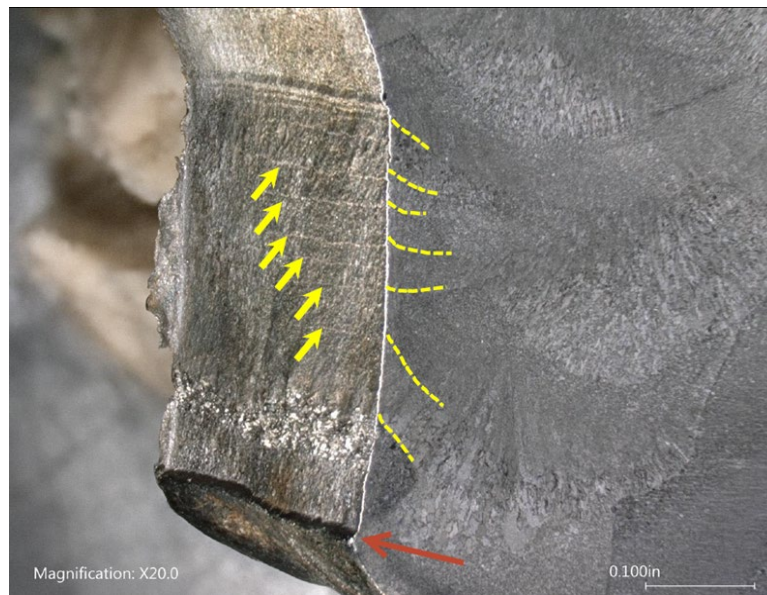
Figure 12. GWD 13520, Beach Marks on the Crack Origin, Showing the Sequential Crack Growth Over Time, Photo from AA.

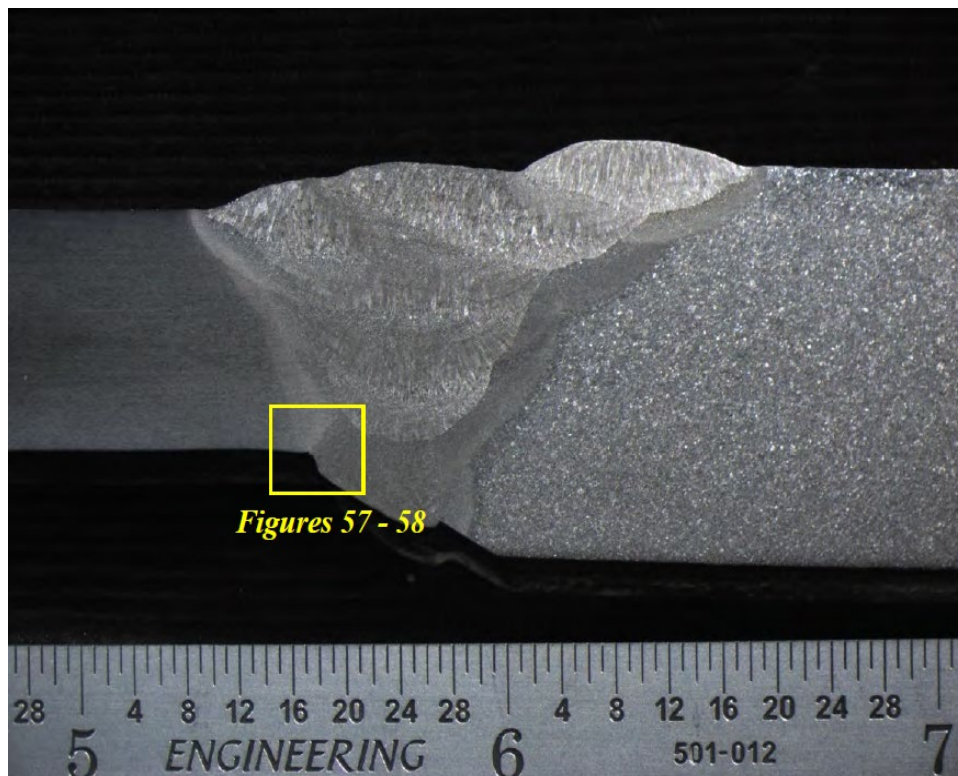
Figure 13 shows a cross section of the failed girth weld where it did not fail, at 500X magnification, that shows the area of the LOF. The welding process was gas metal arc welding (GMAW).

Figure 13. GWD 13520 Location of the LOF, Photo from AA.

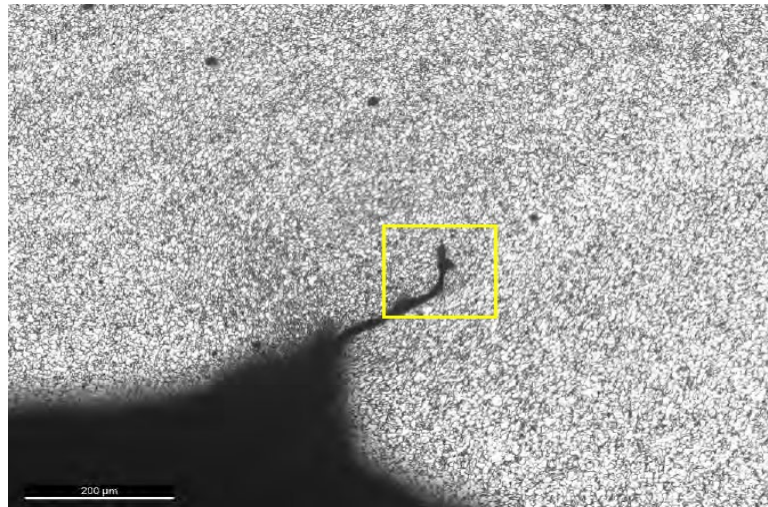
Metallurgical testing of the metal and weld for GWD 13520 confirmed their properties met the API Specification 5L, 43rd Edition. The metallurgical analysis and PHMSA's observation of the metallurgy testing conclude the girth weld failed as a result of cyclic fatigue of the cracks which initiated at points of LOF in the root pass (**Figure 14** and **Figure 15**). The cracks grew to the point that

Figure 14. GWD 13520 LOF in Root Pass, Photo from AA.

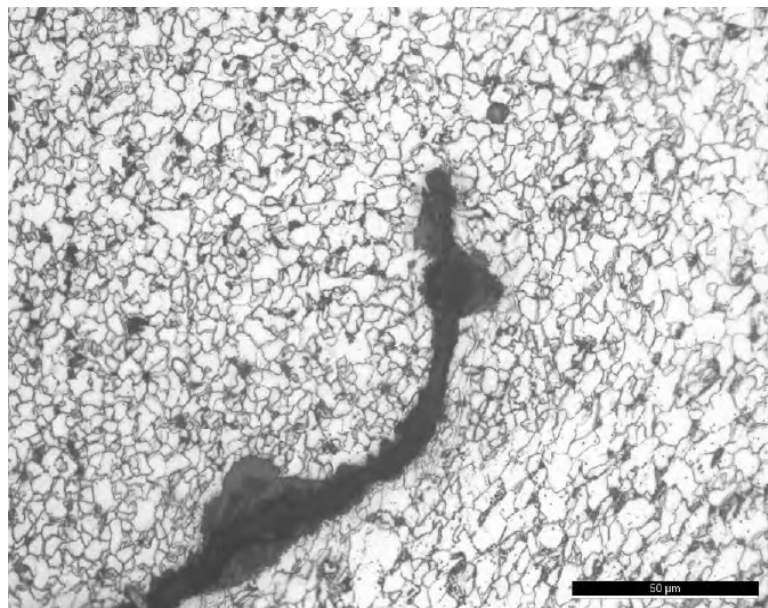
Figure 15. Zoomed-in View of GWD 13520 LOF, Photo from AA.

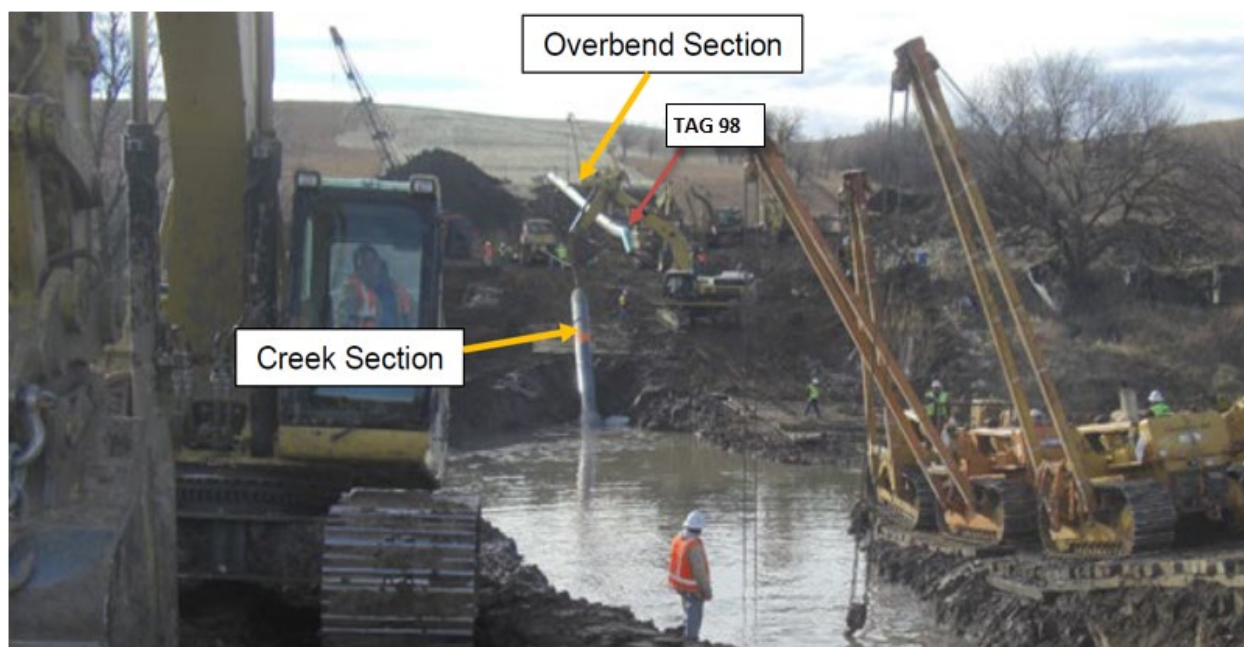
There were three fitting assemblies at the Mill Creek crossing that were replaced as part of the WRP in December 2010 (**Figure 16**). The Mill Creek crossing was an open-trench crossing, (**Figure 16**), as the rising elevation to the south and the depth of the creek crossing exceeded the bending radius of the 36-inch pipe required for a directional bore installation.

Historical weather records provided by the National Oceanic and Atmospheric Administration (Appendix I) indicate that the spoil pile from the excavation was exposed to freezing temperatures between December 11 and December 14. PHMSA believes the bending stress that contributed to the failure originated when inadequately compacted soil underneath the pipeline allowed the unsupported pipe to bend from the 8.5 feet of overburden. The inadequate soil compaction may have occurred from the lack of mechanical compaction and frozen soil used in the backfill.

Figure 16. December 2010 WRP Work at the Failure Location Looking South in the Downstream Direction (TAG 98 Label Added by PHMSA), Photo from TC.

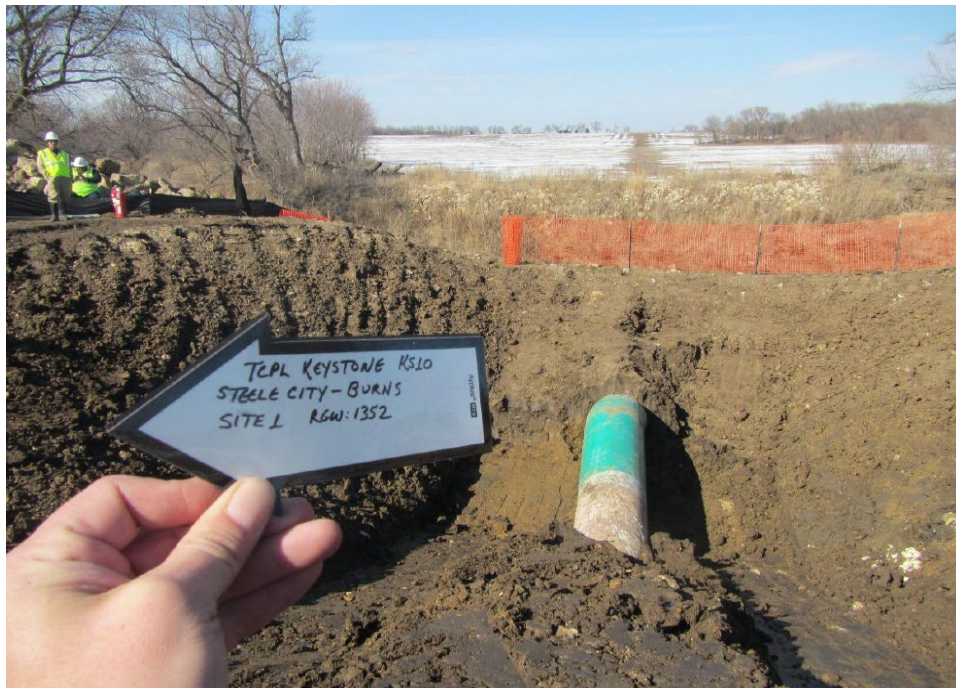
Figure 17. Photo of TAG 98 Fitting Assembly During the 2013 Ovality Inspection Showing the Extent of Excavation. The Excavation Did Not Add or Decrease Any Stress on the Pipeline, Photo from TC.

While the excavation was still open in March 2013, (**Figure 17**), the integrity team worked with the ILI vendor on options to address the restriction in the pipeline. Three options were identified; 1) modify the tool to pass through the restriction, 2) use a dual diameter tool, or 3) cut out a segment of pipe containing the ovality. The options were provided to TC senior leadership, who chose not to cutout and replace the ovality but instead opted for tool modification option. Post incident, during PHMSA interviews with TC integrity personnel, it was stated that the cause of the ovality was not considered a stress-related integrity threat.
