CONSULTING METALLURGICAL ENGINEERS AND TESTING LABORATORY

Re: 250145 South Bow - Metallurgical Analysis of NPS-30 MP-171 Pipeline Incident

Pursuant to your request, this report details the findings of the metallurgical investigation of the Keystone Pipeline rupture near MP-171 near Fort Ransom, North Dakota.

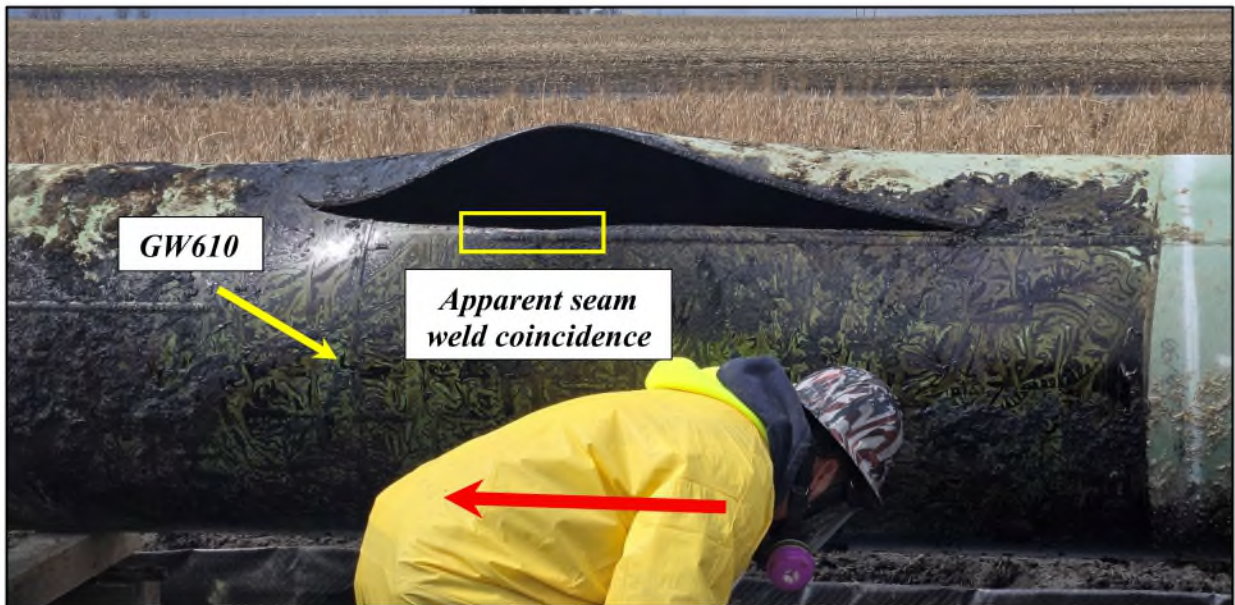
drain from the pipe. The cellophane wrapping that had initially been placed over the rupture was cut away, allowing the first visual inspection of the rupture which is shown in Figure 2. The rupture appeared as a “fish mouth”, and was observed to be partially coincident with the longitudinal seam weld. The fracture was observed to cross a girth weld (GW610) before deflecting in a clockwise direction into the base metal of the downstream joint. The upstream portion of the rupture was also observed to deflect away from the seam weld also in the clockwise direction. It was further noted that the location of top dead center (TDC) on the pipe was marked, the relative clock positions of the seam welds relative to TDC were identified, and the flow direction was also indicated.

Figure 2 – Photograph of the rupture following removal of the plastic wrap covering. It was confirmed at this time that the rupture had a partial coincidence with the seam weld on the joint upstream of GW610, traversed GW610 and propagated in a clockwise direction in the base metal of the downstream joint. The red arrow indicates flow direction.

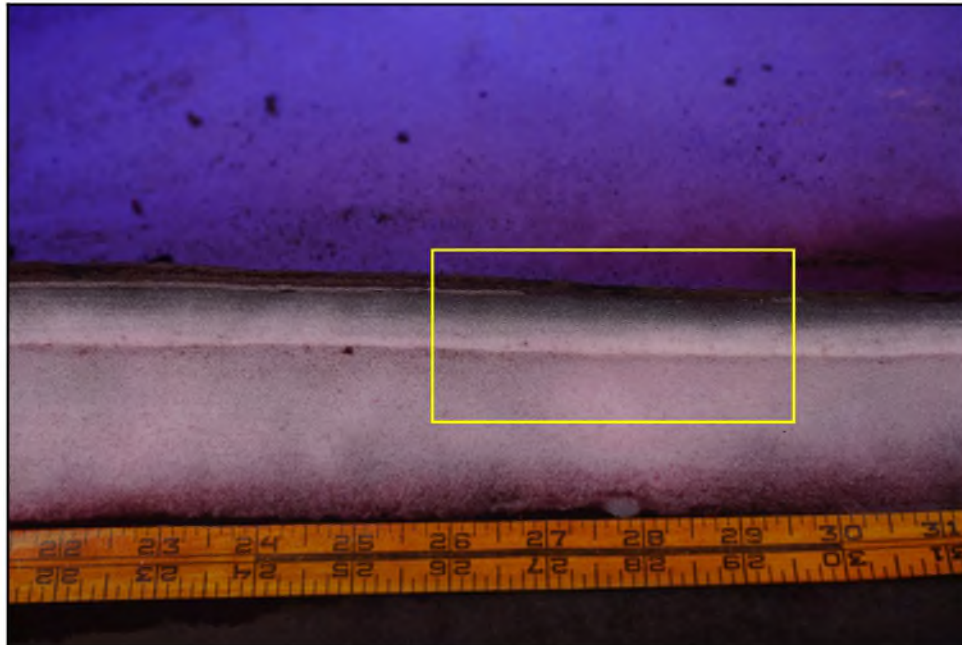
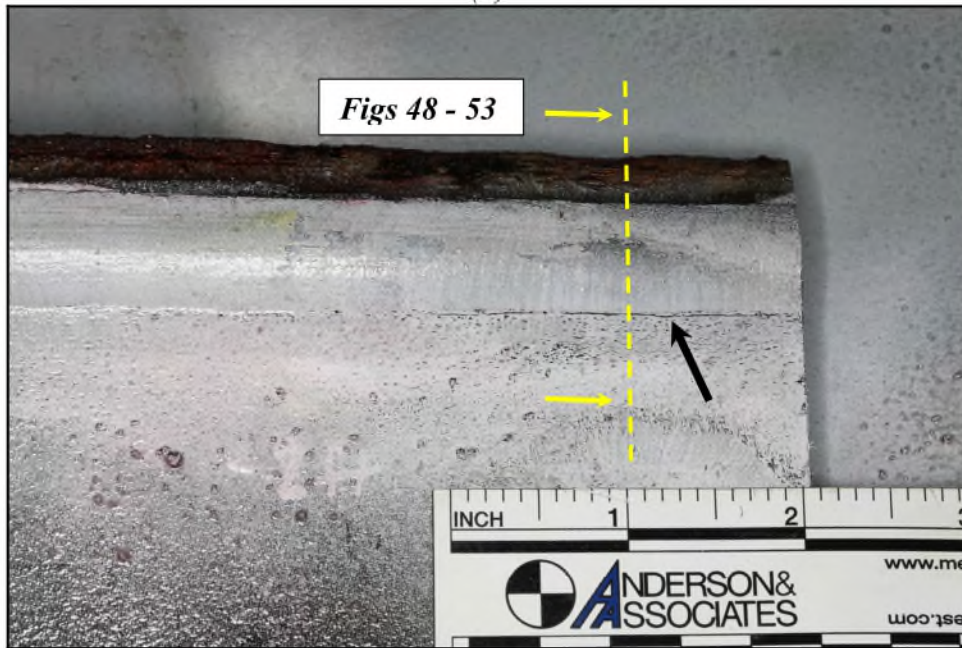
The ID surface of the seam weld along the rupture was initially evaluated for indications using liquid penetrant testing (LP). This examination was performed after removal of the panel containing the rupture, and was done for the purpose of identifying any possible secondary cracks along the ID toes of the seam weld. A prerequisite to conducting this examination was to lightly degrease the ID surface to remove residual hydrocarbon sludge as residual surface debris can yield false-positive indications. Minimal cleaning was performed at this stage to avoid contaminating the fracture surface. As shown in Figure 12a, the results of the penetrant testing did not show any indications.

Subsequent to removal of the primary feature of interest, the seam weld in the ruptured area was re-examined non-destructively using white contrast magnetic particle inspection (WC-MPI), which is more sensitive with respect to LP. As shown in Figure 12b, there was an indication identified on the opposing toe of the seam weld to the fracture approximately 22 inches upstream of GW610. Metallographic documentation of this section is provided in Figures 48 – 53.

Figure 12 – Photographs showing non-destructive test results on the ID seam weld in the ruptured panel using (a) liquid penetrant testing and (b) contrast magnetic particle inspection. No indication was identified with liquid penetrant, but an indication was noted on the toe opposite the rupture after wire brushing.

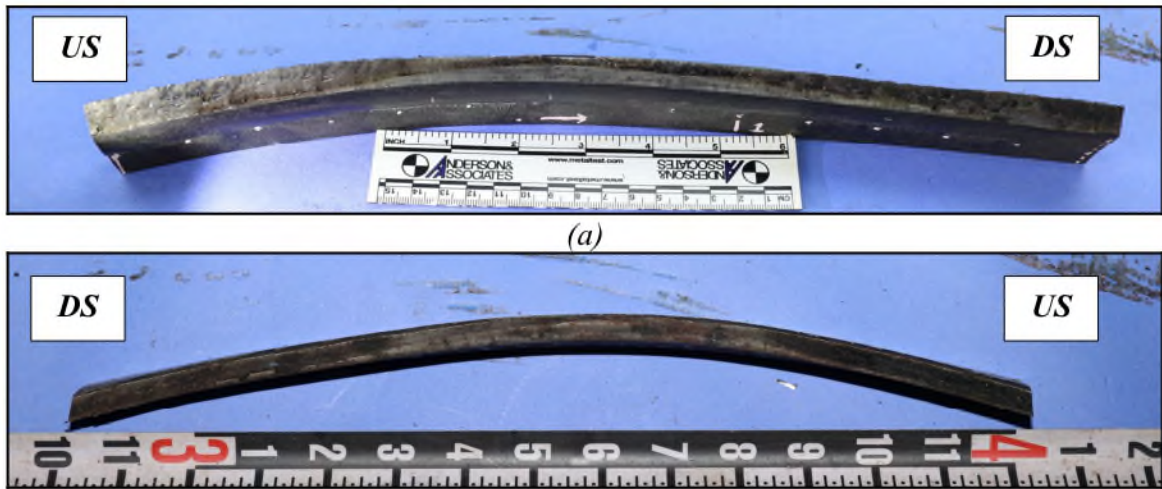
Following the light cleaning, the fracture surface was examined using a Keyence digital microscope and observed to exhibit multiple crack arrest lines, more prominently visible on the fatigued surface nearer the transition to the sudden shear overload region. It was further observed that the ID edge of the fatigue crack appeared relatively smooth, though a fine dispersion of micro-pits were observed under higher magnification as shown in Figure 14. Figure 15 details

Figure 13 – Overall view of the section of the seam-side crack surface encompassing the fatigue crack.

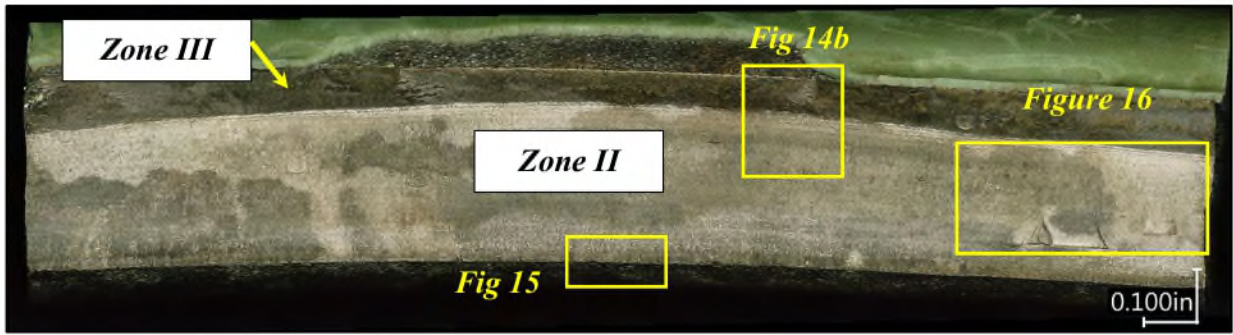
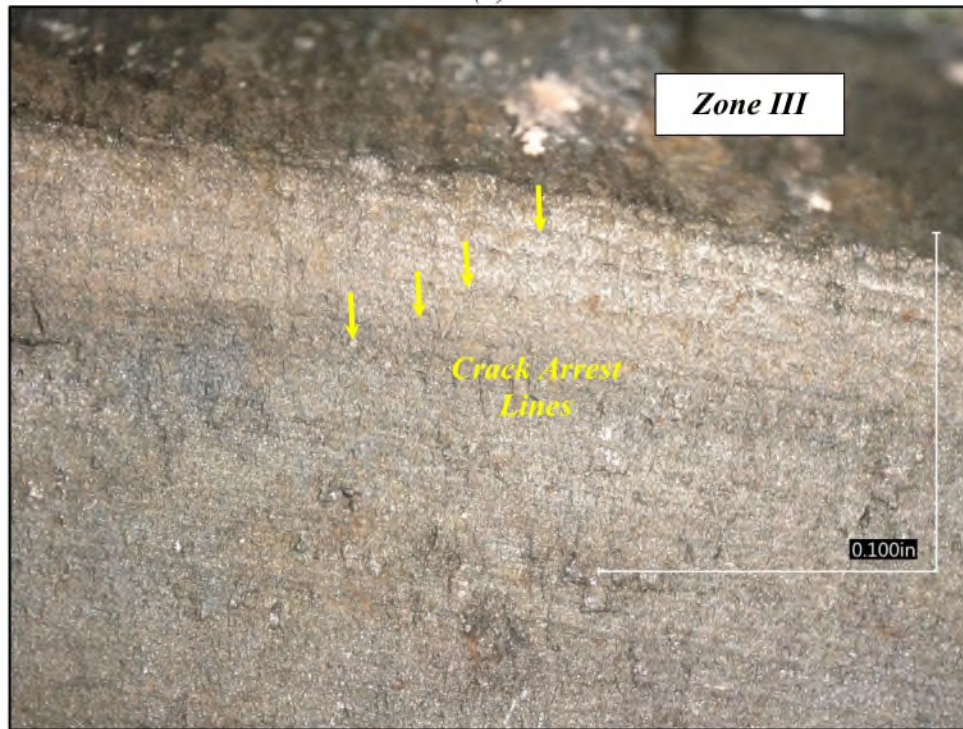
Figure 14 – (a) Low magnification view detailing critical features observed on the cleaned fracture surface section encompassing the deepest fatigue region. (b) Higher magnification view showing multiple crack arrest lines on the fatigued surface near the ductile overload region (Zone III).

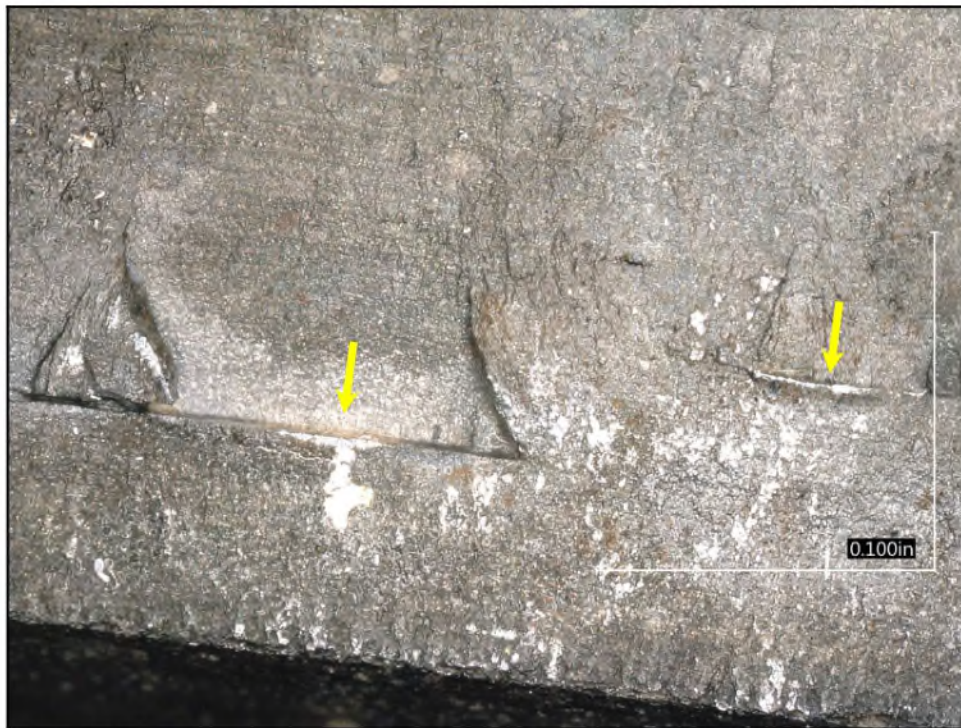
Figure 16 – Low magnification view of several secondary crack-like features identified on the fatigued surface. The secondary cracks were oriented perpendicular to the fatigue crack growth direction. The secondary cracks appeared visually consistent with hydrogen induced cracking (HIC).

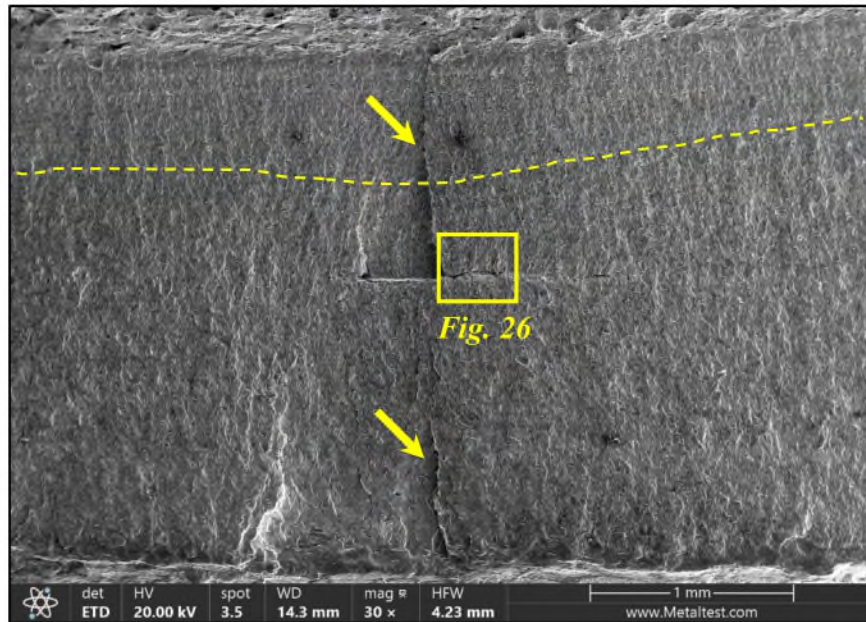
Figure 25 – Low magnification secondary electron fractograph showing a perpendicular crack in the Zone II region. It was observed that the crack arrest lines propagated around the secondary crack, and ratchet marks were identified on both the ID surface and the “top” side of the feature as indicated with the yellow arrows. The arrows below and above the secondary crack identify ratchet marks, with the lower ratchet mark being coincident with the ID surface and upper ratchet being coincident with the secondary crack.

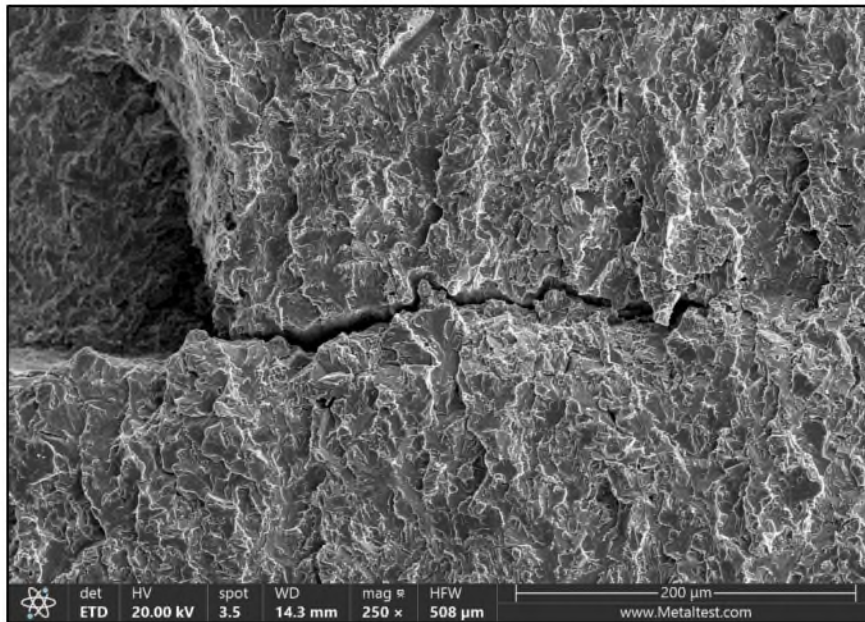
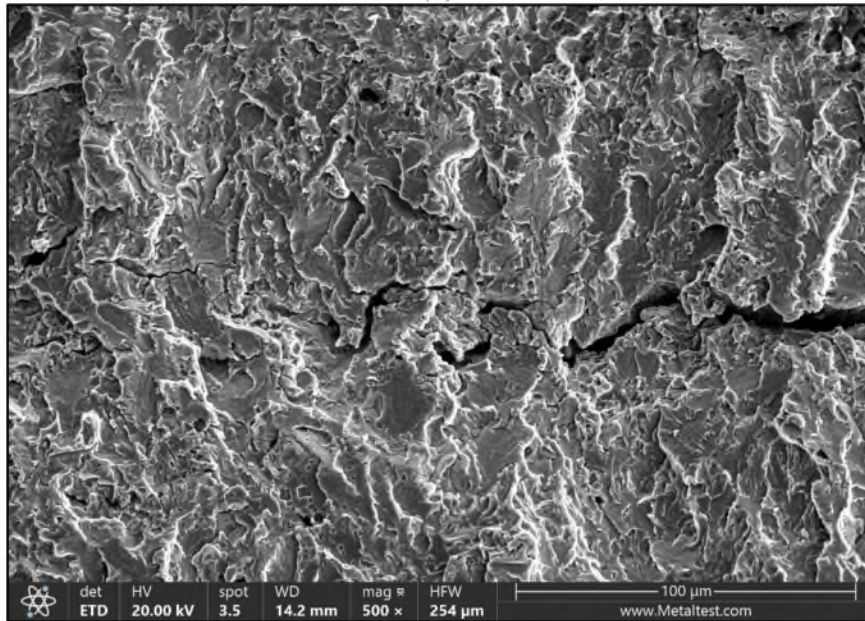
Figure 26 – Secondary electron fractographs showing a perpendicular secondary crack located approximately at mid-wall. It was observed that there was crack extension, with intergranular characteristics propagating circumferentially from the central step.

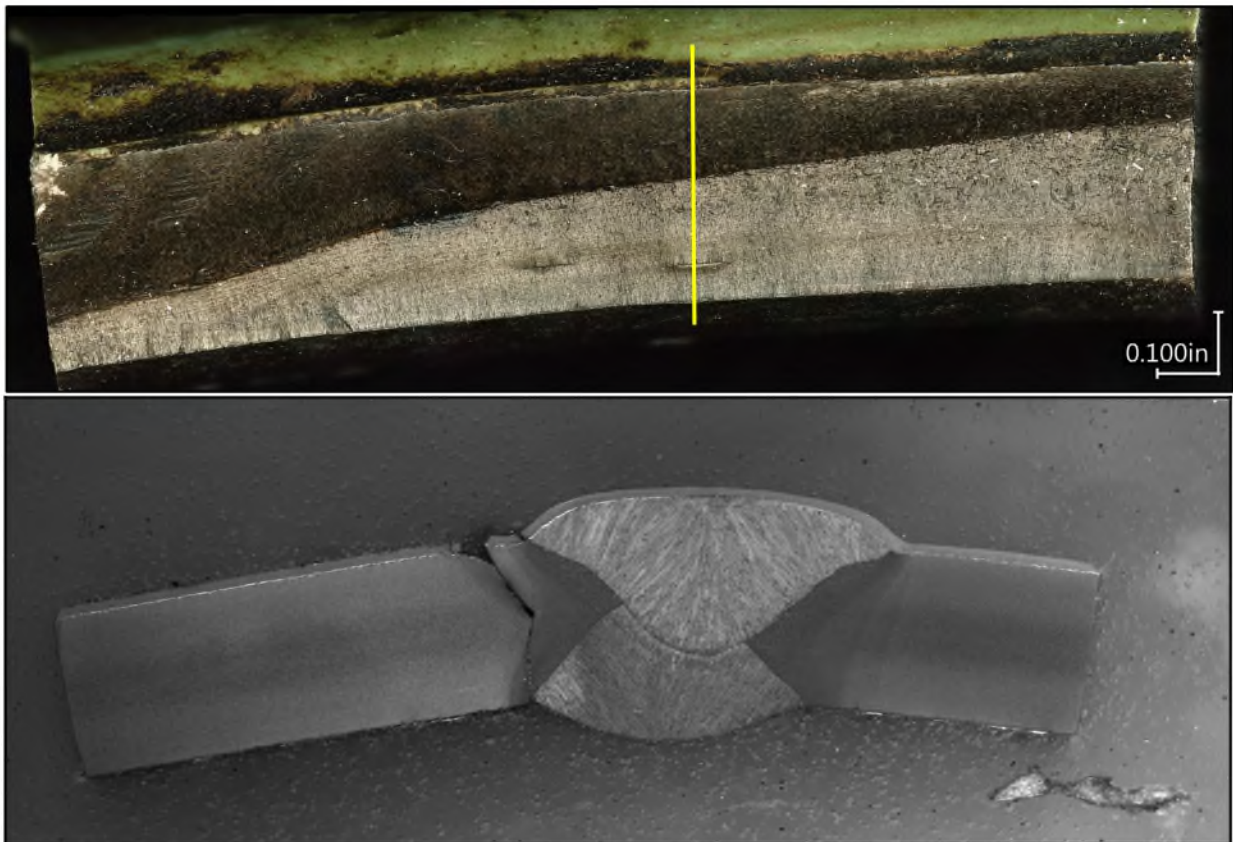
The section representing 50% fatigue crack penetration was specifically selected to intersect a secondary crack located within the Zone II region as shown in Figure 38. It was observed that there was no evidence of any inclusion present in this secondary crack, indicating it was unlikely to be associated with a non-metallic inclusion. It was further observed that the secondary crack was located in equiaxed, fine-grained microstructure, and that the crack was not associated with any microstructural feature.

Figure 38 – Location and metallographically prepared section through the region of 50% fatigue crack progression. This location was selected on the basis that it intersected a secondary crack on the fatigue surface.

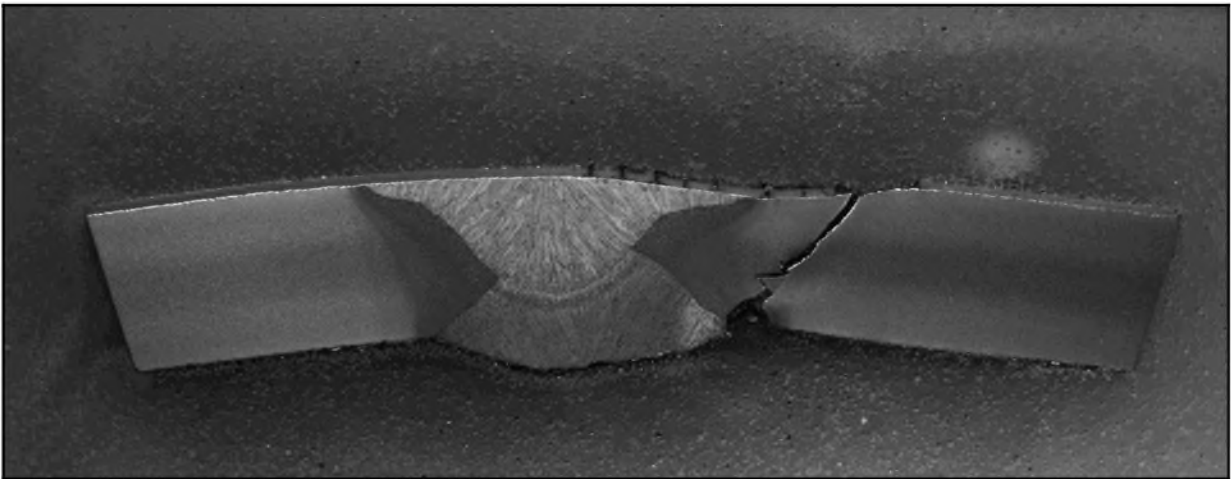
The metallographic section prepared through the location where only a small thumbnail of fatigue crack growth was observed is shown below in Figure 40. As with the previous metallographic sections, there were no metallurgical anomalies identified in the sample.

Figure 40 – Overall view of the metallographically prepared section from the most downstream edge of the fatigue crack. Localized wall thickness reduction (necking) was evident, indicating the onset of ductile tearing.

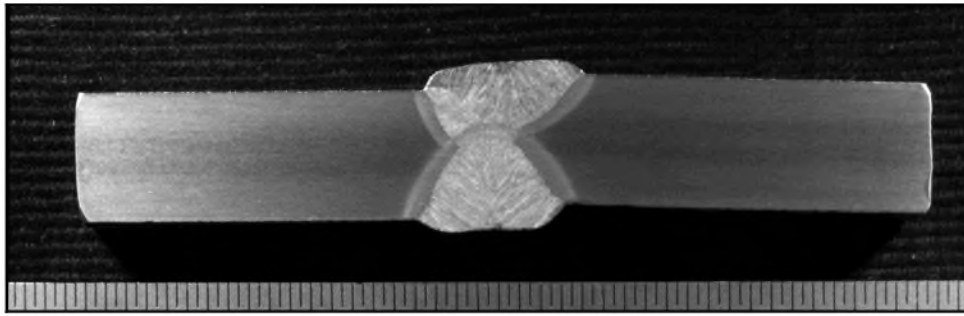
Figure 56 – Cross girth weld section taken from the $\sim 279^\circ$ location on the pipe. The failed joint side is on the left. This section exhibited the most radial offset, measured at $\sim 1\text{mm}$.
