# Final Report

# Root Cause Analysis of the MP 171 Fort Ransom Keystone Pipeline Rupture

**Date:**  
September 15, 2025

**Project Number:**  
SOB-25-003

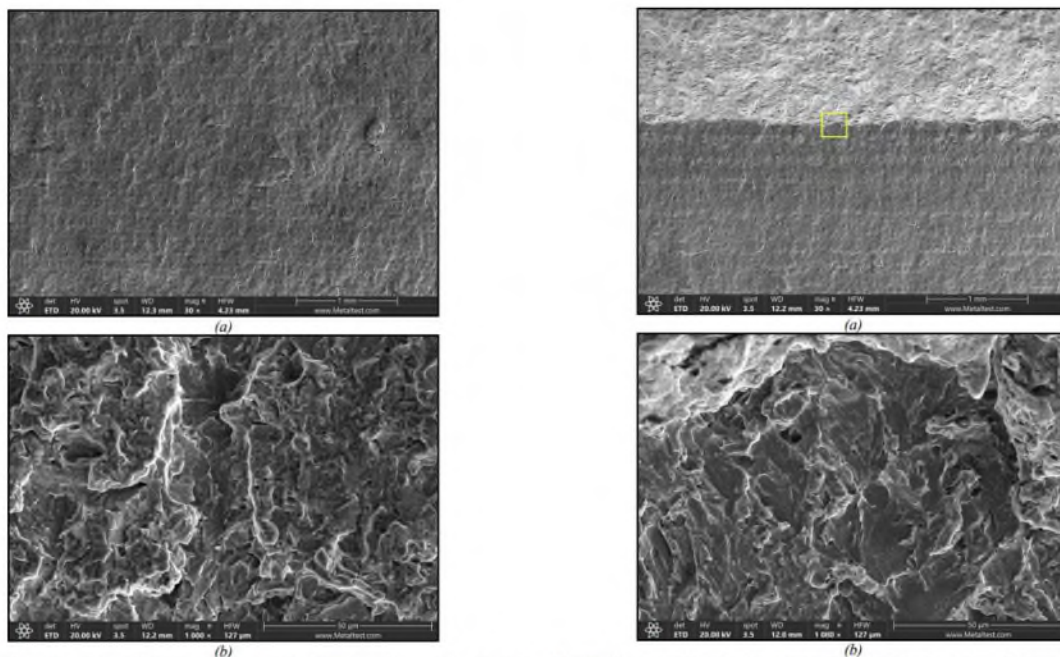
Based on fractography of the preexisting crack, Anderson and Associates reported the probability of hydrogen playing a role in the failure. Anderson reported secondary cracks consistent with HIC-type cracks [2]. Also, the morphology of the fracture surface changed from a purely mechanical fatigue mechanism to an environmentally-assisted fatigue mechanism. Fractographic analysis for an environmentally-assisted crack and for hydrogen is presented in [2] at the midwall in Anderson Figure 21 and at the tip of the preexisting crack prior to overload failure in Anderson Figure 22. Anderson's figures are reprinted here in Figure 4. Anderson makes the argument of the possibility of hydrogen in the "Discussion and Conclusion" section, p. 98 [2].

**Figure 21** – Secondary electron fractographs showing the fatigue crack morphology at mid-wall. At low magnifications as shown in (a), the fracture surface was characterized as having numerous crack arrest lines oriented perpendicularly to the crack growth direction. At high magnifications (b), the fracture surface exhibited features consistent with brittle cleavage.

**Figure 22** – Secondary electron fractographs showing the fatigue fracture near the final overload region (zone III). Examination of the fatigued surface at the transition zone at high magnification showed features consistent with brittle cleavage. (a) 30x (b) 1,000x.

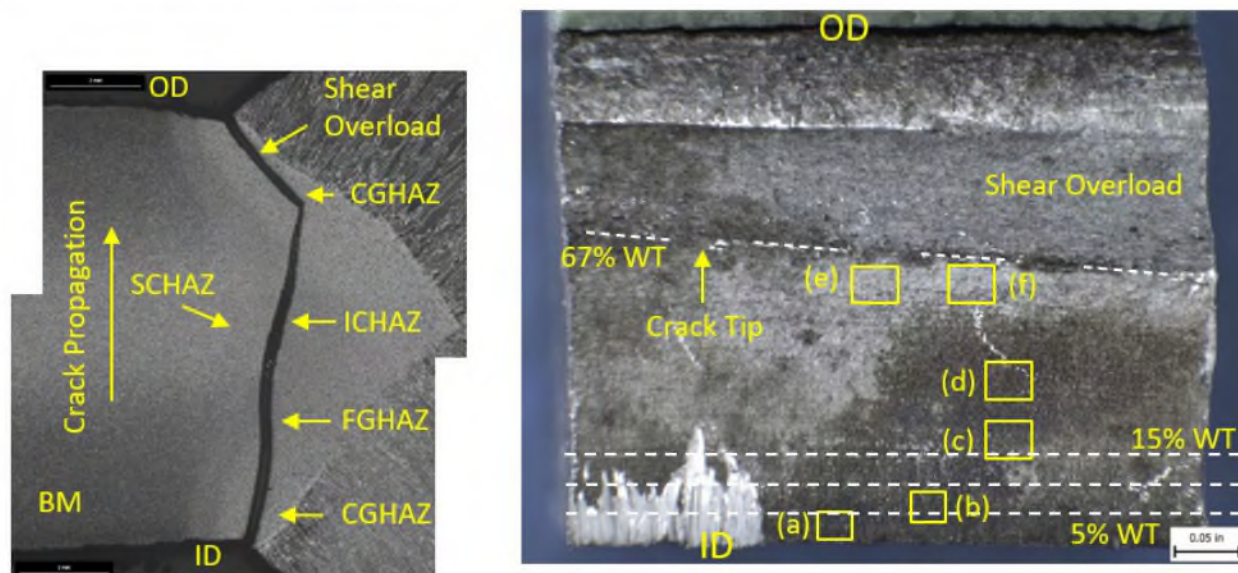
Figure 10: Optical images, cross-section, and crack face, peak depth location

Figure 10 (left) shows the fatigue crack initiated at the ID near the weld toe in the inside CGHAZ, propagated through alternating regions, reaching a critical length as it approached the outside CGHAZ. At that point, the remaining ligament failed by shear overload through the outside CGHAZ zone adjacent to the outer cap weld. This assessment is in agreement with Anderson and Associates [2]. The fractographic locations (a) through (f) are mapped on Figure 10 (right). Figure 10 (left) demonstrates the variance in grain structure and phase fractions as the crack grew from the ID to the OD. The fracture response of the material is a complex interaction of environment, stress intensity, and microstructure. Figure 11 is a map of two locations evaluated under the SEM at <10% WT near the ID.

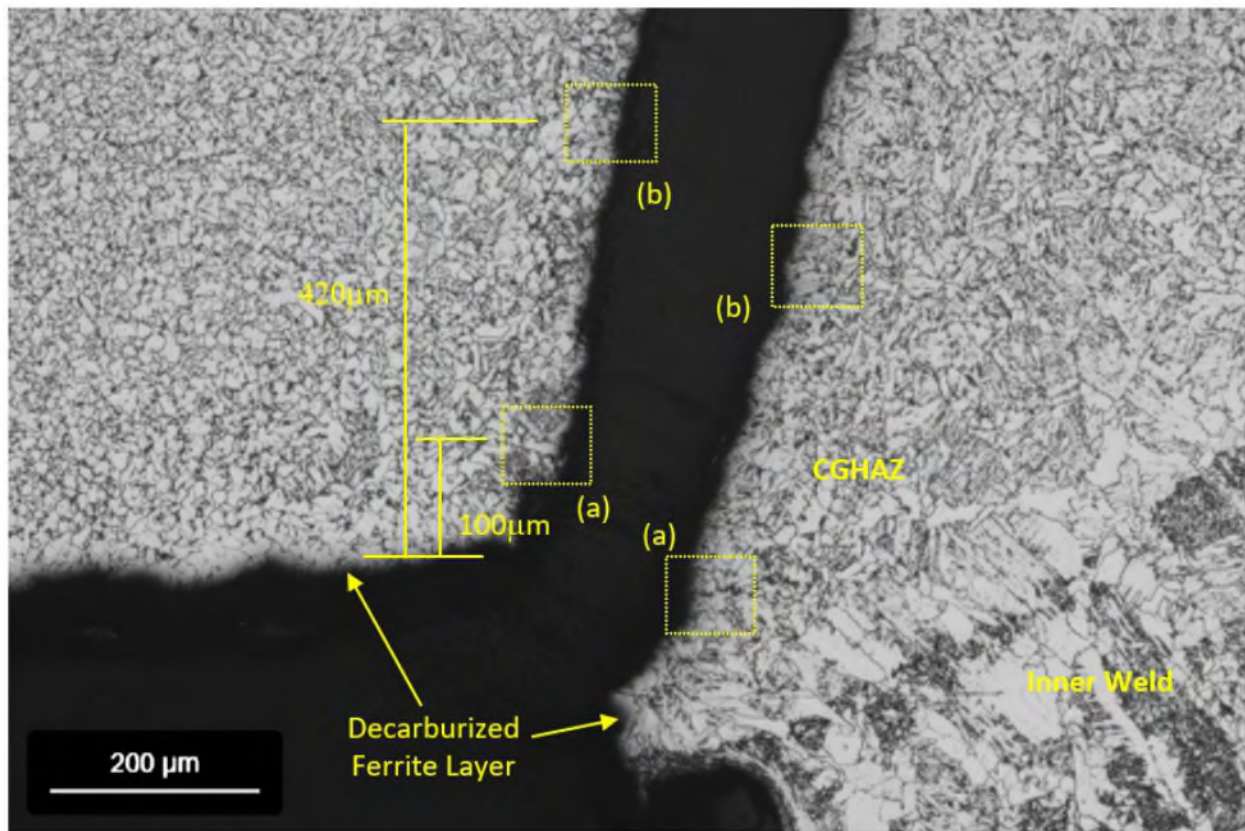
**Figure 12: Anderson micrograph “Met 1” cross-section, crack initiation**

Figure 12 shows the etched and polished microstructure of “Met1” at the ID near the deepest crack location. The image was taken by Anderson at 100X. At this magnification, the microstructure at locations (a) and (b) appears similar. The CGHAZ relative to both (a) and (b) appears to be non-polygonal ferrite and accicular needle-like structures of bainite.

An electron backscatter diffraction EBSD analysis would be necessary to precisely determine the phases present in the CGHAZ or any zone in the greater HAZ; however, Dong [7]. Drexler [8] et.al. describe the CGHAZ as in X70 DSAW seam welds next to the fusion line as mainly granular bainite (GB) with some bainitic ferrite (BF), polygonal/quasi-polygonal ferrite (PF), accicular ferrite (AF), and a few-percent martensite-austenite (M-A) islands along prior-austenite grain and bainite-lath boundaries. The work cited described the CGHAZ as having potentially low relative fracture toughness and lower fatigue resistance relative to the rest of the HAZ [9].

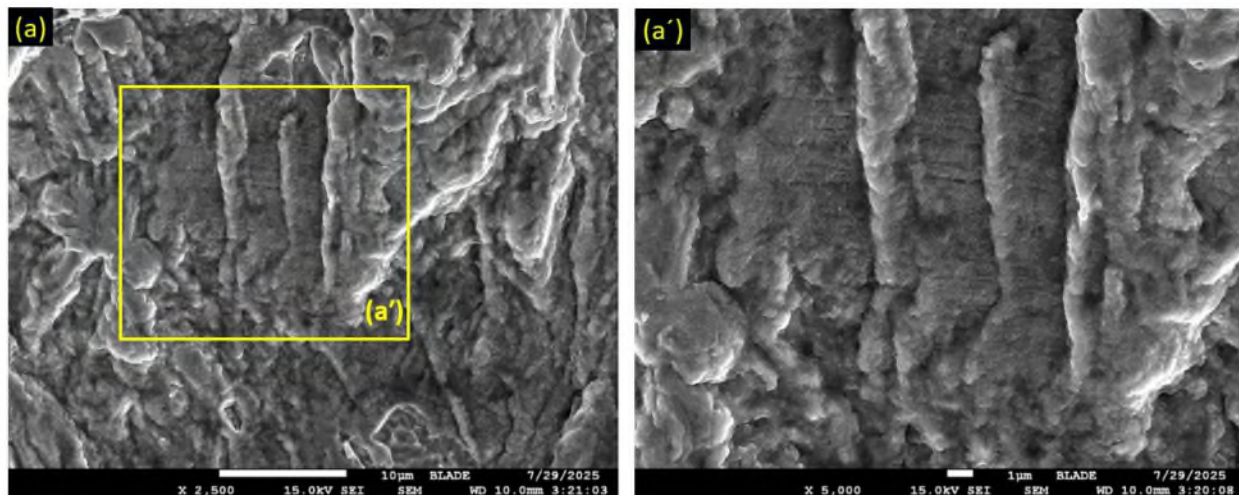
Figure 13: SEM fractography, &lt;5% WT

Figure 13 is an SEM fractograph of location (a) at approximately 100 μm from the ID. At this specific location, fine fatigue striations dominate the area. The morphology of the striations is consistent with the scenario of forming in air and then being exposed to a mildly reactive environment, as the striations appear to be superficially pitted. According to Zhao [10] et al, fatigue striations in the CGHAZ are likely more evident in bainitic lath.

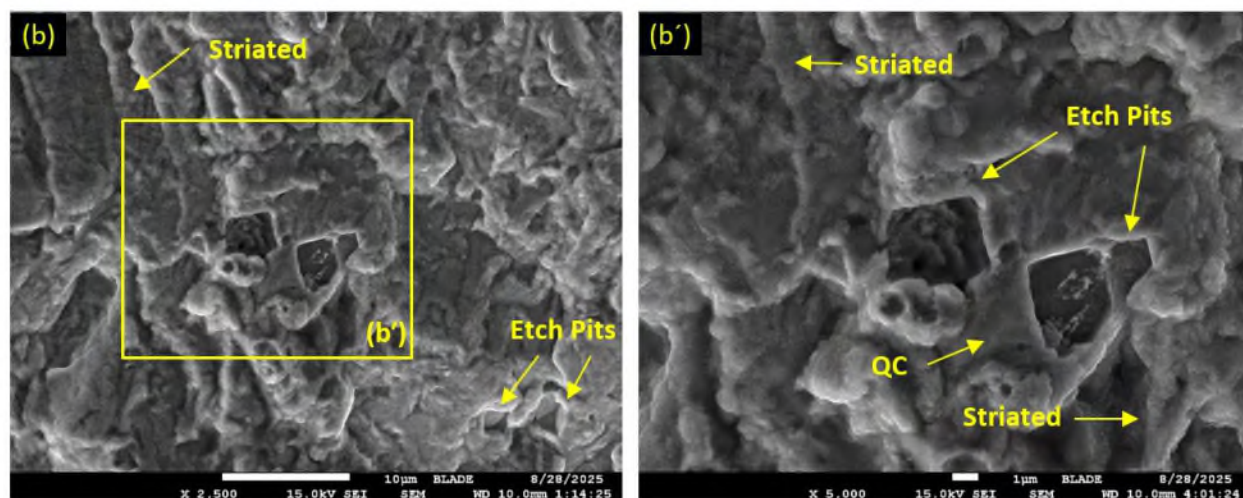
Figure 14: SEM Fractography, 10% WT

Figure 14 depicts a location (b) at 420 µm of crack depth. Here, striations of similar spacing are evident. Also present are relatively large etch pits, indicating larger second-phase particles have dissolved from a non-polygonal ferrite phase over time. Etch pits occur on {100} planes in the ferrite phase [11]. Typically, this morphology indicates cleavage due to environmental interaction or improper material processing. The etch pits are formed as second-phase particles are exposed to an electrolyte and dissolved as an anode in a cathodic matrix. The cleavage would precede the dissolution, indicating that the local phase is susceptible to environmentally enhanced FCG. Hydrogen uptake from the dissolution of second-phase particles may occur. The size of the preexisting 2nd-phase particle determines the size of the etch pit. Etch pits of this size cannot be attributed to metal dissolution during sonic cleaning, given the short exposure time and low concentrations. Therefore, we know the in-situ environment was interacting with the freshly exposed metal of the crack face.

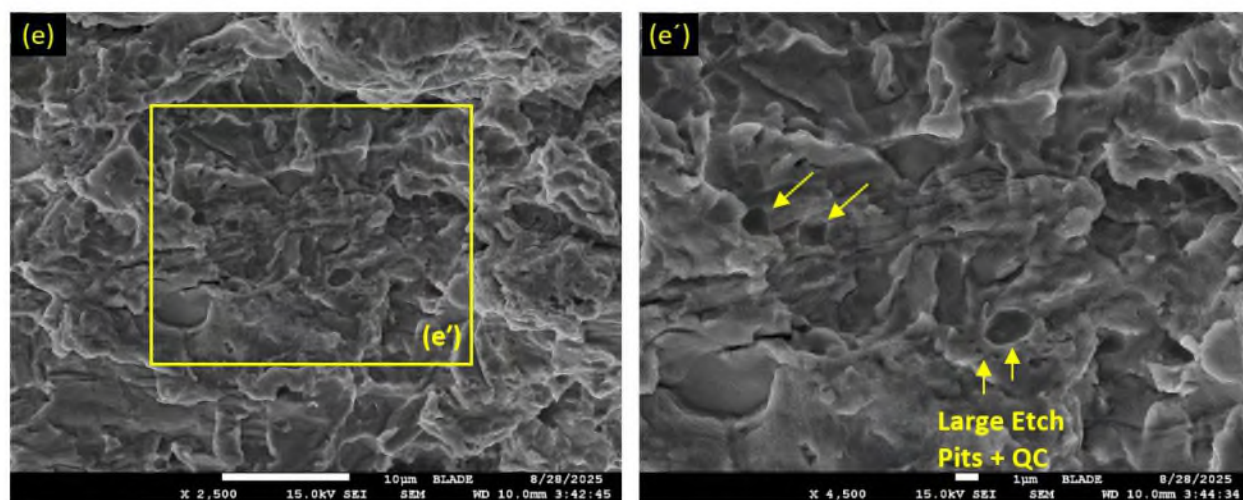
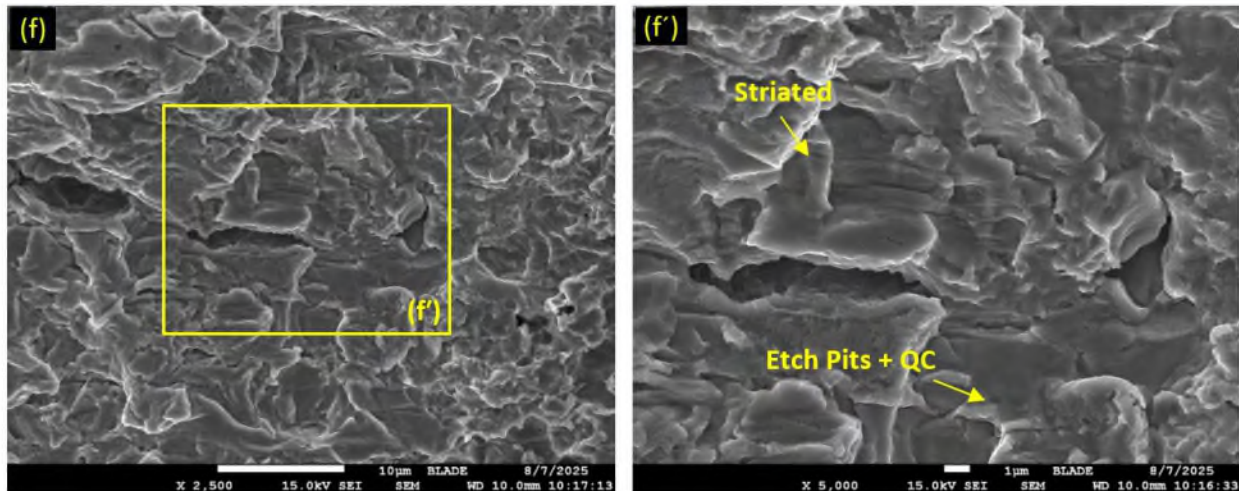
Fatigue striations represent a small area fraction in the regions depicted in Figure 18 350  $\mu\text{m}$  below the crack tip, and in Figure 19 170  $\mu\text{m}$  below the crack tip. In this region of the HAZ, where the crack may be approaching or entering the outer CGHAZ, environmentally assisted cracking is the dominant crack advance mechanism. Supporting evidence of an environmental effect is the presence of crystallographic etch pits in each location. A high-magnification micrograph of the outer CGHAZ was not available for comparison with the initiation region.

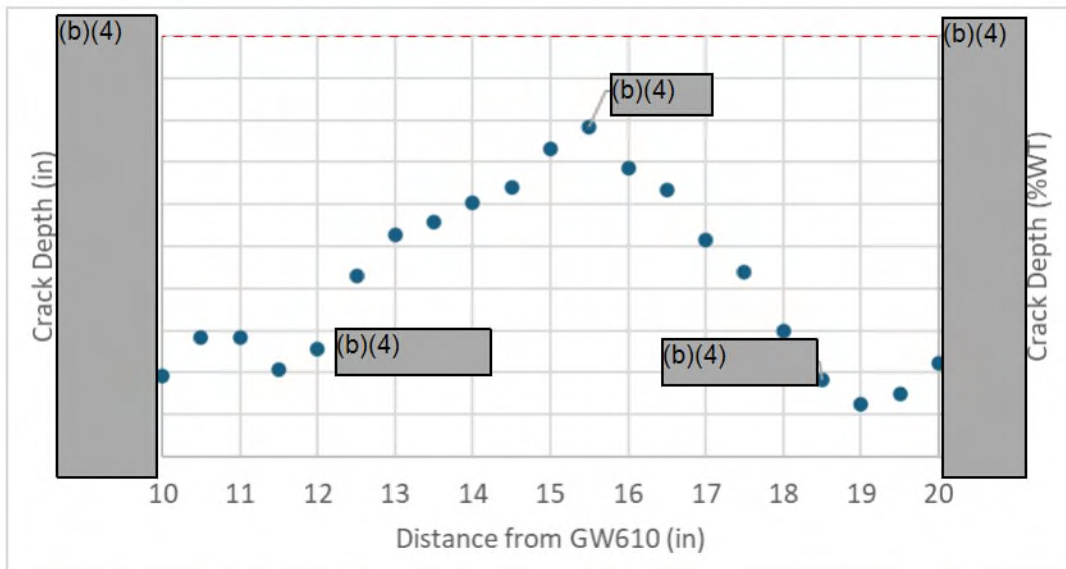
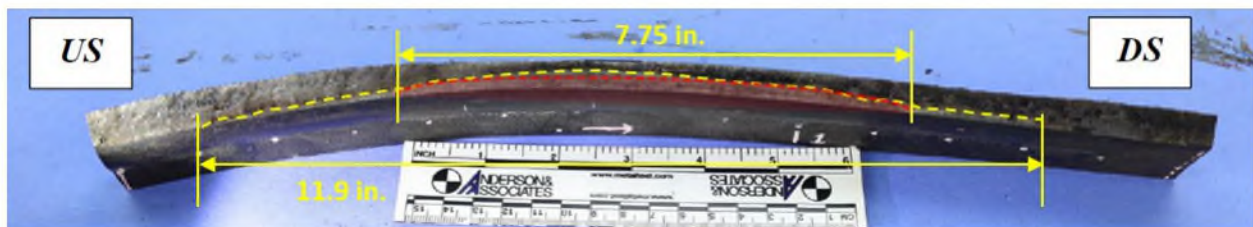
length, based on a semi-elliptical crack shape that covers the deepest and central lobe, is 7.5 in. Figure 32 shows the assumed crack shape, superimposed onto the fracture surface. The scaled length of the assumed shape was 7.75 in.

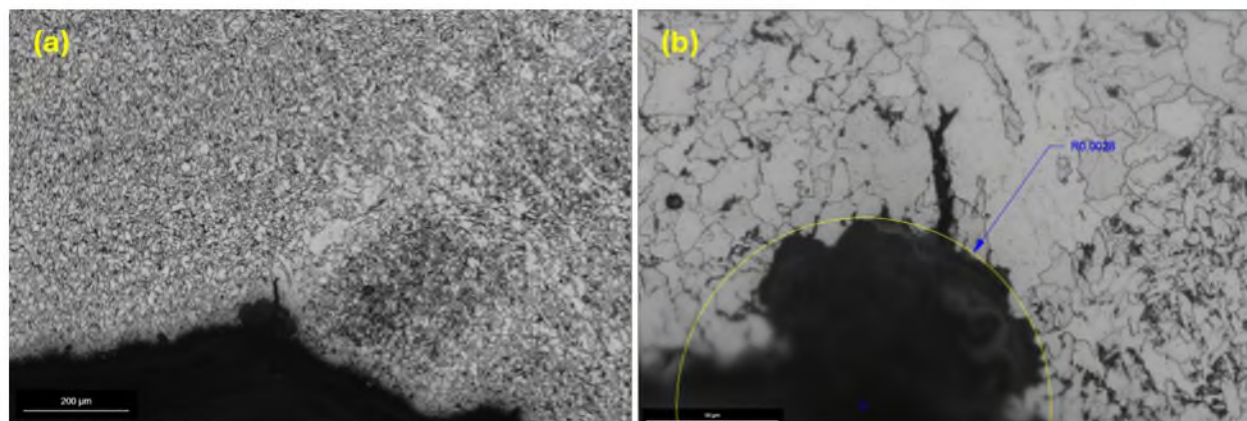
Figure 52: Corrosion pit with a crack at the weld ID root radius

Anderson found a corrosion pit at the internal weld root radius in one of the cross-sections. Figure 52 shows the images from the Anderson report with a radius measurement of the corrosion pit. The radius of curvature for the pit is approximately (b)(4) in., which is consistent with the ID root radius measurements. Since the actual root radius is challenging to measure and can vary along the joint length, two radii were considered for Models 2 and 3. A conservative value of (b)(4) in. was selected based on measurements, and a less conservative value of 0.010 in. was chosen based on the external weld value. Models 2a and 3a use a root radius of 0.003 in., and Models 2b and 3b use 0.010 in.
