## 7 Crude Oil Environment

### 7.1 Crude Oil Chemistry Analysis

## 7.2 Fracture Surface Scale Analysis

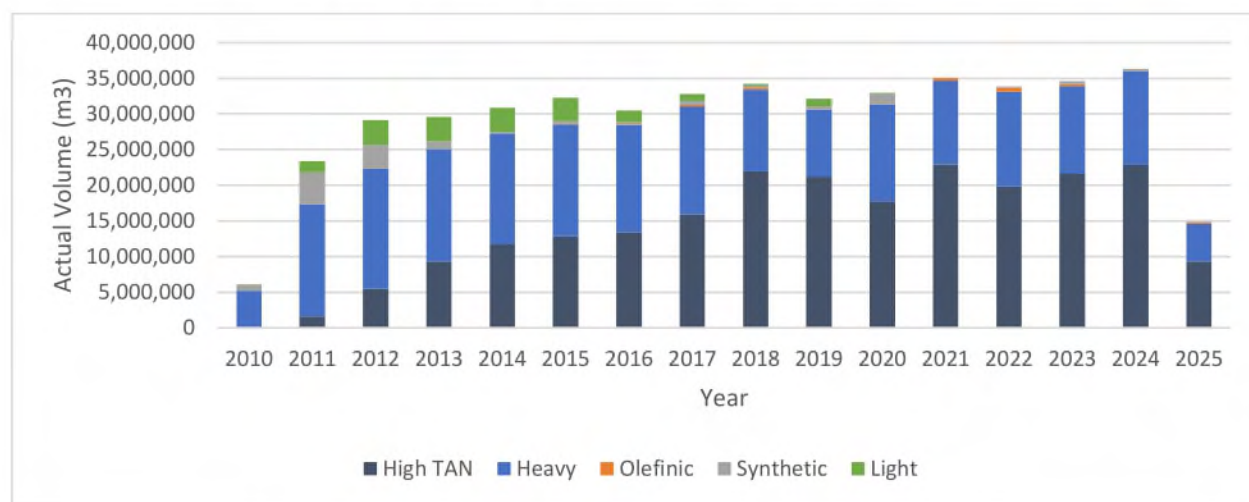
Figure 62 illustrates the consistent increase in TAN numbers as the percentage of crude makeup in the pipeline increased from 2010 to 2025. This would likely correlate to a lower pH of emulsified water and a higher amount of trapped water in the flowing crude. It is factual that these naphthenic acid moieties can provide protons and create acidic conditions in the presence of an aqueous phase, simply by considering the actual measurement. This indicates the availability of protons to create acidic conditions sufficient to catalyze the reactions referenced in this work.

Figure 62: TAN over time of the crude in the Keystone pipeline

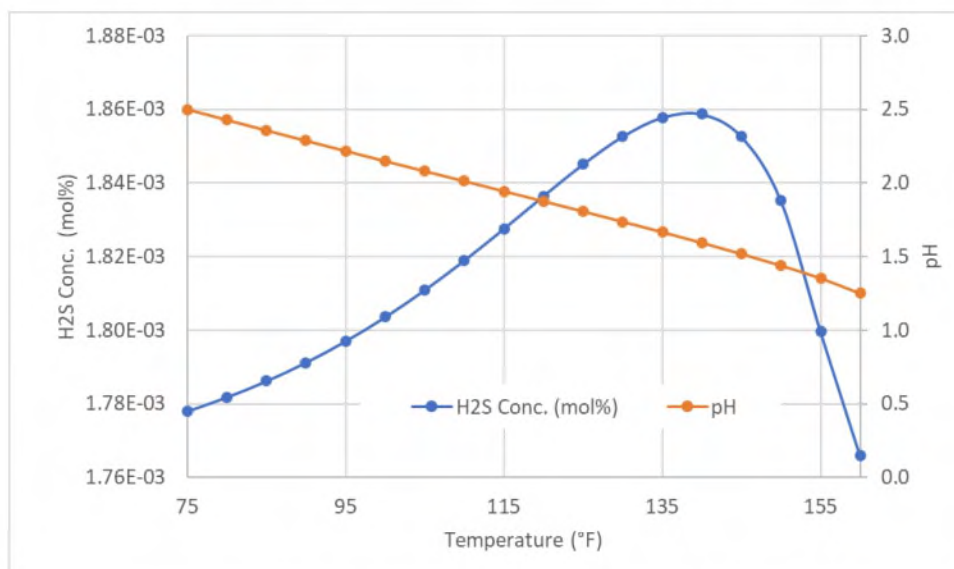
**Figure 63: Plot of possible H<sub>2</sub>S concentration in the oil phase of diluted bitumen**

The conditions screened were 1,440 psig pressure and 75-160°F. The results are summarized in Figure 63. The amount of H<sub>2</sub>S is predicted to reach a maximum around 130°F. The trend line is that more H<sub>2</sub>S is produced as the temperature increases to approximately 135°F. It is primarily a temperature-dependent response. Above 135°F, the solubility of the water increases and combines with the oil phase. At this point, there is little or no free aqueous phase available to react with sulfur, and it is thus no longer available for reaction to make H<sub>2</sub>S.

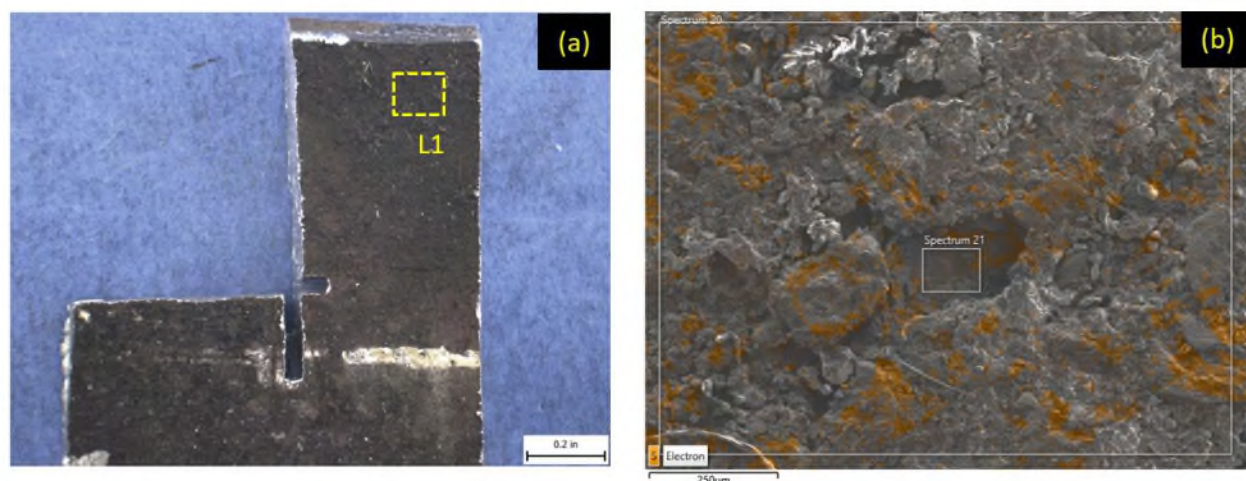
EDS was used to determine the elements present on the ID and fracture surface near the location of the greatest crack depth. Figure 64(a) shows the ID side of the fractographic sample as-received. Figure 64(b) is a higher magnification where sulfur from an EDS mapping is superimposed. Sulfur was not elevated in the pits, but rather distributed ubiquitously over all surfaces. Figure 64(b) also reflects petroleum and bitumen on the surface, obscuring the underlying mill scale.

**Figure 64: Spectroscopy Locations on ID, As-received**

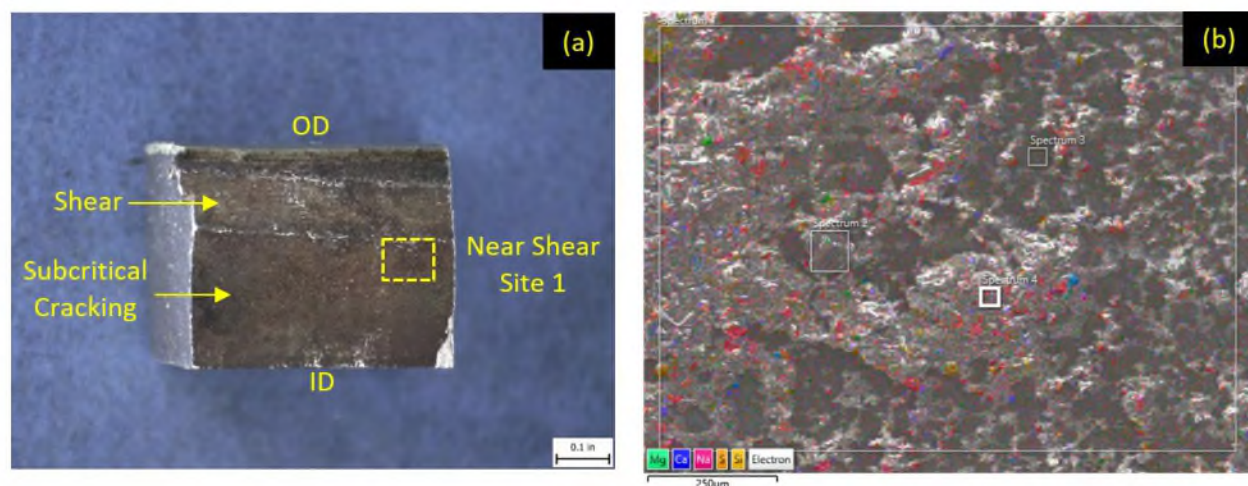
Figure 65 shows the fracture surface on the base metal side close to the point of deepest subcritical crack depth. This surface is shown in its as-received condition. As received EDS elemental composition in wt% of the ID and fracture surface is shown in Table. It should be noted that sulfur was present at an order of magnitude greater on the ID than on the fracture surface.

Figure 65: Spectroscopy locations on fracture face, as-received

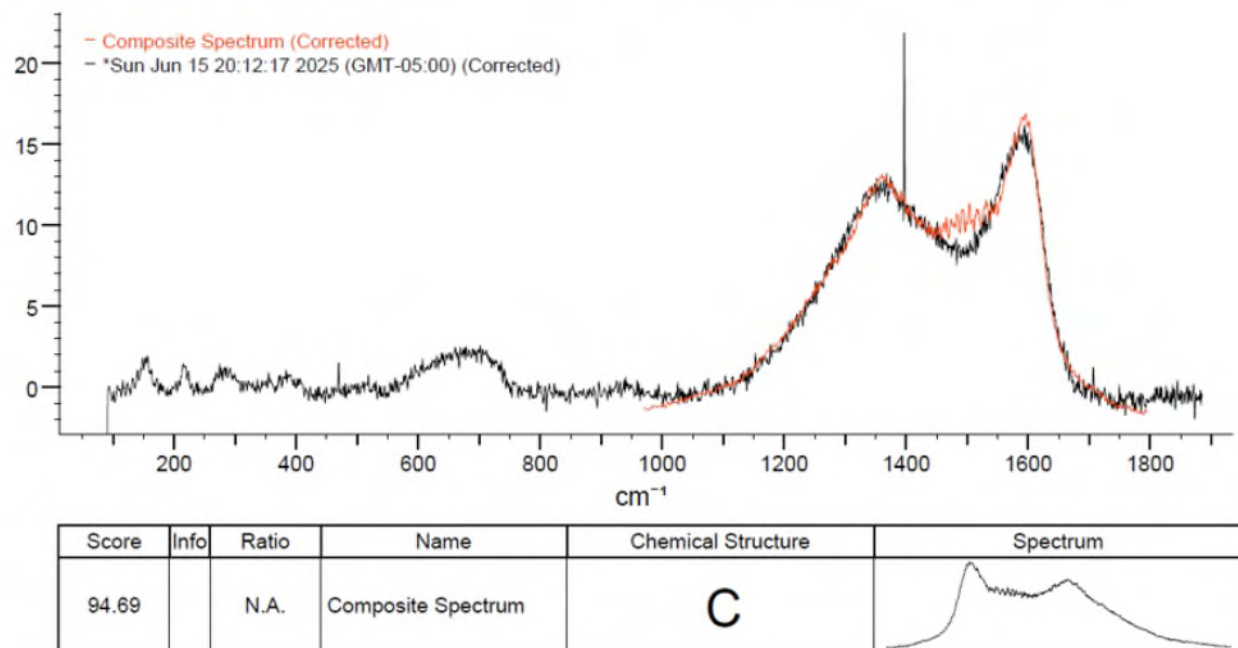
Raman spectroscopy was performed on the sample under the condition shown in Figure 65 using a ThermoScientific DX1 microscope with a 532nm laser at 1 to 3 laser power. Spectral analyses were performed with the Wiley KnowItAll tool. Several points in the region of L1 on the ID (see Figure) were evaluated. The two most common findings representing the most predominant compounds on the ID surface are shown in Figure and Figure. The Wiley tool returned “Ivory Black,” which consists of carbon-

based on organic compounds, which is a mix of crude oil residue and surface compounds. Also indicated is "Burnt Umber," which contains  $\text{Fe}_2\text{O}_3$ ,  $\text{Fe}_3\text{O}_4$ , and manganese oxides.

Figure 66: Raman spectra, as-received ID surface, L1a, carbon organics

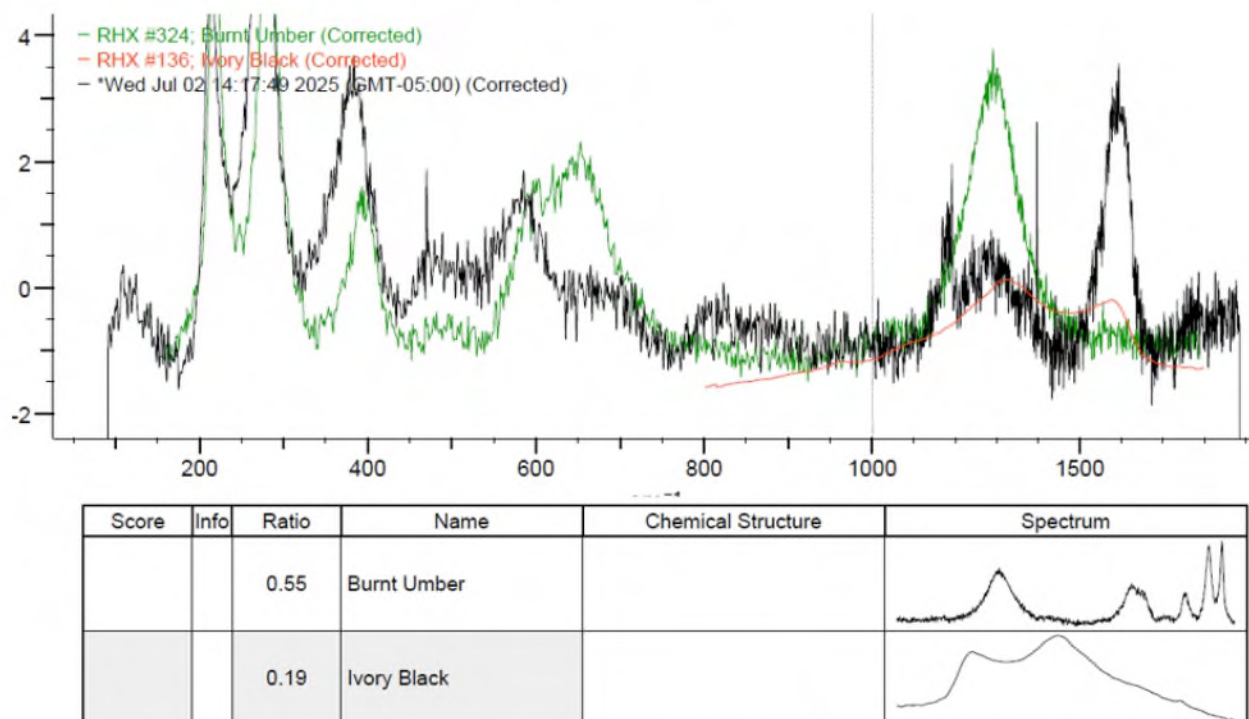
Figure 67: Raman spectra, as-received ID surface, L1b, iron oxides, carbon organics, Si, Mn

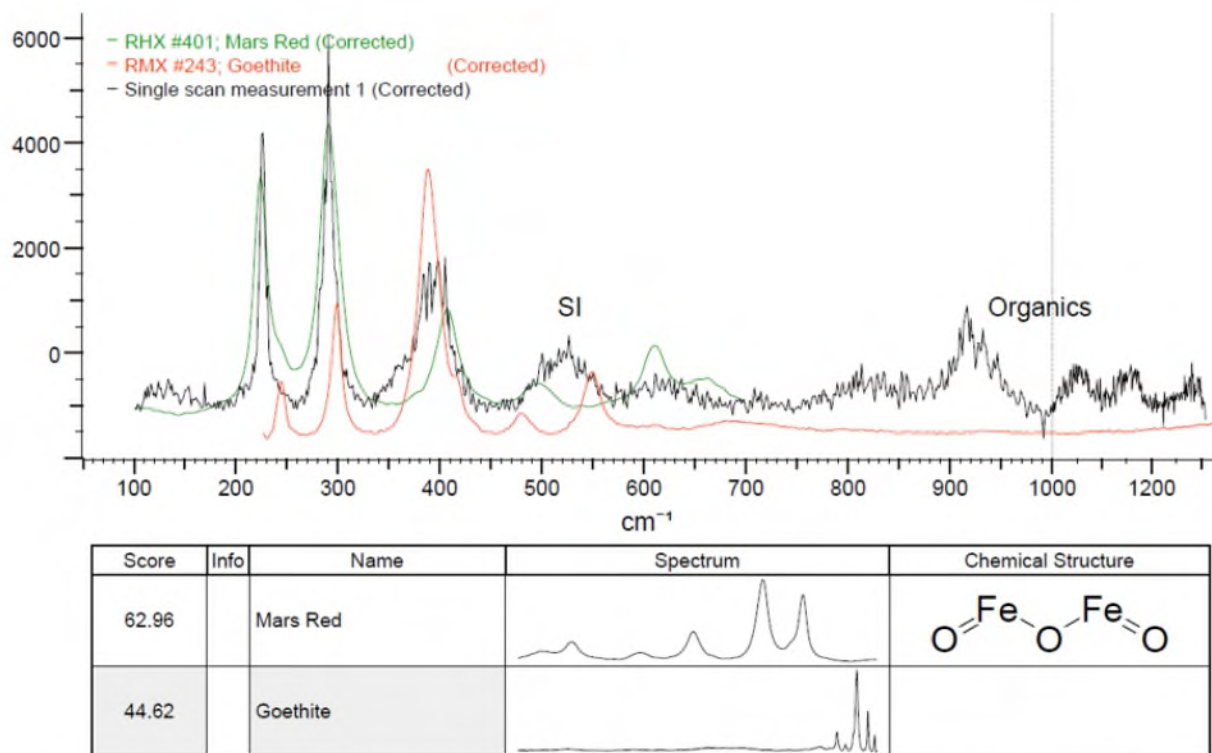
The fracture returned “Mars Red,” which  $\text{Fe}_2\text{O}_3$  and  $\text{Fe}_3\text{O}_4$ , as well as silicon and a small mix of earth elements. It also includes hydrated iron oxide. Goethite, the alternative finding, is a related iron oxyhydroxide,  $\alpha\text{-FeO}(\text{OH})$ . It is likely that Mars Red/goethite exists here as contaminants or secondary reactions and are not indicative of the failure conditions. Hydrated iron oxides may have been occluded on the surface due to the greater presence of organics.

Figure 68: Raman spectra, fracture surface, iron oxides, iron hydroxide, Si, and carbon organics

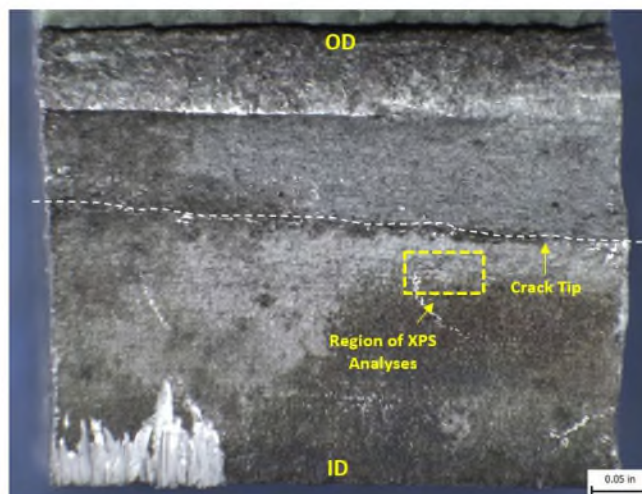
**Figure 69: XPS location and surface condition**

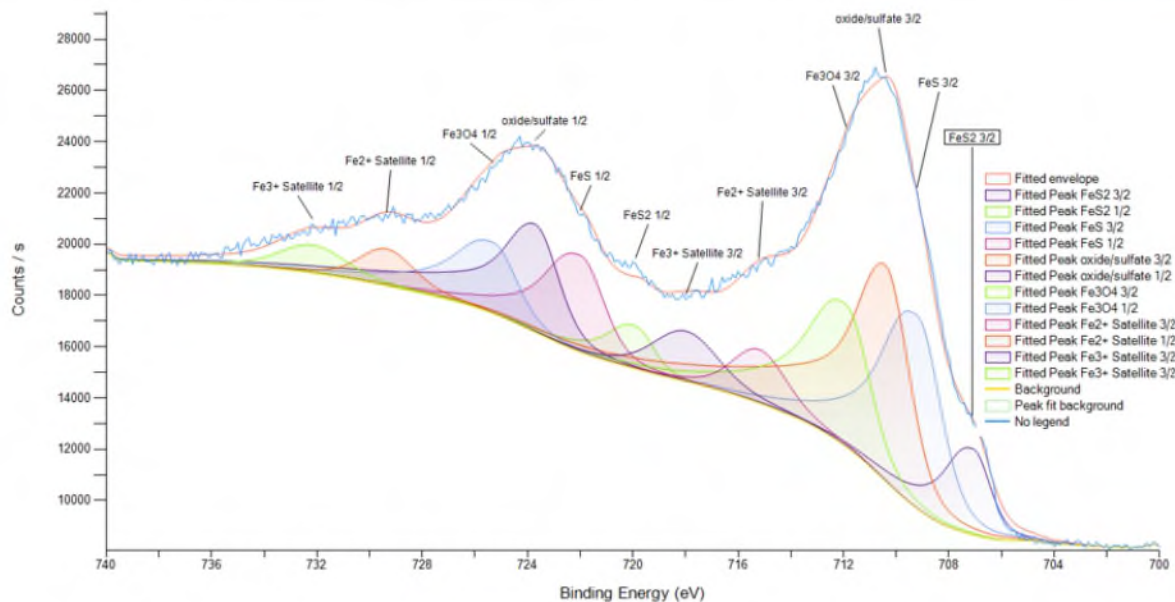
Figure 70 shows the fitted iron or Fe2p XPS spectrum of compounds in intimate contact with the steel substrate just below the crack tip. Figure 70 is a complex mix of iron-sulfur compounds along with iron oxides. Binding energy peaks below 710 eV represent the weaker Fe<sup>2+</sup> oxidation state [35] [36], which, in this case, are iron-sulfur reactions such as iron sulfide and iron sulfate.

The satellite peaks in Figure 70 support the identification of both Fe<sup>2+</sup> (sulfide and sulfate) and Fe<sup>3+</sup> (iron oxide) oxidation states [37]. The key finding by XPS is the table included with Figure 70, which shows that Fe<sup>2+</sup> iron-sulfur reaction byproducts are present, intimately associated with the metal surface, which exist in addition to the Fe<sup>3+</sup> iron oxides found by Raman.

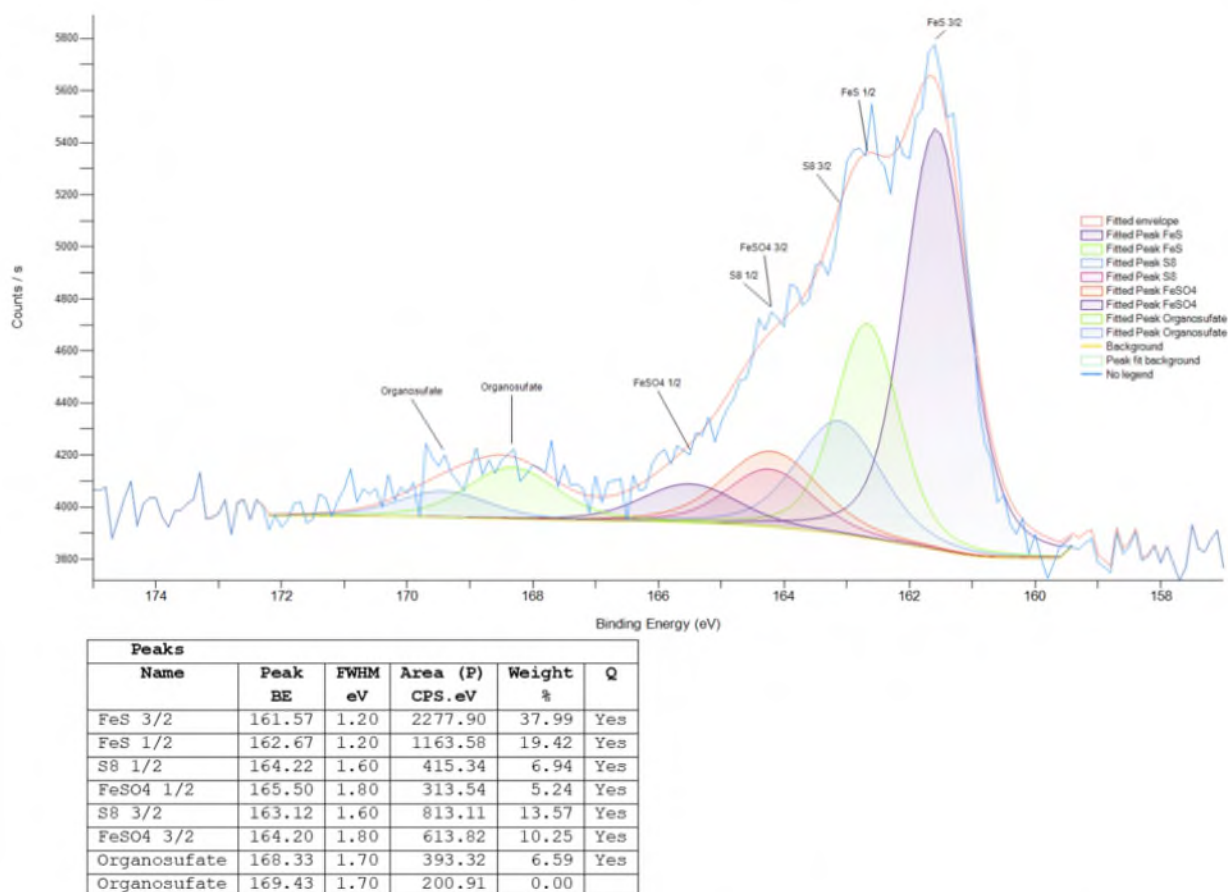
Figure 71 shows the fitted sulfur or S2p spectra. The analysis is consistent with the conclusion derived from fitting the iron Fe2p curve. Doublets required to fit the curve correspond to the presence of iron sulfide, iron sulfate, elemental S8 sulfur, and organic sulfur mixed compounds.

Figure 71: XPS fitted S2p spectra

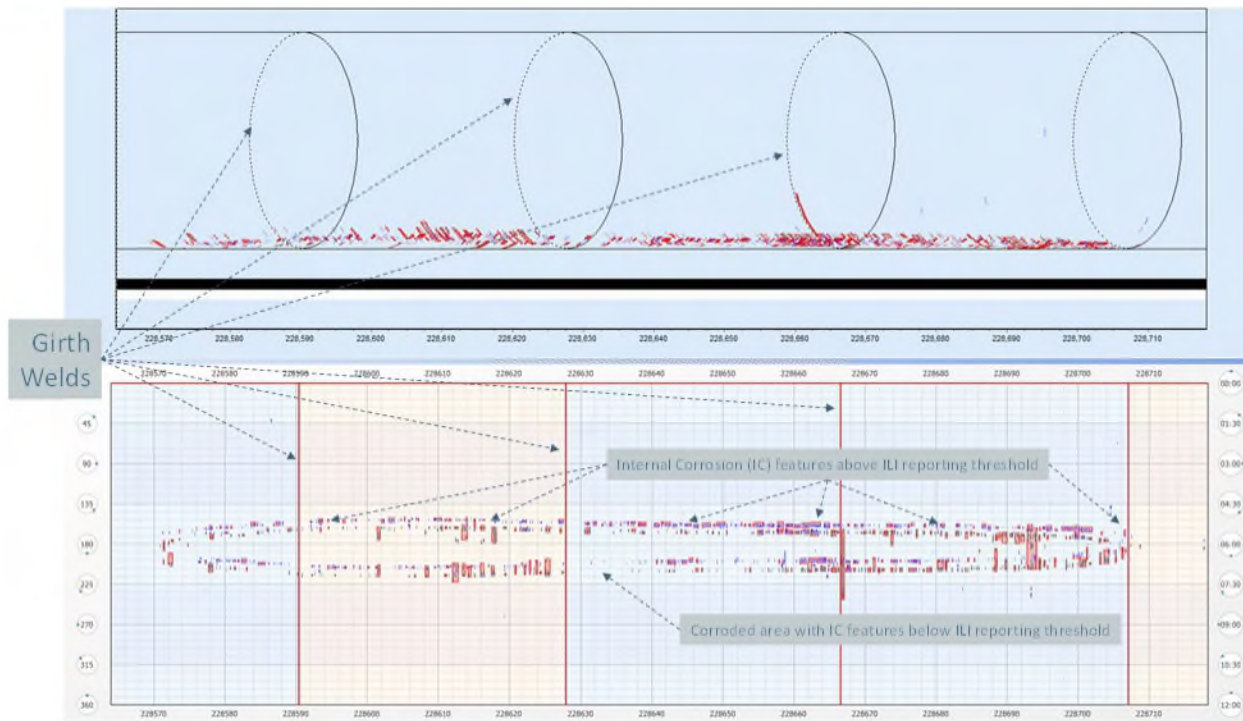
The 2012 ILI reported corrosion features consistent with internal corrosion by stagnant water left after the commissioning hydrotest, which accumulated in relatively low-elevation areas. The resulting corrosion patterns are lenticular and centered on the bottom of the pipe, with pitting occurring at the interface between the stagnant water and the air in the pipeline (before commissioning) and the transported oil (after commissioning), as illustrated in Figure 72.

**Figure 72: Lenticular internal corrosion pattern**

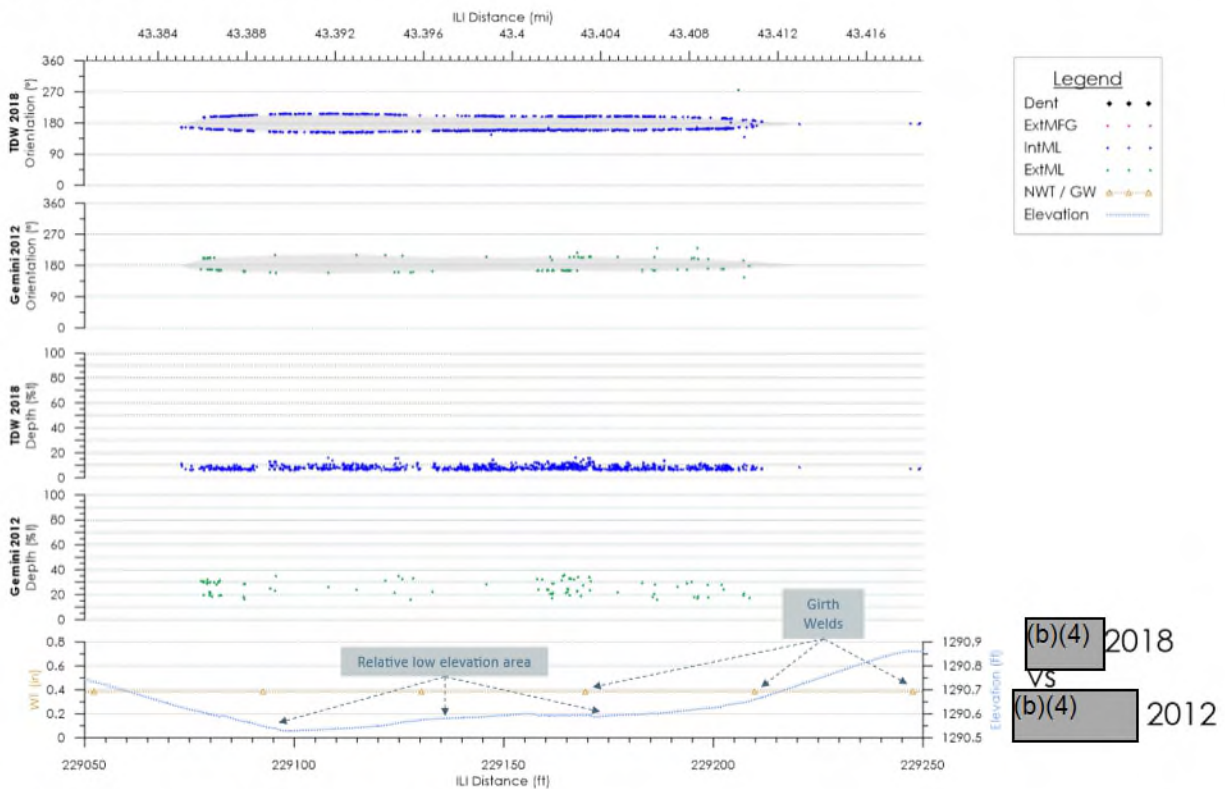
Figure 73: Example of aligned ILI features (b)(4) 2018 vs (b)(4) 2012) – Same area as Figure 72

It should be noted that the 2012 ILI listed those corrosion features as external. However, following excavation analysis, the external corrosion features were confirmed to be internal and further verified through subsequent ILIs. The differences in the number of corrosion features reported are due to varying detection capabilities and threshold settings among ILI vendors.

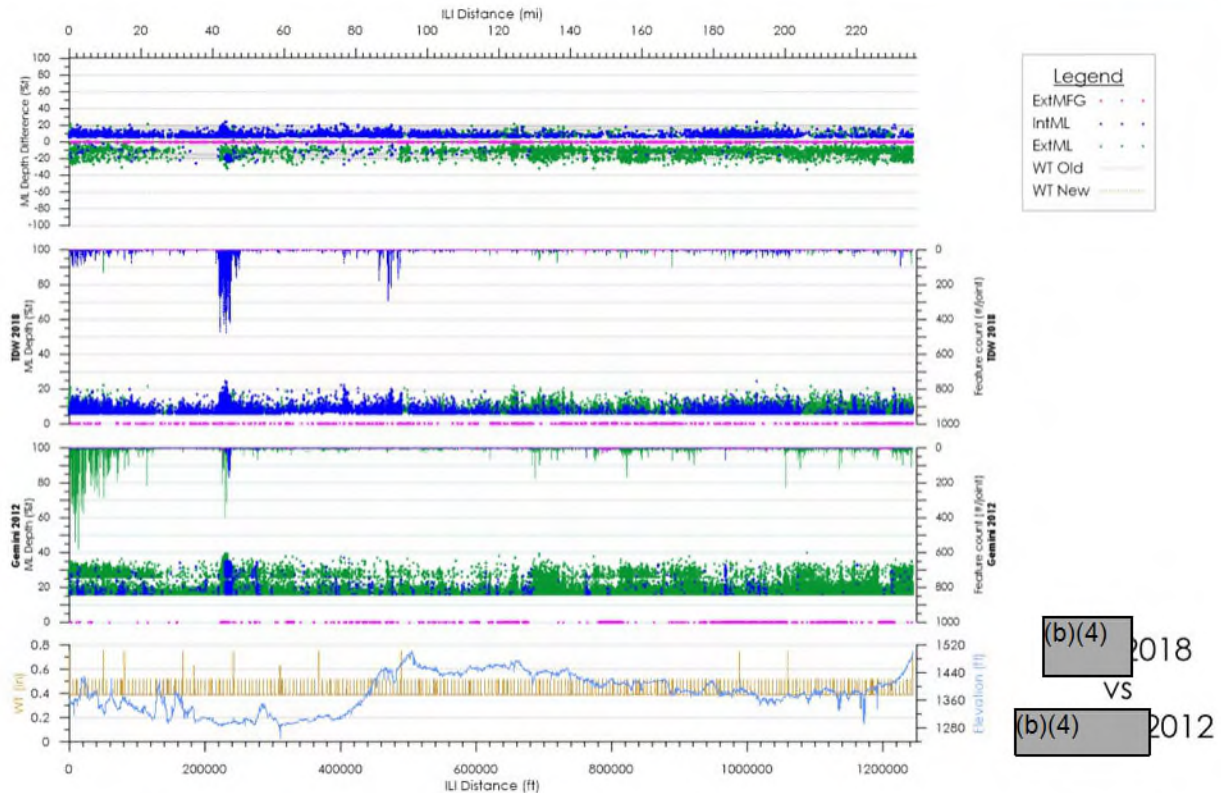
Finally, the number of features per joint is calculated, and the deepest feature depths are compared between ILI to identify areas of potential new corrosion or corrosion growth along the pipeline section, as illustrated in Figure 74.

Figure 74: Depth comparison of the deepest feature per joint – 2018 vs 2012

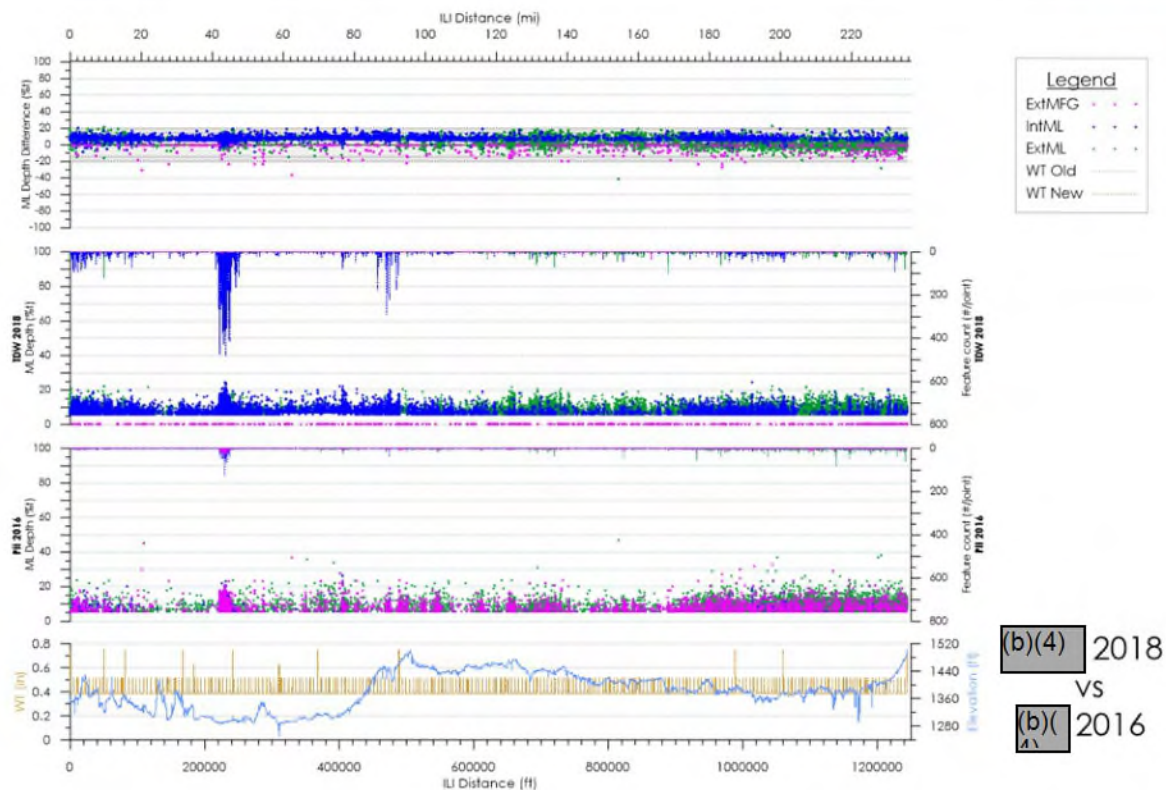
The same comparison and signal review exercise was performed between the (b)(4) 2018 and (b)(4) 2016 ILIs and between (b)(4) 2016 and (b)(4) 2012, with similar results, as shown in Figure 75 and Figure 76, respectively.

Figure 75: Depth comparison of the deepest feature per joint – 2018 vs 2016

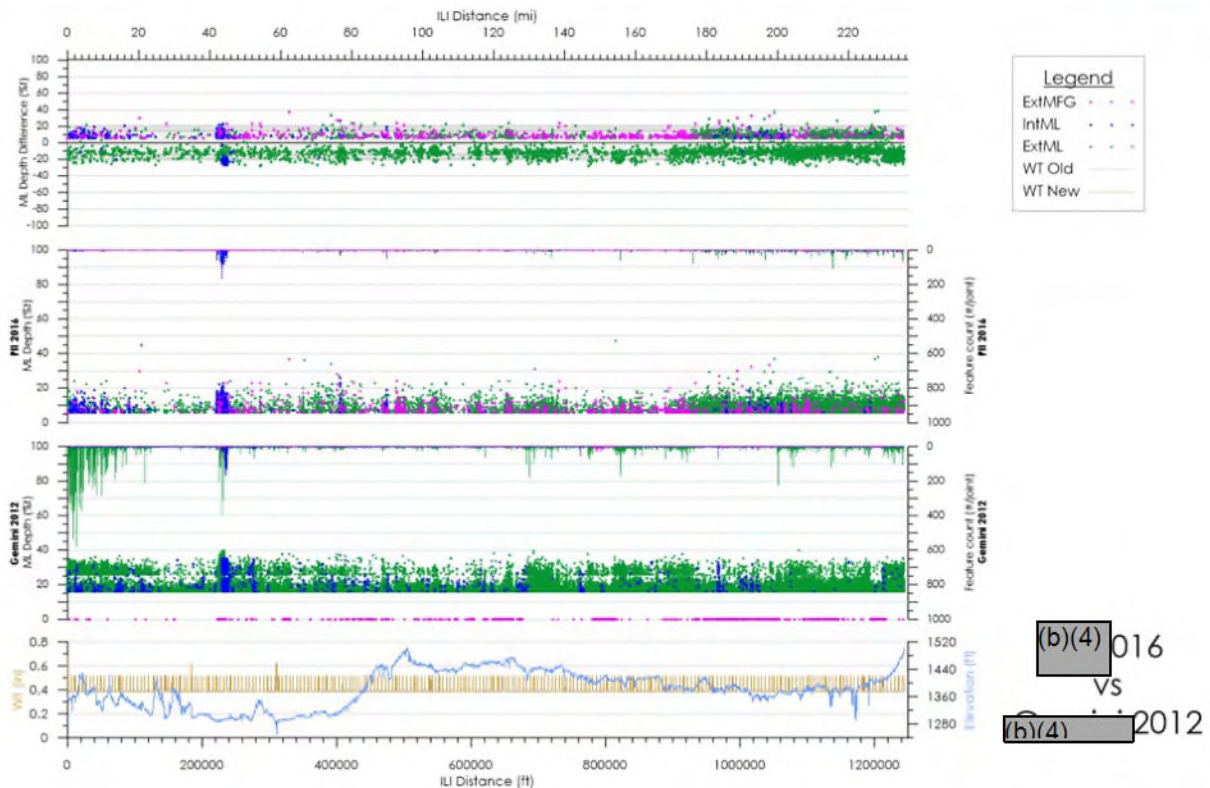
Figure 76: Depth comparison of the deepest feature per joint – 2016 vs 2012

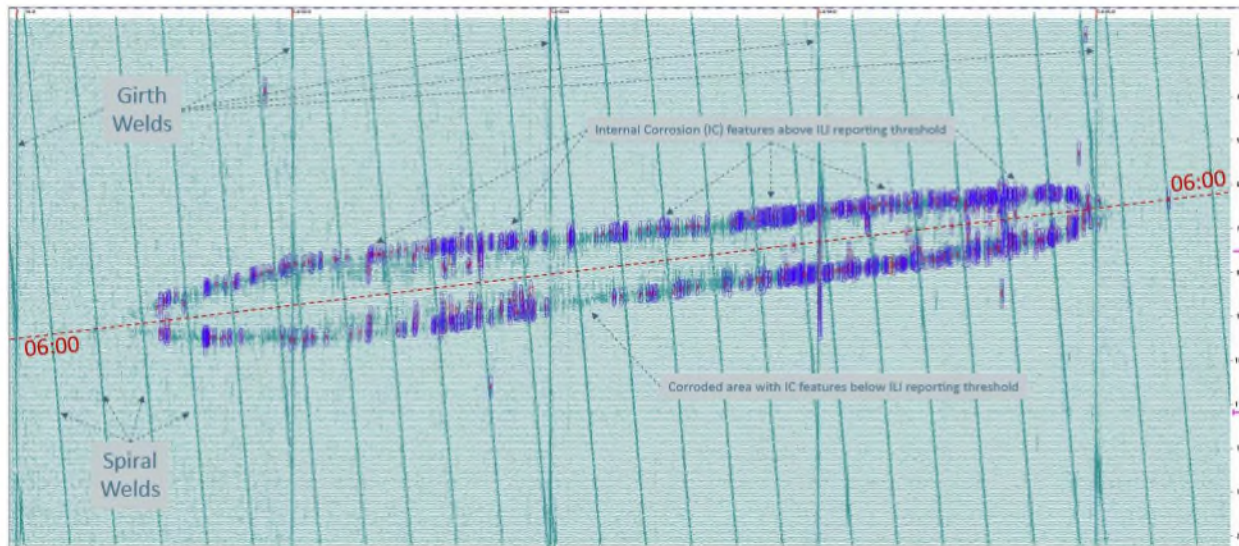
Figure 77: ILI signals for the same are in Figure 72

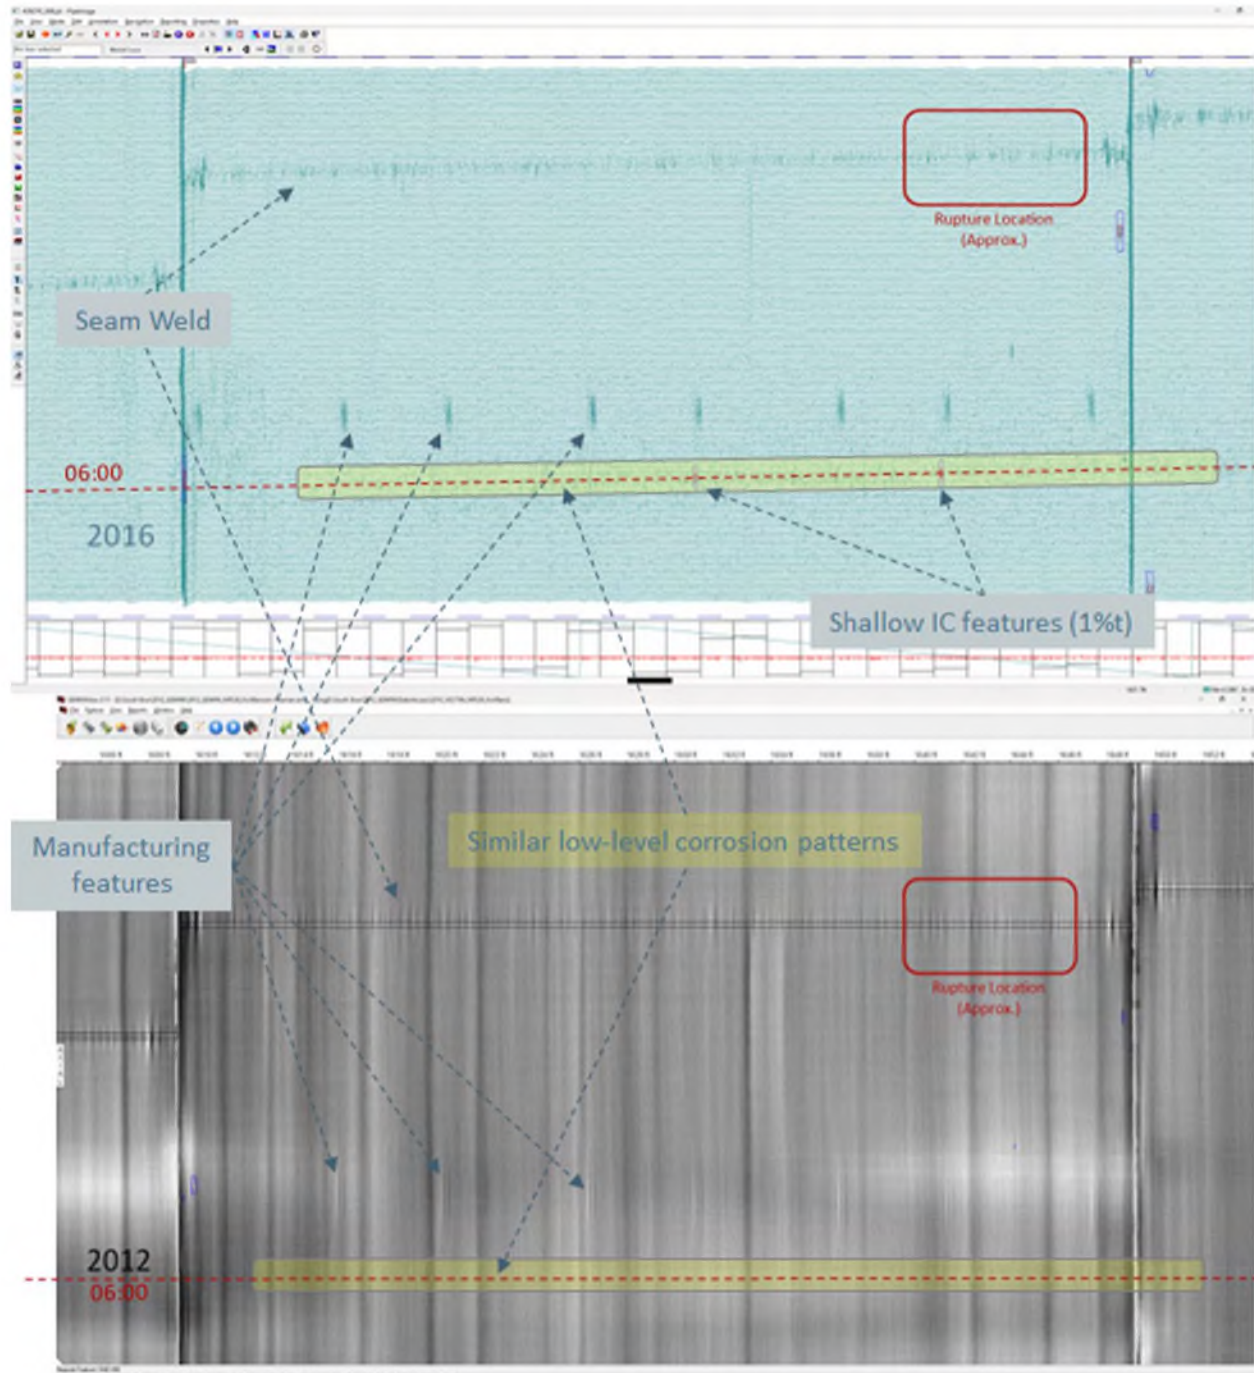
Blade compared the ILI signals of the three MFL ILIs, looking for signal differences that may suggest new internal corrosion below the ILI reporting thresholds. Five joints downstream and upstream from the rupture location (GW 610 – 4 ft) were reviewed in detail. No evidence of new internal corrosion was found in them. An example of these signal comparisons (at one-joint scale) is shown in Figure 78.

Figure 78: Example of MFL signal comparison – ruptured joint

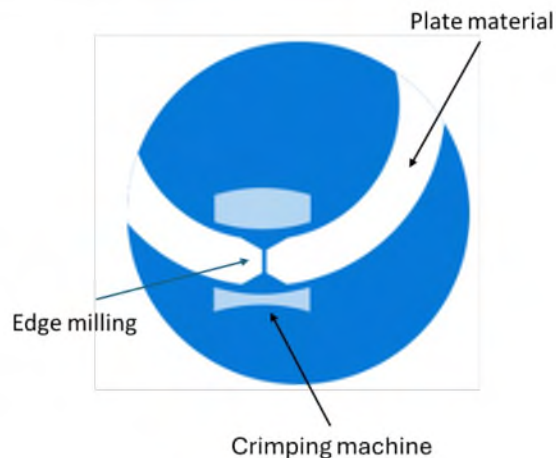
During crimping, as shown in Figure 80, several seam-geometry risks can be introduced in one step. If the edge curvature is mismatched, the seam can "peak" (roof-topping), so the edges meet as a ridge that concentrates strain at the weld toe and can initiate toe cracking.

Figure 80: Edge crimping

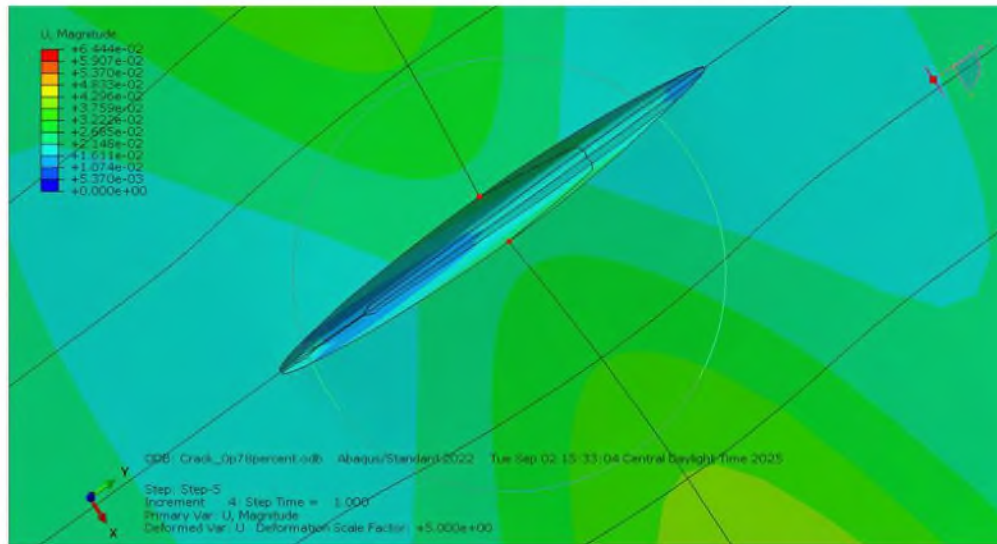
alternative that may be worth pursuing. Additional FEA modeling to assess the CMOD as a function of pressure, crack depth, and length should inform the decision-making process.

**Figure 85: CMOD for an 8 in crack at 1440 psi and 78% depth.**

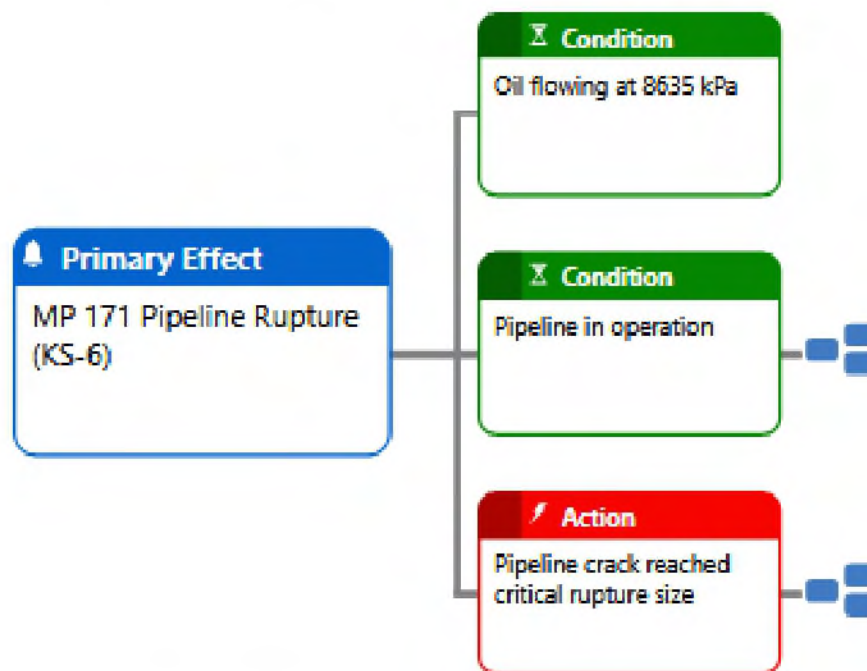
Figure 88 shows the primary effect associated with the causes. The MP 171 Rupture is the primary cause. It was caused by Oil flowing at (b)(4) kPa), the Pipeline was transporting hydrocarbon liquid, and the crack along the weld seam reached a critical crack size.

Figure 88: Primary Effect with associated causes

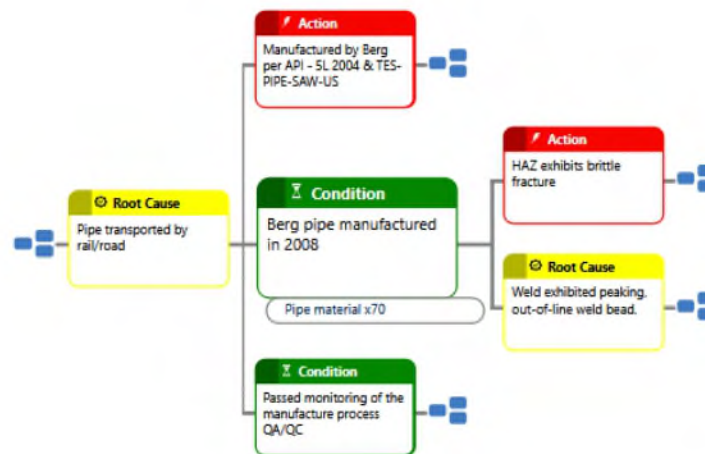
- The Heat-affected zone exhibited brittle behavior at -5 °C through the J-R testing. Cleavage was observed in the HAZ in both used and unused pipes. This is significant because any impact of the operating environment was absent in the unused pipe. The HAZ was clearly brittle before being put into operation. The manufacturing process is responsible for the brittleness.
- The seam weld consistently showed peaking and an out-of-line weld bead in the 2025 and 2019 failures.

Figure 92: Causes for Berg pipe manufactured in 2008

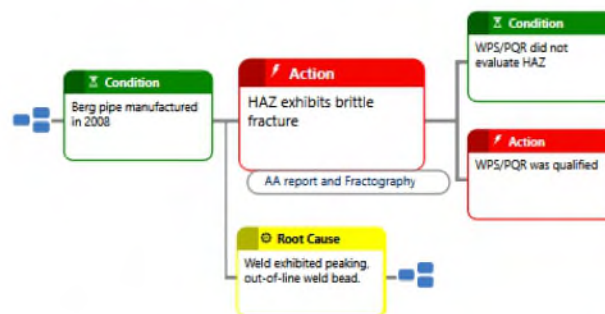
The causes for HAZ exhibiting the brittle fracture are that the WPS/PQR did not evaluate HAZ. This wasn't part of the weld qualification. The other condition for the brittle fracture was that the WPS/PQR without the HAZ was qualified. Both these causes terminate as desired conditions. These are shown in Figure 93 .

Figure 93: Causes for HAZ to exhibit brittle fracture

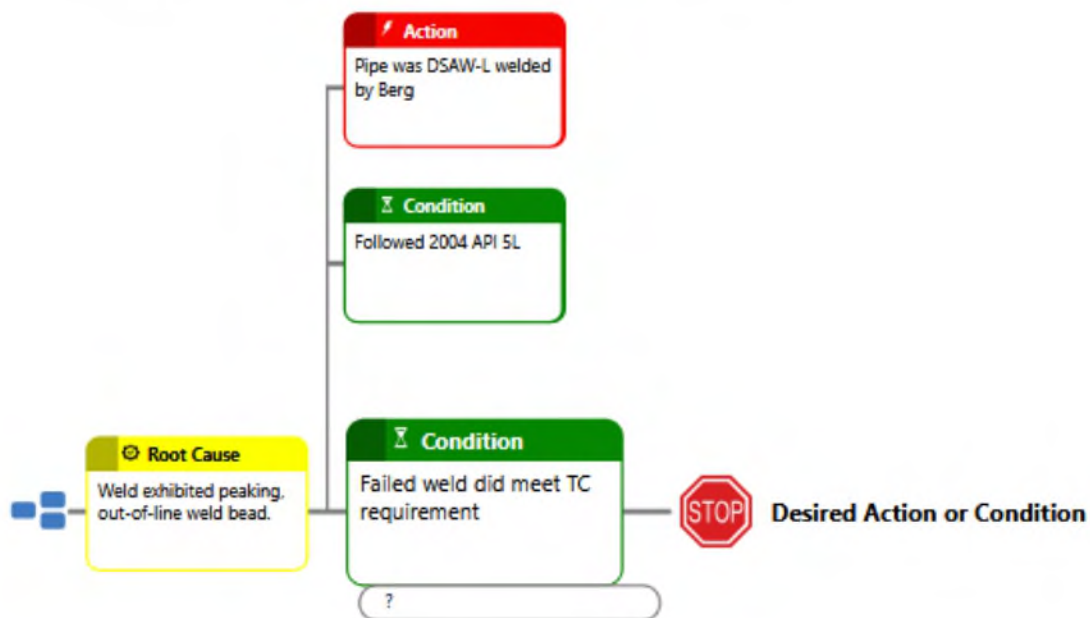
The causes of the weld exhibiting peaking and an out-of-line weld bead are that the pipe was DSAW welded by Berg, in accordance with API 5L 2004 requirements, and the failed weld did meet the TC peaking requirements. This causal set was terminated due to a desired condition and is summarized in Figure 94.

Figure 94: Causes for the weld issues

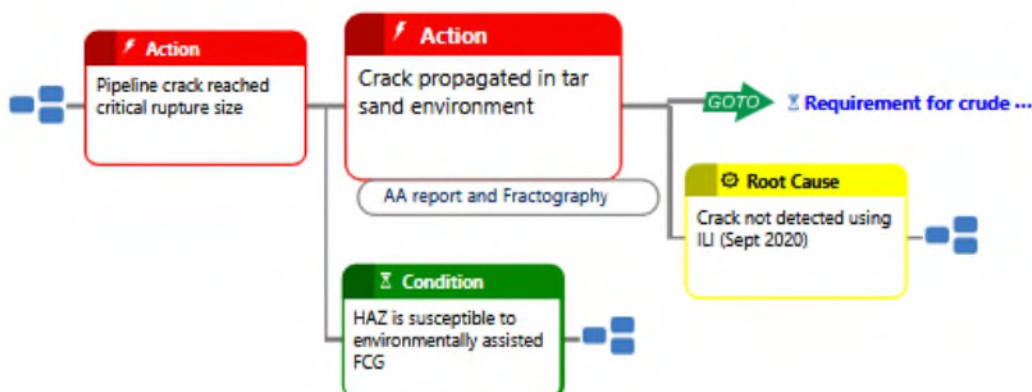
- The subcritical crack propagated through fatigue in the hydrocarbon environment. Further, the cause for this propagation is the liquid hydrocarbon environment, and the fact that the September 2020 ILI (b)(4) did not detect this crack.
- The Heat-affected zone is susceptible to environmentally assisted fatigue crack growth.

Figure 95: Causes associated with the crack reaching a critical crack size

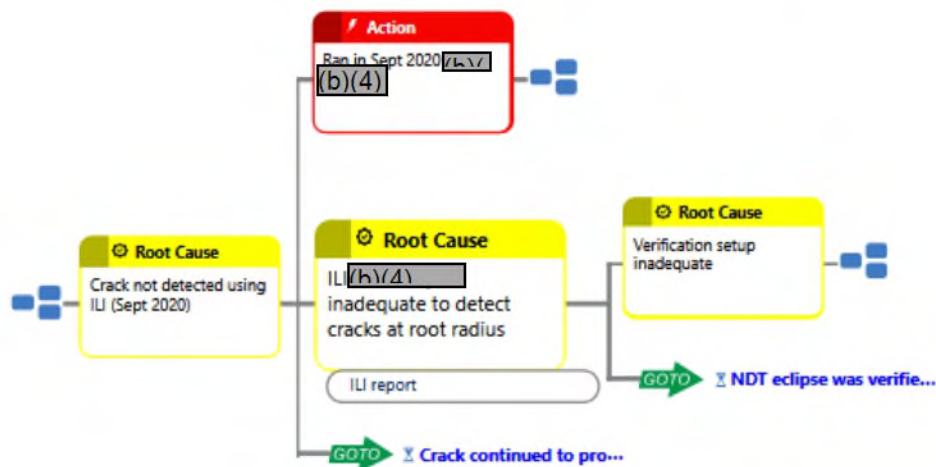
The causes for the ILI not detecting the cracks are shown in Figure 96. The (b)(4) was run in September 2020. The tool was inadequate for detecting cracks in the weld root radius due to weld peaking and a corresponding radial tilt of the crack. There was an extensive effort to verify the tool's efficacy; (b)(4) The inadequacy was possibly due to the weld geometry not being adequately modeled experimentally as a combination of the peaking angle and radial tilt of the flaws, and/or the fatigue cracks not being simulated adequately, as shown in Figure 97. These are terminated due to a lack of control.

Figure 96: Causes for Sept. 2020 ILI not detecting the cracks

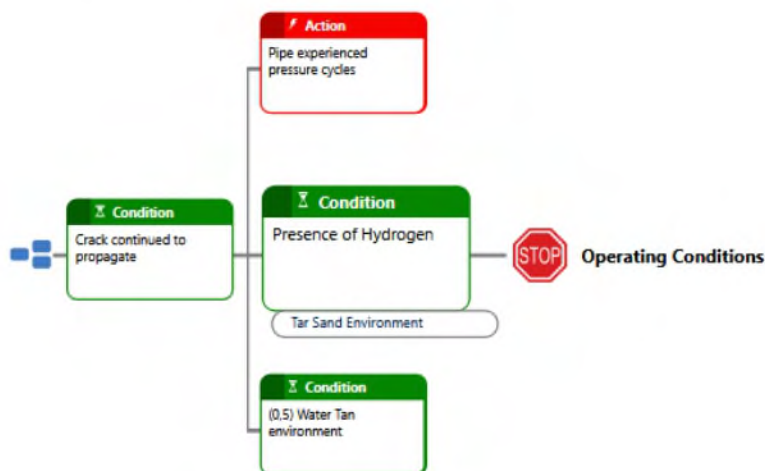
The cause for the crack continuing to propagate is summarized below in Figure 101. The pipe experiences pressure cycles during operations, and the number of cycles continues to decrease over time. Additionally, the presence of hydrogen was likely caused by a minor quantity of water and high TAN diluted bitumen commodities transported; the tar sands environment could have contributed to the formation of hydrogen.

Figure 101: Causes for crack propagation.

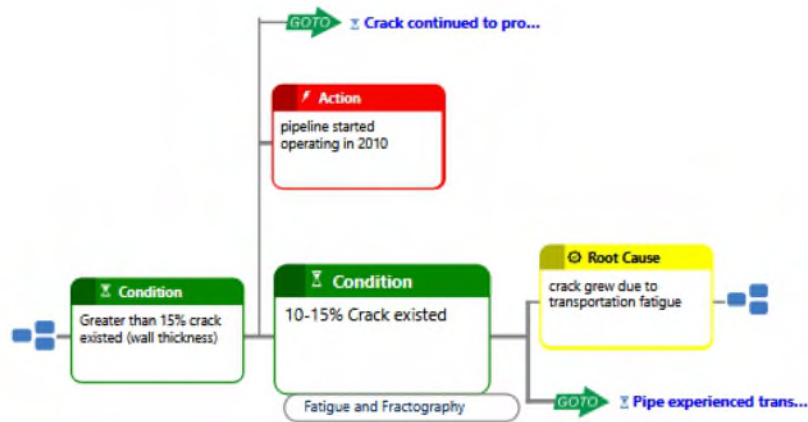
estimates that a crack of approximately 10-15% existed in 2010. This crack existed in 2010 due to transportation fatigue.

Figure 102: Causes for a crack greater than 15% in 2017

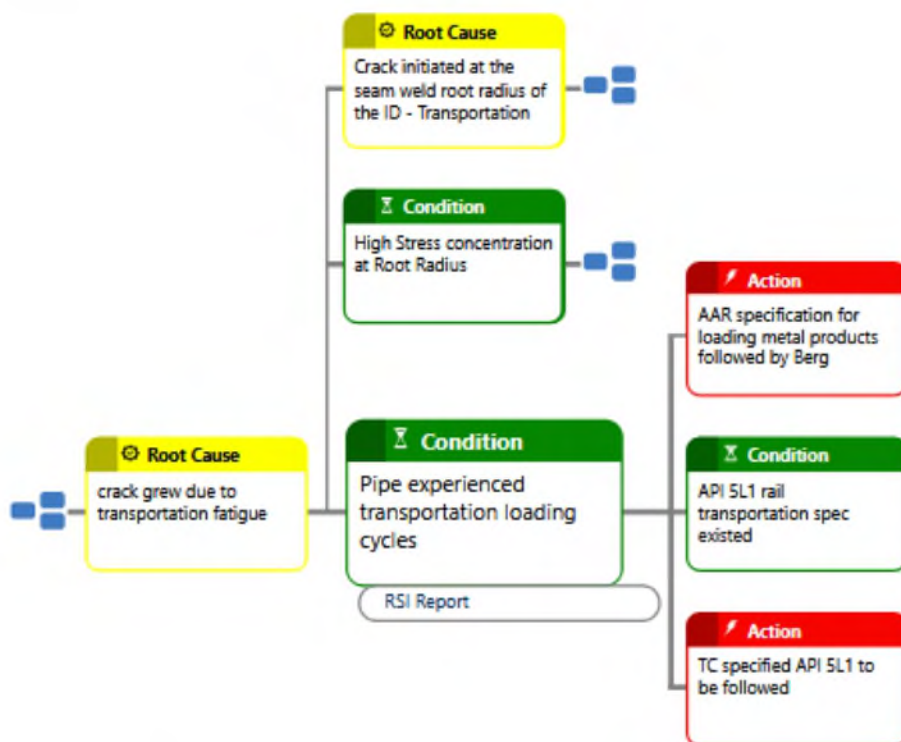
- Crack had to initiate at the weld root radius on the ID during transportation. The initiation was due to a combination of weld geometry and transportation loads. The data indicates that rail transportation was per guidelines, and the weld geometry was also consistent with API specification. However, the presence of the peaking and weld bead offset contributed to high SCF that resulted in crack initiation and growth during transportation.
- There is a high stress concentration at the root radius.
- The Pipe experienced transportation loading cycles. The causes for this include
  - Berg followed the AAR specification of loading pipe.
  - API 5L1 transportation specification existed and was specified by TC Energy. It is important to note that API 5L1 defers to AAR when there is a conflict in guidelines between the documents.

Figure 103: Causes for crack propagation during transportation

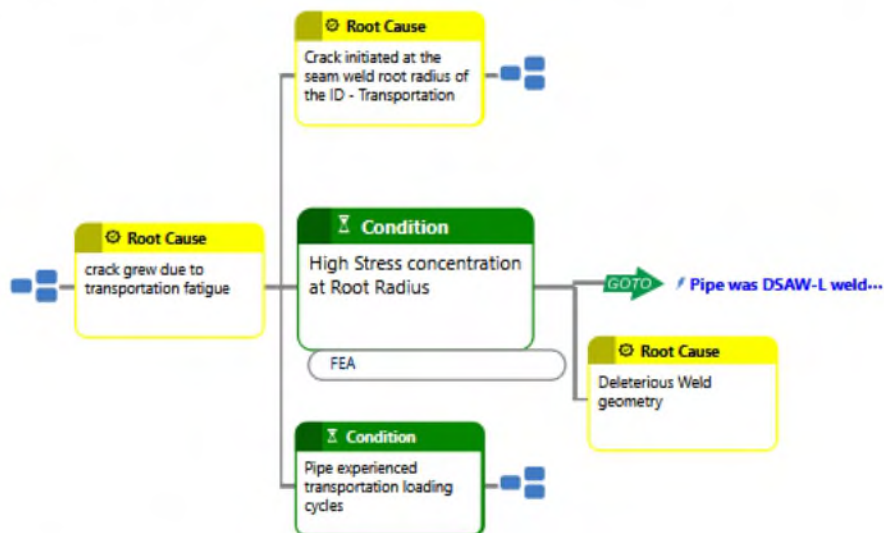
The cause of the high stress at the root radius is the weld geometry, specifically a combination of peaking weld geometry and an out-of-line weld, resulting in high SCF at the weld toe. The weld bead is a termination point due to a lack of control.

Figure 104: Cause for high stress concentration at the root radius
