## Failure Investigation Report

### South Bow Infrastructure Operations Inc.

### 1. Summary of the April 8, 2025, South Bow Failure

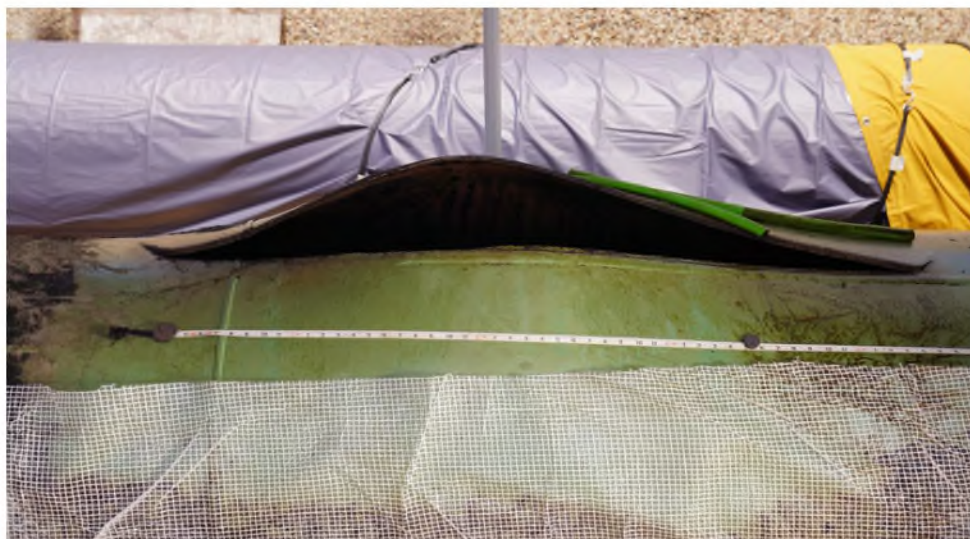
The feature of interest is shown in **Figure 3**, which shows a fish-mouth split that originated along the long seam of the pipe. The center portion of the fish-mouth split exhibits signs of fatigue measuring 11.9 inches, with a maximum measured depth of 0.302 inches where the crack penetrated 79.3% of the measured actual wall thickness.

**Figure 3.** Fish Mouth Feature, Photo from Anderson & Associated Report.

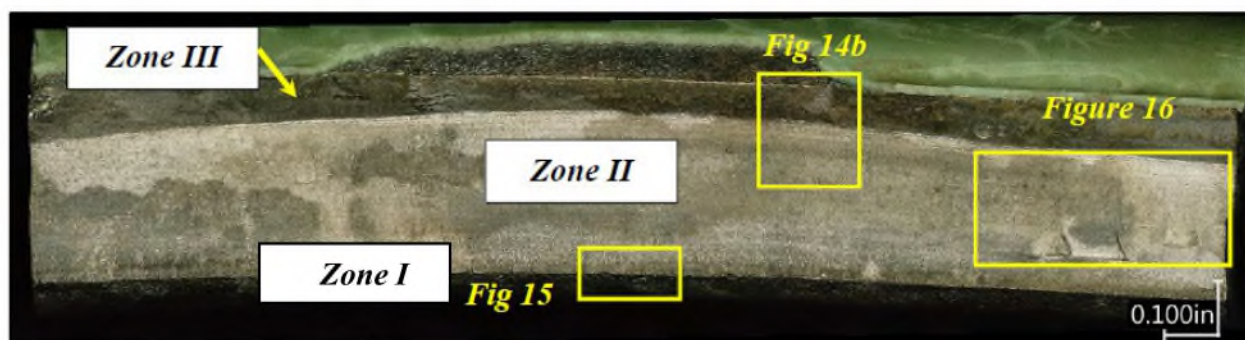
A close-up view of this area is shown in **Figure 4** and denotes three zones. Zone I indicates the transportation-related fatigue crack. Zone II shows the environmental fatigue-related crack progression. Zone III shows the shear overload region when the steel could no longer support the hoop stress caused by the pressure in the pipe. The green material in the figure is the FBE coating.

**Figure 4.** Low Magnification views Detailing Crack Features and Arrest Lines.  
Image from Anderson & Associated Report.

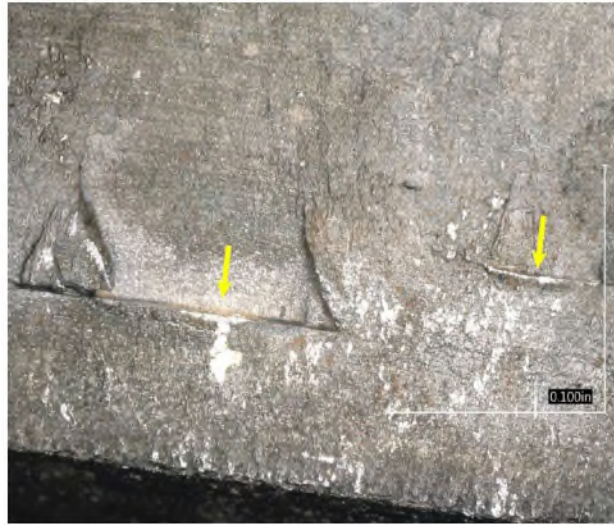
Further metallurgical analysis detected evidence of hydrogen due to secondary cracking perpendicular to the primary fracture surface. These secondary cracks are a sign of HIC and appeared across approximately 3% of the length of the primary fracture surface. These secondary cracks indicate the presence of hydrogen in the steel, which reduces toughness. These secondary cracks are located perpendicular to the primary fracture surface. They did not substantially contribute to the progress of the primary crack in Zone II. **Figure 5** shows these features.

**Figure 5.** Crack features identified on the fracture surface, consistent with HIC.

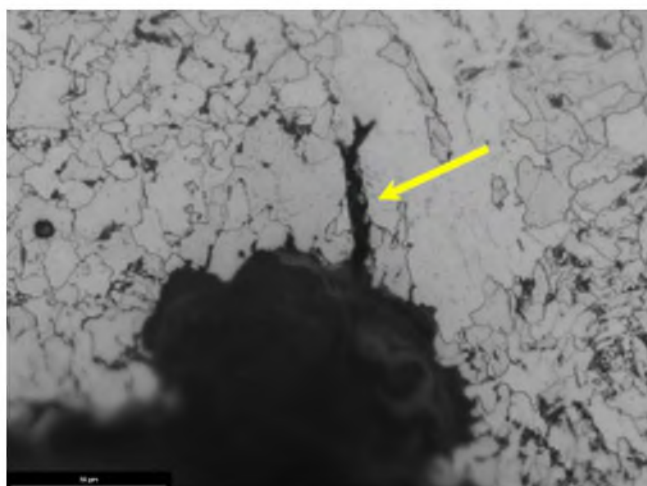
**Figure 6.** Corrosion micropitting at long seam weld toe from MP 171 Release (Image from 2025 Anderson & Associates report)

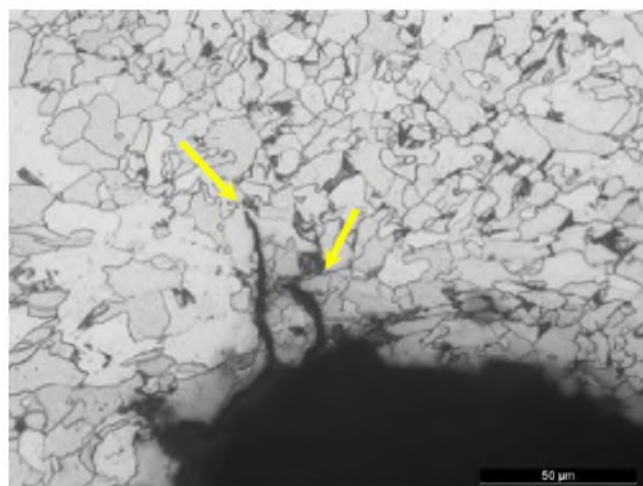
**Figure 7.** Corrosion micropitting at long seam weld toe from Edinburg Failure (Image from 2019 Anderson & Associates report)

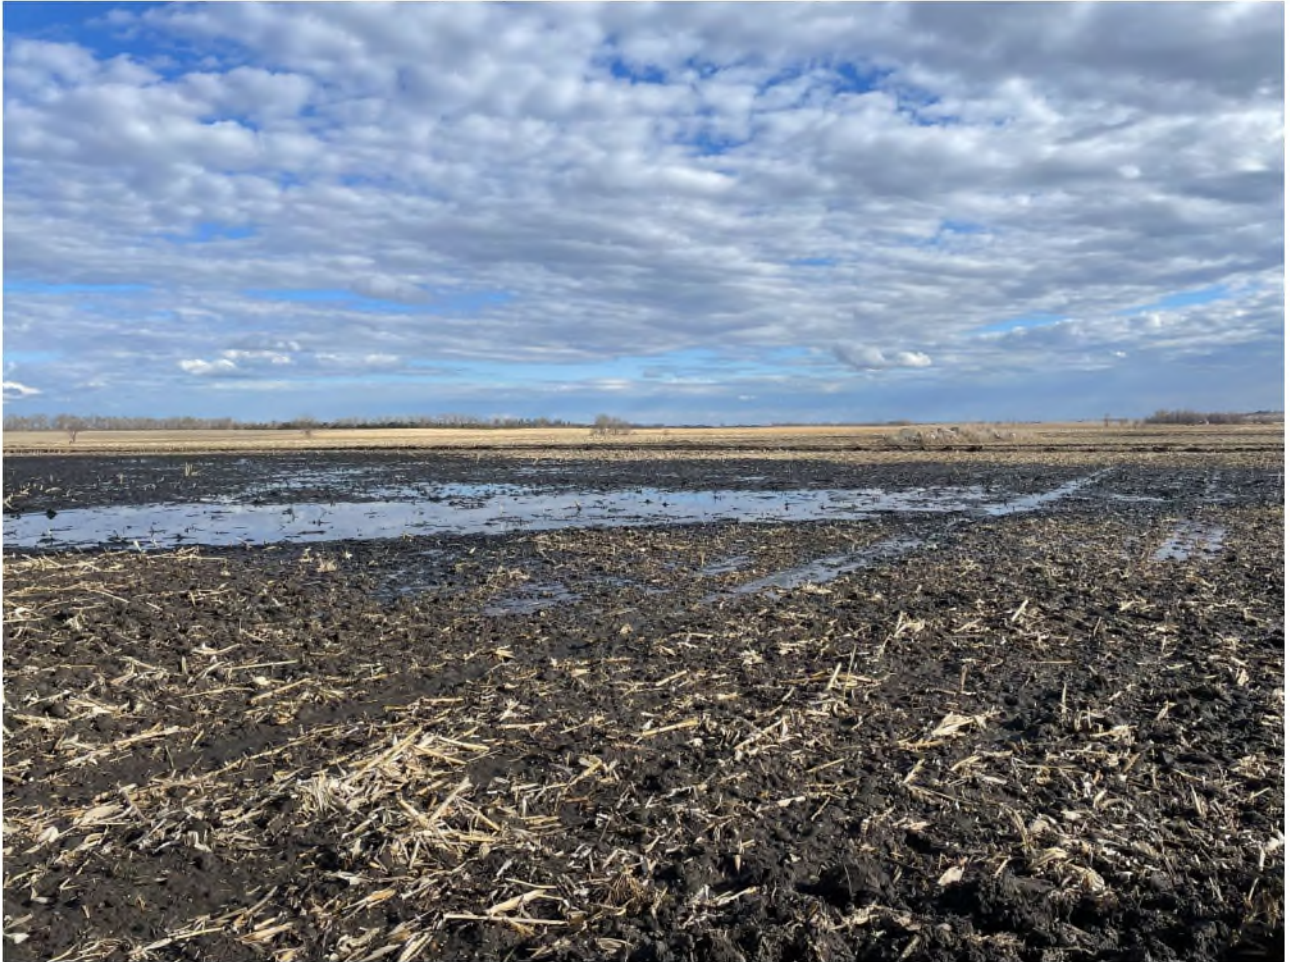
**Figure 14.** View of MP 171 failure site prior to cleanup. PHMSA AID Photo.

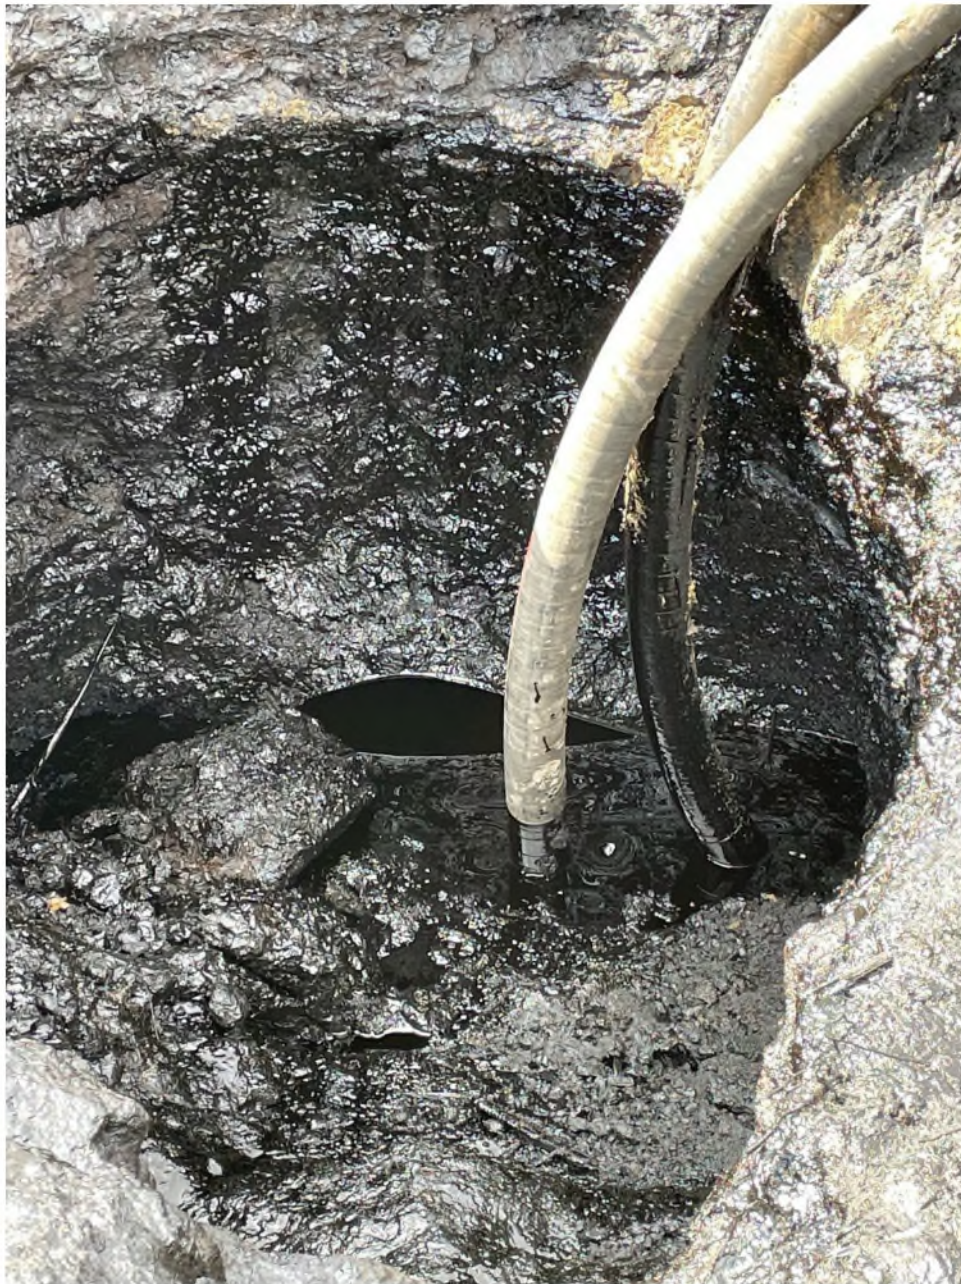
**Figure 15.** In Situ view of failure. PHMSA AID Photo.

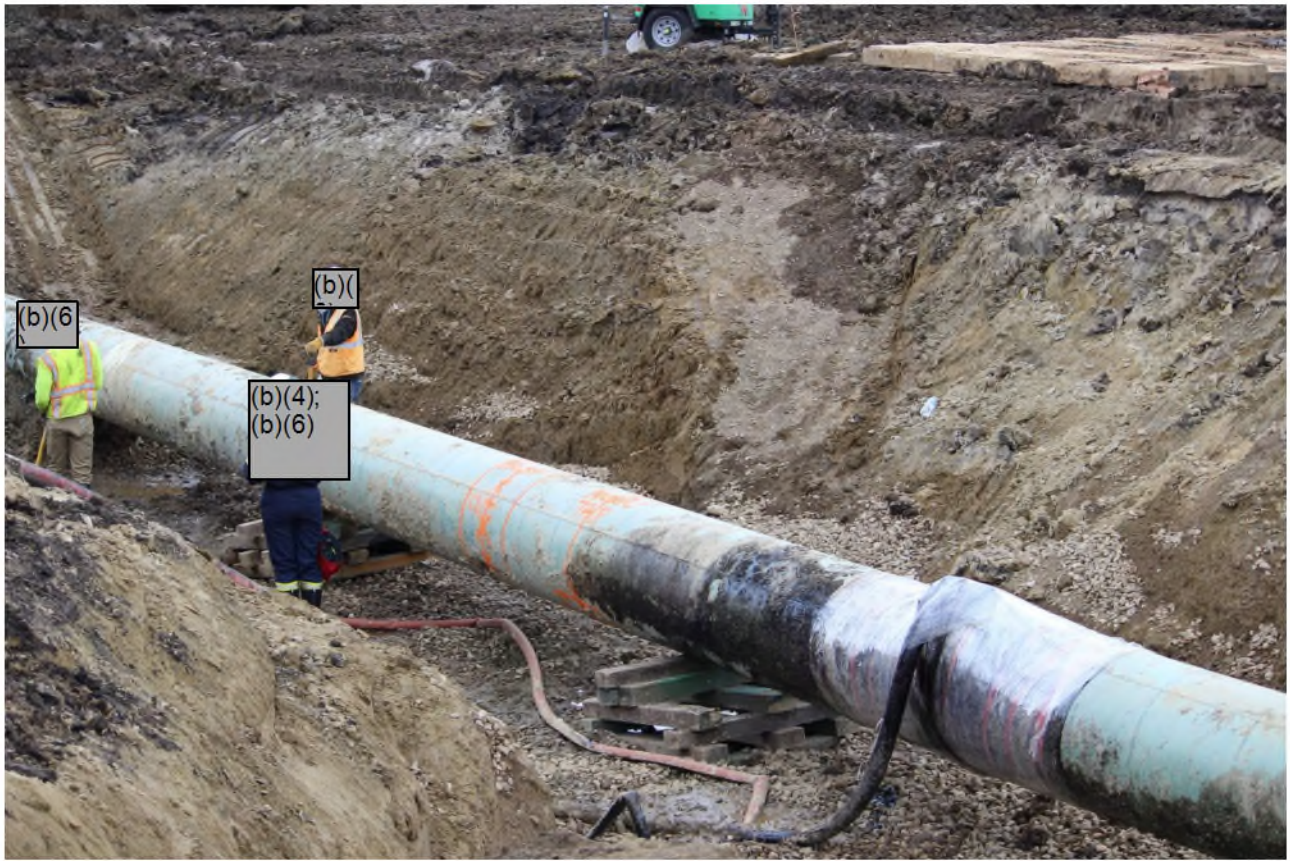
**Figure 16.** Fully excavated failure during the drain down operation. PHMSA AID Photo.

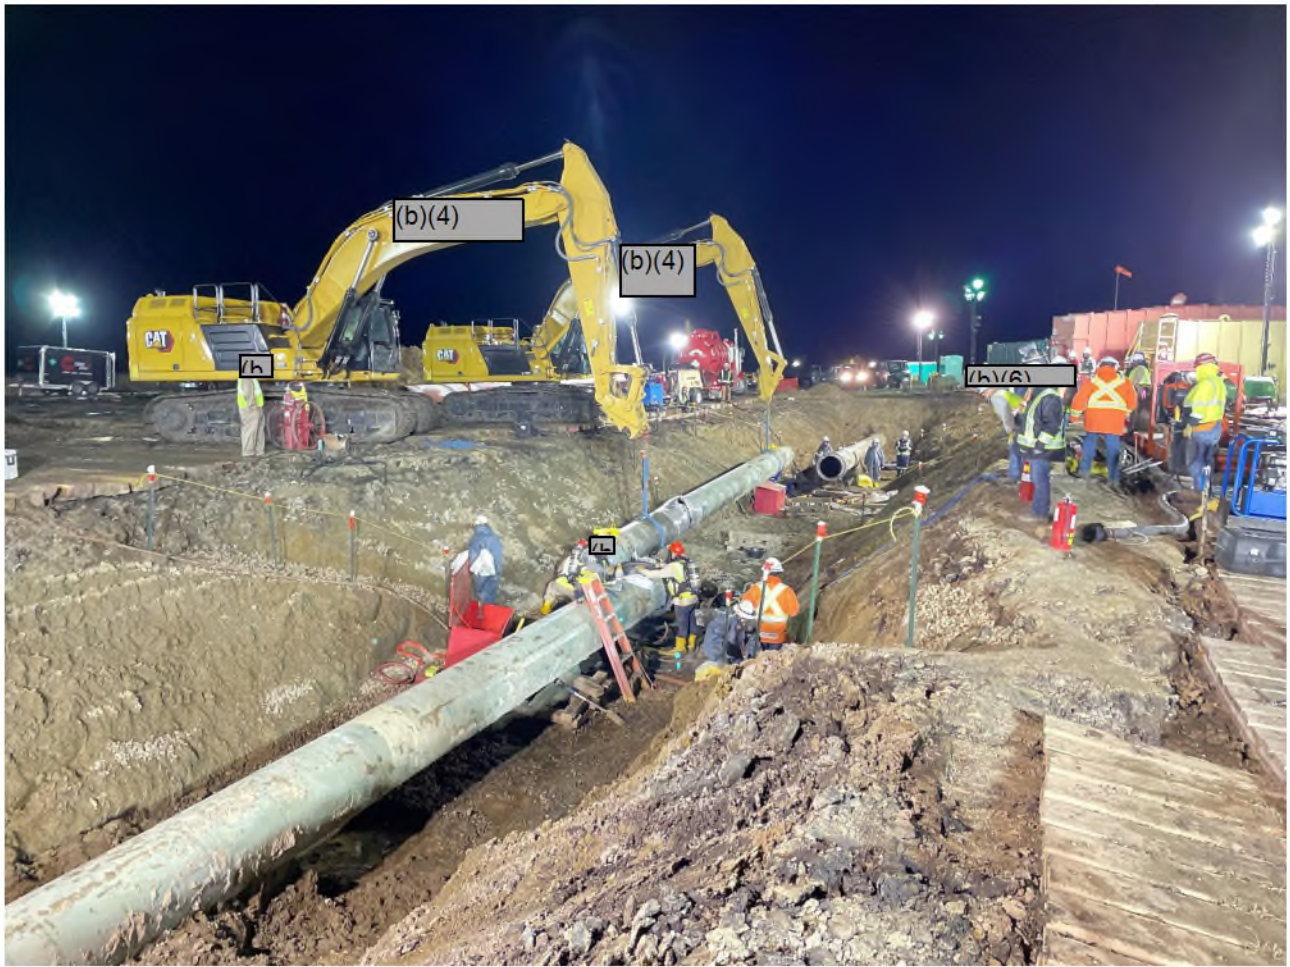
**Figure 17.** Cutout and removal of section of pipe with feature. PHMSA AID Photo.

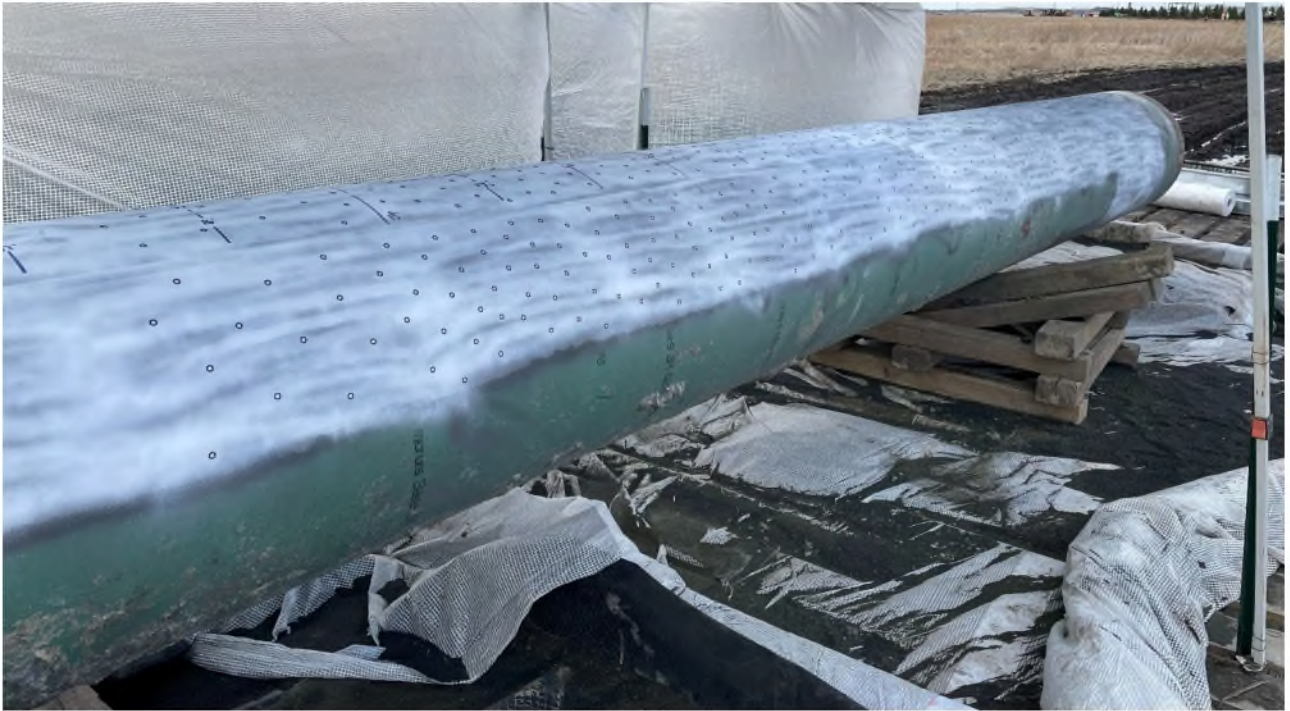
**Figure 18.** Segment with failure origin prepared for on-site non-destructive testing. PHMSA AID photo.

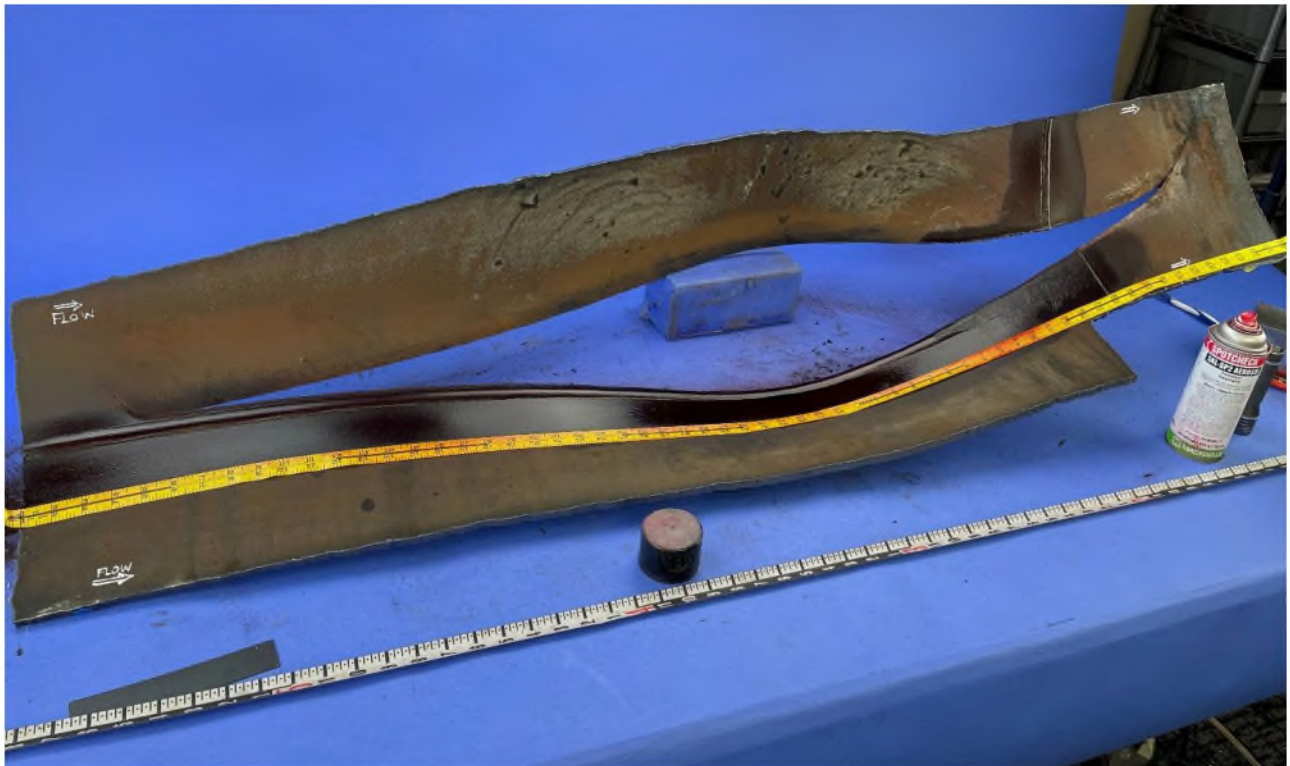
**Figure 19.** Failure origin feature cut-out for measurement and preparation for further lab analysis. PHMSA AID Photo.

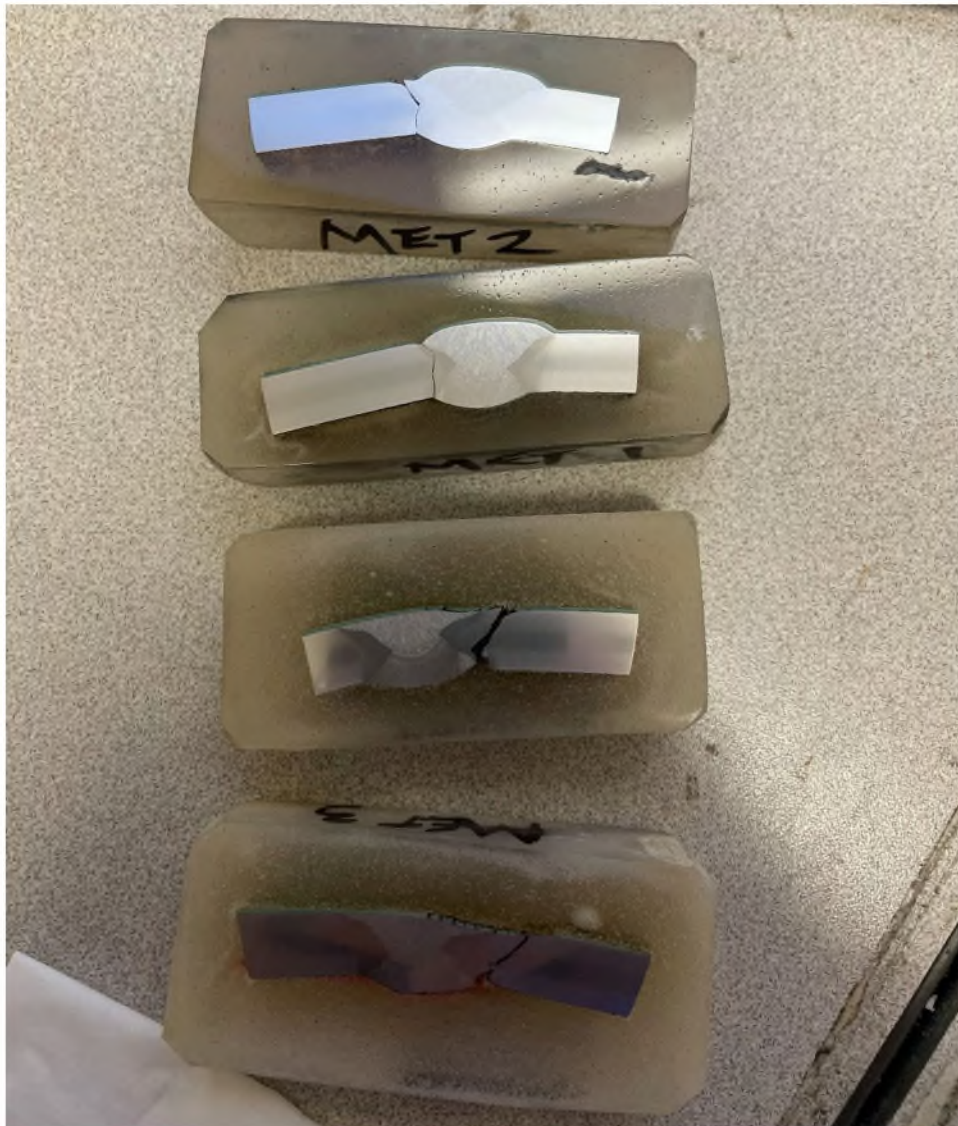
**Figure 20.** Cutout samples prepared by Anderson & Associates for further analysis. PHMSA AID Photo.
