**Principal Investigator** Gery Bauman/Bryan Louque  
**Senior Accident Investigator** Brian Pierzina/Karen Butler  
**Region Director** Ivan Huntoon/Allan Beshore  
**Date of Report** 07/01/2015  
**Subject** Failure Investigation Report—TE Products Pipeline Company, LLC (TEPPCO)—Incorrect Operations

**Date of Failure** April 13, 2010  
**Commodity Released** Transmix of Refined Products (Diesel and HVL Vapors)  
**City/County & State** Seymour/Jackson County, IN  
**OpID & Operator Name** 19237 TE Products Pipeline Company, LLC (TEPPCO)<sup>1</sup>  
**Unit # & Unit Name** 2703 Seymour  
**SMART Activity #** 129705  
**Milepost/Location** Seymour Terminal/P35 Pipeline  
**Type of Failure** Accidental Ignition, Incorrect Operations During Maintenance Activity  
**Fatalities** 0  
**Injuries** 1 (hospitalization), 3 (additional injuries<sup>2</sup>)  
**Description of area impacted** Seymour Terminal Facility, HCA (drinking water)  
**Total Costs** \$35,229

## **Failure Investigation Report—TE Products Pipeline Company, LLC—Incorrect Operation**

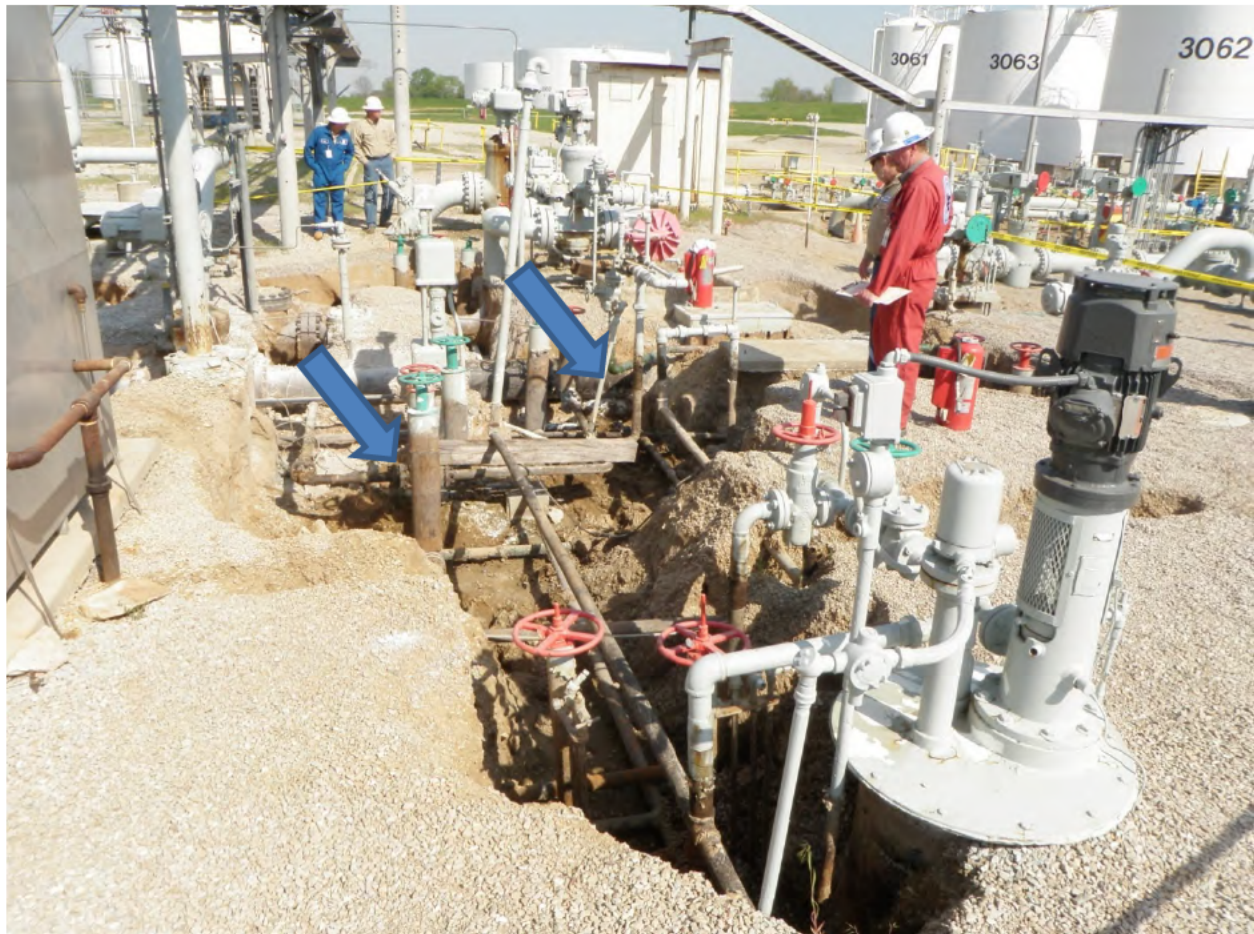
After returning from lunch, the EPCO team resumed work on the other side of the valve and the contract team started work on a valve located near the center of the bell hole. When the EPCO team began work on removing bolts on the upstream side of the valve the flange started to drain product. At the same time, product began to drain from a valve the contract team unbolted. A station operator, who was making rounds, was also present at the bell hole, and noticed vapors coming from the contract team's valve flange. Simultaneously, the EPCO team decided the flow from their flange was too much to be contained by the materials (adsorbent pads) and equipment (a bucket) used to capture product, and stopped the drain by tightening a flange bolt using an electric impact wrench that was not electrically rated for the location. Vapors and product were ignited by the electric impact wrench and a flash fire ensued. The EPCO employees suffered burns on their hands and faces, while the contract employees suffered singed hair during the fire but not burned skin.

An investigator from PHMSA's Central Region arrived at the Seymour Terminal on April 14, 2010. PHMSA conducted interviews, examined the accident site, photographed the accident location, reviewed procedures, and requested company records. EPCO completed a separate internal investigation of the accident. The pipeline moved diesel fuel prior to being taken out of service, and an attempt had been made to drain the sump system and pump the sump dry. Product remained in the sump system, however, as evidenced by product draining into the area when workers cracked the flanges. The results of the internal company investigation revealed that the employees were burned when hazardous vapors and product, which had accumulated in the bell hole, were ignited by the use of an electric impact wrench that was not intrinsically safe.

Photo 2 – Photo shows the sump system. Arrows point to the locations of valves which were being worked on at the time of the flash fire. Photo taken by PHMSA.
