Principal Investigator Roger Sneegas/Iowa Utilities Board (Interstate Agent)/Karen Butler
Region Director David Barrett/Allan Beshore
Date of Report 7/10/2015
Subject Failure Investigation Report—Northern Natural Gas Co.—Other Outside Force Damage

Failure Investigation Report—Northern Natural Gas Co.—Other Outside Force Damage

NNG Hawkeye Ethanol Town Border Station

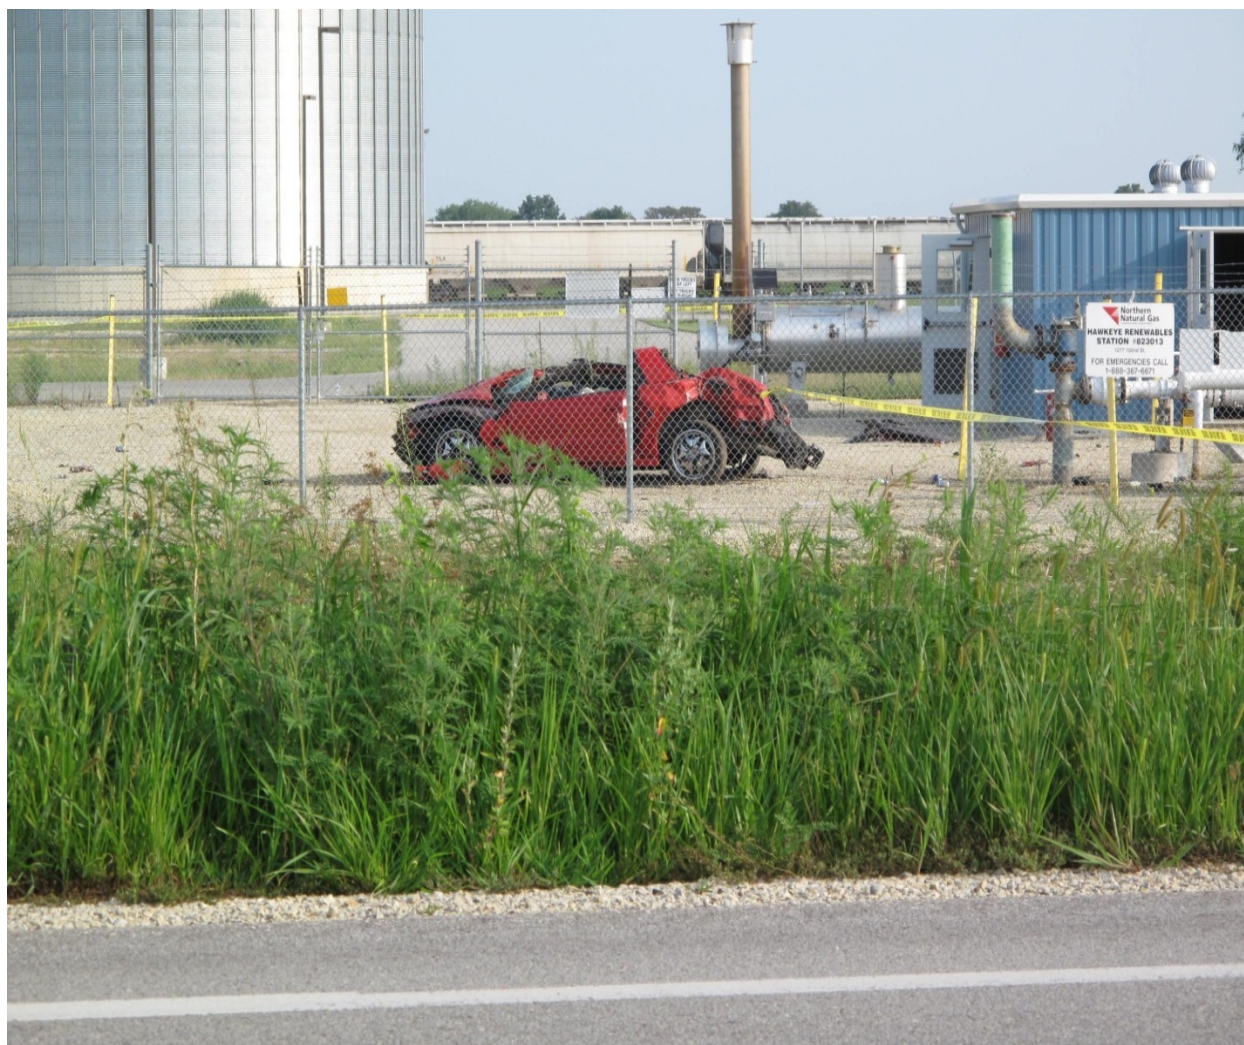
A .25-inch diameter pipe fitting located between the station inlet filter and the filter inlet gauge was cracked, resulting in a release of natural gas. The above-ground 6-inch diameter in-line inspection tool receiver inlet and the 4-inch diameter station inlet valves were also damaged and replaced, along with several fittings and minimal short pieces of pipe to allow for the valve replacements. The Hawkeye/Menlo town border station was operating at 740 psig at the time of the impact, and the Hawkeye/Menlo Branch Line had to be isolated from the facility as a result of the damage. A blowdown of more than 7 miles of pipeline was required, resulting in a total loss of 727 Mcf. NNG inspected the remaining facilities for leaks after the station piping was repaired, and the pipeline was returned to service in the evening on the same day.

(Outside Source Photo, Picture Taken Looking North, Vehicle Cleared Fencing)

After the field investigation was complete, replacement pipe, valves, and fittings were installed in the area where the damage occurred. The pipeline was purged, packed, and returned to service on August 6, 2010, at 4:40 p.m.
