DOT	US Department of Transportation
PHMSA	Pipeline and Hazardous Materials Safety Administration
OPS	Office of Pipeline Safety
	Central Region

Principal Investigator	Dan Munthe (MNOPS)
PHMSA Investigators	Bryan Louque/Karen Butler
Region Director	David Barrett/Allan Beshore
Date of Report	05/30/2015
Subject	Failure Investigation Report—Enbridge Energy, Limited Partnership— Line 1 Leak, Equipment Failure

Failure Investigation Report – Enbridge Energy, Limited Partnership – Leak, Equipment Failure

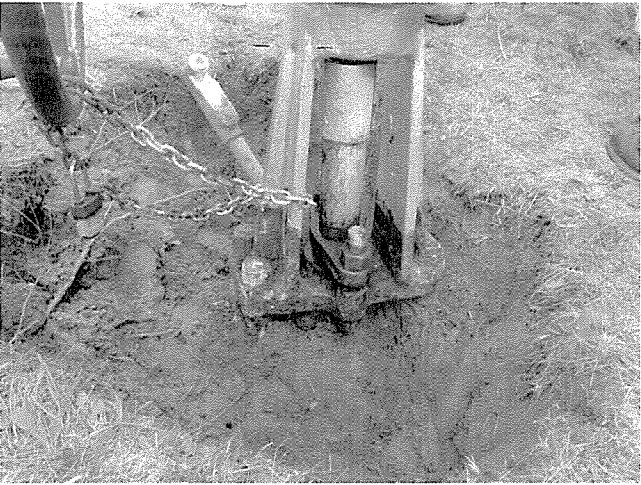
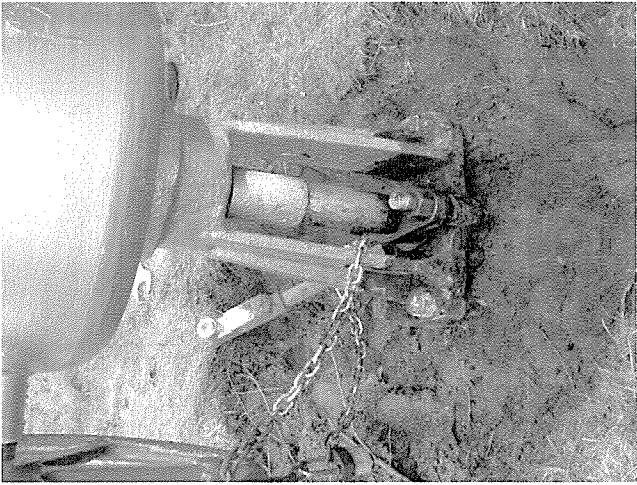
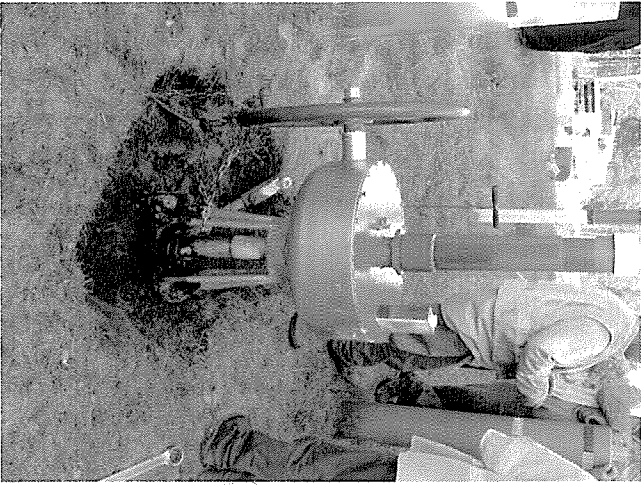
100728 1700 – Valve Stem	100728 1700 – Valve Stem

The Enbridge Line 1 leak at MP 958.33 was caused by equipment failure that allowed crude oil to leak through a worn valve stem packing on a gate valve located at the mainline valve setting. The gate valve was originally installed in 1951. The valve stem packing was replaced on site and the pipeline was returned to service the same day.

On 7/28/10 in the AM, an Enbridge Energy painting crew discovered a leaking substance from a Kerotest 600 gate valve stem on Line #1 (18") which was located on the NW corner of Hwy 2 and Pike Bay Loop NW road in the Unorganized township of Cass Lake which is just east of the City of Cass Lake at MP958.33, Cass County. Though reported to the NRC (#949152 at 11:37) by Enbridge as an estimated 5 barrel spill, actual leakage was minimal. The contaminated soil was hand excavated and removed. The ~1950s vintage valve stem was repacked, observed for leakage, and returned to service.

Enbridge personnel were able to repack the valve stem on site without removing the valve from the pipeline. The repair required the packing seal retainer to be tightened. In addition to making the repairs, monitoring wells were installed.
