Principal Investigator Joe Elmer
Senior Accident Investigator Karen Butler
Region Director Linda Daugherty/ Allan Beshore
Date of Report 05/26/2015
Subject Failure Investigation Report – Enterprise Products Operating, LLC –
Material Failure

Failure Investigation Report – Enterprise Products Operating LLC – Material Failure

Failure Date 08/12/2013

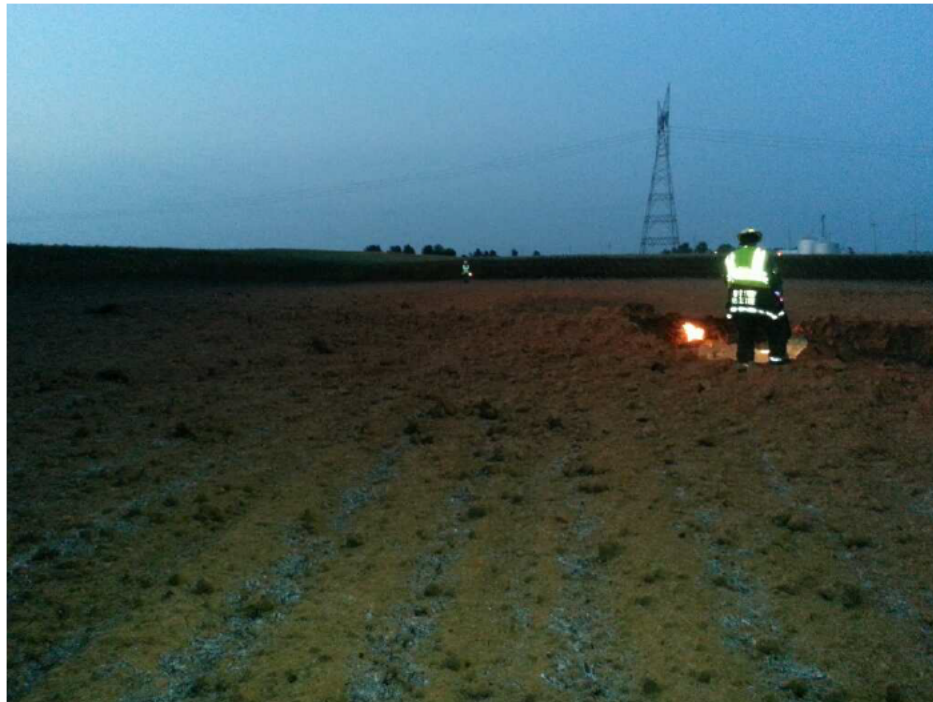
View of Accident Site Looking South
(Photograph Taken by Enterprise Products Operating, LLC)

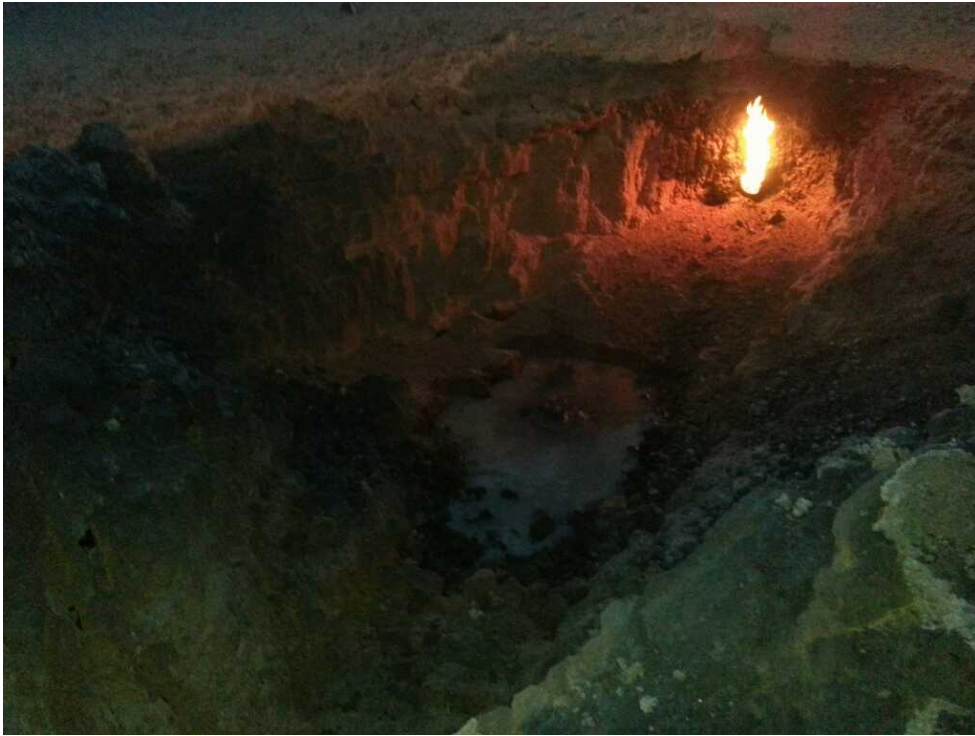
View Rupture Area Looking Southeast
(Photograph Taken by Enterprise Products Operating, LLC)

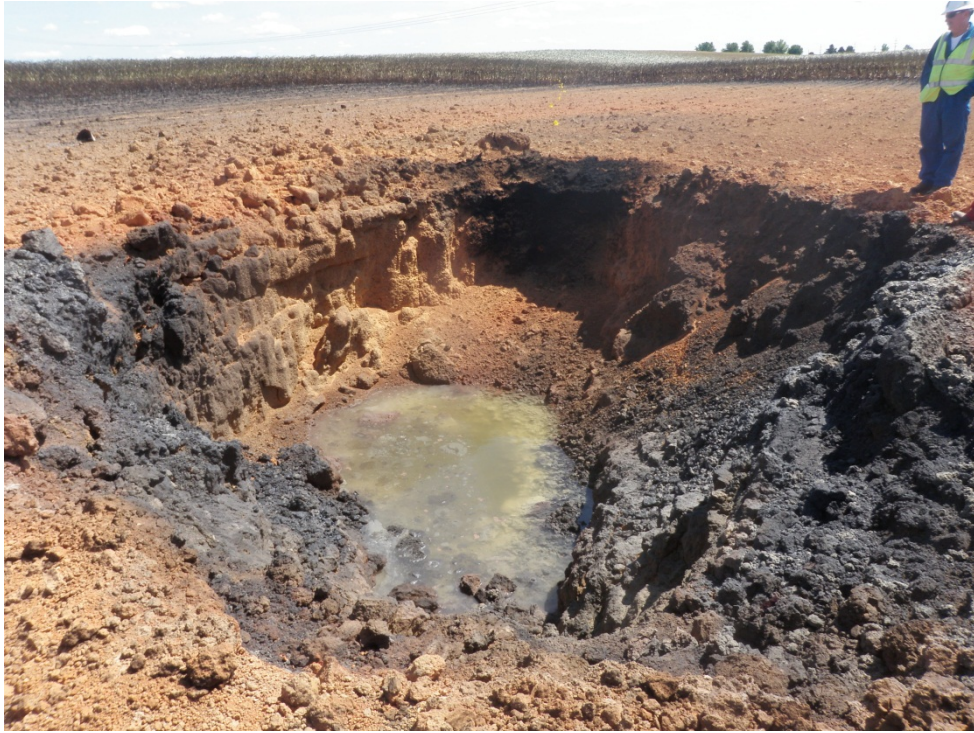
View of Rupture Area Looking Southeast

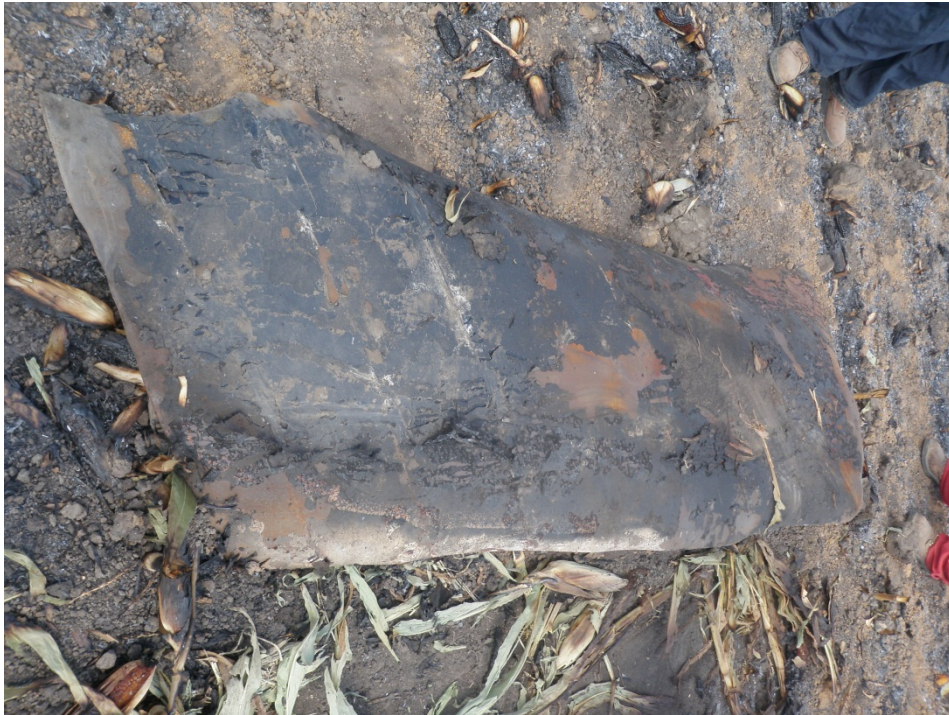
The fracture propagated both upstream and downstream from the origin of the failure. Metallurgical analysis determined that the pipe failure was caused by a defect that formed in the longitudinal ERW (HF) pipe seam. The defect was a combination of two flaws: an external surface breaking hook crack and a crack that formed at the base of the hook crack and that grew to a critical size over time. Significant corrosion by-products were also found present during the failure metallurgical analysis. Three failure mechanisms were present and possible: 1) Environmental cracking such as SCC, 2) Pressure-cycle induced fatigue crack growth, and 3) Corrosion-fatigue.

The Kiefner metallurgical examination determined that the cause of the failure was an original manufacturing defect that grew in service until it reached critical size and failed at the operating pressure. The original manufacturing defect was an external surface-breaking hook crack that measured approximately 4.4 inches long and had a maximum depth of .062 inches, approximately 30 percent of actual pipe wall thickness. A secondary defect formed at the base of the hook crack and grew over time while the pipeline was in service. The overall length of the defect at the time of failure was 4.4 inches, and the maximum depth of the combined defects was 0.161 inches, approximately 78 percent of actual pipe wall thickness. Fractographic and metallographic examinations of the fracture surface were completed. Thermal damage of the fracture surface prevented detailed microscopic examination of the fracture surface, which could have helped to identify the actual growth mechanism of the secondary defect. Metallurgical characteristics of the fracture surface were consistent with environmental cracking (SCC) and with pressure-cycle induced fatigue, but were insufficient to conclusively identify the exact growth mechanism. Corrosion-fatigue could also not be eliminated.

Exterior View of Piece # 2 (Containing Failure Origin)

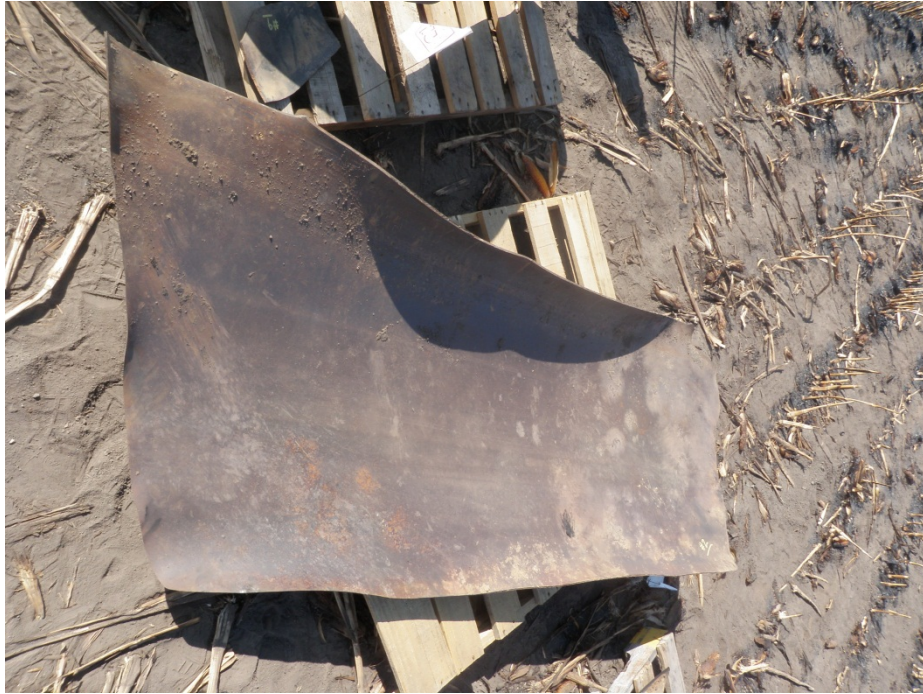
Interior View of Piece # 2 (Containing Failure Origin)

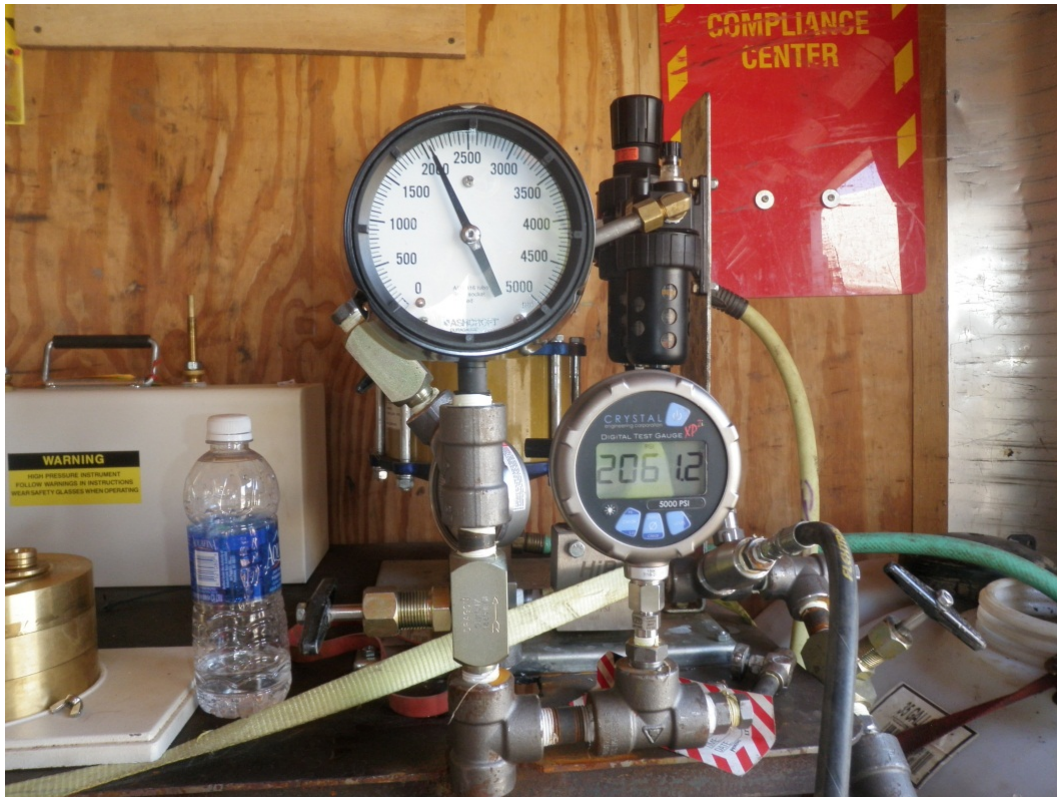
View of Pressure Gauge During Hydrostatic Test of Replacement Pipe

The replacement pipe segment was located above ground adjacent to the excavation. It was filled with water and placed on hydrostatic at 2:45 p.m. on August 16, 2013. The replacement pipe segment was tested to a pressure of 2,000 psig, which is equivalent to 110 percent SMYS. The test was complete at 7:28 p.m. on August 16. After the test was complete, the segment was dewatered, the end caps were cut off, and the segment was cut into two segments to facilitate installation in the ditch.

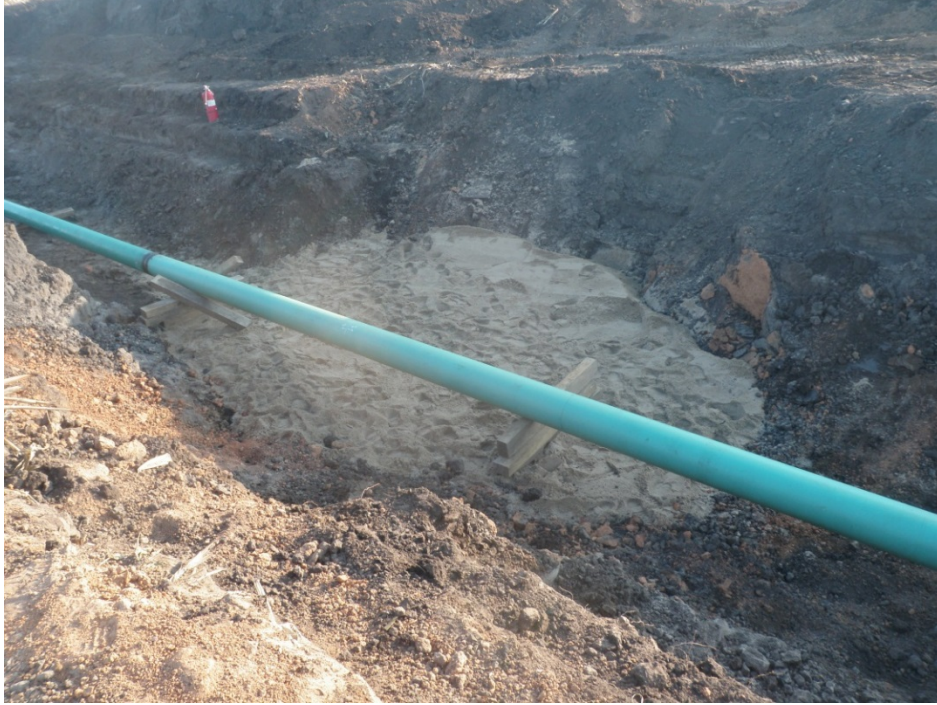
View of Crater with Replacement Pipe

The replacement pipe segments were placed in the ditch and aligned with the ends of the existing pipeline. The three welds were completed early in the morning of August 17. The welds were radiographed and met the requirements of API 1104.

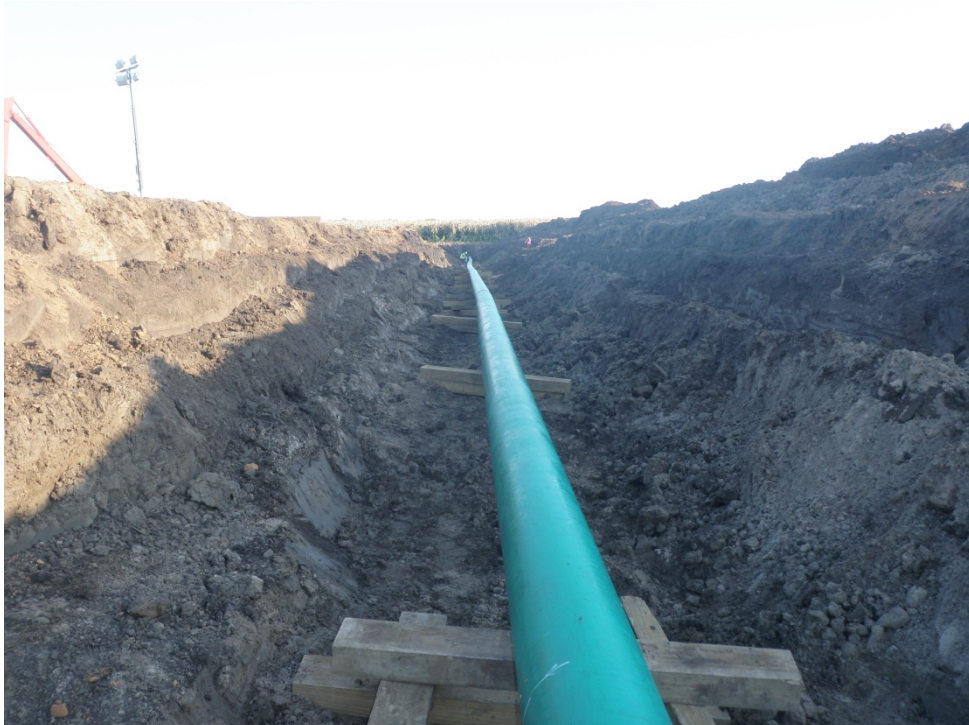
View of Repaired Pipe Looking Northwest
