Principal Investigator Patrick Raichel – NYSDPS (Buffalo)
Kristi Fogle – NYSDPS (Buffalo)
Senior Accident Investigator Michael Yazemboski
Region Director Byron E. Coy
Date of Report 7/27/2015
Subject Failure Investigation Report – Buckeye Partners CD803RC Pipeline Leak

Failure Investigation Report – Buckeye Partners CD803RC Pipeline Leak

144745 Appendix A - Maps and Photos and Leak Location

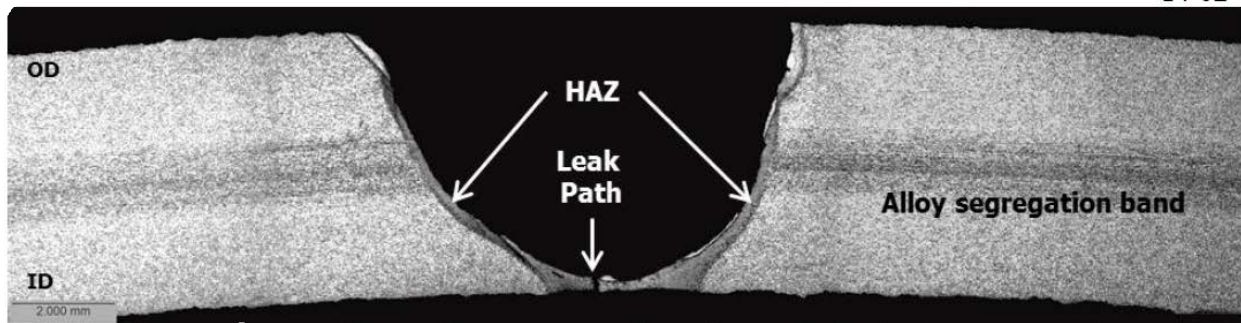
7. The cut out section and a portion of the casing were sent to Kiefner & Associates, Inc. (Kiefner) for examination. Metallurgical analysis of the anomaly showed a pronounced heat affected zone along the surfaces of the hole, along with melted and re-solidified metal. The pit had a smooth surface appearance and no evidence of corrosion or corrosion product. These taken together are significant evidence of an electrical discharge being the cause of the metal loss.

Metallographic section taken through the leaking anomaly
