DOT US Department of Transportation
PHMSA Pipelines and Hazardous Materials Safety Administration
OPS Office of Pipeline Safety
Western Region

Principal Investigator Peter Katchmar
Regional Director Chris Hoidal
Date of Report 8/04/2011
Subject Failure Investigation Report – Bridger Lake LLC Crude Oil Release

Failure Investigation Report – Bridger Lake LLC Crude Oil Release
4/2/2010

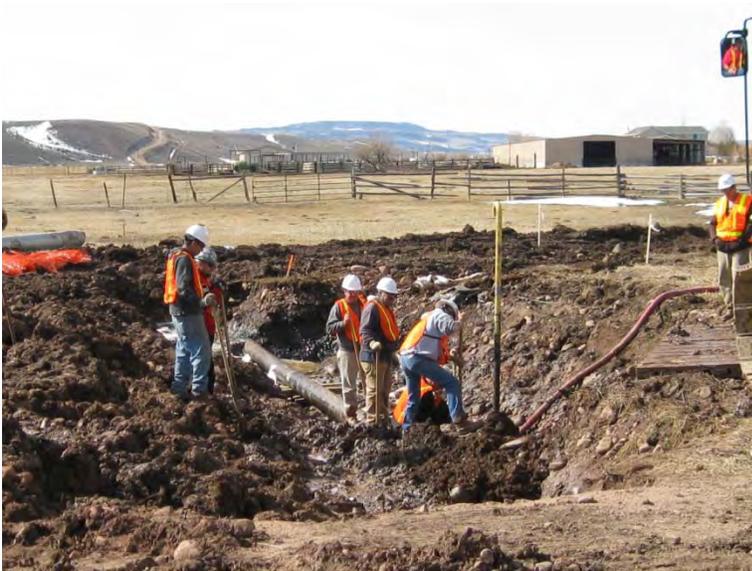
Release location before repairs.

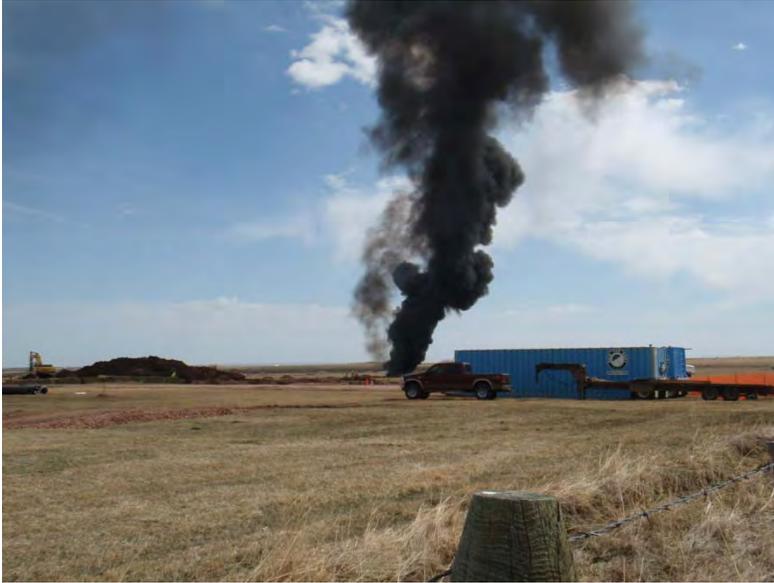
Bridger Lake remediation site allowed burn off of product.

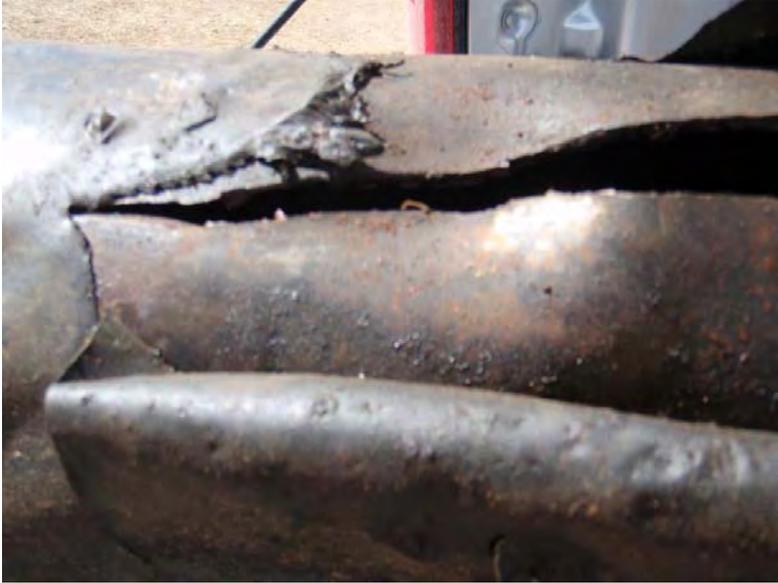
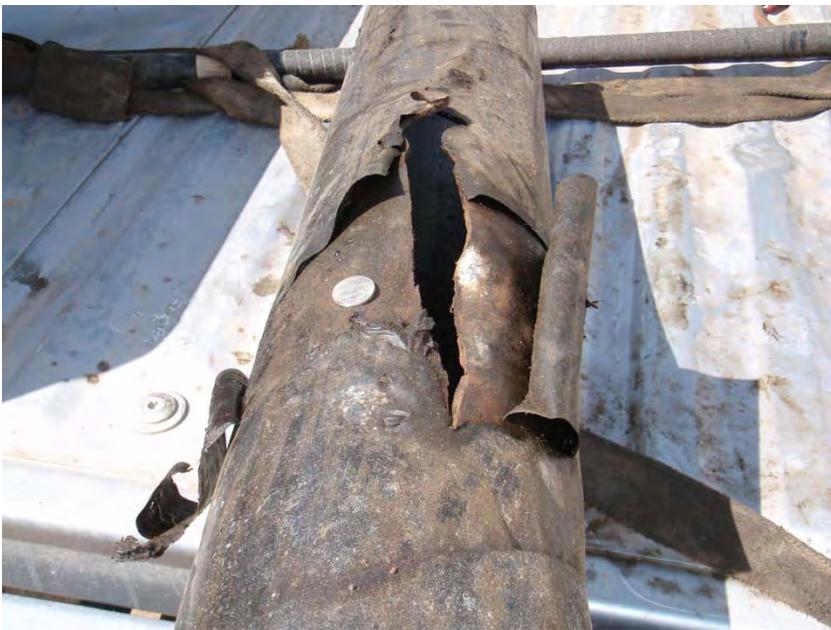
PHMSA's investigation revealed that the pipeline failed due to the line being over pressured by pumping against a closed valve. After the failure, approximately 1,473 barrels of crude was pumped into the pipeline over the weekend by the production company who is the only shipper who uses this pipeline. Also, the line fill from the top of the mountain to the release site is $204 \text{ BPM} * 13.5 \text{ miles} = 2754 \text{ BBLs} + 1473 \text{ BBLs} = 4227 \text{ BBLs}$ estimated total released volume.

PHMSA finds that the root cause of this failure was that there was no mechanical over-pressure protection provided to protect the 6-inch transmission pipeline.

Bridger Lake failed pipe.

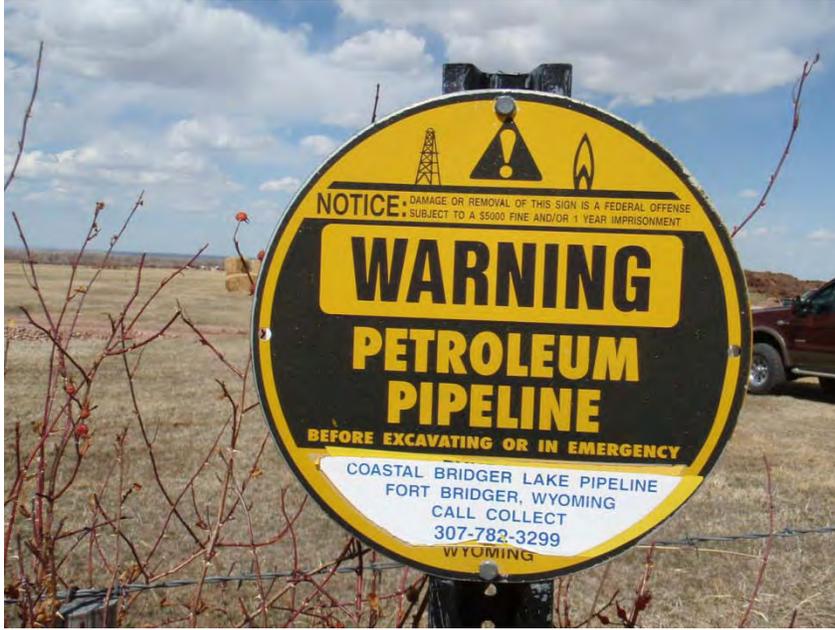
Bridger Lake Crude Line Marker not updated since Coastal Owned and Operated the line.

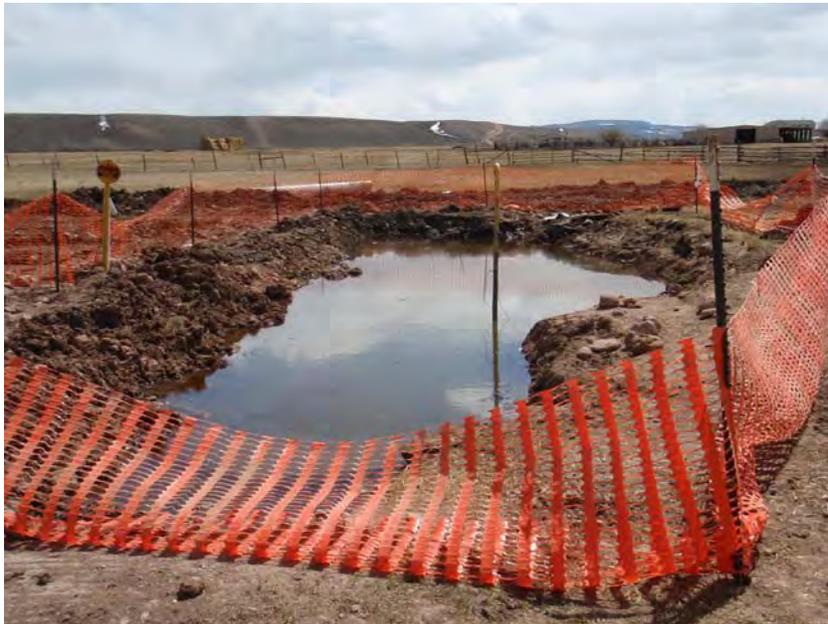
The Release site.

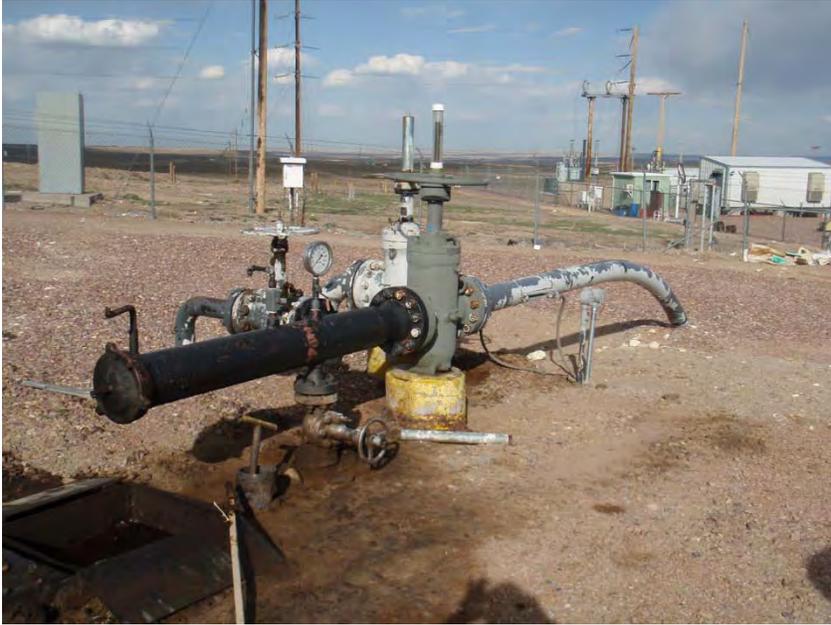
The end of line scraper receiver and associated valving.
