Failure Investigation Report – Columbia Gas Transmission Rupture – Activity ID 122980

Principal Investigator Dave McMillan, PHMSA ER
Regional Director Byron Coy
Date of Report 2/18/2011
Subject Failure Investigation Report – Columbia Gas
Transmission Pipeline Rupture

On November 5, 2008, at approximately 2:10 p.m., Columbia Line 1278 failed near Milford, PA, during an uprating procedure to increase the pressure in the line from a reduced 800 psig operating pressure back to the original 1000 psig MAOP of the pipeline. Columbia had recently been given authorization by PHMSA to increase the pressure in the pipeline back to the original MAOP after demonstrating that the integrity of the pipeline was adequate. The pipeline failure resulted in a rupture that involved three lengths of pipe in a wetland area. The failure occurred in the northern portion of the pipeline between Weber Road, Pike County, PA and Millrift, PA, 46 miles from the upstream compressor station at Easton, PA.

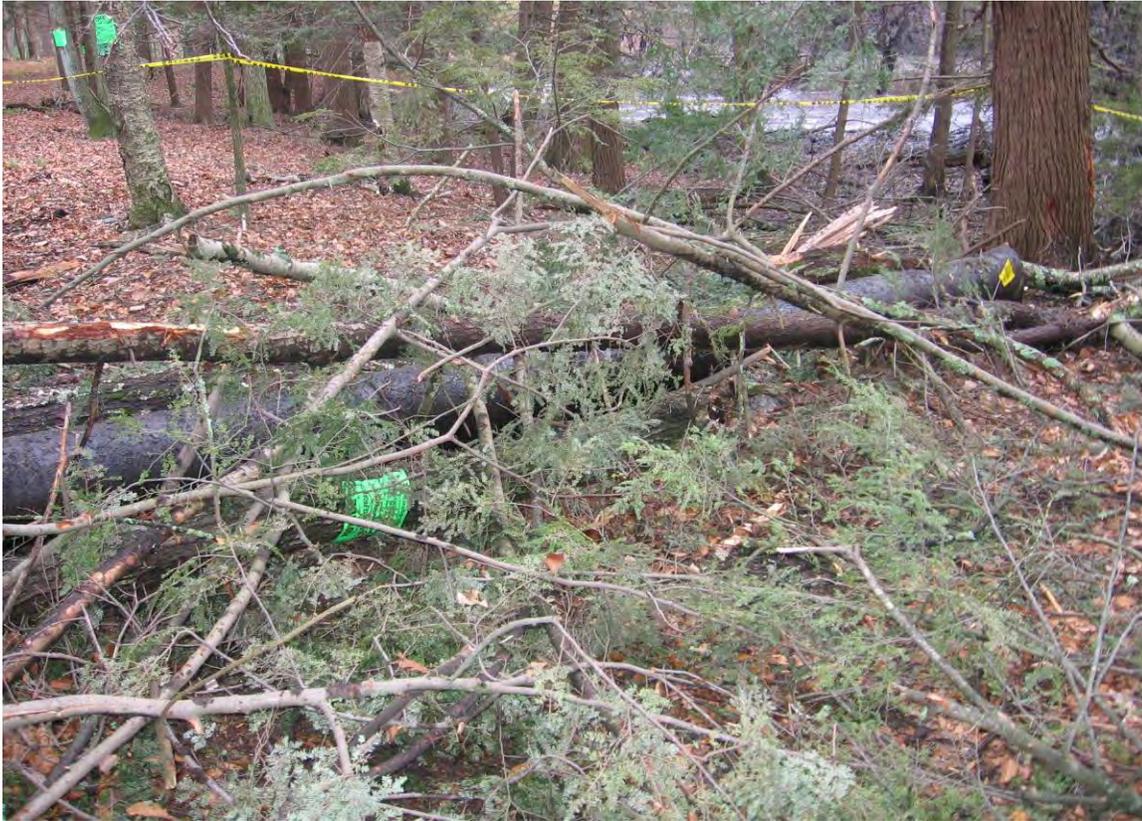
Figure 1: Severed 14.9 foot section of pipeline

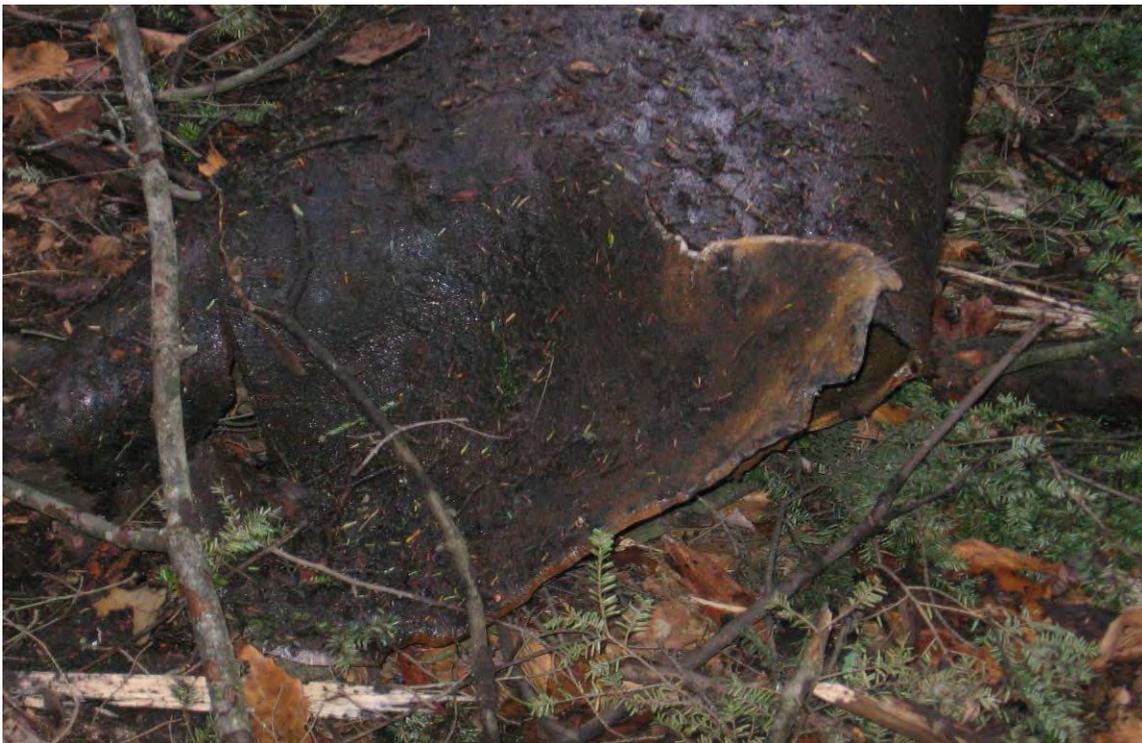
Figure 2: Severed 37.1 foot section of pipeline

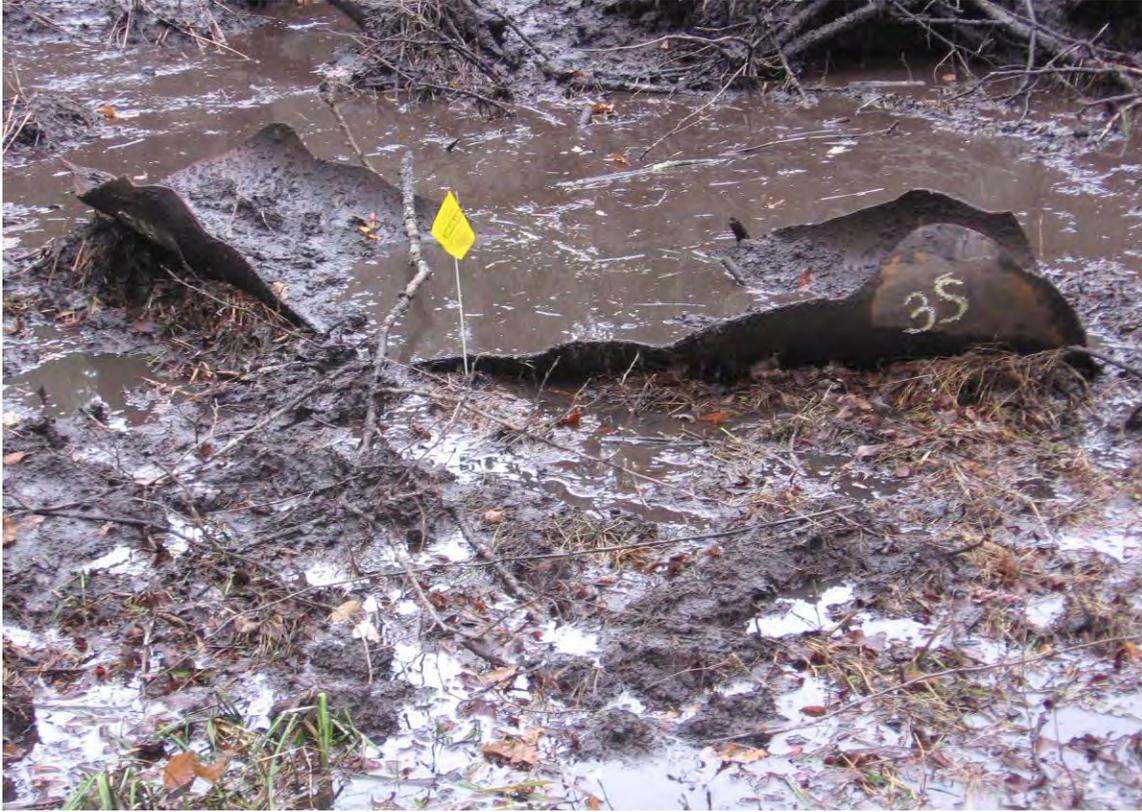
Figure 3: Severed 9 foot section of pipeline

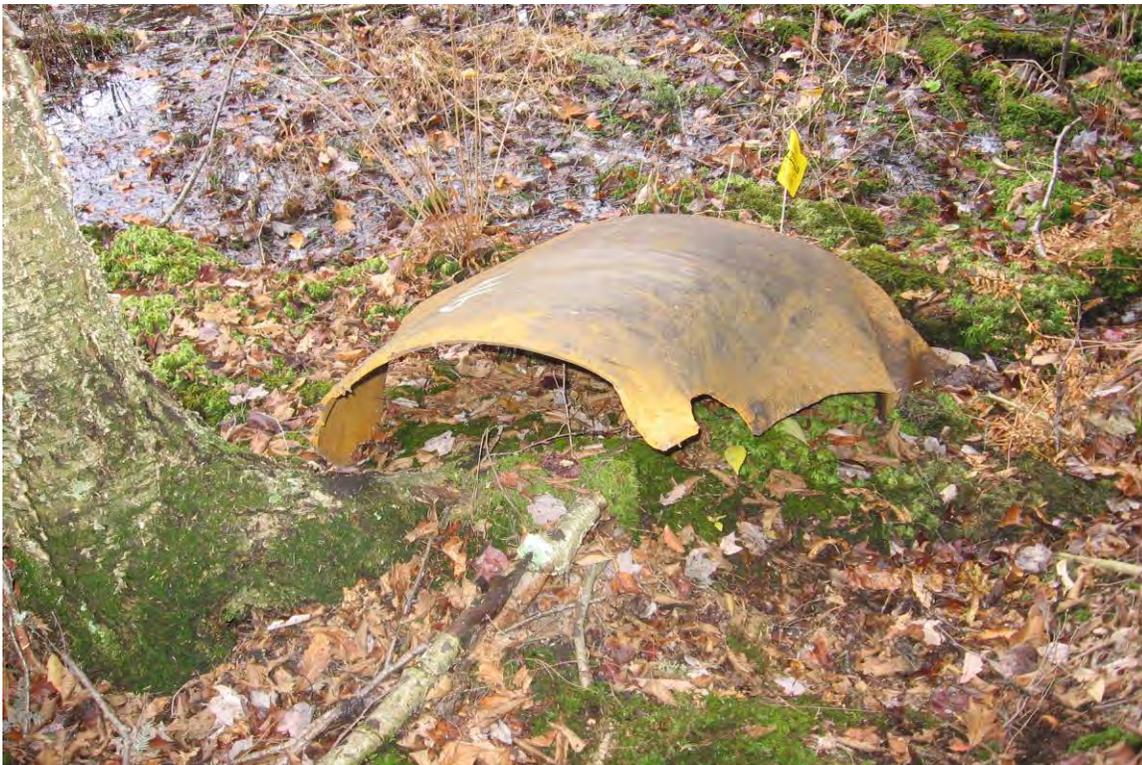
Figure 4: Severed 4.7 foot section of pipeline, piece 4

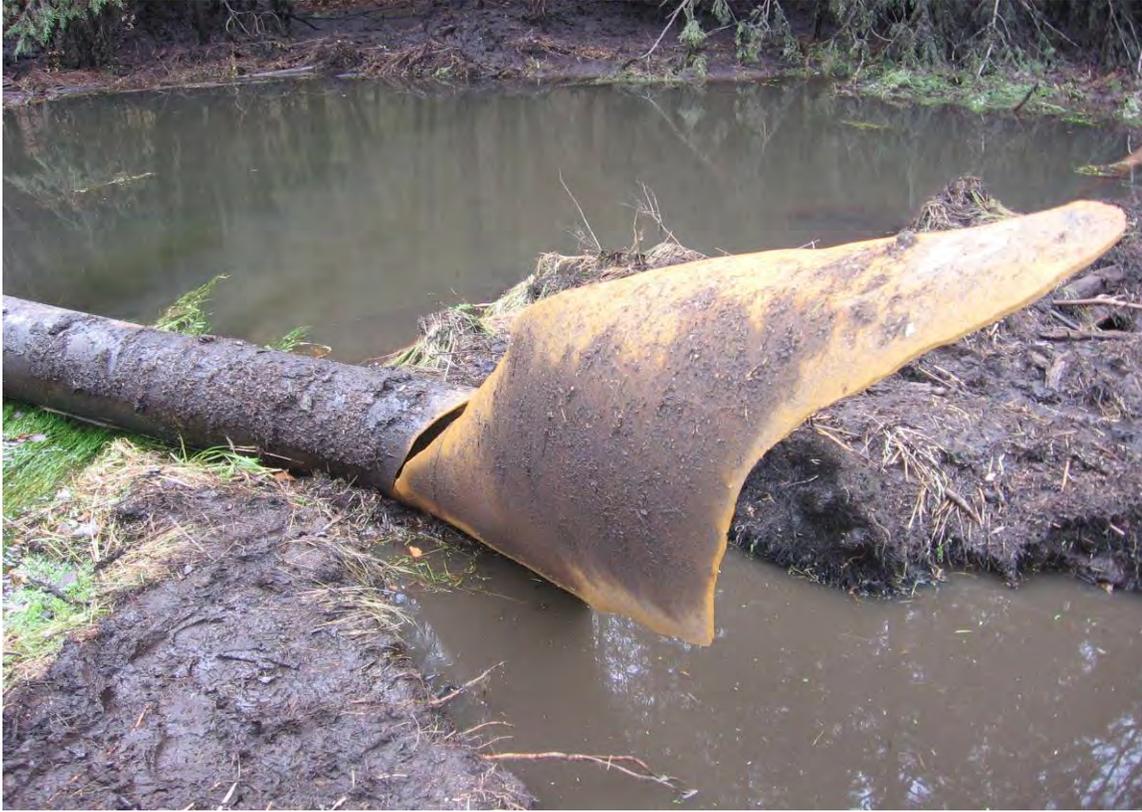
Figure 5: End of severed 37.1 foot section of pipeline

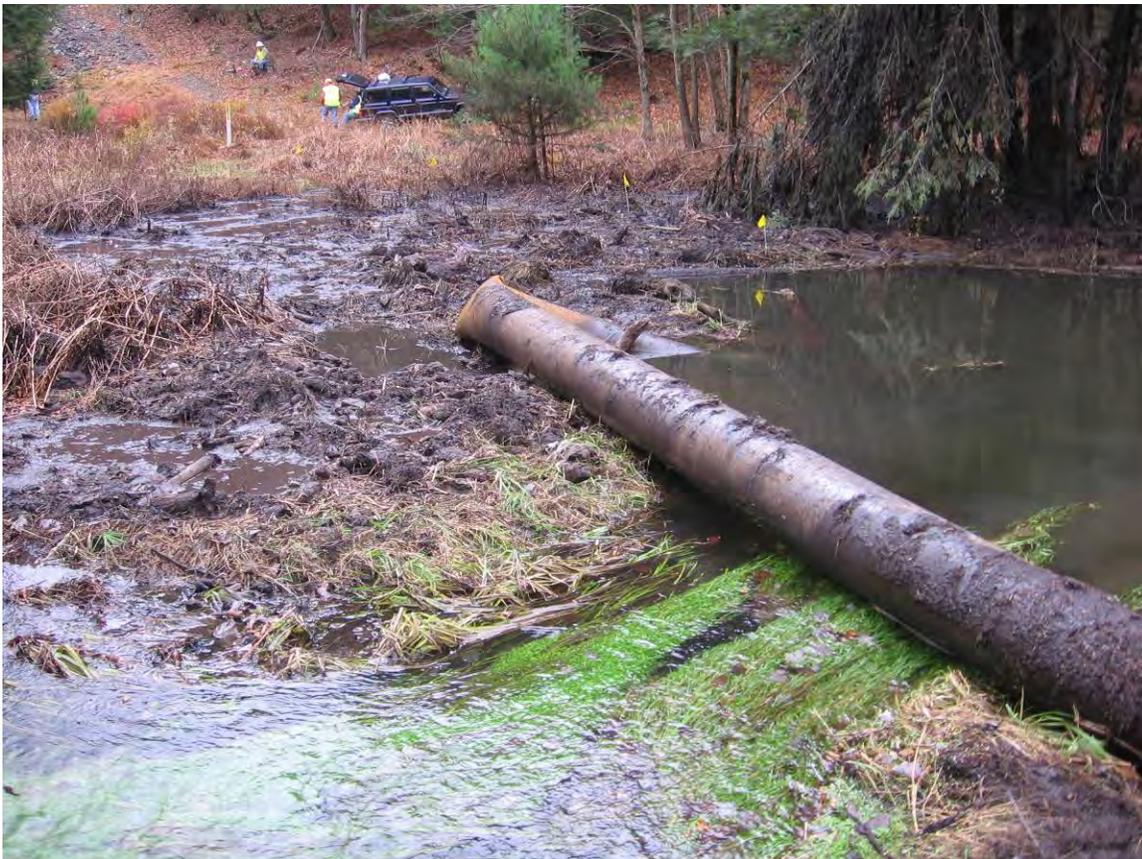
Figure 6: End of 21.7 foot section of pipe in swamp

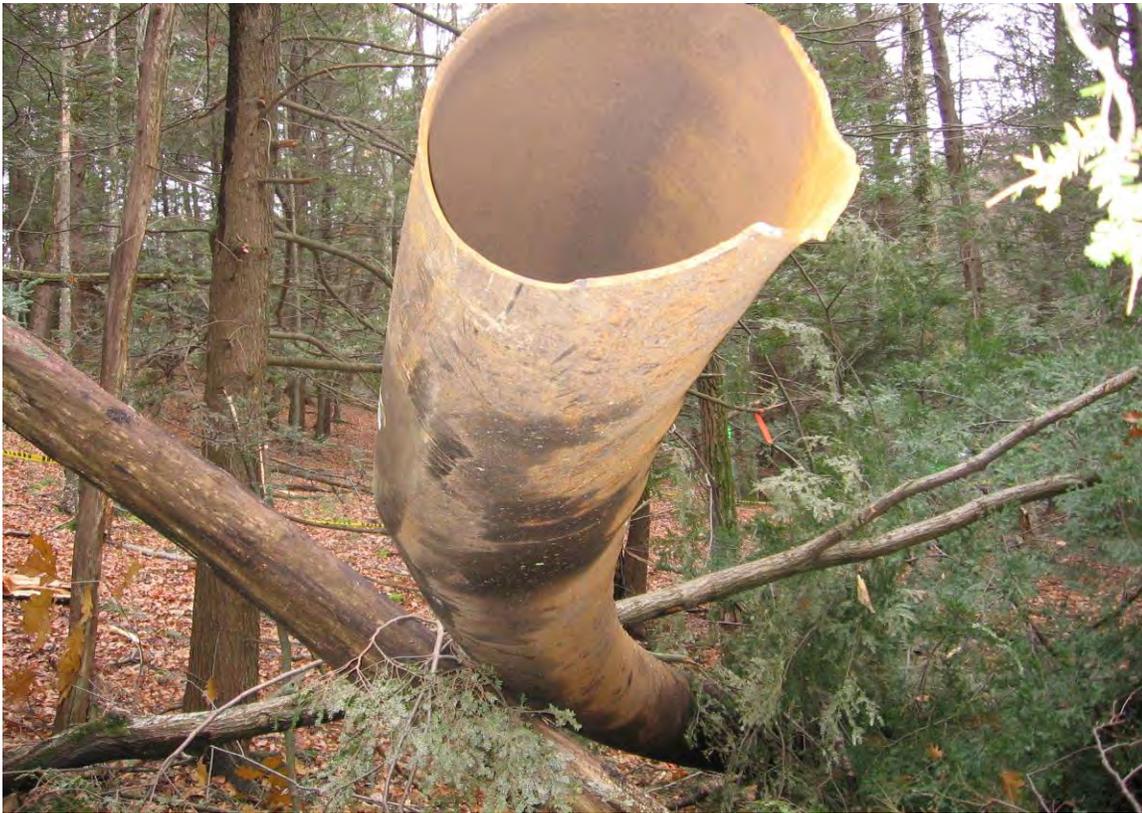
Figure 7: Bent 21.7 foot section of pipe in swamp

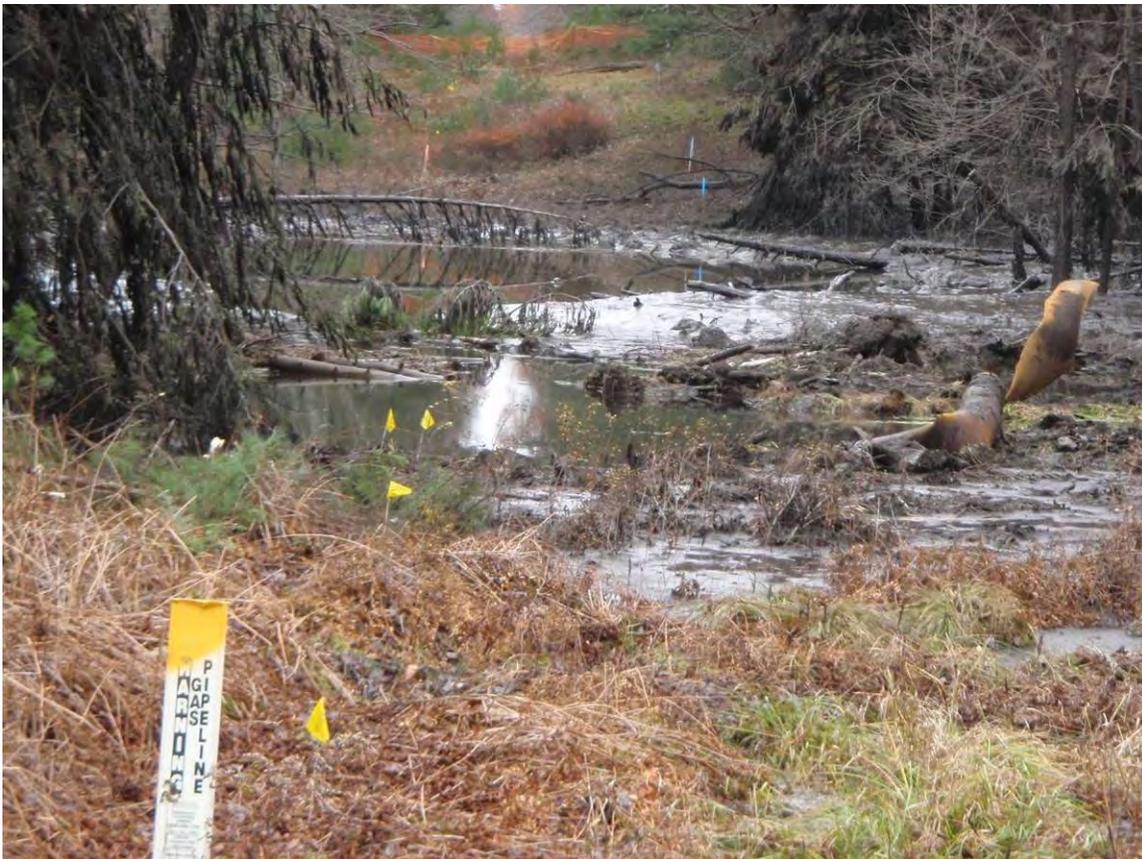
Figure 8: Ruptured pipe in swamp

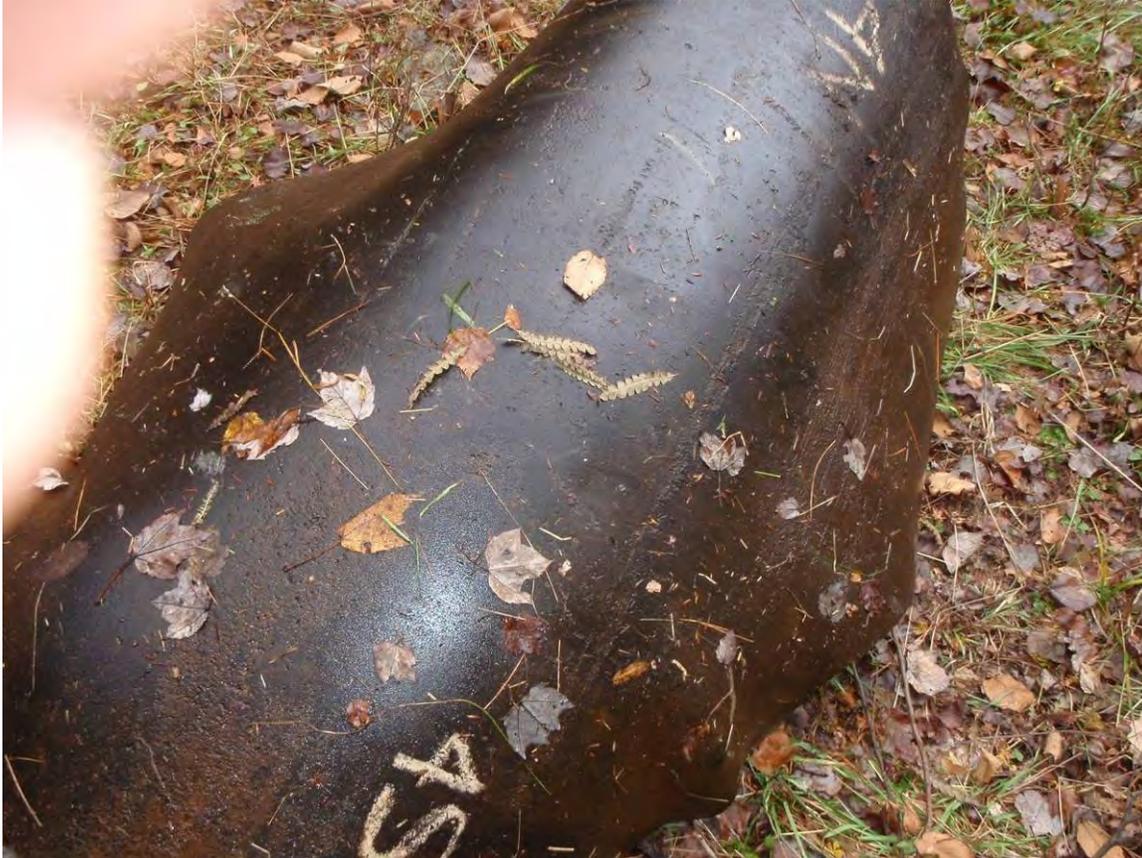
The failed section of pipe separated into four pieces. These pieces along with several other segment of the pipeline were visually examined and analyzed by Kiefner and Associates, Inc. The lab tests results indicated that the failure was caused by near-neutral-pH stress corrosion cracking (SCC). This has been noted in the company reported apparent cause in Part G of Appendix 3.

Figure 9: Piece 4 exhibiting corrosion

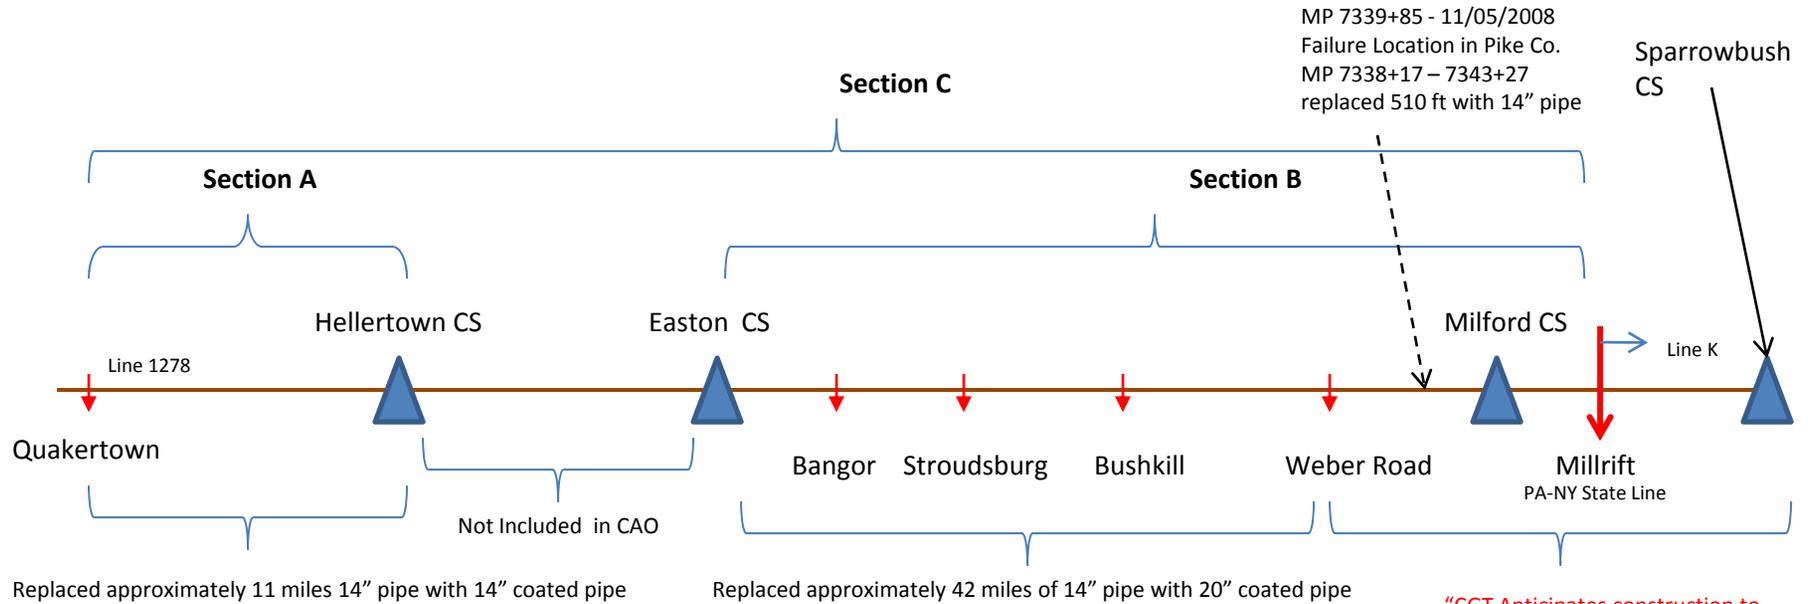
Columbia Gas Transmission Line 1278 and Line K 02/09/2011

MP 7339+85 - 11/05/2008
Failure Location in Pike Co.
MP 7338+17 - 7343+27
replaced 510 ft with 14" pipe

Replaced approximately 11 miles 14" pipe with 14" coated pipe

Replaced approximately 42 miles of 14" pipe with 20" coated pipe

"CGT Anticipates construction to replace this section starting in May 2011 and ending in September 2011. NGT&S commits to maintaining the operating pressure at a restricted level of 800 psig, as established by the CAO, from Weber Road in PA to the Sparrowbush Compressor Station in NY. This section contains the remaining 14" bare pipe along Lines 1278 and Line K. NGT&S commits to replace the remaining bare pipe in PA; approximately 12 miles." According to Columbia letter dated November 30, 2010.
