DOT **US Department of Transportation**
PHMSA **Pipeline and Hazardous Materials Safety Administration**
OPS **Office of Pipeline Safety**
 Eastern Region

Principal Investigator Edwin Clarkson - WV PSC
Region Director Byron Coy
Date of Report 8/5/2011
Subject Failure Investigation Report – Columbia Gas Transmission Ripley Valve Failure

Date of Failure 11/16/2009
Commodity Released Natural Gas
City/County & State Ripley/Jackson County WV
OpID & Operator Name 2616 – Columbia Gas Transmission
Unit # & Unit Name 65951 - Ripley & Rockport Storage Fields - WV
SMART Activity # 129902
Milepost / Location Latitude 38.84527 Longitude -81.69804
Type of Failure Leak - Failed cap screws on Pig Valve
Fatalities 0
Injuries 0
Description of area impacted Class 2 area, non-HCA
Property Damage \$5,167

Failure Date 11/16/2009

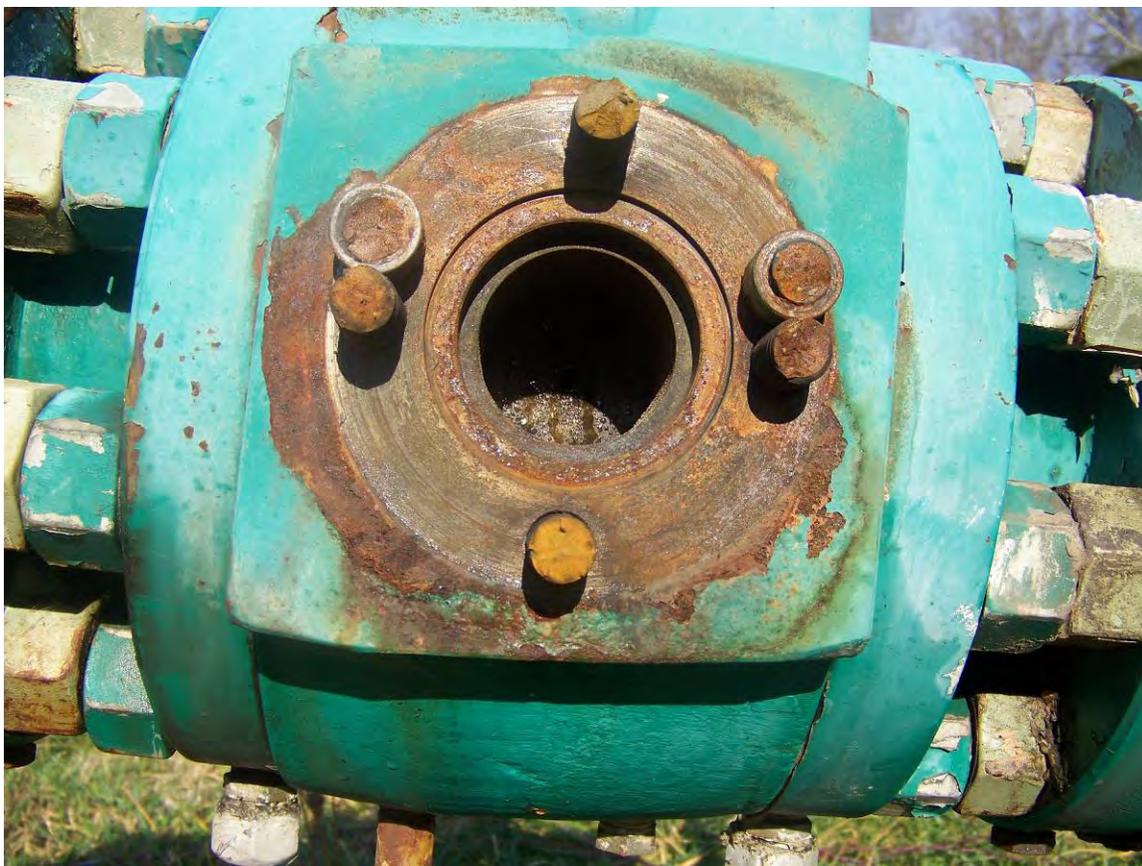
Photo 1
Columbia Gas Transmission
Ripley Storage valve failure
Manufacturer Tulsa Valve
ANSI 900 4 inch
Shut- off pigging valve
X-59-W7308
Photo by ED Clarkson
West Virginia Gas Pipeline Safety

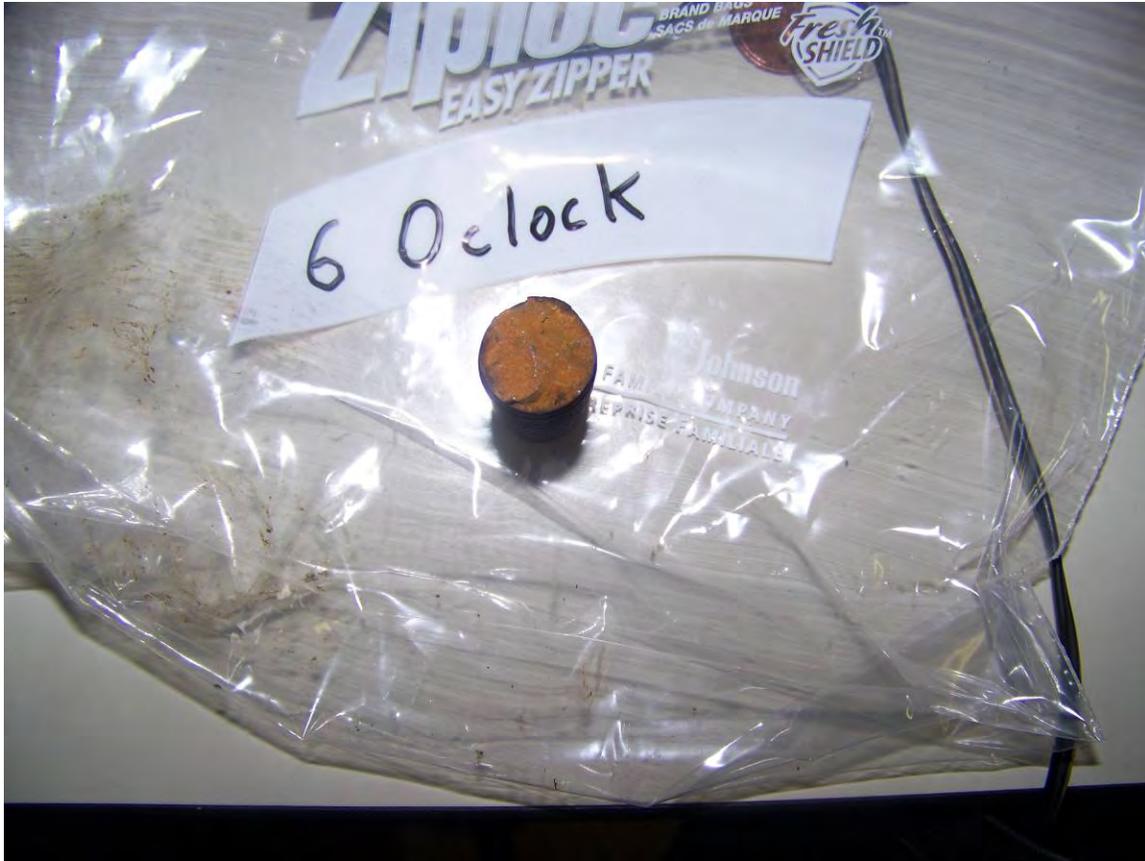
Field investigation indicated that four cap screws associated with the trunnion plate of the 4" shut-off pig valve (Appendix B) had failed. The manufacturer of this valve was notified (Appendix E), the failed valve was removed from the site and the storage line was plugged and capped at both ends. The failed valve (Appendix A) and the recovered cap screws were sent to a laboratory for analysis to determine the cause of the failure. The analysis indicated that the cap screws had failed due to improper tempering. There were no indications of elongation, fretting or thread deformation indicative of over torquing the screws during installation.

The leak from the pig valve was caused by the failure of cap screws associated with the valve trunnion plate. Laboratory analysis showed that the cap screws were not properly tempered to the required temperature level.

Photo 2
Columbia Gas Transmission
Ripley Storage valve failure
Manufacturer Tulsa Valve
ANSI 900 4 inch
Trunnion cover bolt
Photo by ED Clarkson
West Virginia Gas Pipeline Safety

Laboratory analysis (Appendices C and D) indicated that the cap screws had failed due to improper tempering. The cap screws on the pig valve that failed, and the cap screws on a second similar valve in the Ripley Storage facility, were replaced, and the portion of the system affected was returned to full operation. Pig valve trunnion plate cap screws were also replaced in other similar valves at a separate Columbia Gas Transmission Storage facility.

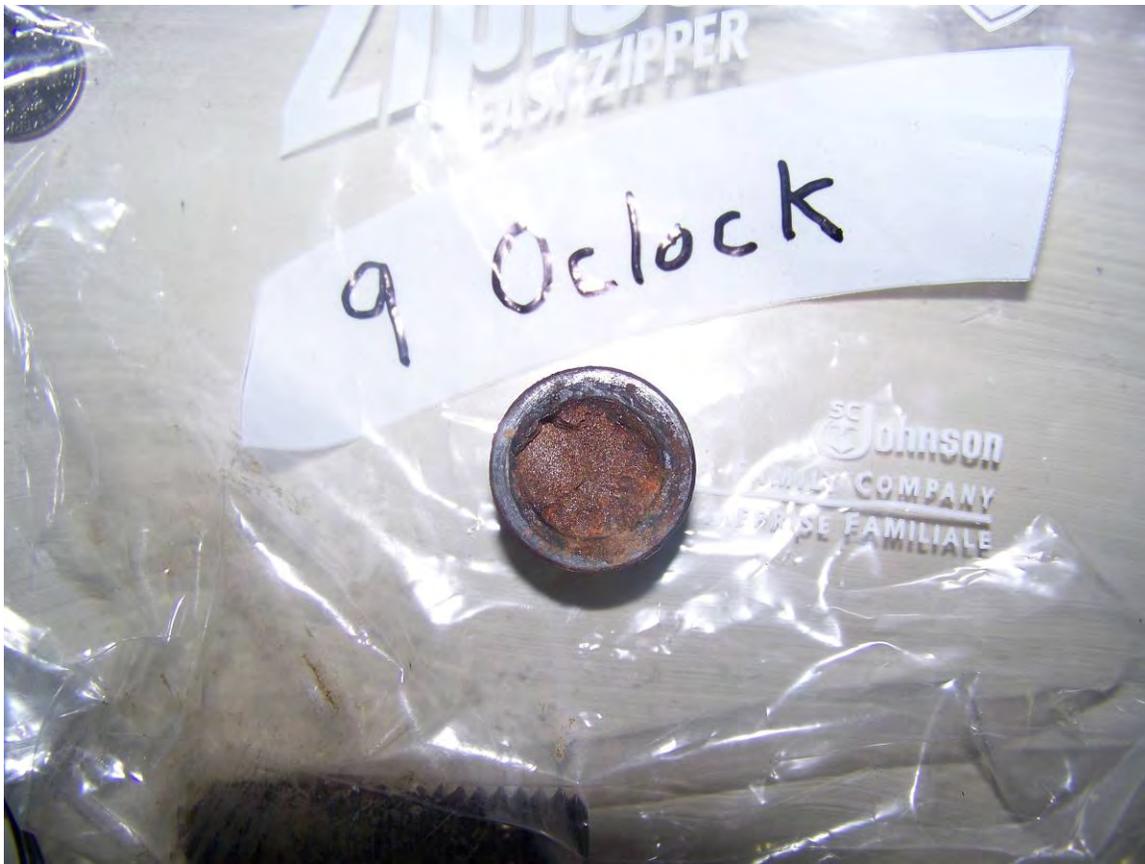
Photo 3
Columbia Gas Transmission
Ripley Storage valve failure
Manufacturer Tulsa Valve
ANSI 900 4 inch
Trunnion cover bolt
Photo by ED Clarkson
West Virginia Gas Pipeline Safety

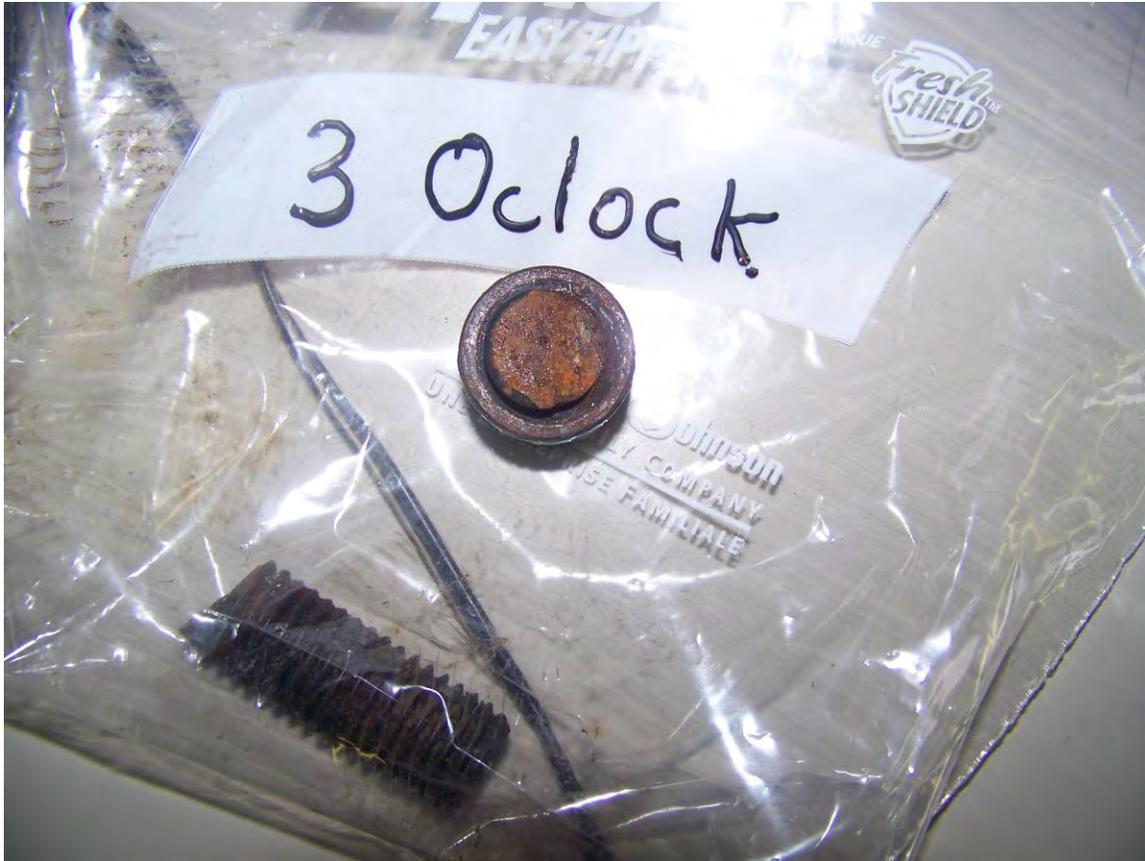
Photo 4
Columbia Gas Transmission
Ripley Storage valve failure
Manufacturer Tulsa Valve
ANSI 900 4 inch
Trunnion cover bolt
Photo by ED Clarkson
West Virginia Gas Pipeline Safety

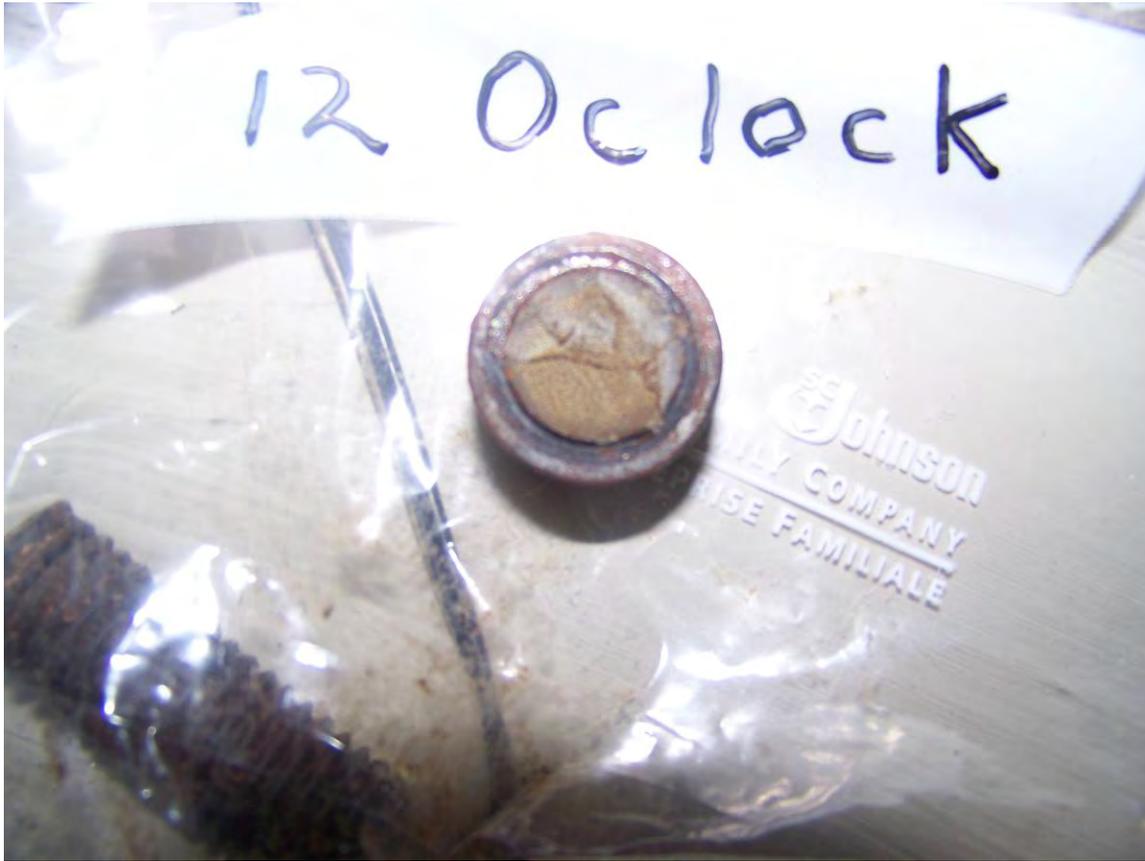
Photo 5
Columbia Gas Transmission
Ripley Storage valve failure
Manufacturer Tulsa Valve
ANSI 900 4 inch
Trunnion cover cap
Photo by ED Clarkson
West Virginia Gas Pipeline Safety

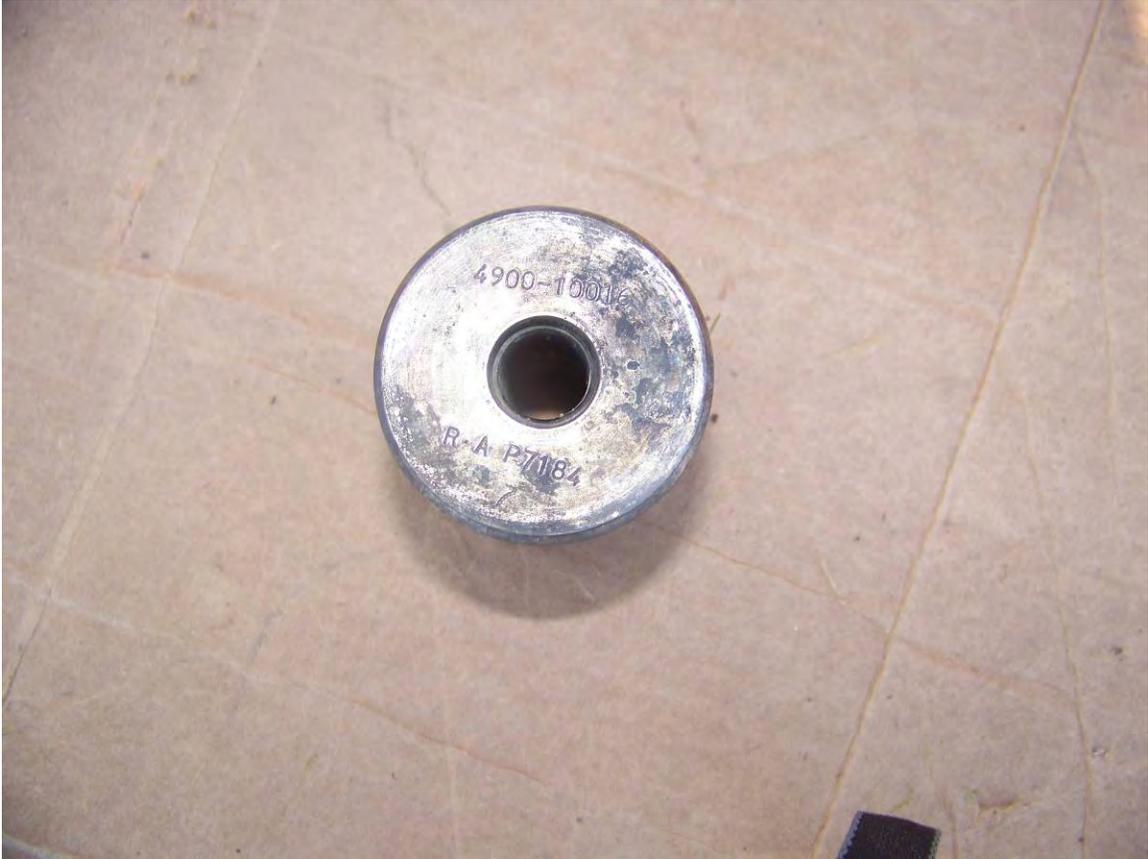
Photo 10
Columbia Gas Transmission
Ripley Storage valve failure
Manufacturer Tulsa Valve
ANSI 900 4 inch
Trunnion
Photo by ED Clarkson
West Virginia Gas Pipeline Safety

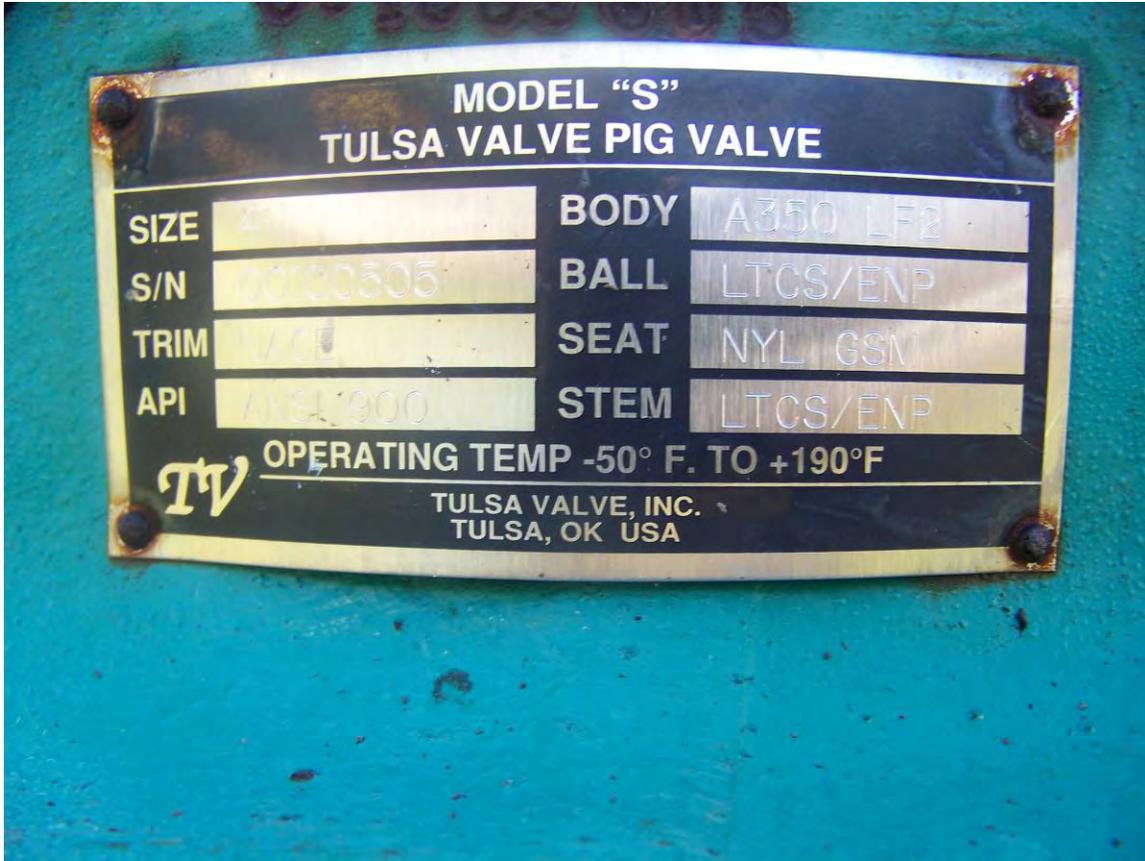
Photo 11
Columbia Gas Transmission
Ripley Storage valve failure
Manufacturer Tulsa Valve
ANSI 900 4 inch
Valve cover plate
Photo by ED Clarkson
West Virginia Gas Pipeline Safety
