DOT US Department of Transportation
PHMSA Pipelines and Hazardous Materials Safety Administration
OPS Office of Pipeline Safety
Western Region

Principal Investigators Peter J Katchmar
Region Director Chris Hoidal
Date of Report 4/14/2011
Subject Failure Investigation Report – Chevron Leak

Failure Investigation Report – Chevron Leak

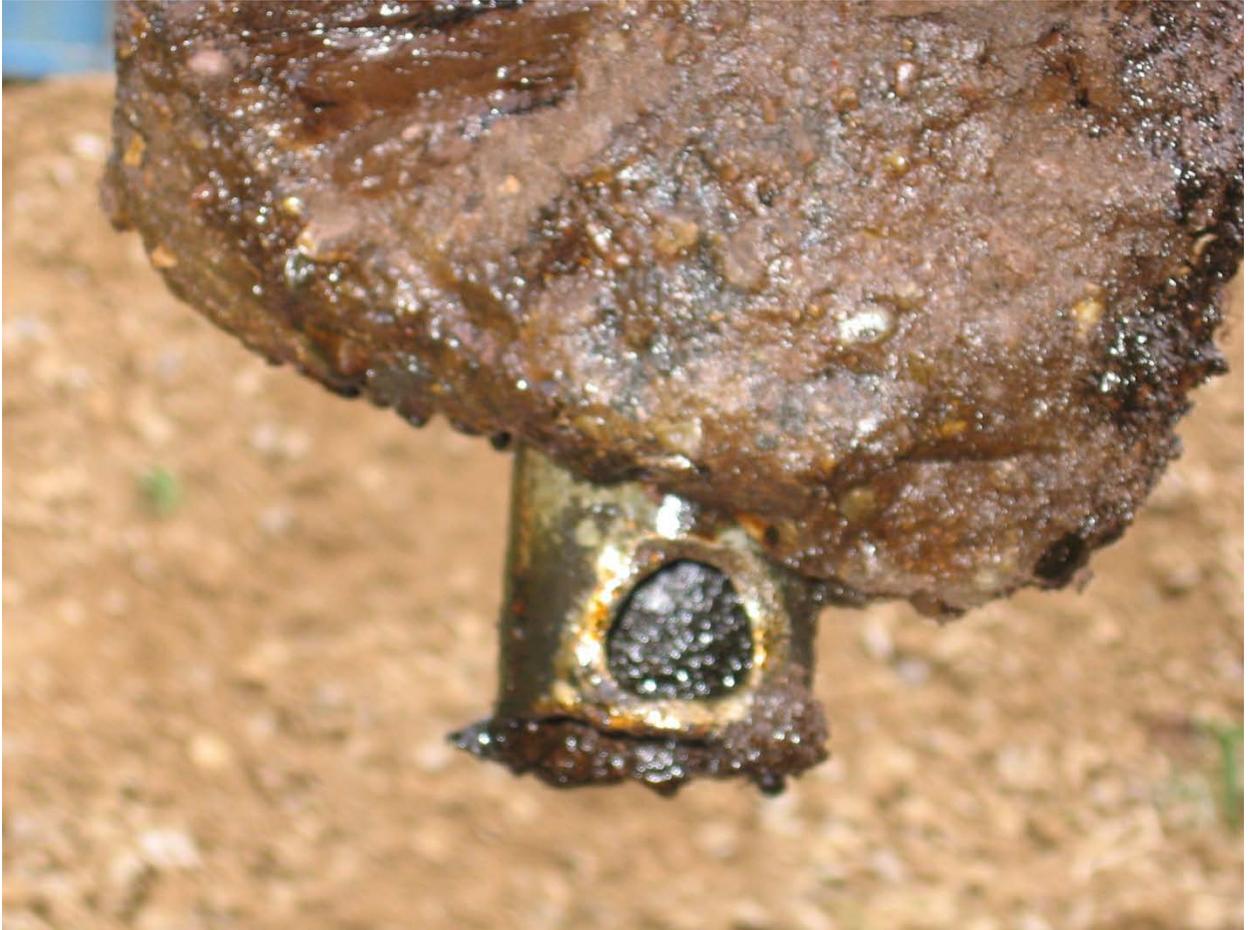
Post release investigation revealed that the ground fault sent a very large surge of electricity through the fence. The surge of electricity flowed through the corner fence post and jumped from the bottom of the fence post onto Chevron’s #2 crude pipeline. This electrical surge event left an approximate one (1) inch hole in the bottom of the metal fence post and left an approximate one half (1/2) inch hole in the

Bottom of fence post with one inch hole, installed 3 inches above pipeline

RMP removed all of the transition footings from the Chevron ROW and moved the electrical transition installation ~30 to 50 feet to the west. Because of new technology, RMP is able to install a single underground line in lieu of the 3 lines previously installed. They also installed a concrete boundary between the new electrical transition station and the Chevron ROW as a barrier or shield to protect Chevron's lines. Since Chevron's lines lie to the east of the electrical transition station now, there is no longer any possibility of an electrical discharge damaging Chevron's lines in the area around Red Butte Creek.

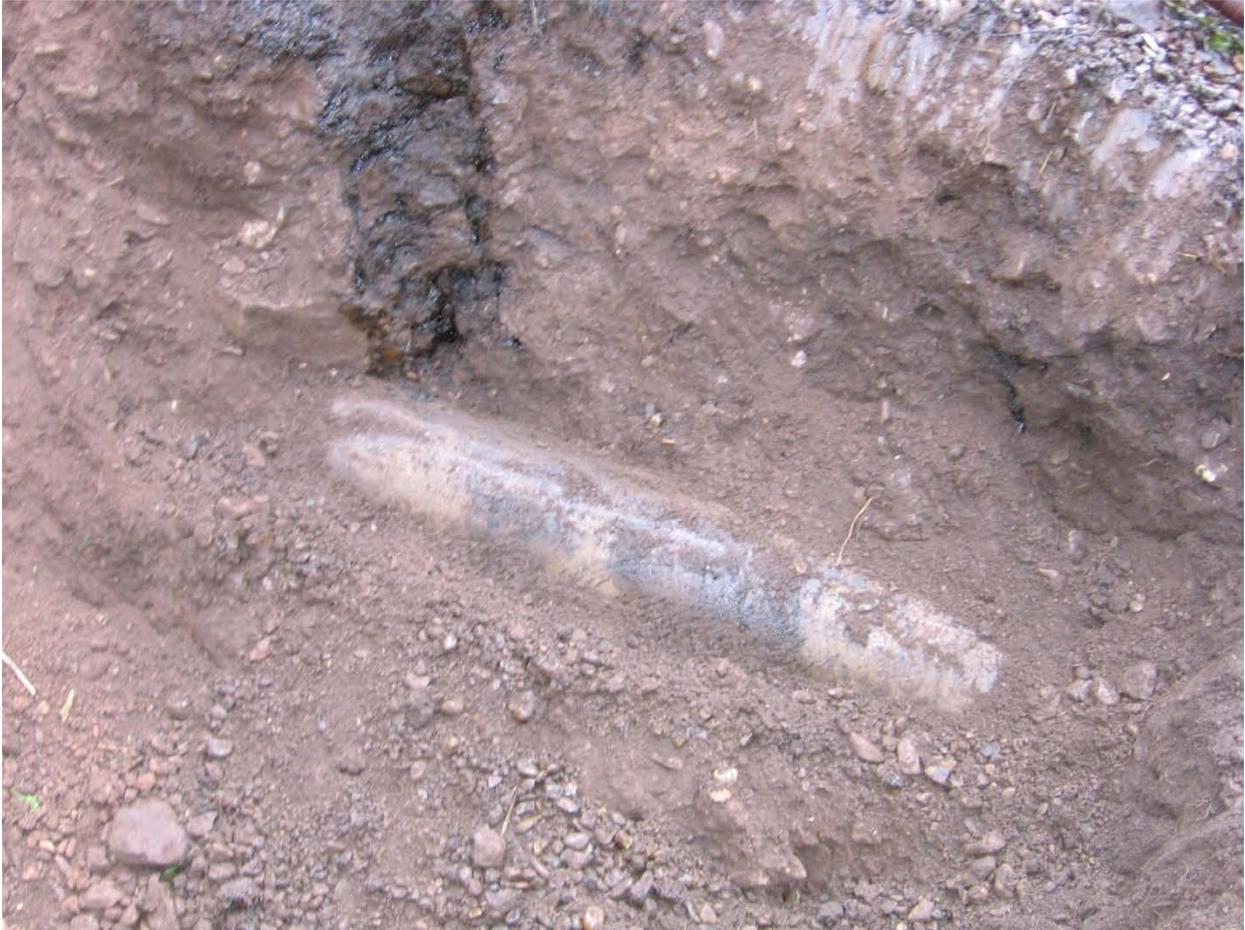
10 inch crude oil pipeline partially exposed at leak site

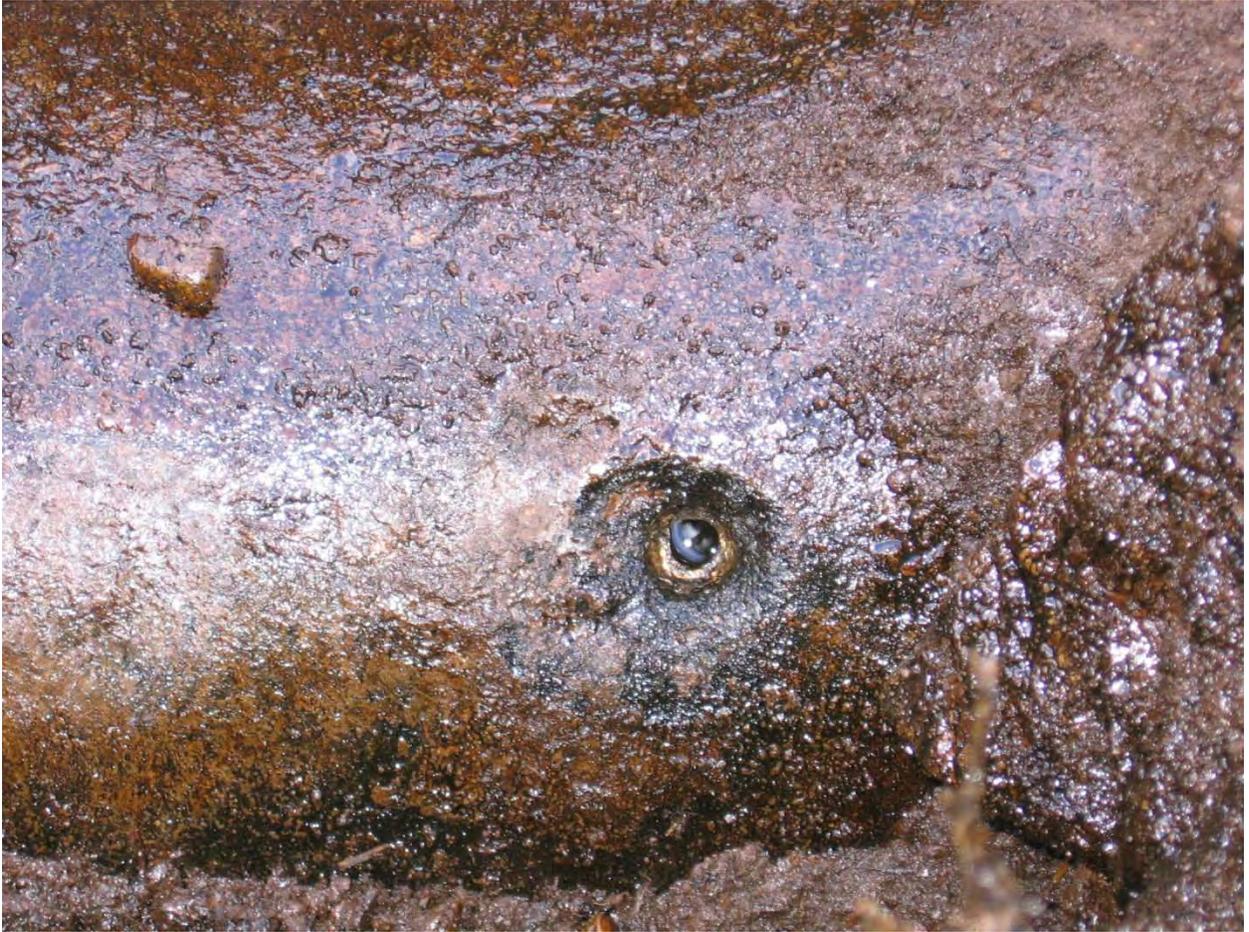
top of the crude oil pipeline. Crude oil was released from the 1/2" hole in the pipe and it flowed to the surface and downhill into Red Butte Creek. There was some apparent arcing damage at the block valve installation approximately 300 feet downstream of the release site. The block valve configuration included an upstream pressure sensor, a downstream pressure sensor as well as a "pig-sig" (a device that sends a signal to the controller that an internal device called a pig just went by). The pig-sig had wires coming off of it going to the ground and there was obvious effects (tell tale black residue from arcing) of electrical damage in the area of the pig-sig. In order to complete the electrical circuit, the electricity has to return to the nearest transformer. The nearest transformer is approximately 2 miles perpendicular to the pipeline. It has been surmised from the evidence that the surge of electricity got onto the pipeline at the release point and flowed through the pipeline down to the block valve assembly and that is where it left the pipeline and flowed through the ground back to the transformer.

10 inch crude oil pipeline with one-half inch hole from electrical arcing

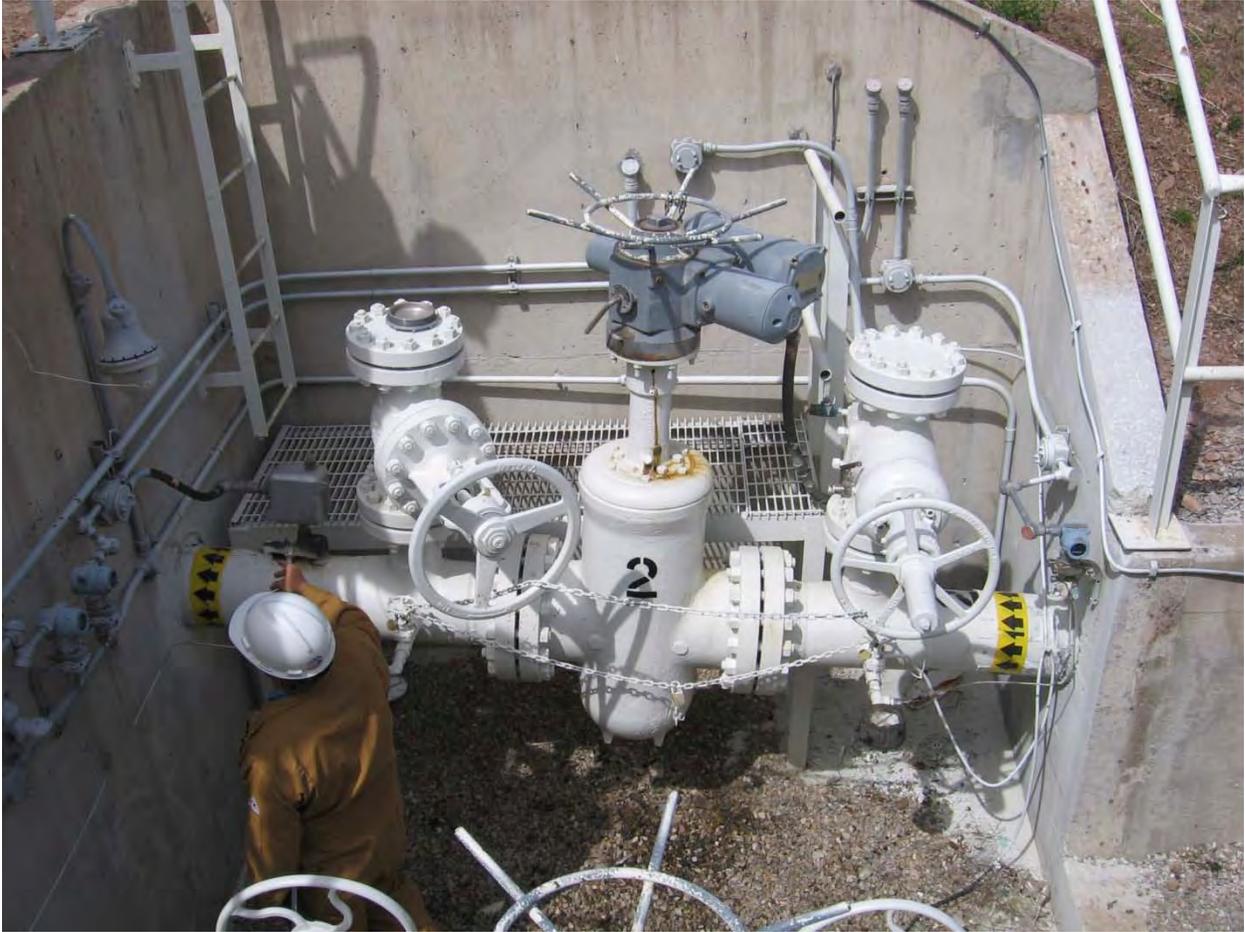
Red Butte Block Valve, 300 yards downstream of failure site. Person is pointing to arc burn location

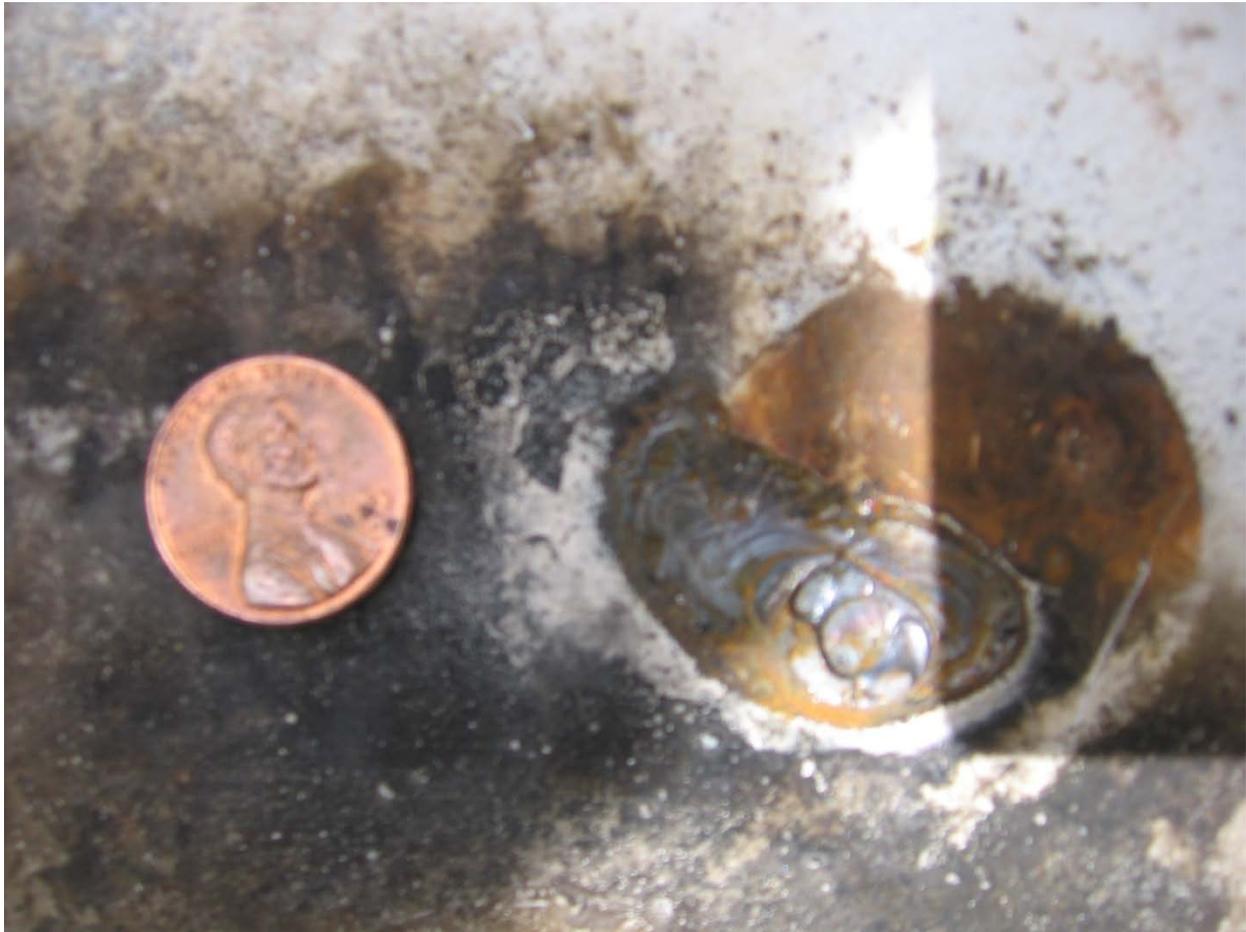
Arc burn on pipe at Red Butte Block Valve
