**Principal Investigator** Stephen Bender  
**Senior Accident Investigator** Peter Katchmar  
**Regional Director** Chris Hoidal  
**Date of Report** 6/7/2011  
**Subject** Failure Investigation Report – Chevron Pipe Line Crude Oil Release

**Date & Time of Failure:** 12/1/2010  
**Commodity Released:** Crude Oil Condensate  
**City/County & State:** Salt Lake City/Salt Lake County, UT  
**OpID & Operator Name** 2731 Chevron Pipe Line Company  
**Unit # & Unit Name** 225 Crude System  
**SMART Activity #:** 132398  
**Milepost / Location** Milepost 175.0  
**Type of Failure:** Leak caused by Inadequate Procedures for Draining Water  
**Fatalities:** 0  
**Injuries** 0  
**Description of area impacted** Adjacent to University of Utah Campus  
**Property damage** \$7,334,364

## Failure Investigation Report – Chevron Pipe Line Co Crude Oil Release

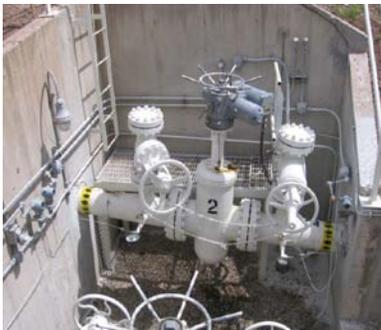
Figure 1

CPL chose Stress Engineering Services (SES) in Houston, TX to perform the forensic analysis of the valve. To the right is a picture of the Red Butte Block valve installation after the June release but before the stand up water test. Notice the flange at the top of the 6” valve to the right in the picture below (Figure 1). CPL had to replace the full flange on this subject valve with a flange with a weld-o-let penetrating it to allow water to be injected into the line for the June 2010, stand up water test. In the next picture (Figure 2), one can see the same flange with a bull plug in it as well as the fact that the downstream valve was removed because the electricity jumped off the line at this point and had damaged the line. A spool piece was installed downstream of the main line valve following the valve removal in June 2010.

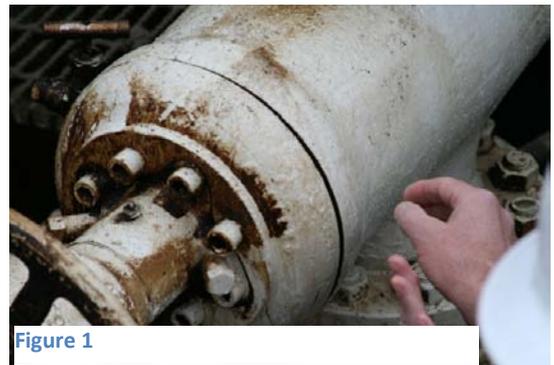
Once the vault was cleaned up and made safe to enter, PHMSA was able to inspect the release site. It appeared that the valve bonnet had been pushed away from the body of the valve by some force from the "bottom-right" in the picture at the right to the "top-left." There was a locked chain looped between the 10" valve handle and the 6" valve handle. It appeared that if the hand wheel on the 10" valve were to have been operated remotely, there may have been enough force applied to cause the damage to the 6" valve bonnet. (Figure 3).

As this failure mechanism was ruled out, there appeared to be only one additional force that could have caused the valve to fail as it did and that was a force from the inside of the valve. Having investigated the release in June, the PHMSA Accident Coordinator was familiar with the repairs made at that time and the fact that a stand up test with water was performed after the repairs. It was also known that this valve was the water injection point for that stand up water test.

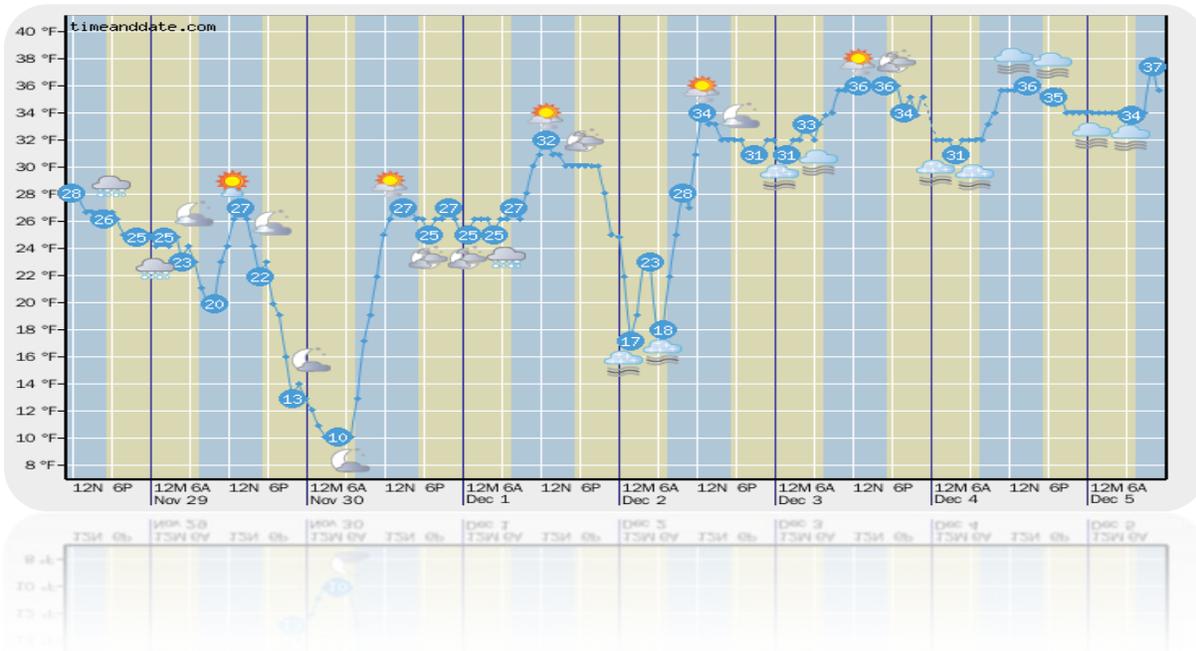
Because water freezing inside the valve was suspected as the cause of the valve failure, historical temperatures for the area were checked on the internet. Below is a graph of the temperatures encountered in Salt Lake City 12 noon November 28, 2010 through 6 am December 5, 2010. One can see from the graph that the temperatures were well below 32 degrees Fahrenheit (F) from before November 28 2010, until after the release was discovered on the night of December 1, 2010. During this period, the line was shut down for the month end tally for 6 and one half hours in the early morning of Wednesday, December 1, 2010. The line was started up at 10:34am MST (11:34 am CST) on December 1, 2010. The temperature got up to 32 degrees F and the sun was out all day. The temperature of the crude being pumped through the line was at approximately 50 degrees F.
