Pipeline Failure Investigation Report
OPID 2714; Unit ID 3261; NRC #N/A; Activity #127584

Pipeline System: H-197 **Operator:** Dominion Transmission
Location: Taylor Ridge, Marshall County **Date of Occurrence:** October 23, 2008
Medium Released: Natural Gas **Quantity:** Not Provided

While constructing a new cross-over connection between existing transmission lines H-197 and TL-558 the backhoe operator snagged the top of an abandoned tap on H-197 about 3" below grade. The existence of the tap was unknown to the construction crew and was not shown on the existing plant drawings. The "original" drawing (5-29-1958) did not show the existence of the 2" tap, but did note modifications done to the yard piping in 1990. The 2" tap is believed to be a pre-code component that pre-dates the drawing. The tap was damaged sufficiently to cause a leak, but the gas did not ignite. The dig-in occurred with the line in service and operating at 250 psig. Pressure was reduced to 50 psig to allow the line to be repaired. The dig-in occurred at 10:10 AM and repairs were completed at 3:30 PM. Crews left the site at 6:30 PM, October 23.

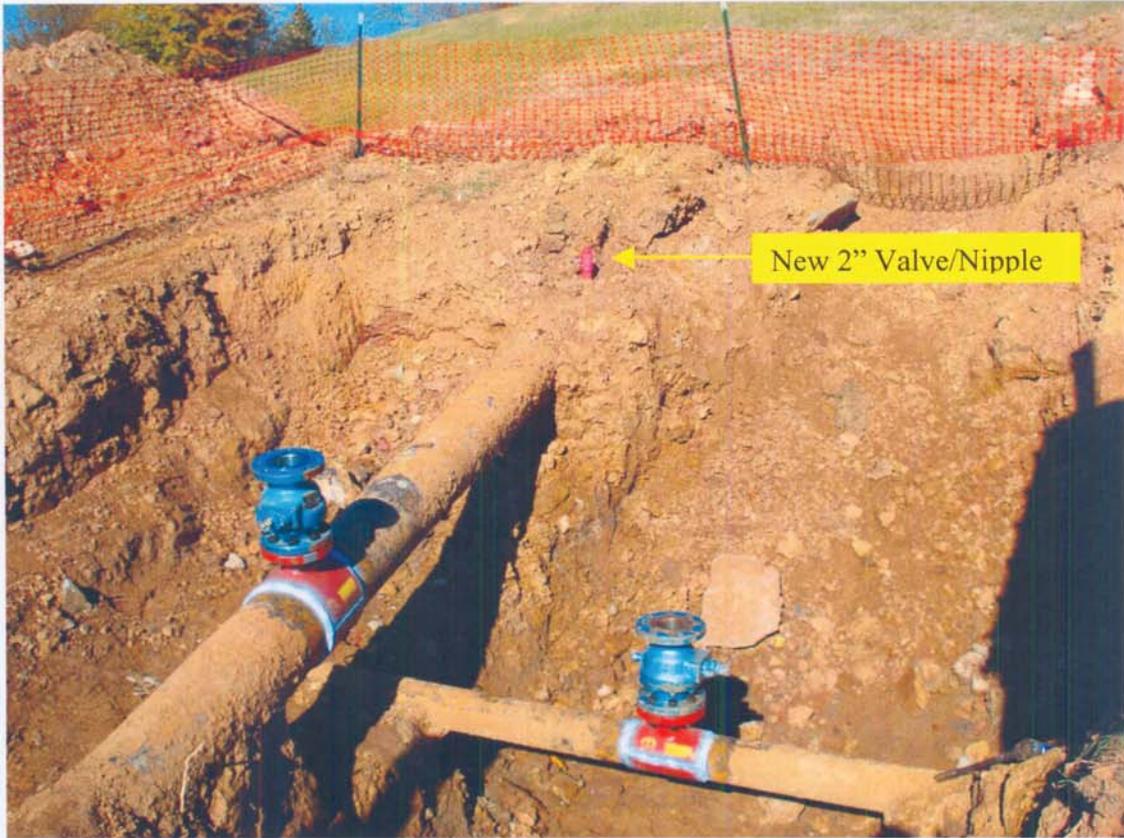
New 2" Valve and Nipple.

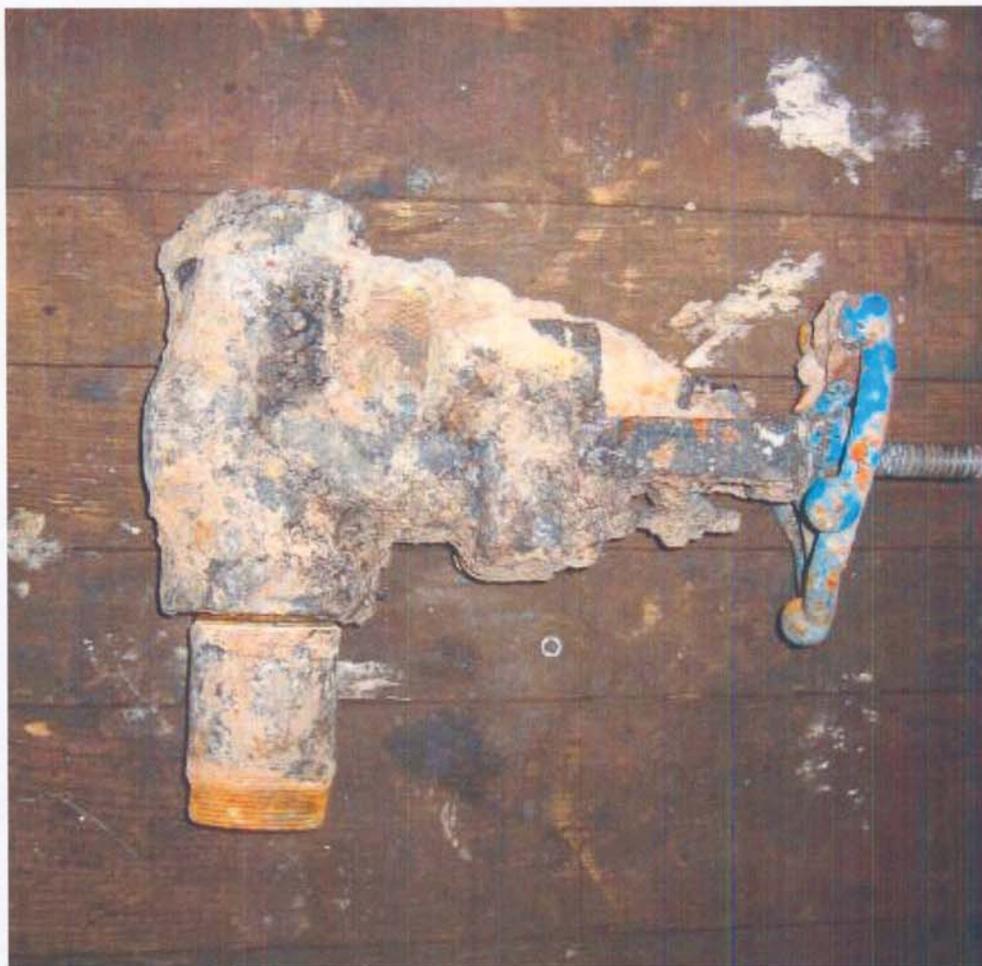
Damaged 2" Valve and Nipple Assembly

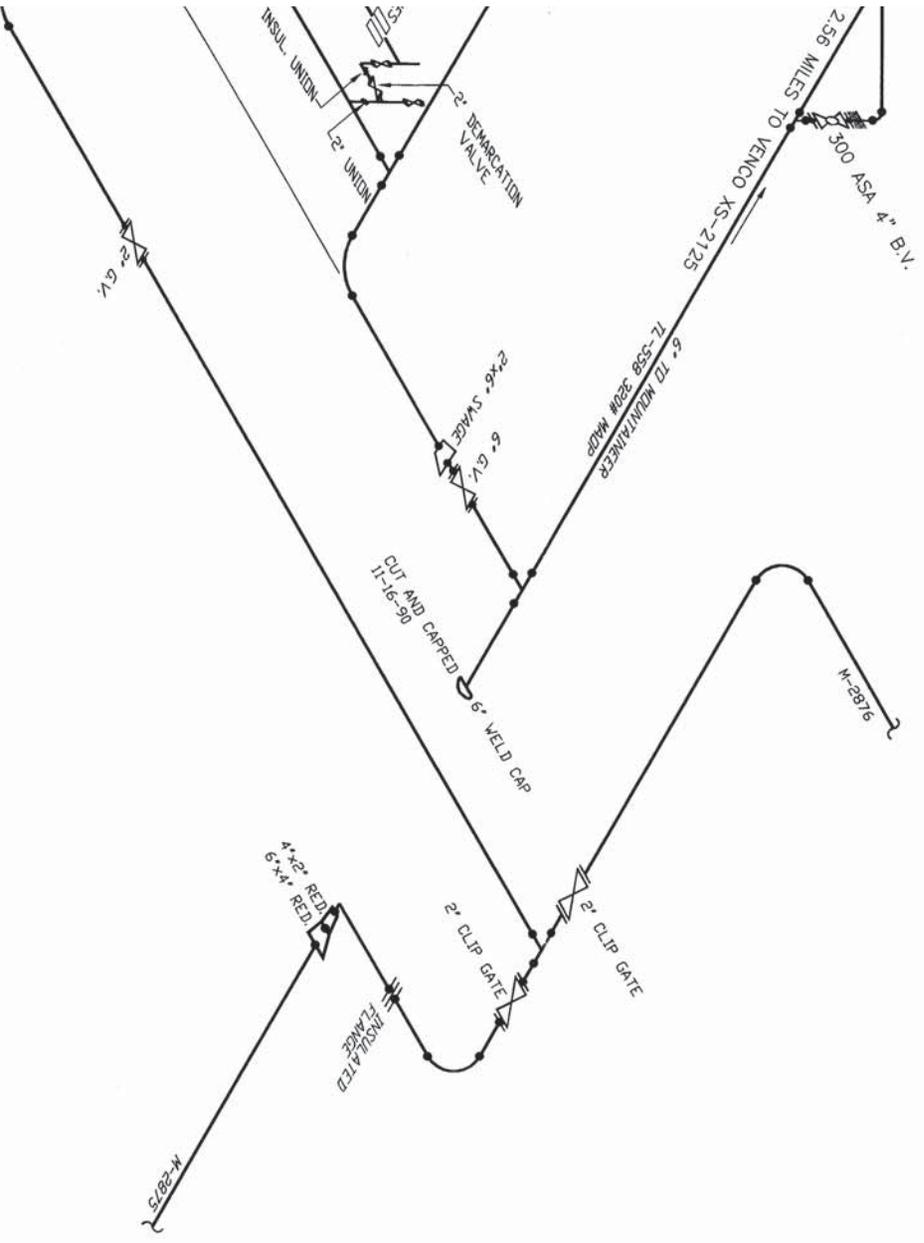
TITLE:
 TAYLOR RIDGE/GATTS
 XS-2118

<i>Maps & Records</i>		<input type="checkbox"/> N/A
Are Maps and Records Current? ⁽⁵⁾ <input type="checkbox"/> Yes <input checked="" type="checkbox"/> No		
Comments: The "original" drawing (5-29-1958) did not show the existence of the 2" tap, but did note modifications done to the yard piping in 1990. The 2" tap is believed to be a pre-code component that pre-dates the drawing.

Dominion revised the equipment drawing for XS-2118 to show the presence of the abandoned 2" tap on H-197 (2" 600# BV, screw [threaded connection], 12' from new crossover). (Appendix 2 – Appendix 3)

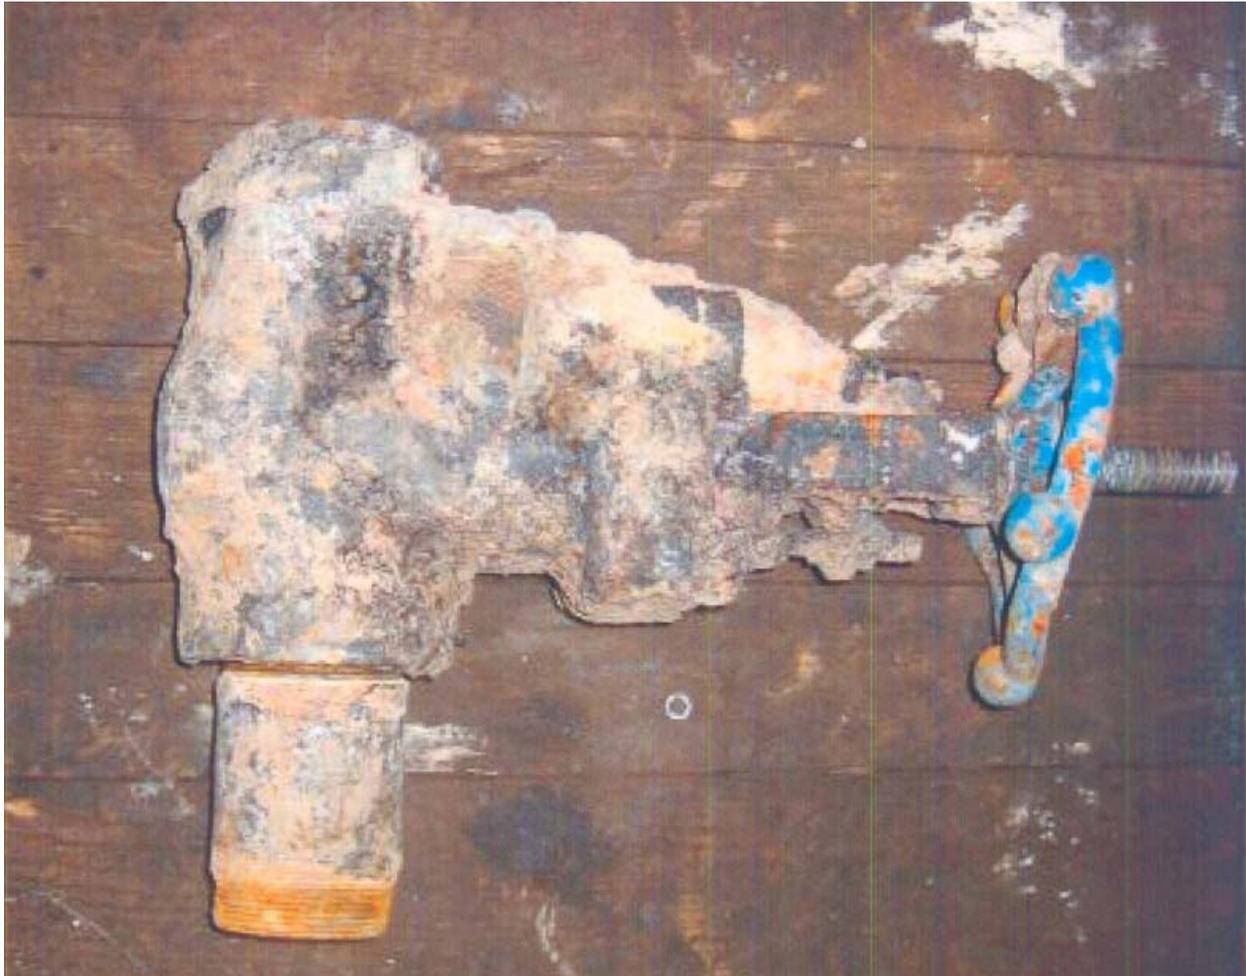
Photo 3 - Damaged Valve and Nipple
