Principal Investigator Arizona Corporation Commission (ACC)
Senior Accident Investigator Peter J Katchmar
Region Director Chris Hoidal
Date of Report April 19, 2011
Subject Failure Investigation Report – El Paso Material Failure

Date of Failure 3/1/2010
Commodity Released Natural Gas
City/County & State Kingman/Navajo, Arizona
OpID & Operator Name 4280 – El Paso Natural Gas Company (EPNG)
Unit # & Unit Name 55334 – ACC--Topock Area
SMART Activity # 129403
Milepost / Location 361 (35 miles E of Kingman near Interstate Hwy 40)
Type of Failure Leak caused by Material Failure
Fatalities 0
Injuries 0
Description of area impacted Next to the westbound lanes of I-40
Property Damage \$ 99,567

Failure Investigation Report – El Paso Material Failure

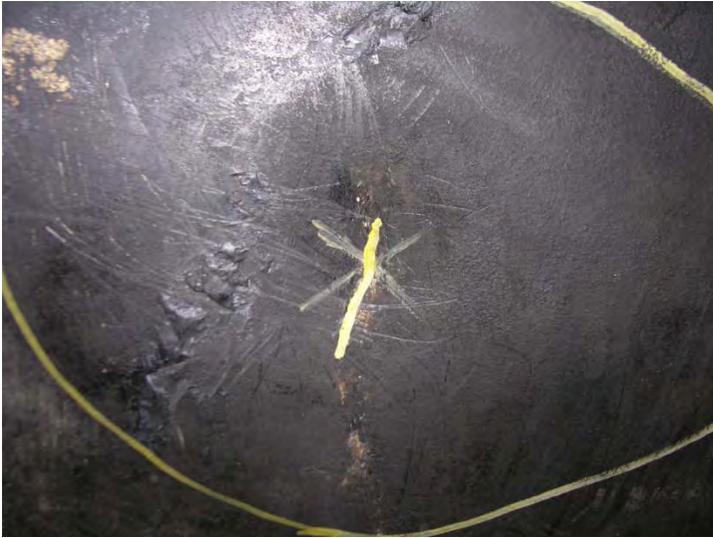
The affected segment was approximately 18 miles in length. On 3/2/10, the pipeline was exposed and it was discovered that the line was resting on a rock at about the 7 o'clock position. The result was a dent (2.78% of OD) with some identified metal loss. The line is 30 inches OD with a 0.438" wall that was installed sometime around 1953. Once the rock was removed, the dent was measured and inspected, and tests (magnetic particle and x-rays) were done on the line to ensure its integrity. Following the tests, a full encirclement sleeve was welded on to strengthen the area before the line was re-coated and backfilled. The ACC oversaw the work.

The ACC found that the root cause of this failure was mechanical failure of the pipe (crack in a dent) due to rock impingement.

EPNG Crack in Dent

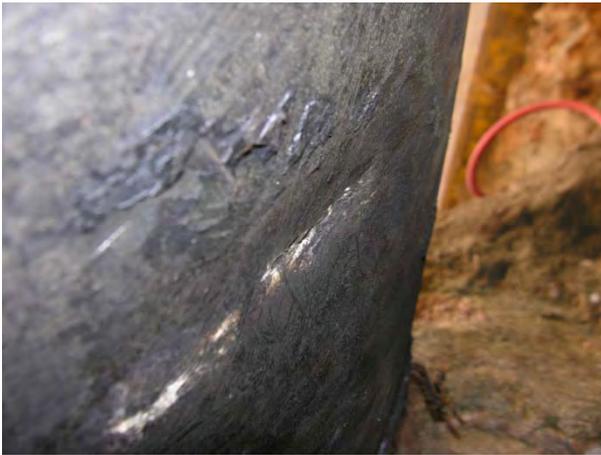
EPNG Crack in Dent

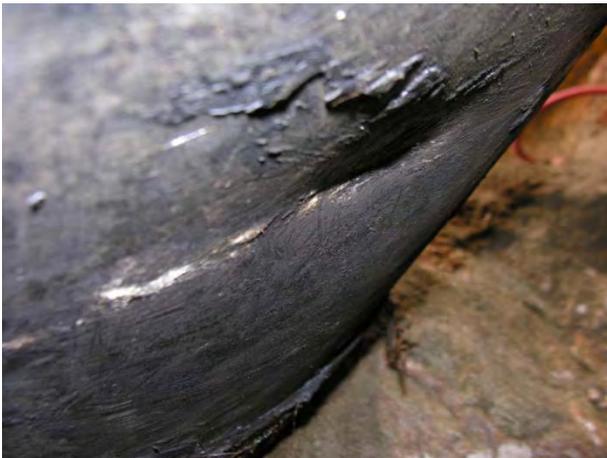
EPNG Crack in Dent
