DOT US Department of Transportation
PHMSA Pipeline and Hazardous Materials Safety Administration
OPS Office of Pipeline Safety
Southwest Region

Principal Investigator Richard Lopez
Region Director R.M. Seeley
Date of Report 10/20/2011
Subject Failure Investigation Report – El Paso Pipe Failure at Saddle

Date of Failure 11/5/2009
Commodity Released Natural Gas
City/County & State Bushland / Potter County, TX
OpID & Operator Name 4280 El Paso Natural Gas
Unit # & Unit Name 6464 Amarillo Complex
SMART Activity # 127304
Milepost / Location ~15 miles west of Amarillo, TX
Type of Failure Rupture caused by Pipe Failure at Reinforcing Saddle
Fatalities 0
Injuries 3
Description of area impacted Newly-developed residential area - Class Location 2
Property Damage \$436,156

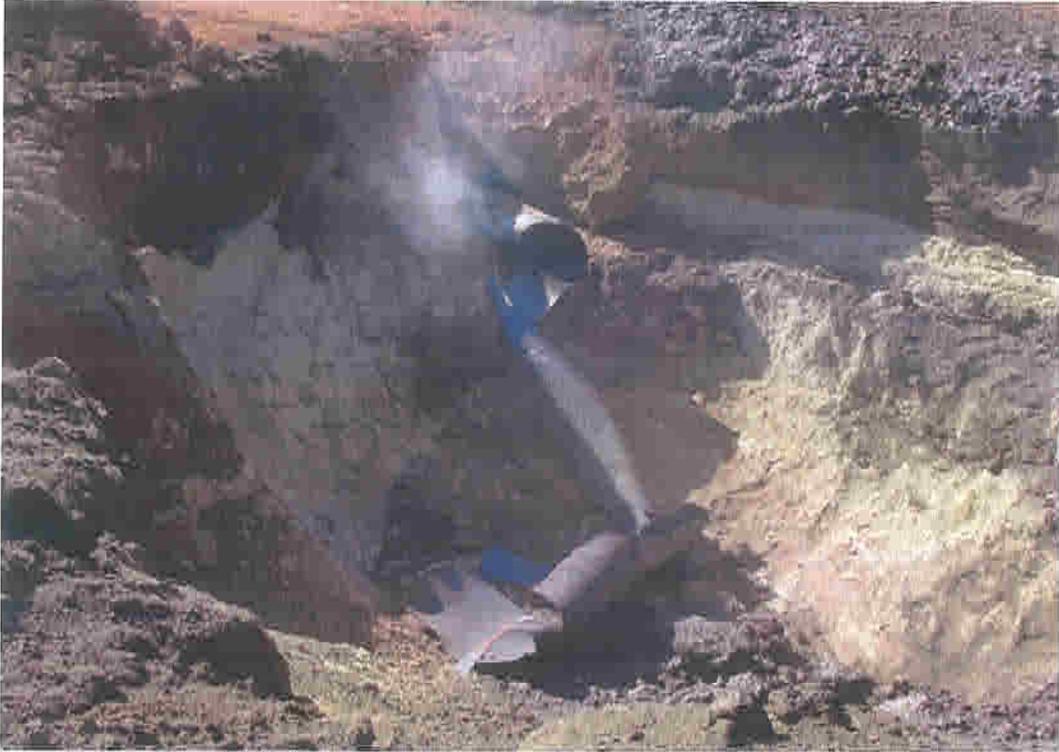
View of rupture site

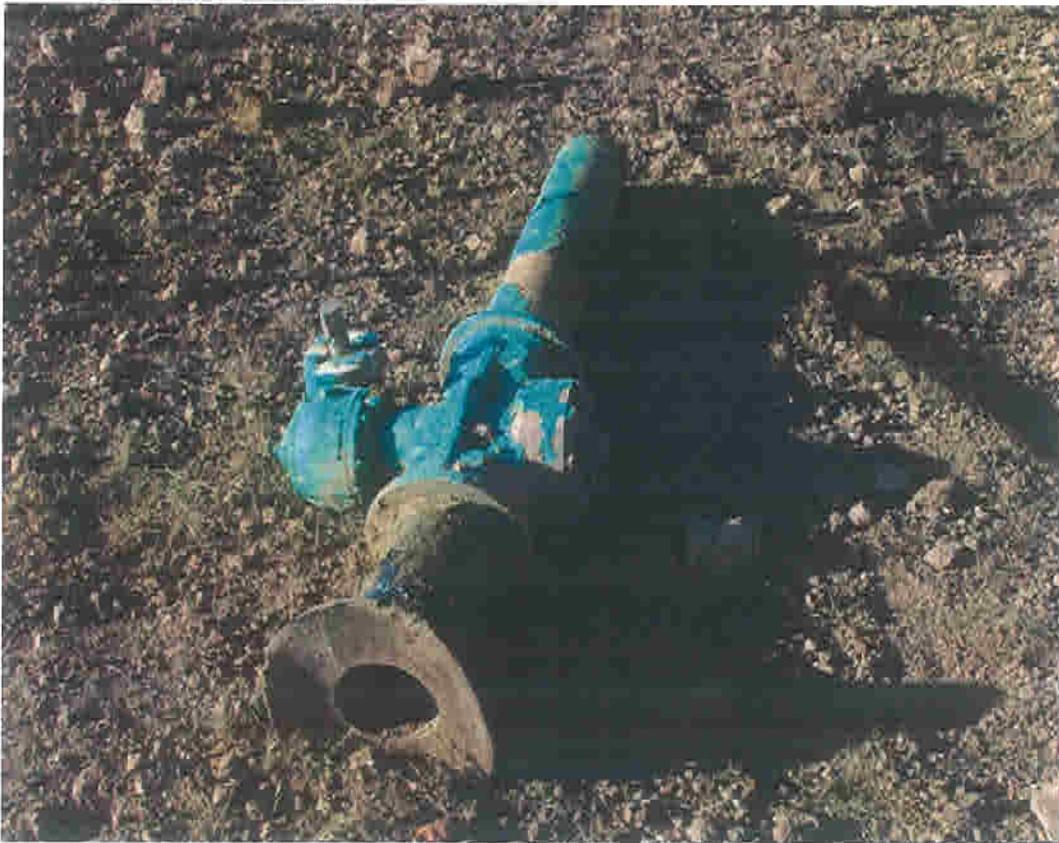
The ultimate cause of failure was attributed to upward bending stresses on the abandoned branch connection placed tensile stresses across the thickness of the carrier pipe on the underside of the branch connection and across the laminations in the pipe wall. The branch connection was abandoned in 2007 with a 5-foot segment of the 6 inch branch connection left in-place and attached to the 24 inch carrier pipe.

View of abandoned tap that failed

Although it is permissible to use reinforcing saddles, full encirclement sleeves are designed to fully encircle the carrier pipe and distribute stresses around the full circumference of the pipe. EPNG's procedure 300 was amended in 2006 to limit the use of reinforcing saddles on pipeline branch connections and require full encirclement sleeves on certain applications for below ground service.

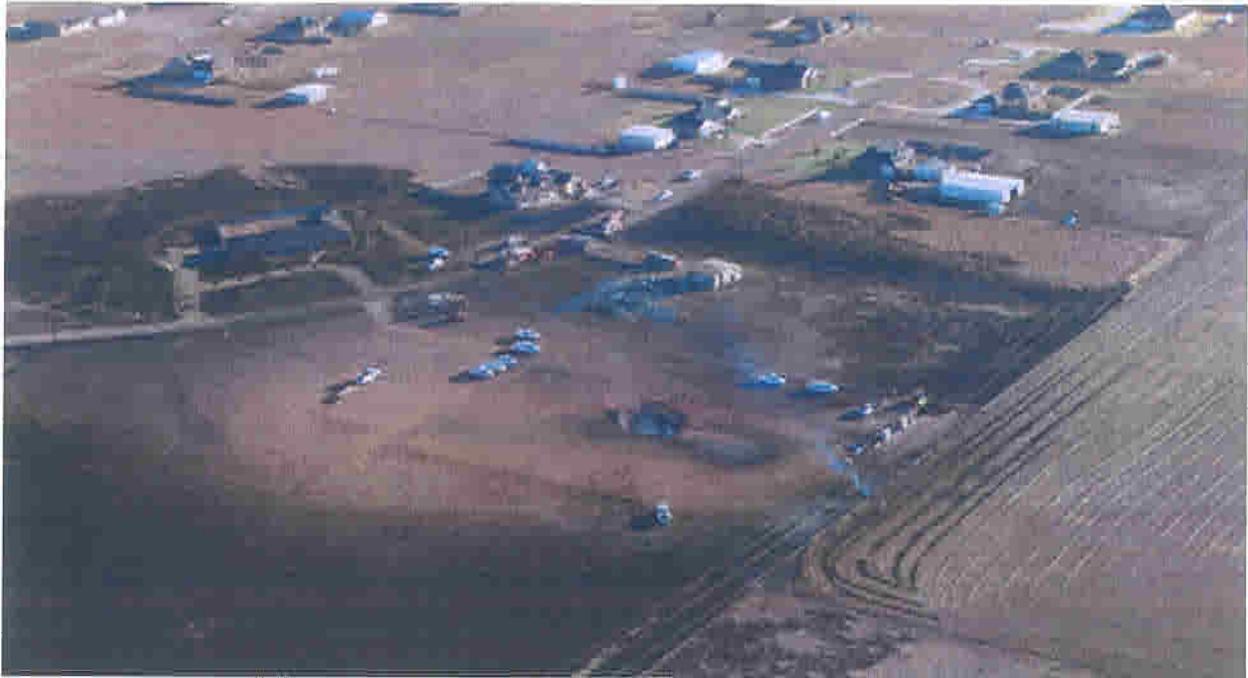
Aerial view of incident site

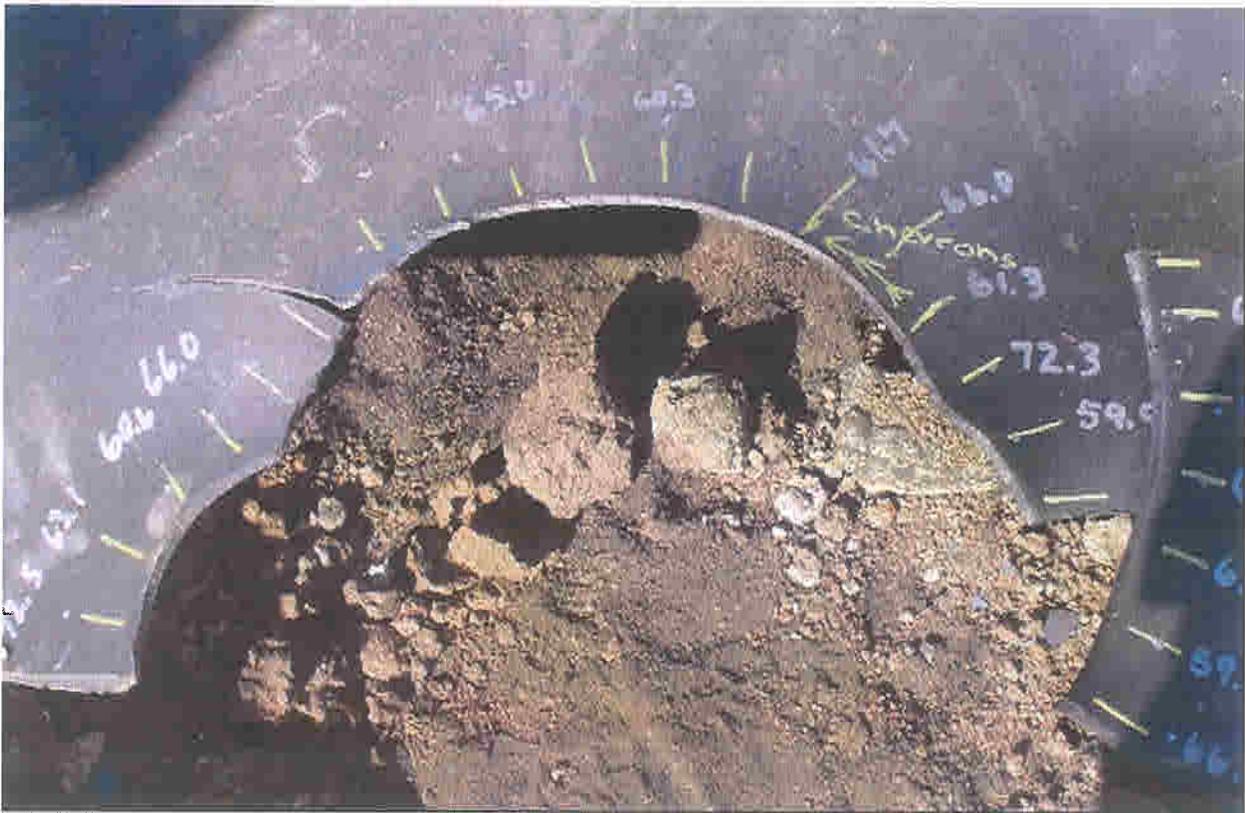
1. The fracture originated in the carrier pipe at a series of step-like features spanning a region along the saddle-to-carrier pipe weld centered at the approximate 7:30 position on the underside of the branch connection (looking from the branch connection towards the carrier pipe with 12:00 being up);

5. Examination of the crack initiation sites at each step-like crack origins indicated that the pipe rupture was the result of a one-time 'mechanical' overload event of the laminations within the carrier pipe wall;

View of pipe at failure origin - tap was located at this point
