DOT US Department of Transportation  
PHMSA Pipelines and Hazardous Materials Safety Administration  
OPS Office of Pipeline Safety  
Western Region

**Principal Investigator** Hossein Monfared  
**Regional Accident Coordinator** Peter J. Katchmar  
**Region Director** Chris Hoidal  
**Date of Report** 03/14/2013  
**Subject** Failure Investigation Report – El Paso-Mojave GT 2012-5-2

Mojave Pipeline Relief Event 2 MAY 2012

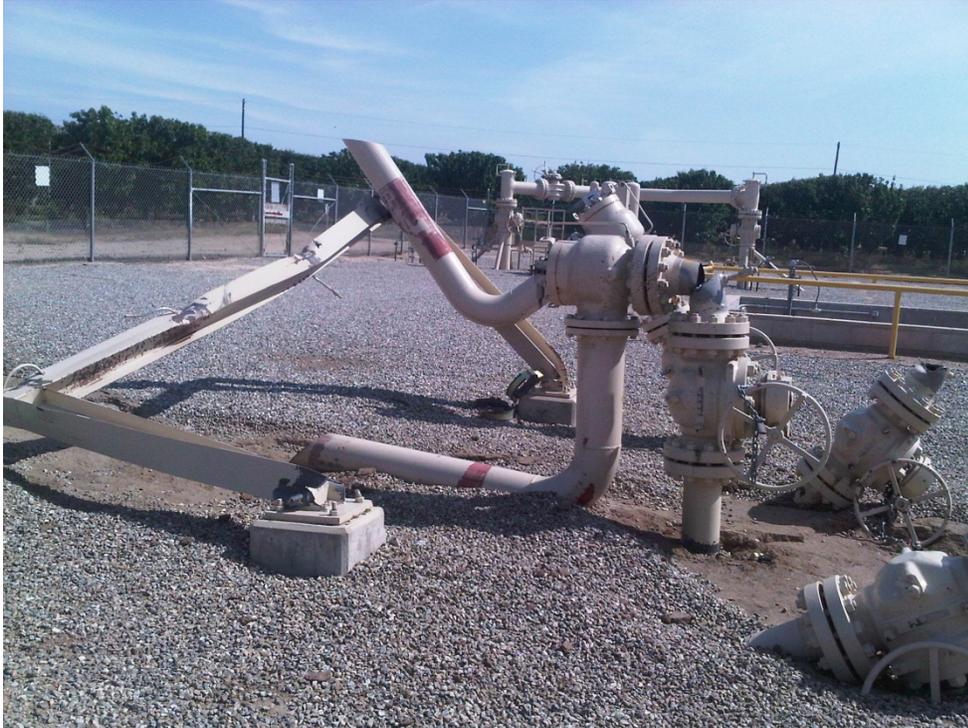
- Undersized structural members in support to withstand predicted forces of venting
- Incorrect orientation of support columns and cross member (weak axis exposed)
- Connection between tail pipe and support didn't insure transfer of forces”

Failure of RV Support System. I-Beam is 90 degree from proper for maximum support. No 45 degree braces to counter moment applied by relief force.

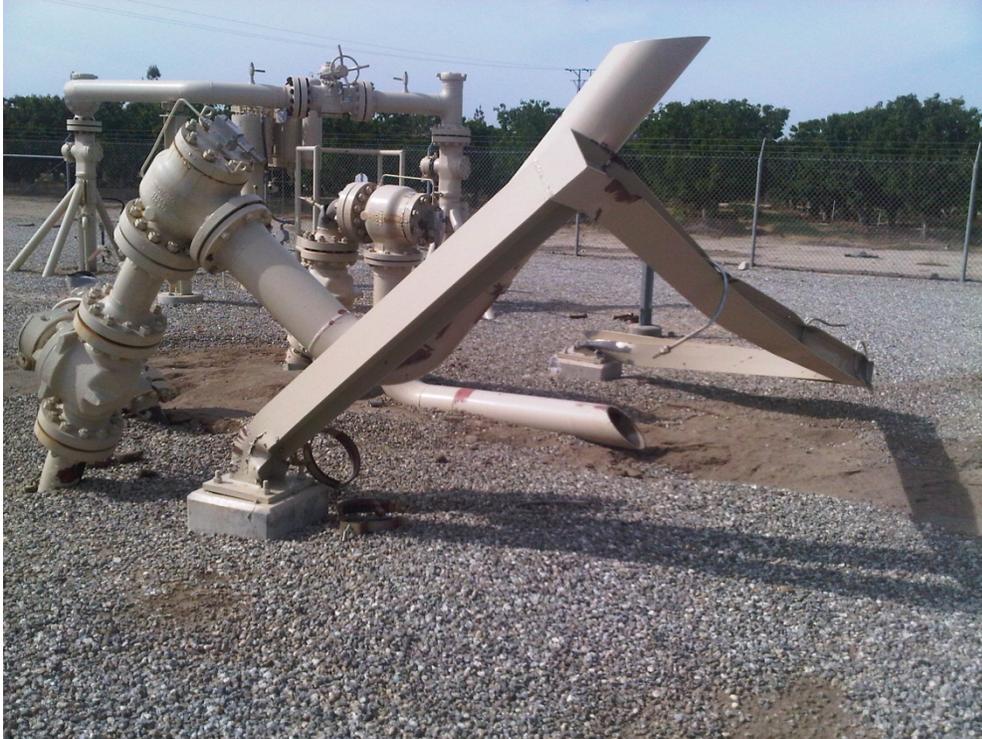
180 degree picture from prior picture.

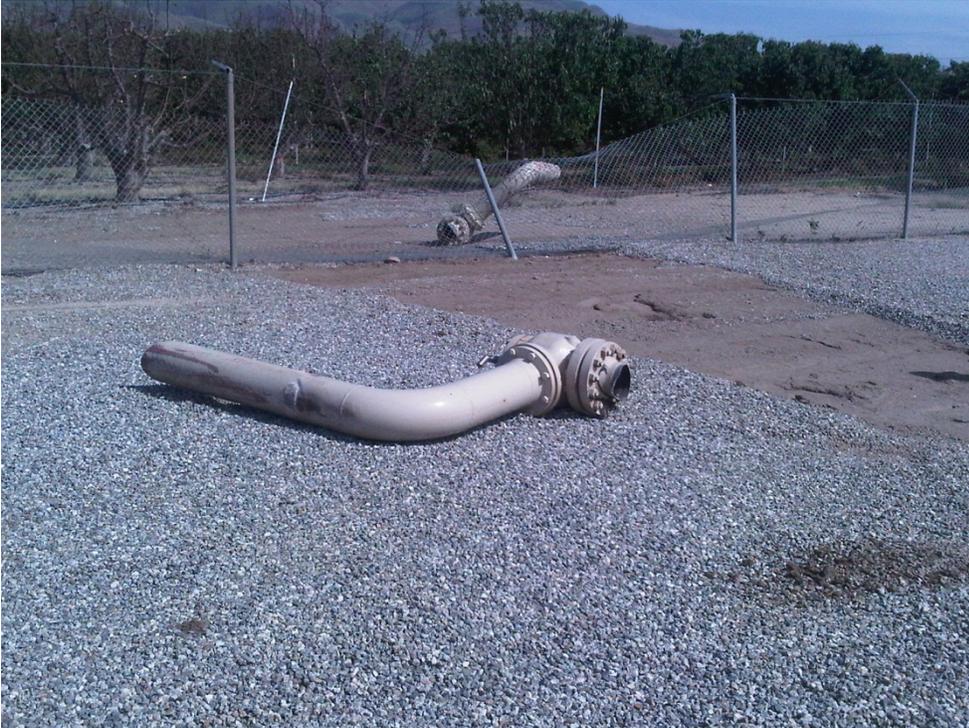
Two (2) Relief vents thrown clear after failure of relief support system.

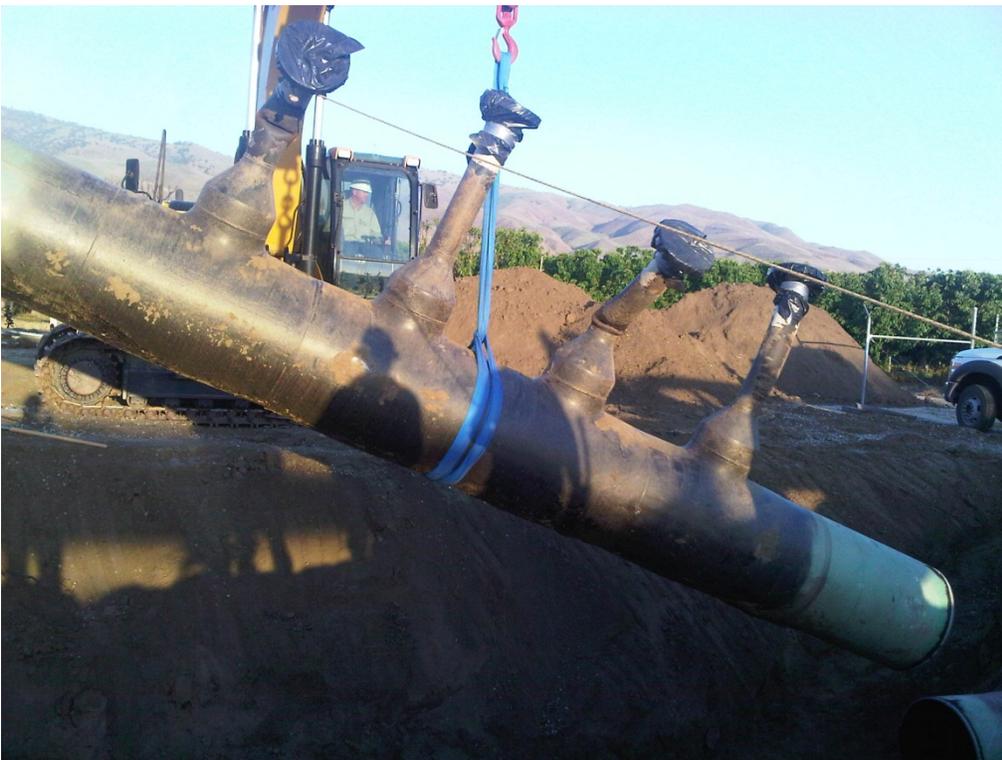
30" RV Header Pipe being removed. Tee outlets are 8" swaged down to 6".

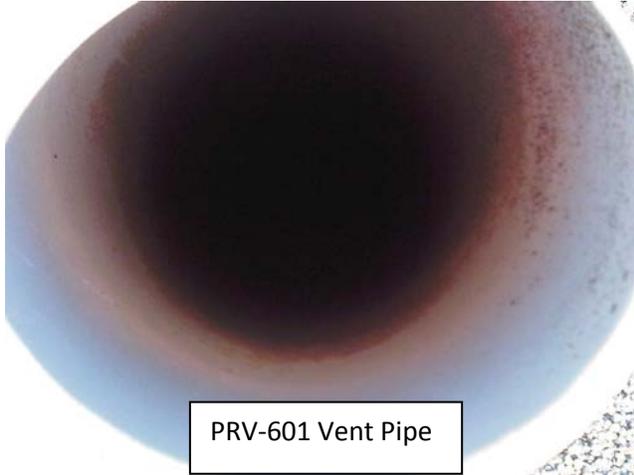
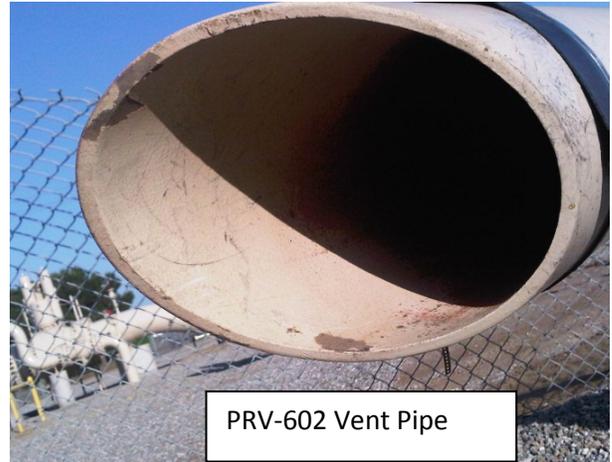
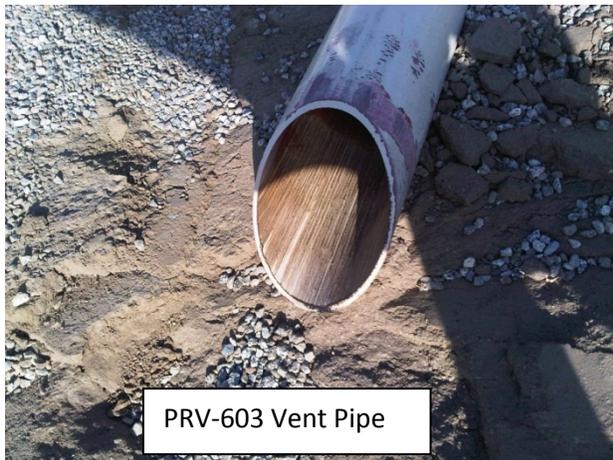
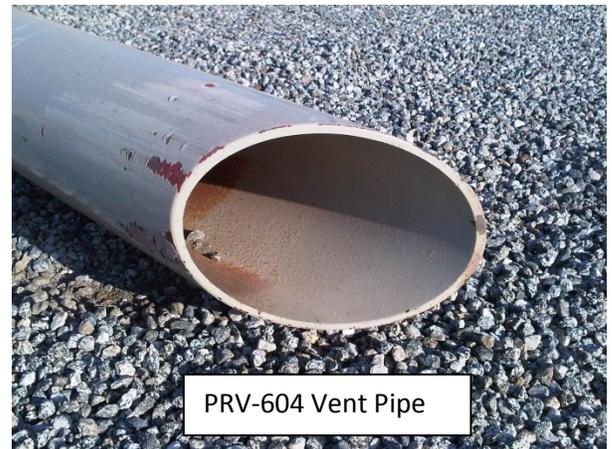
Four (4) Vent Stacks showing only PRV-603 possibly relieved. Operator stated that none of these relief devices have ever actuated prior to 5/2/12. Installation was circa 1991/1992.
