**CENTRAL REGION OFFICE
Construction Inspection Report**

Project: Alberta Clipper Superior Station work

Location: Superior WI

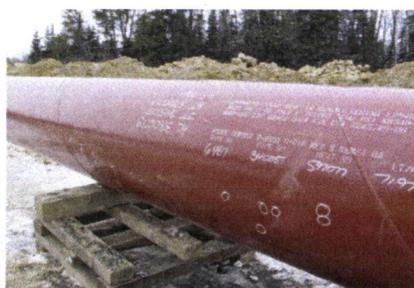
Photograph Description
Photo 2: Region containing lots of holidays found during jeeping.

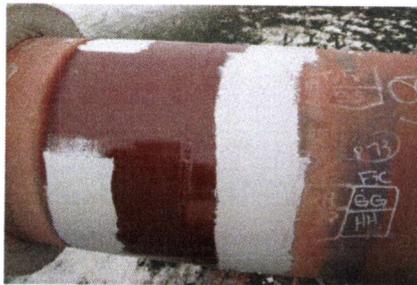
Met with Jay Black (Chief Inspector), Doug Love and Darrel Cradell (weld Inspectors) at MP 1033. Observed 36" pipe with concrete overlay that contained two part epoxy near the girth weld on nearly all pipe sections. Jay Black explained that this was required since the width of the ring used to apply FBE was limited due to the concrete on the pipe hence FBE did not extend to parent coating and required the two part epoxy.

Photograph Description
Epoxy to Parent Coating.

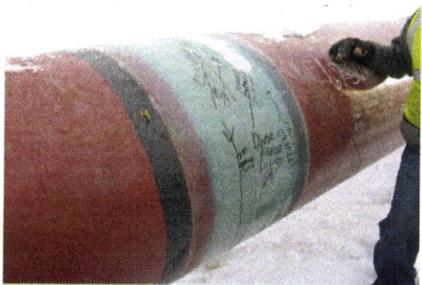
Coating:
 --Observed coating repairs made to FBE coated girth weld areas between station 15898+68.8 and 15869+32.5. The repairs consisted of pin hole and blister repairs made on the field applied coating with 2-part epoxy.

Photograph Description
Coating Repairs

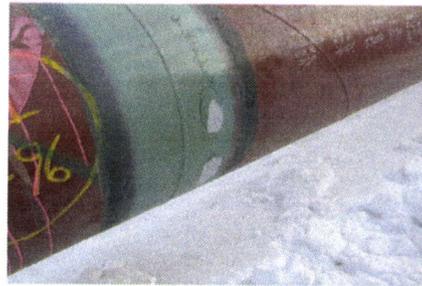
Photograph Description
Coating Repairs

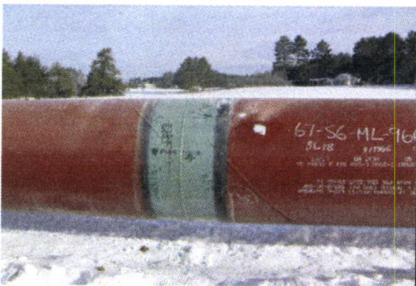
Photograph Description
Coating Repairs

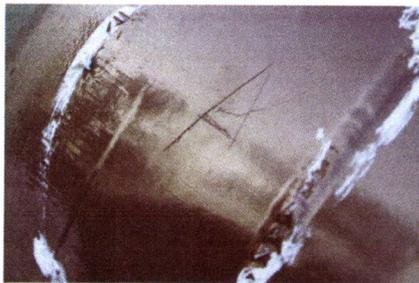
The inspection prompted a knife test to be performed at station 10600+00 (MP973) to see if any disbondment of the coating from the pipe would occur at the areas of cracking. Upon conclusion of the test, no signs of coating disbondment were noted. Enbridge stated that they would investigate the depth of the spider cracking in follow up.

Photograph Description
Cut in coating after knife test and view of cracks in coating.

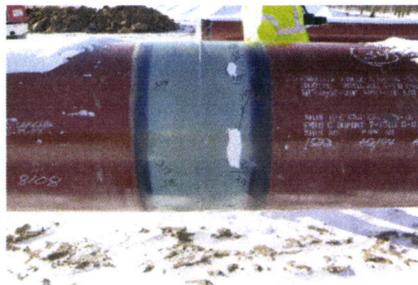
Photograph Description
FBE Coated girth weld after holiday repair and verification of coating thickness.

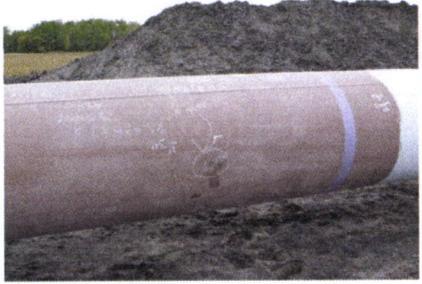
Photograph Description
 missed repair - jeep.

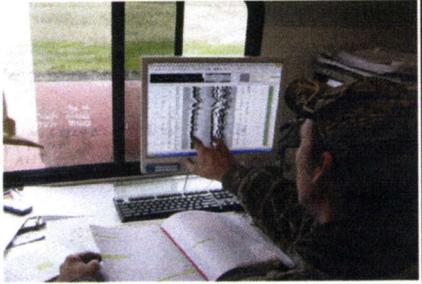
Photograph Description
 Reviewing cracked weld

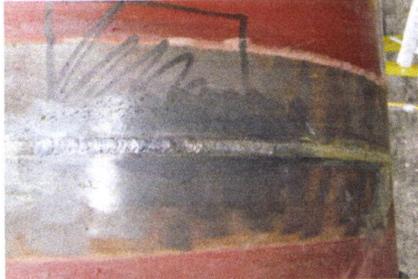
Photograph Description
 Repair weld

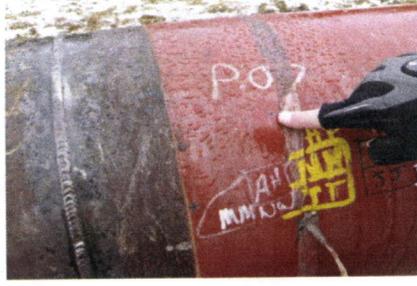
Photograph Description
 Weld Splatter

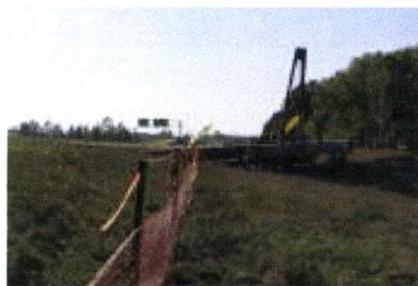
- Observed the failure of a highway 2 crossing. Enbridge attempted to push a 36" dia pipe under the highway with a machine called a "thumper". It basically uses brute force and thumps the pipe. In this case, a large boulder was hit and deflected the pipe upward. The pipe pierced the surface about 4ft on the east side of the north bound lane. The crossing was then open cut during the weekend with the damaged pipe removed and a new pipe section installed.

Photograph Description
Hwy 2 crossing "failure" of the 36" pipe using the "thumper".
