Memorandum

U. S. Department
of Transportation
**Pipeline and
Hazardous Materials
Safety Administration**

Subject: Incident Report – Enterprise Products Operating LLC
Operator Number 31618, Unit Number 60534
Accident Location: Port Bolivar Galveston, TX
Date of Accident: December 23, 2009, NRC Number: 926954
SMART Activity # 128212 IO3

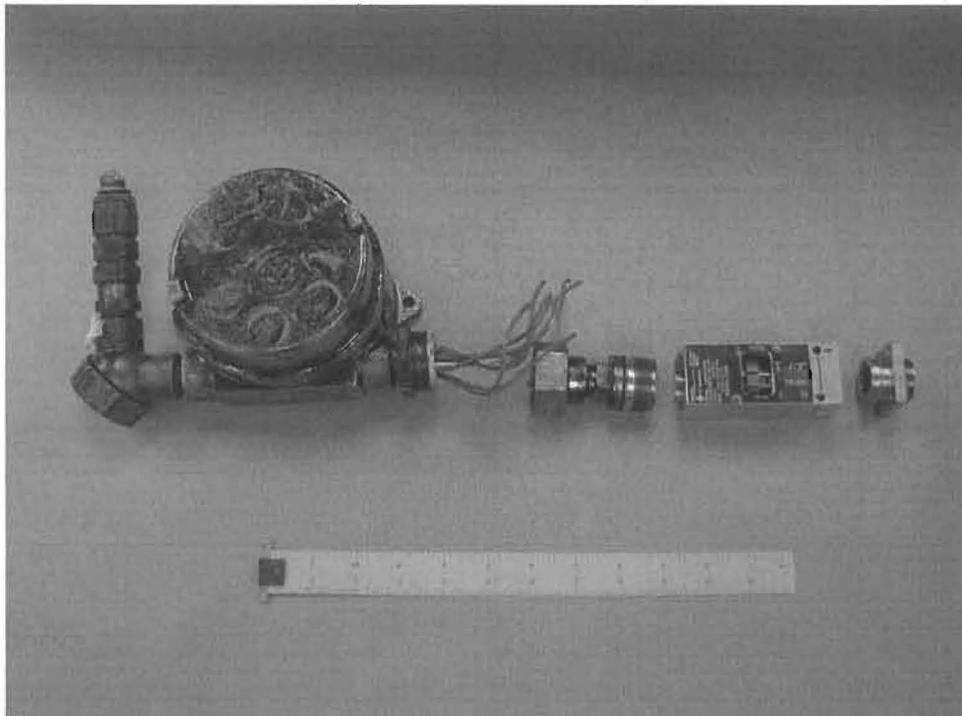
A view of the failed switch is presented in Photograph 1 (in Appendix A). A closer view of the cap that separated from the remainder of the switch is shown in Photograph 2. The end of one of the four screws that failed during the incident is just visible in Photograph 2 and is marked by the arrow in the photograph.

Photo 1: The failed switch supplied for this investigation. The failure occurred at the right end of the switch, as shown in this photograph.

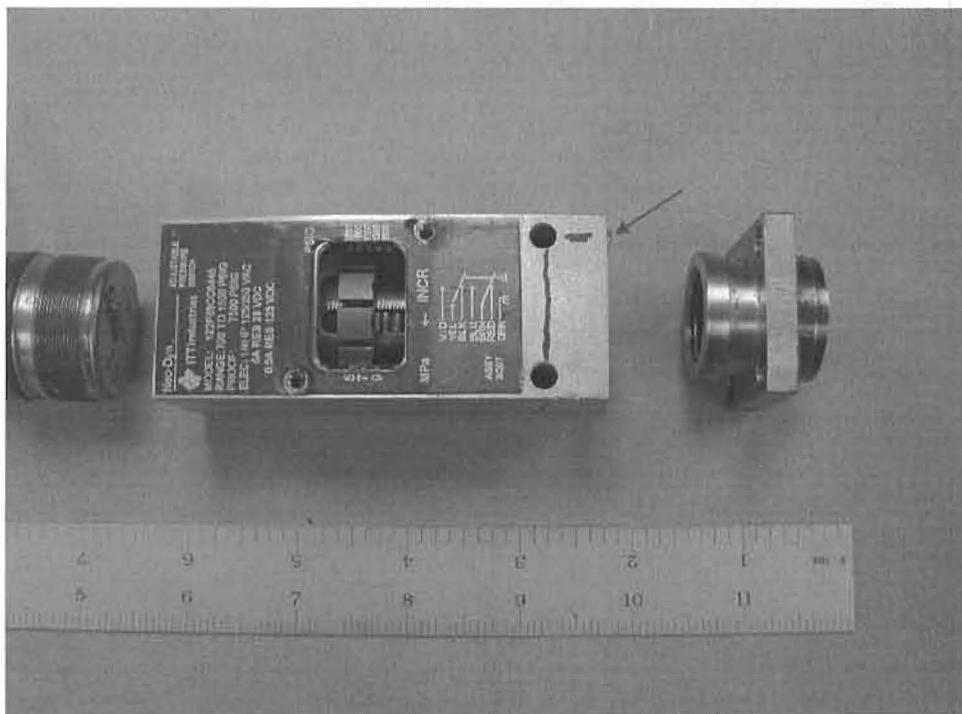
Photo 2: A closer view of the failure location. One of the failed screws is just visible in this view and is marked with the arrow.

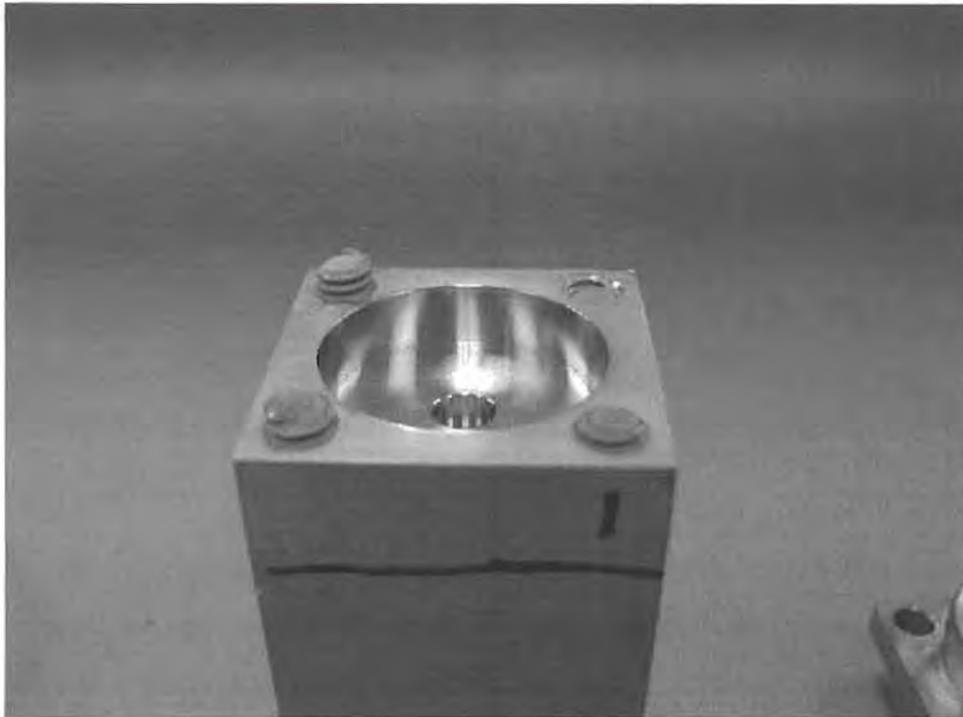
Closer views of the ends of the broken screws are presented in Photographs 3 and 4. The outer ends of all the broken screws were apparently lost during the incident.

Photo 3: A view of the outer ends of all the failed screws.

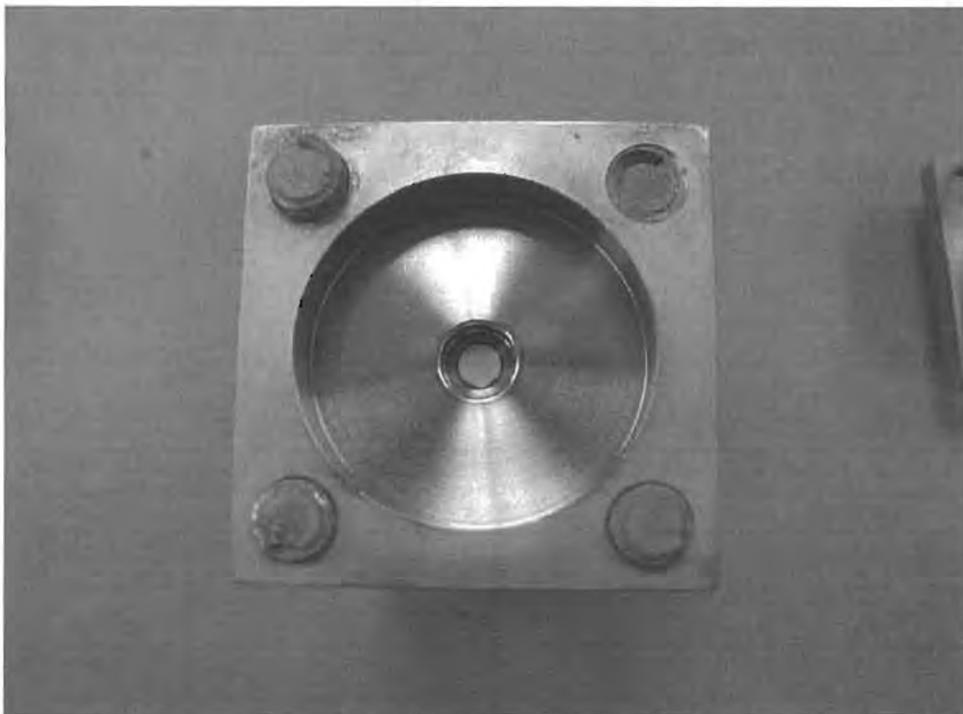
Screw # 1 had what appeared to be a coating of a foreign substance on its fracture surface, while the fracture surfaces of the other three screws were very clean and appeared to be essentially identical. The ends of screws # 1 and # 3 were thus removed from the body of the switch for more detailed examination of their fracture surfaces. In view of their similarity to screw # 3, screws # 2 and # 4 were not examined in detail.

Photo 4: A closer view of the fracture faces on the screws. Screw # 1 is the upper left, screw # 2 is at the upper right, screw # 3 is at the lower right and screw # 4 is at the lower left in the photograph.

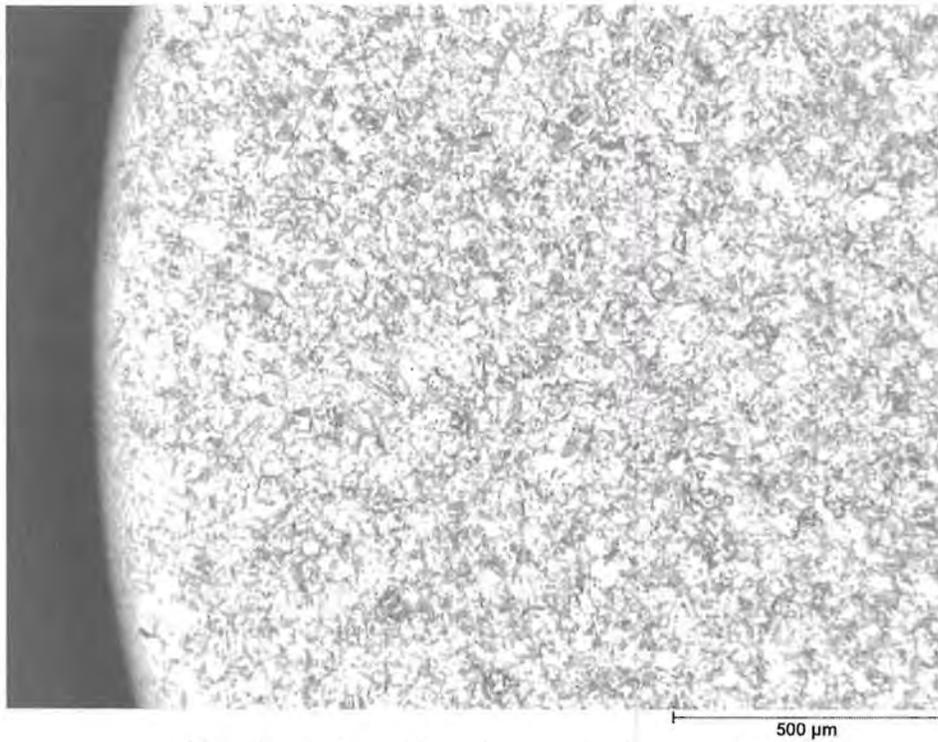
Photo 5: A view of the microstructure in screw # 1.

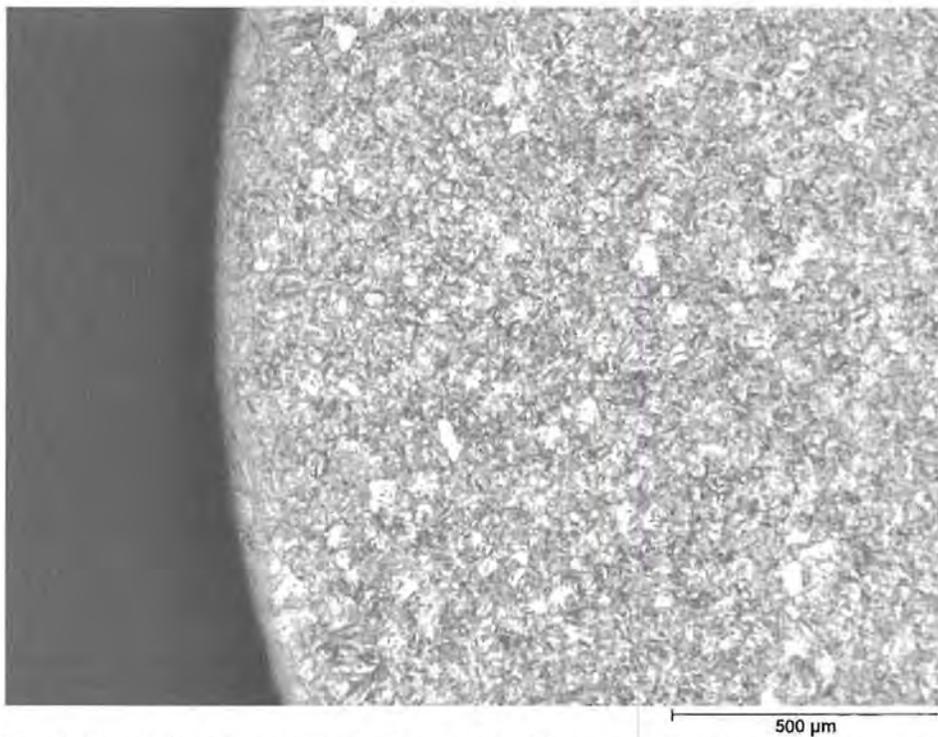
Photo 6: A view of the microstructure in screw # 3. The structures in both screws are essentially identical and appear typical of a quenched and tempered high alloy steel.

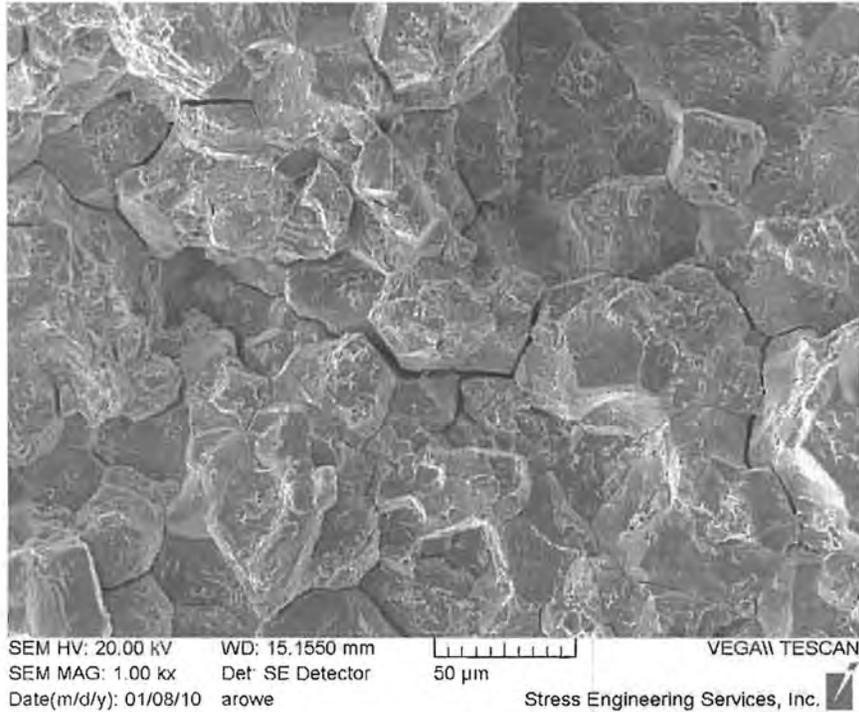
The fracture surfaces on screws # 1 and # 3 are shown in Photographs 7 and 8, respectively. As can be seen the fracture surfaces appeared to be identical. The fracture surfaces both had the "rock candy" texture that is typical of hydrogen stress cracking that has occurred along prior austenitic grain boundaries in a quenched and tempered steel structure.

The similarity of the clean fractures on screws # 2, # 3, and # 4 plus the similarity of the fracture surface structures shown in Photographs 7 and 8 indicate that all of the failed attachment screws apparently failed primarily due to hydrogen stress cracking. The lack of any significant corrosion damage on the cleaned face of screw # 1 indicates that corrosion due to the presence of the zinc carbonate deposit apparently played little, if any, direct role in the fracture of screw # 1.

Photo 7: The fracture surface on screw #1 following ultrasonic cleaning. The fracture face appears typical of hydrogen stress cracking.

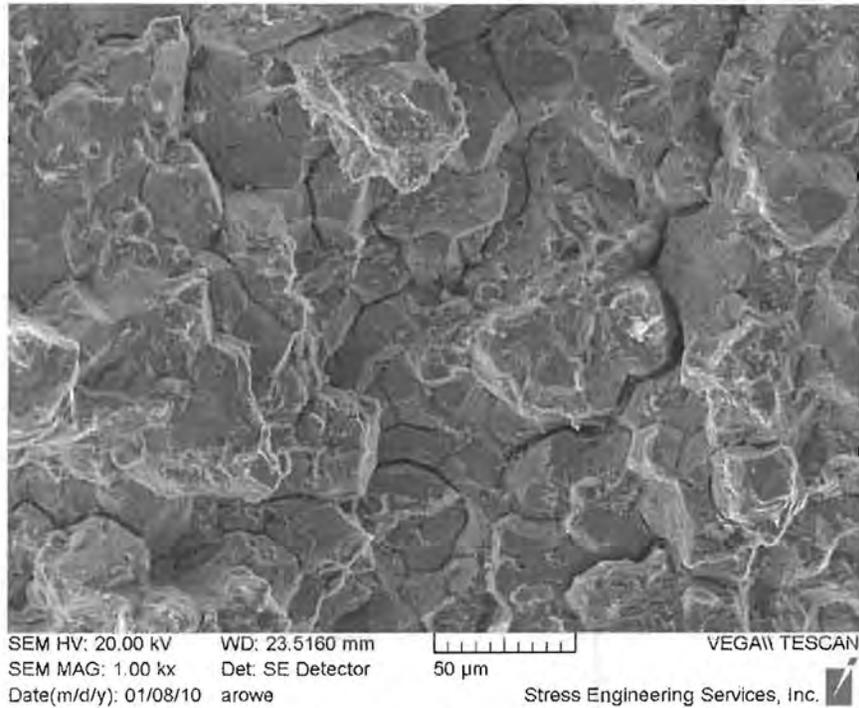
Photo 8: The fracture surface found on screw # 3. The structure is essentially identical to that shown in Photograph 7.

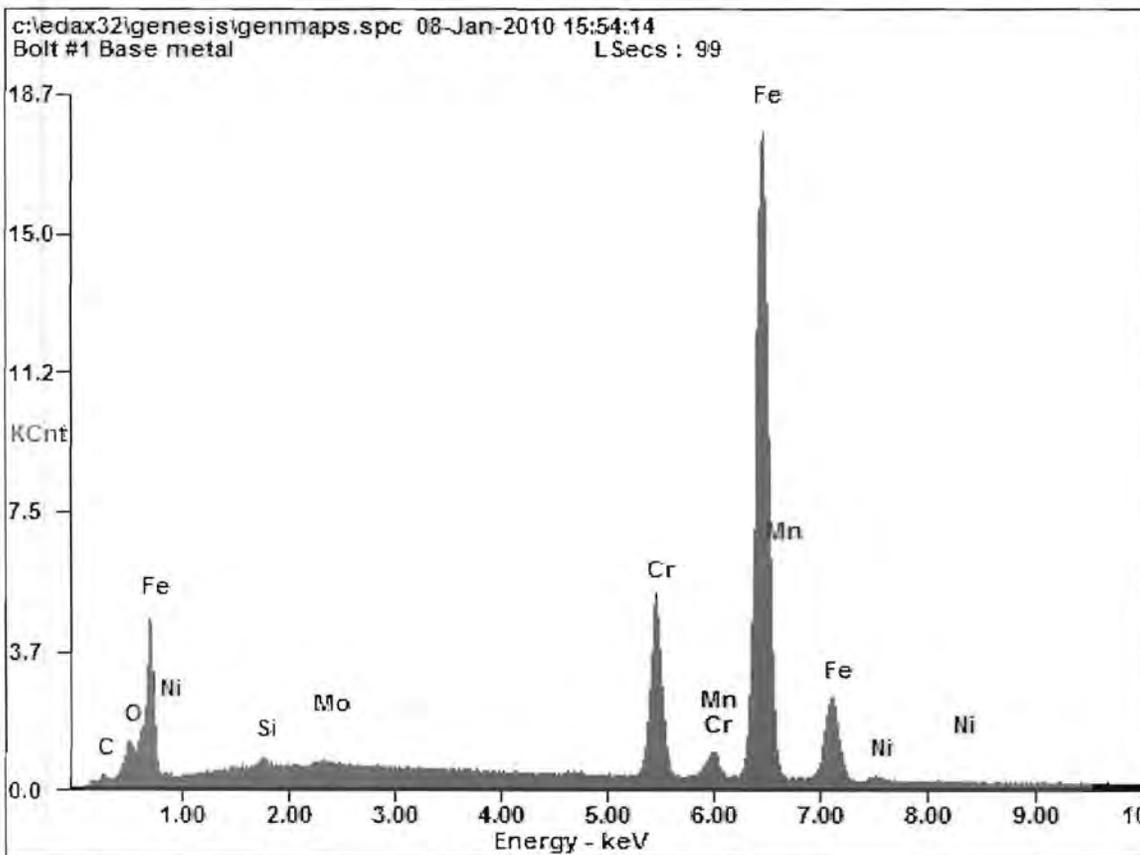
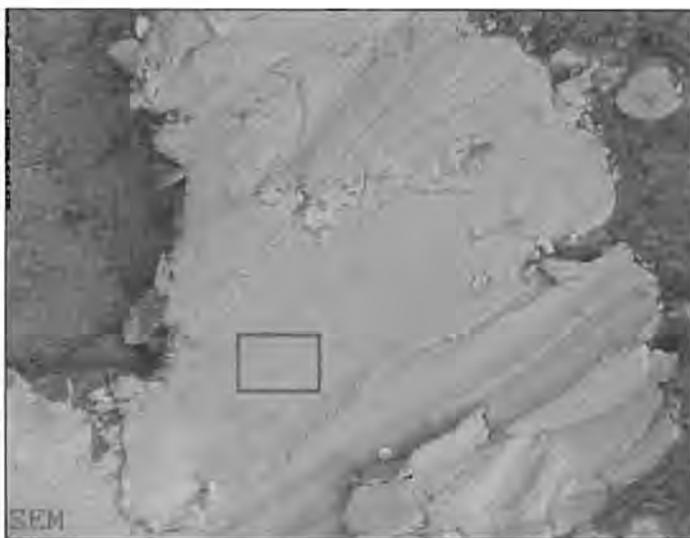
SCAN I

The measured compositions of the screws # 1 and # 3 are presented in Scans I and II in Appendix B. The analyses indicated that the screws had been fabricated of stainless steel containing approximately 13 % chromium.

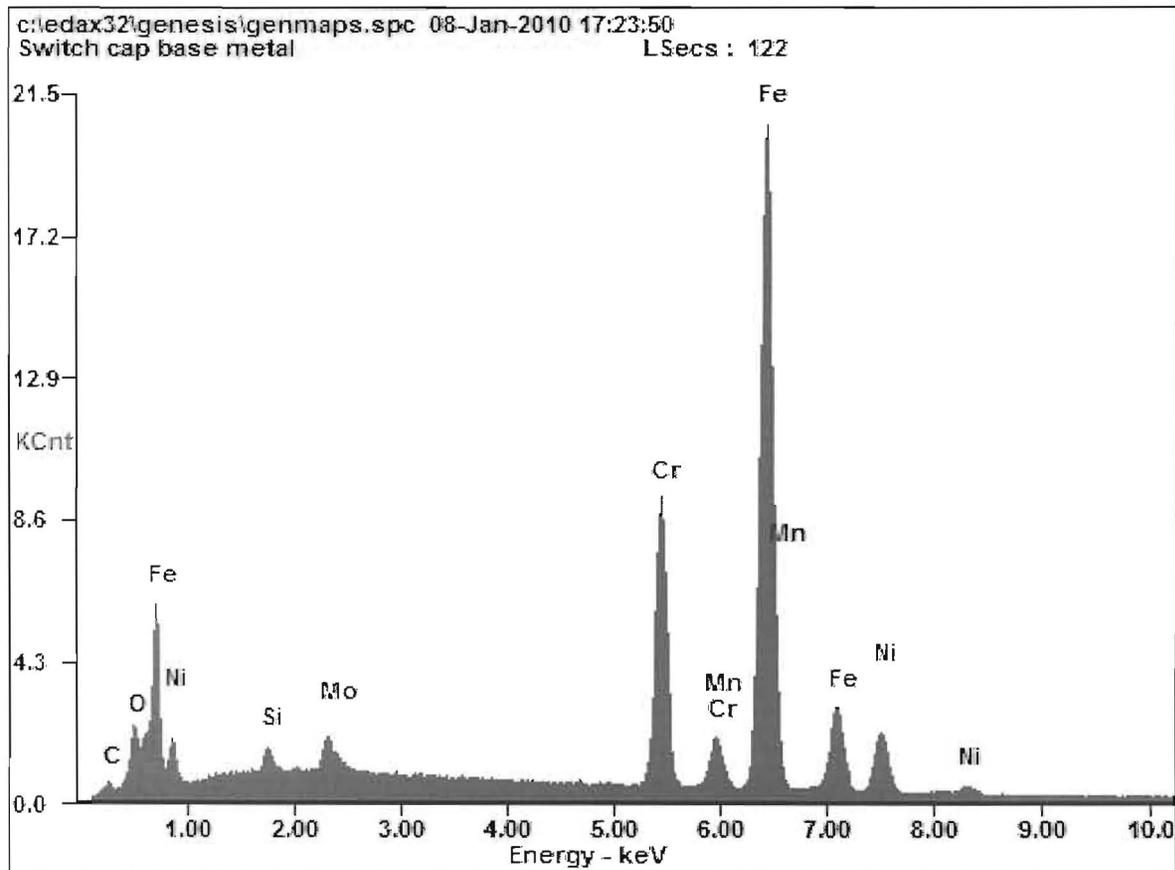
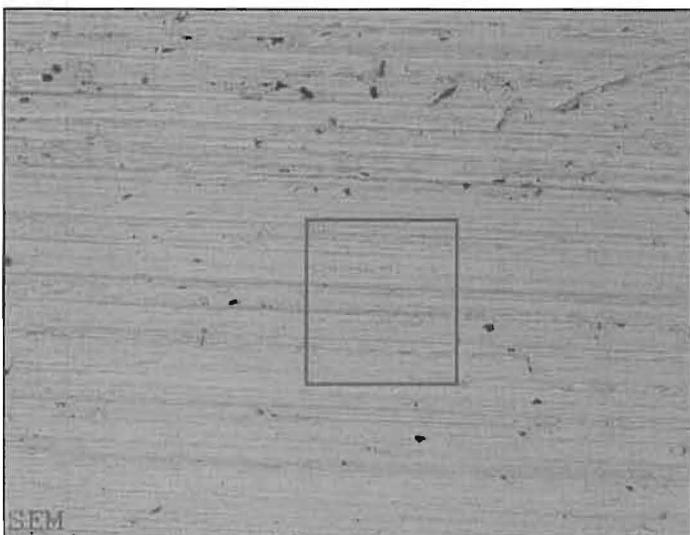
SCAN III

The composition of the housing in which the screws had been located during use is presented in Scan III. The analysis of the housing showed that it had apparently been fabricated of a Type 316, austenitic stainless steel.

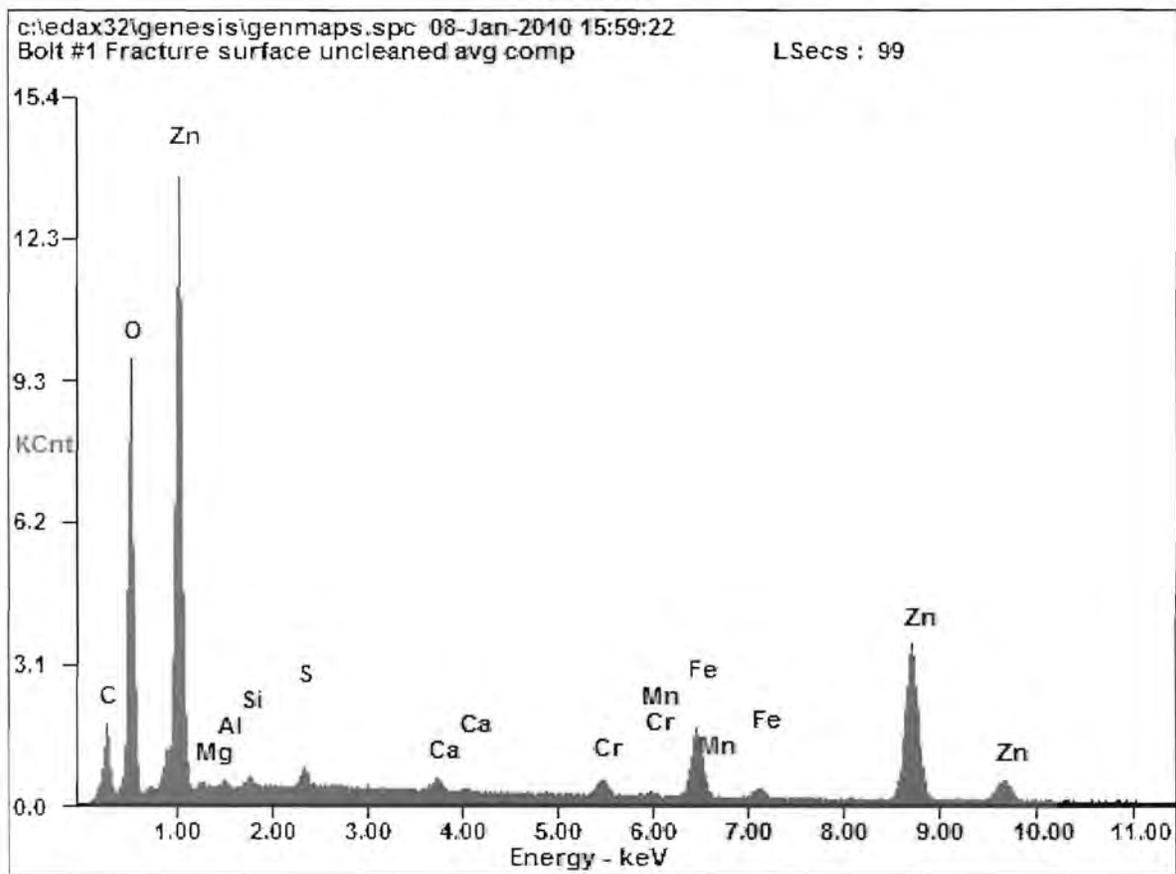
SCAN IV

Also presented in Appendix B (Scan IV) is the composition of the foreign substance found on the as-received fracture surface of screw # 1. As shown in scan IV, the foreign substance appeared to consist primarily of zinc, carbon, and oxygen. It thus appeared that the foreign substance may have consisted of zinc carbonate.

On the other hand, it should be noted that the foreign substance contained low concentrations of iron and chromium and thus did not appear to have been a corrosion product. Corrosion of the underlying screw would probably have produced a layer of mixed iron and chromium oxides on the screw surface.

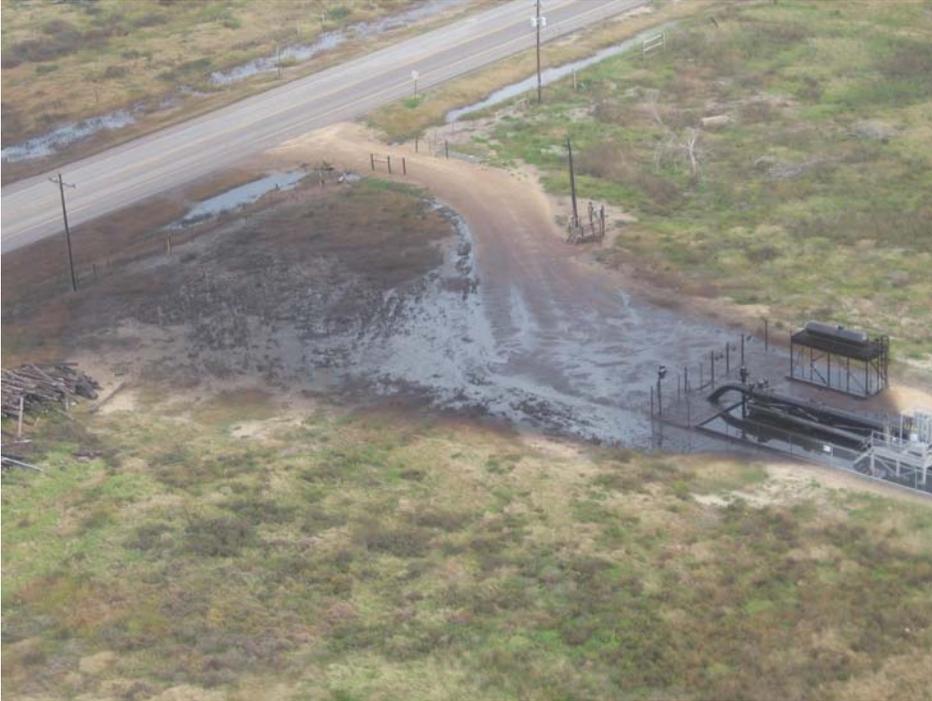
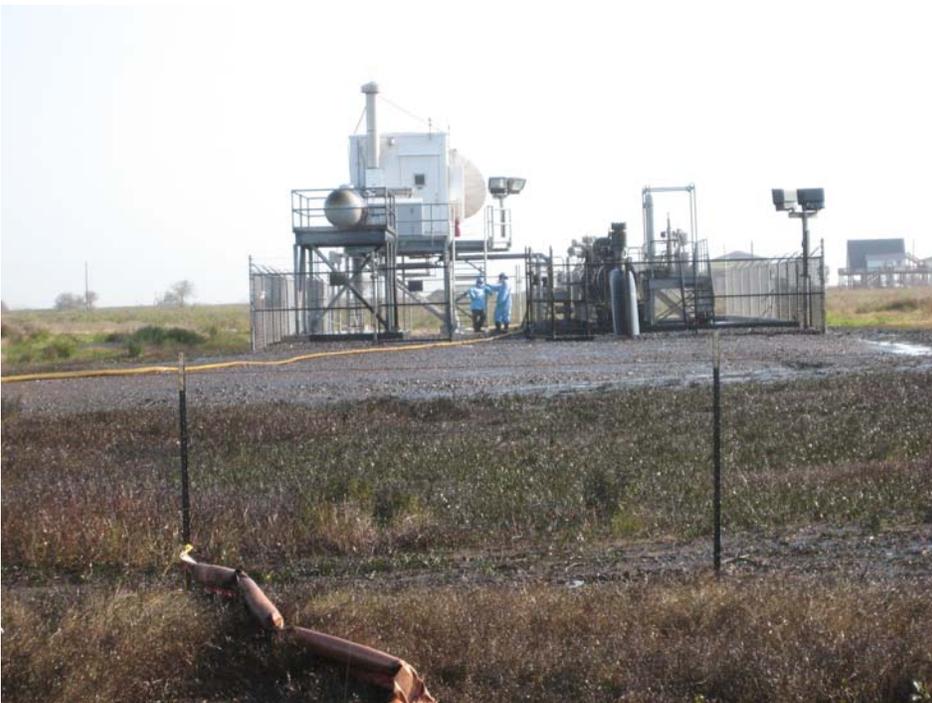
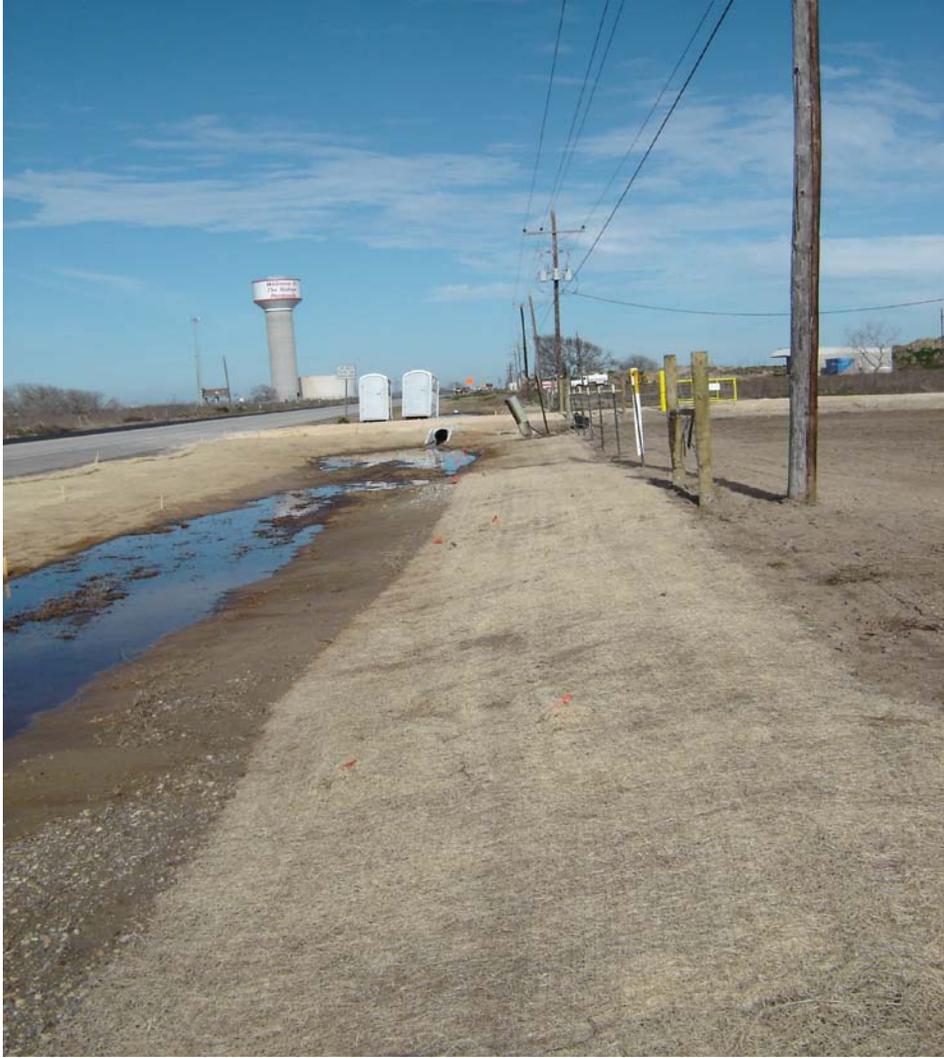
Figure 1 – Photographs taken on December 23, 2009 showing aerial view and ground view of Enterprise Bolivar Station facility following release of crude oil. Highway 87 is shown in the aerial view, and it was the road closed as a result of the release.

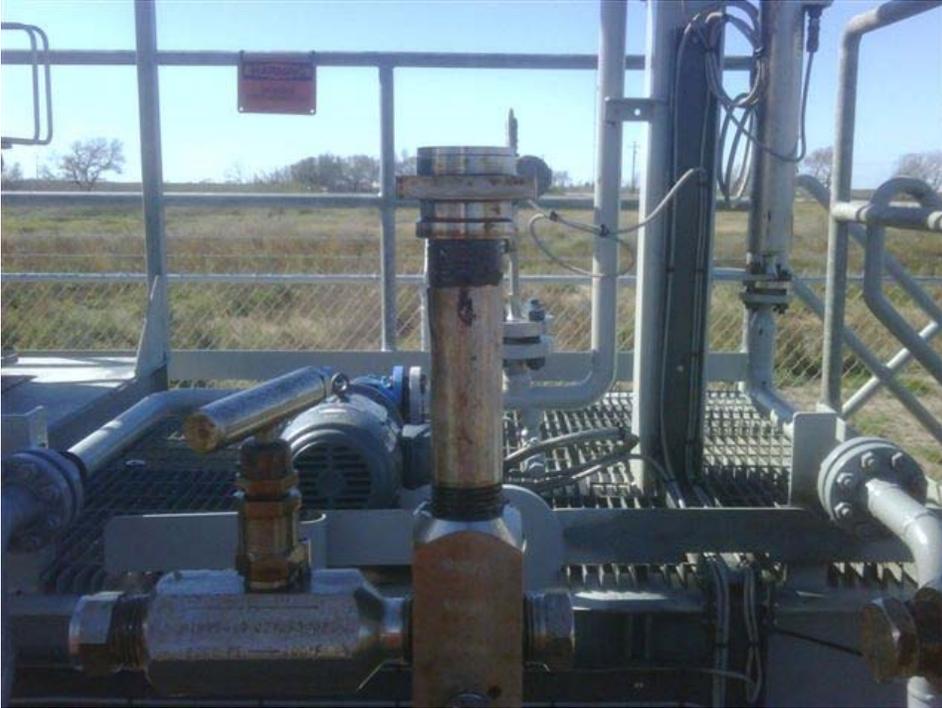
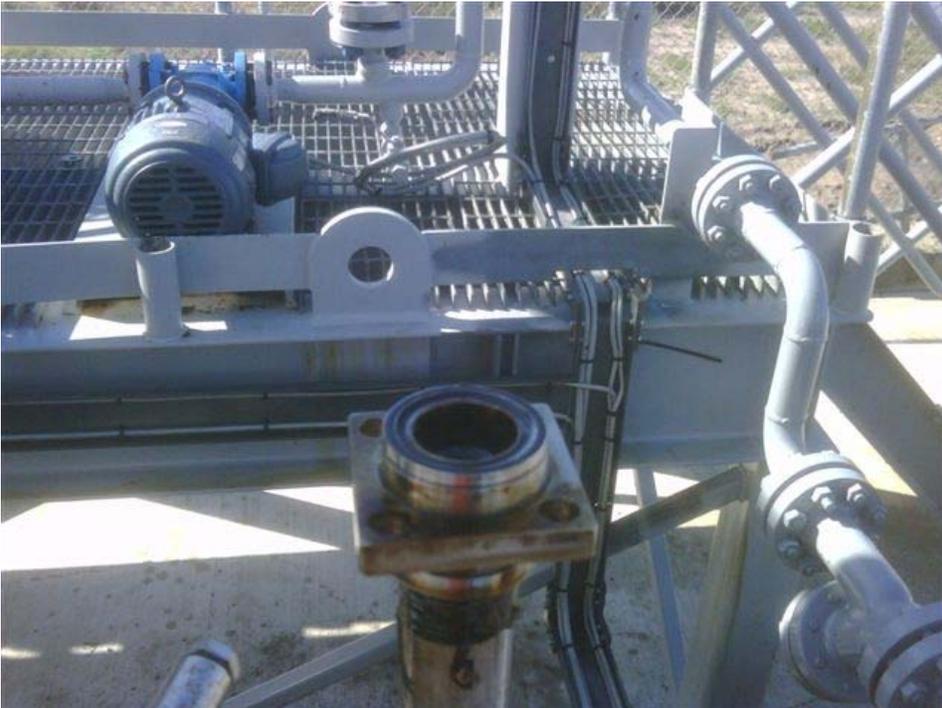
Figure 2 – Photographs showing station piping where the failed pressure switch was located. The pressure had been removed prior to these photographs, and it is shown in the Metallurgical Report in Appendix E.

- Replaced the failed pressure switch (ITT Neodyne, model 122P88CC6448) with a different pressure switch manufactured by Custom Control Sensors, model 646GZE. This model has been widely used at the facility and proven to be reliable. Enterprise has had no problems in the field with this model, to date.
- Installed excess flow valves between the ¾” Whitley isolation ball valve and PSL-11004 and PSH-11003 to prevent overflow
