Principal Investigator Jon Manning
Region Director R.M. Seeley
Date of Report 10/20/2011
Subject Failure Investigation Report – Enterprise Offshore Gas Platform Fire

Failure Investigation Report – Enterprise Offshore Gas Platform Fire

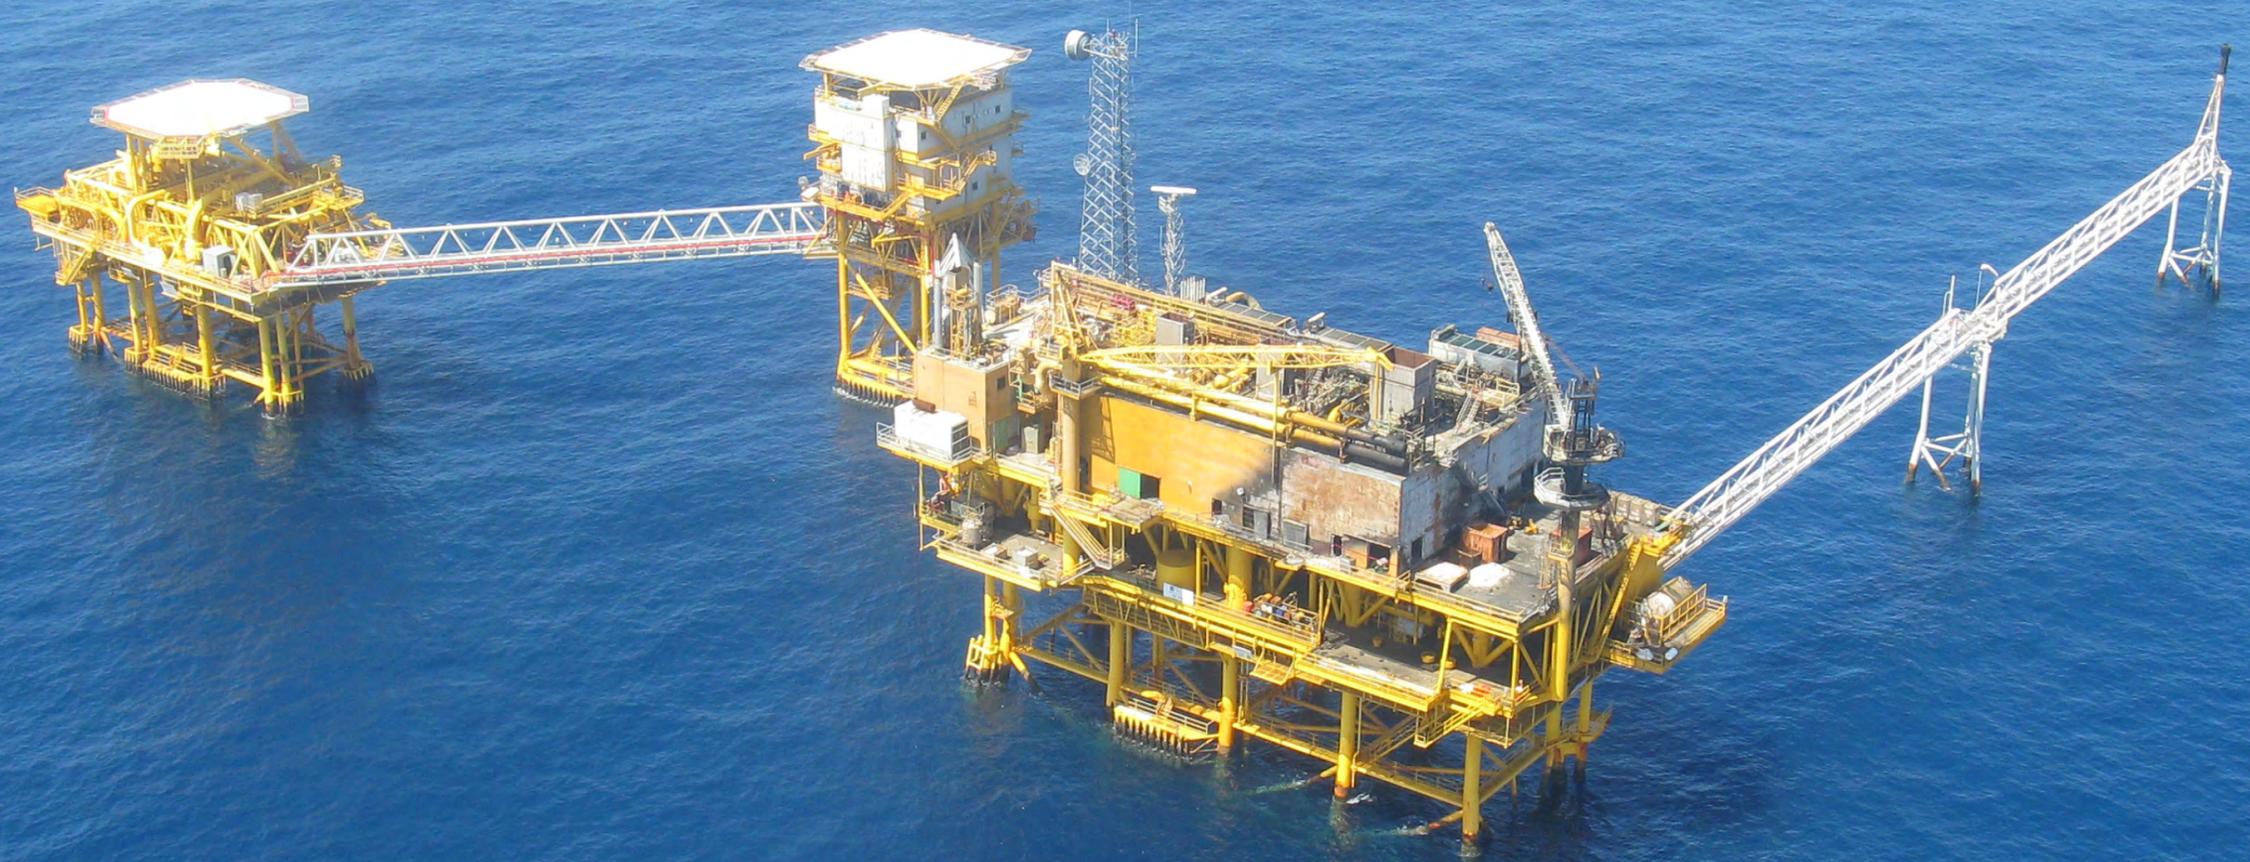
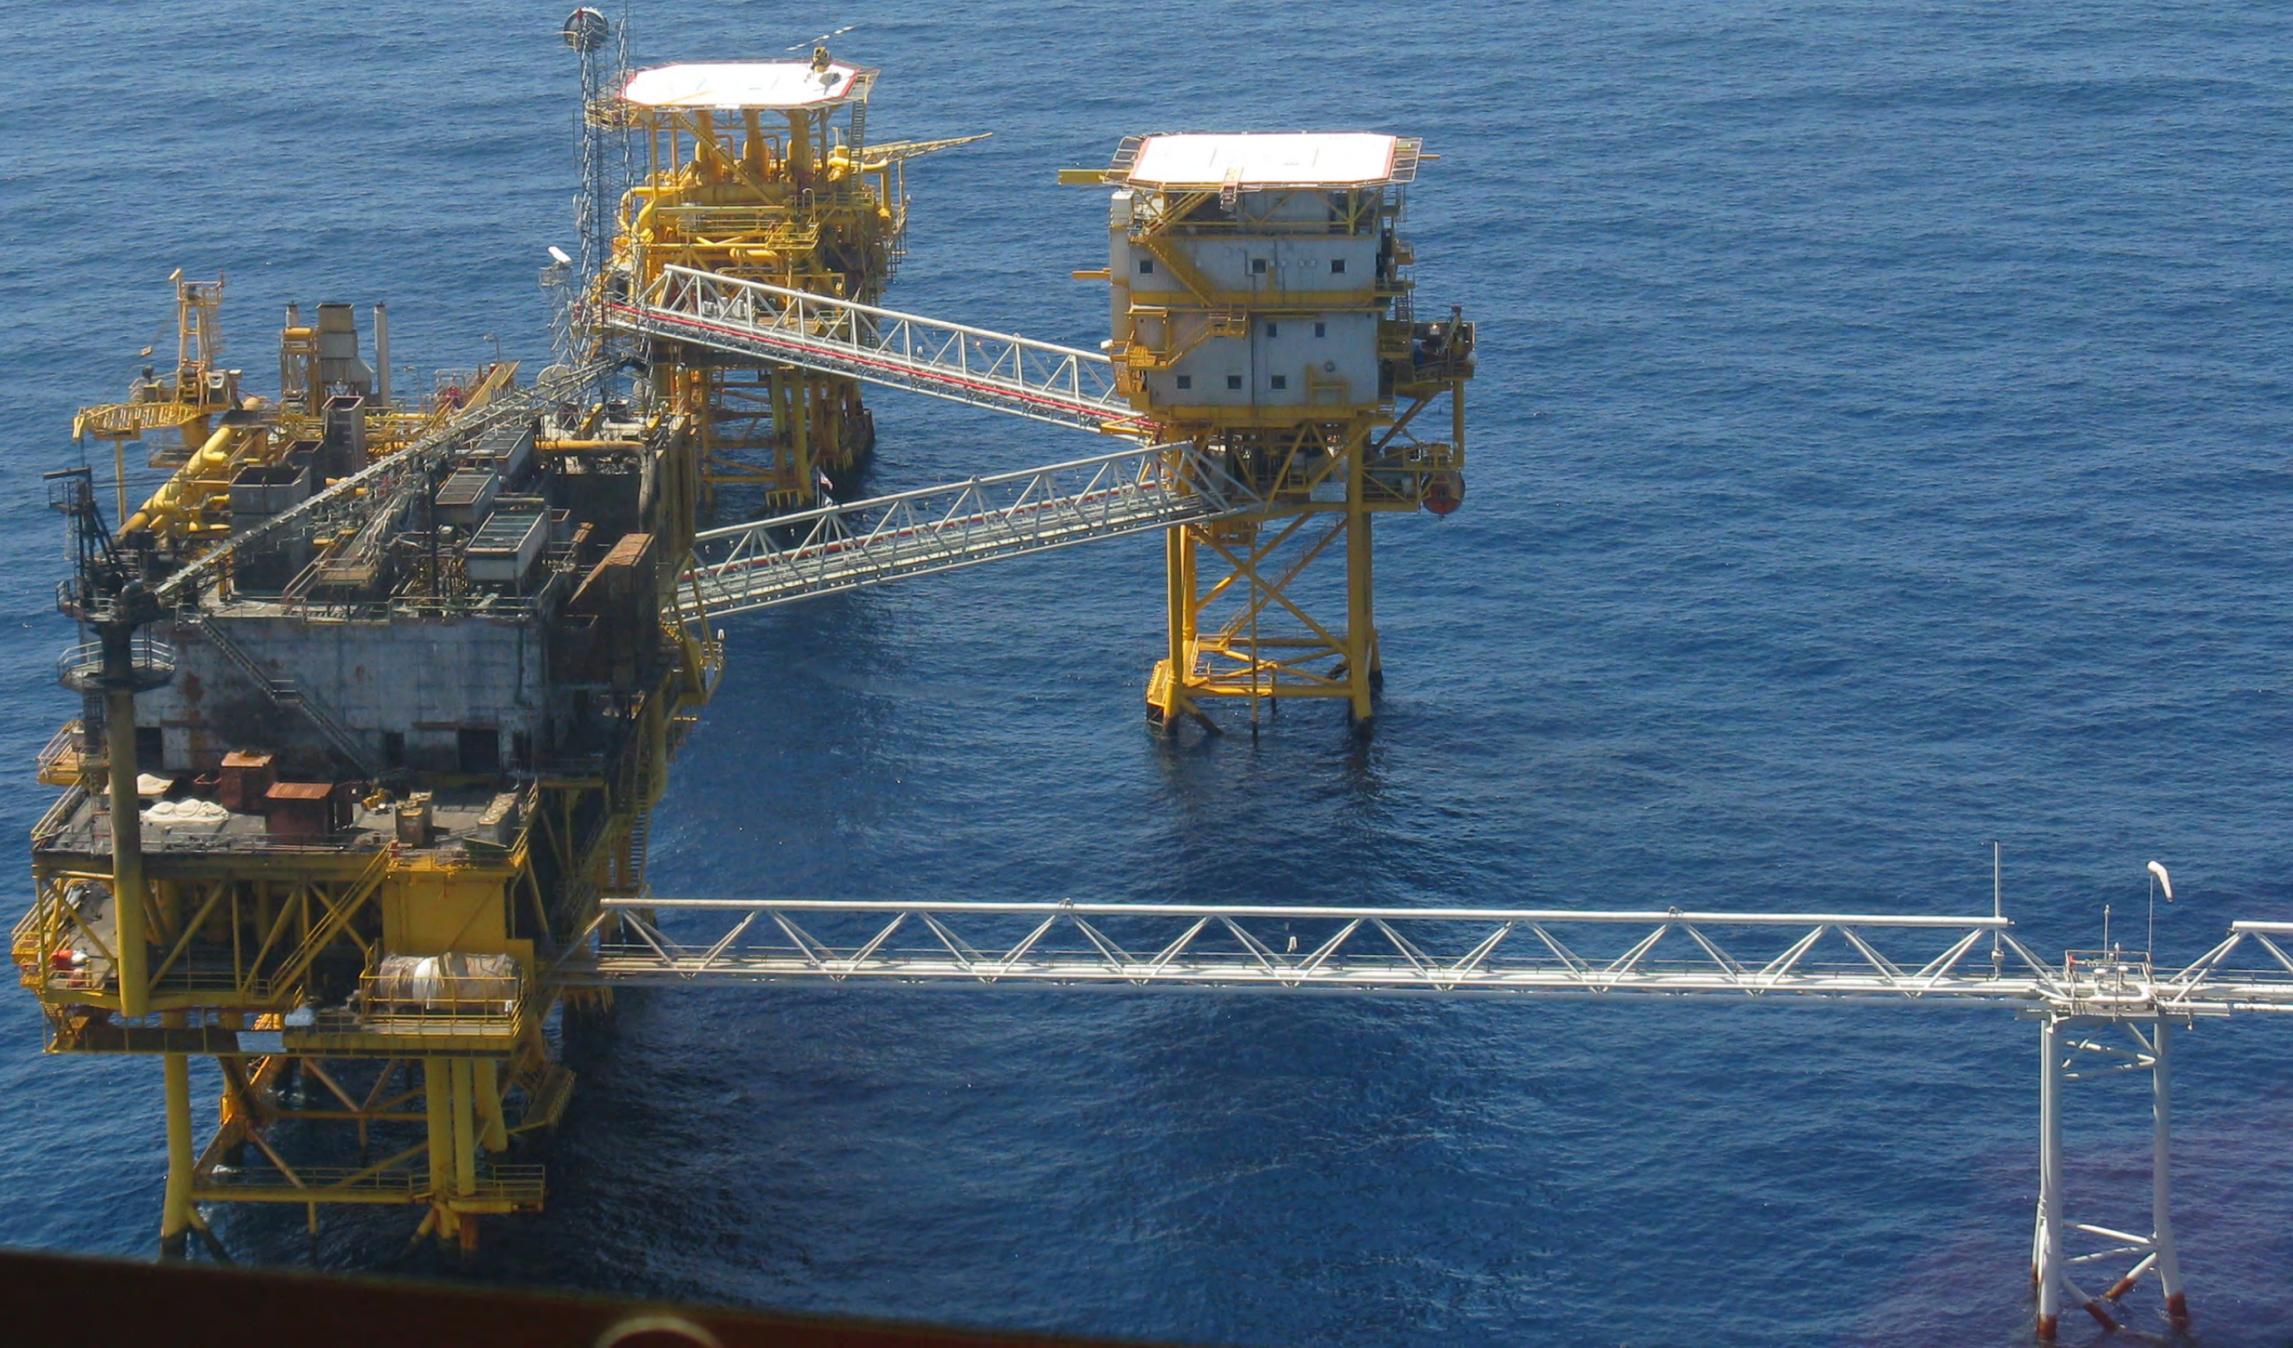
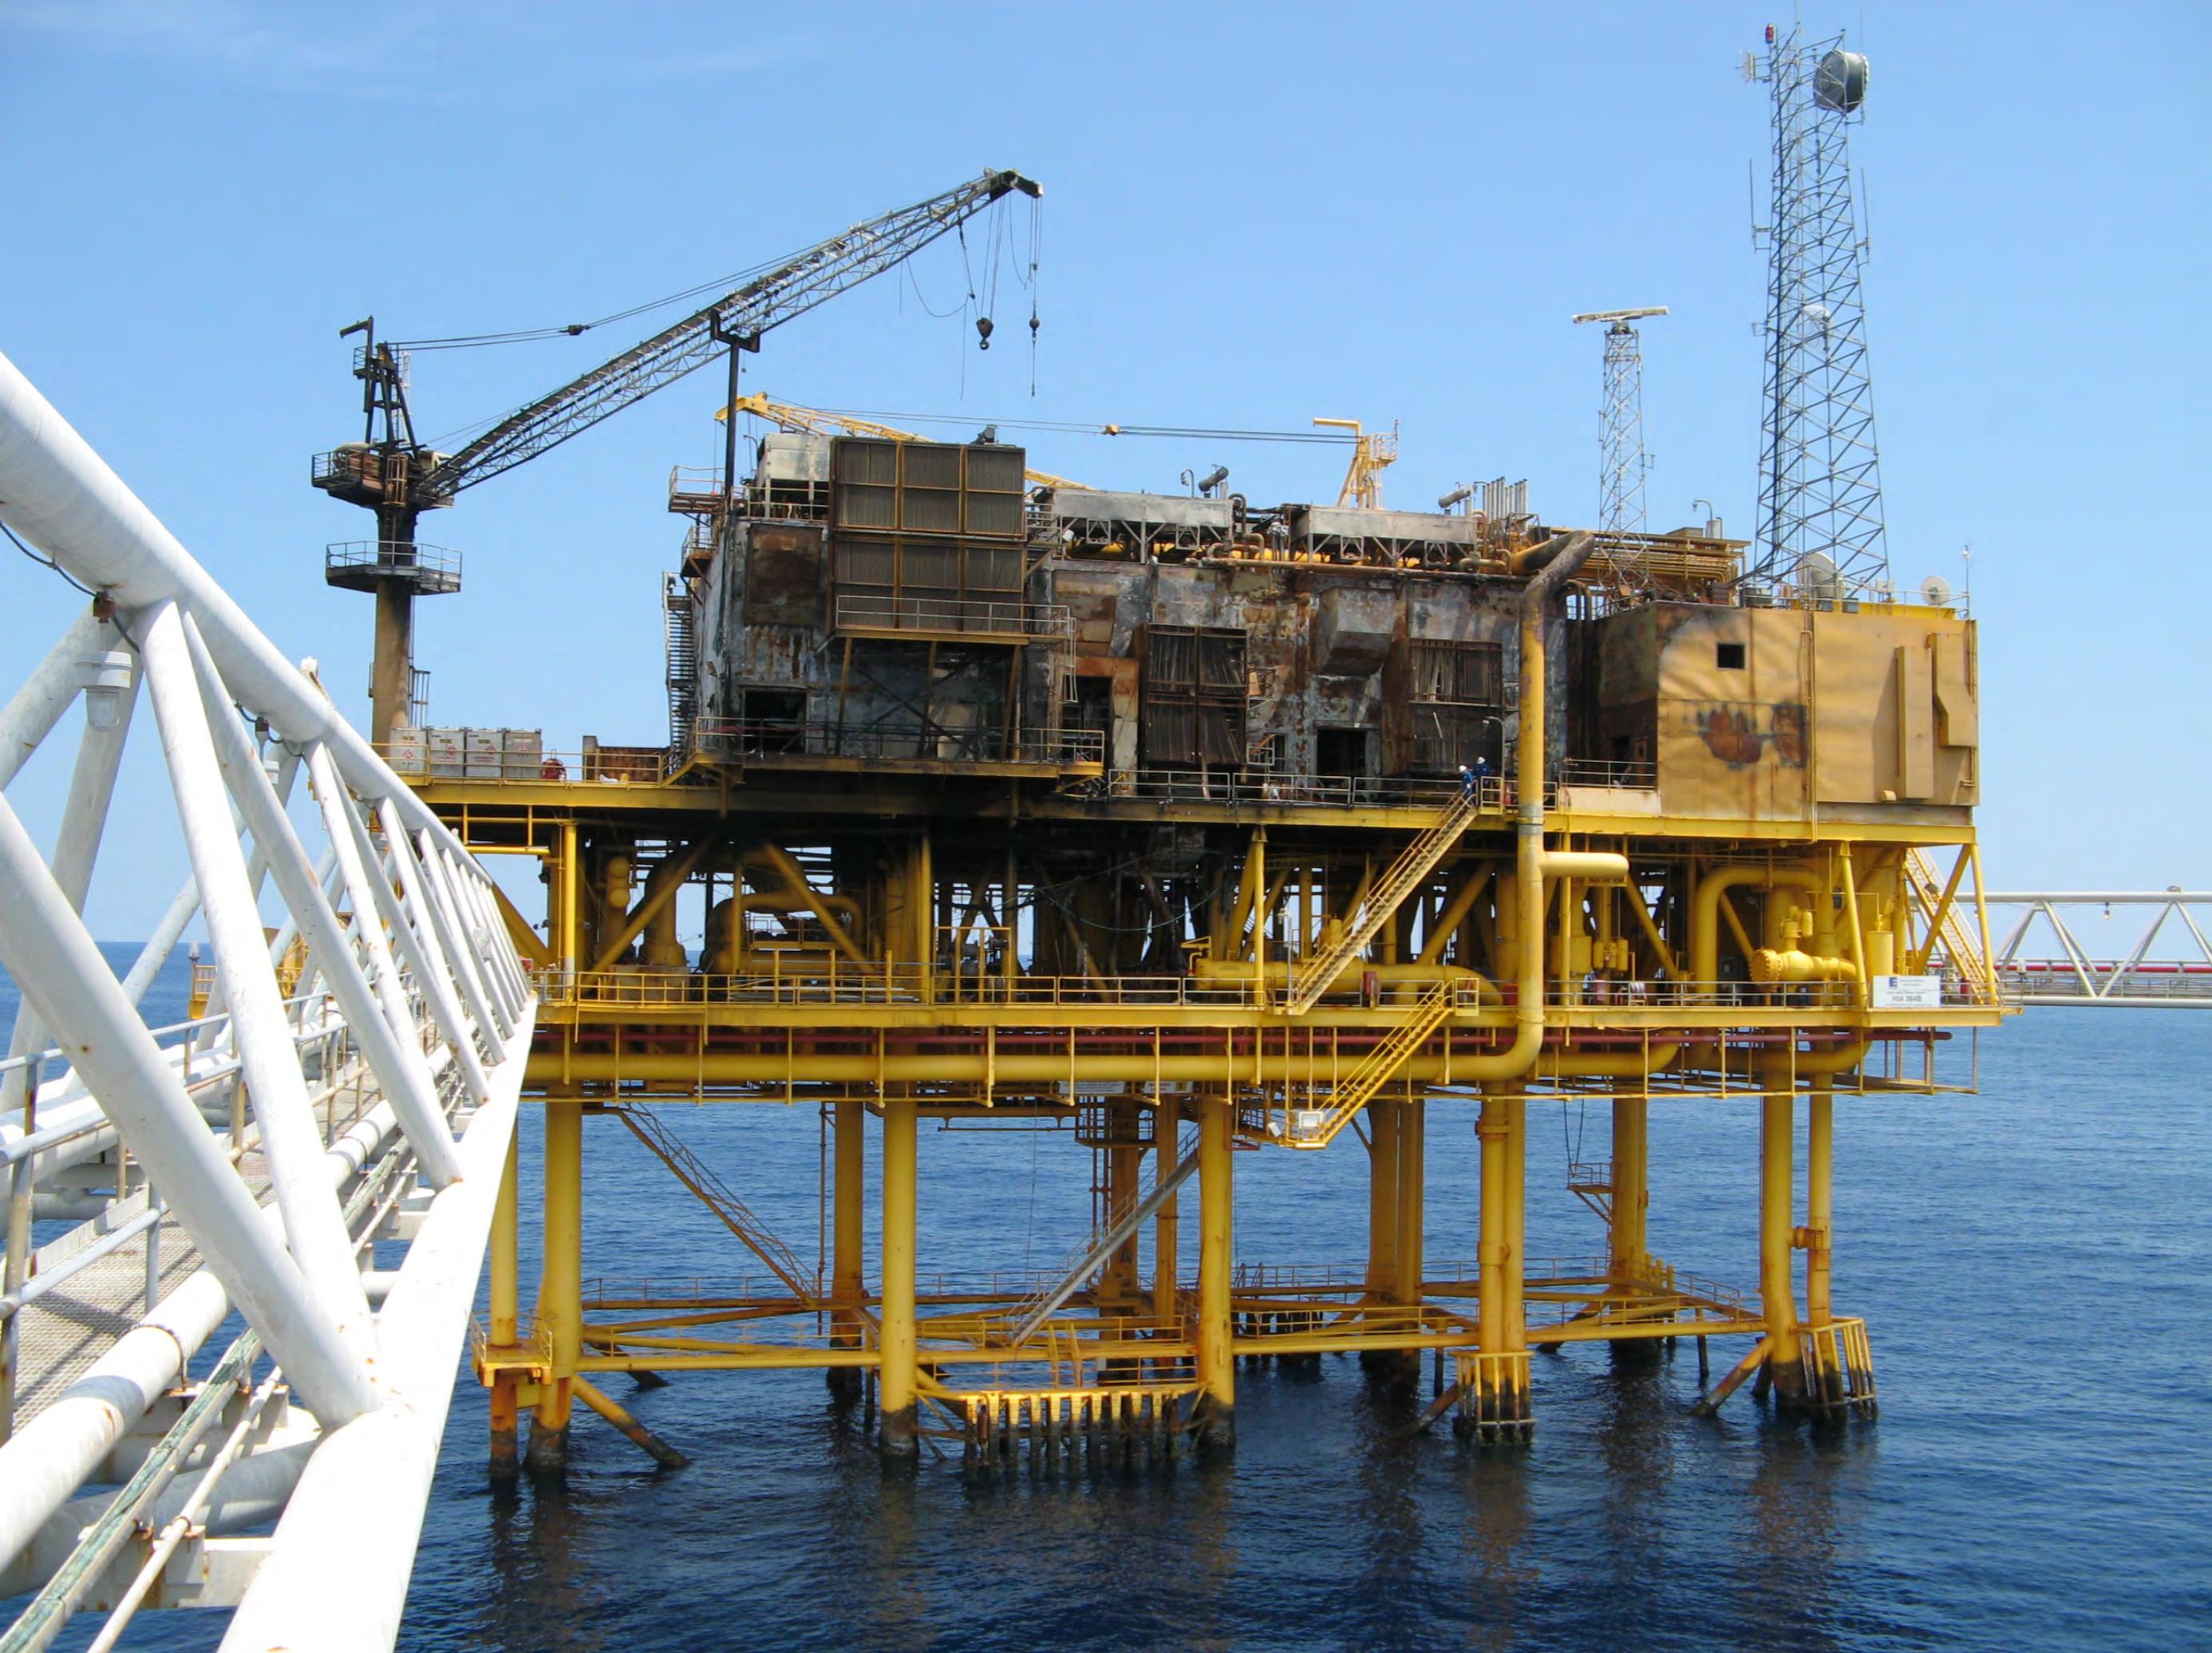
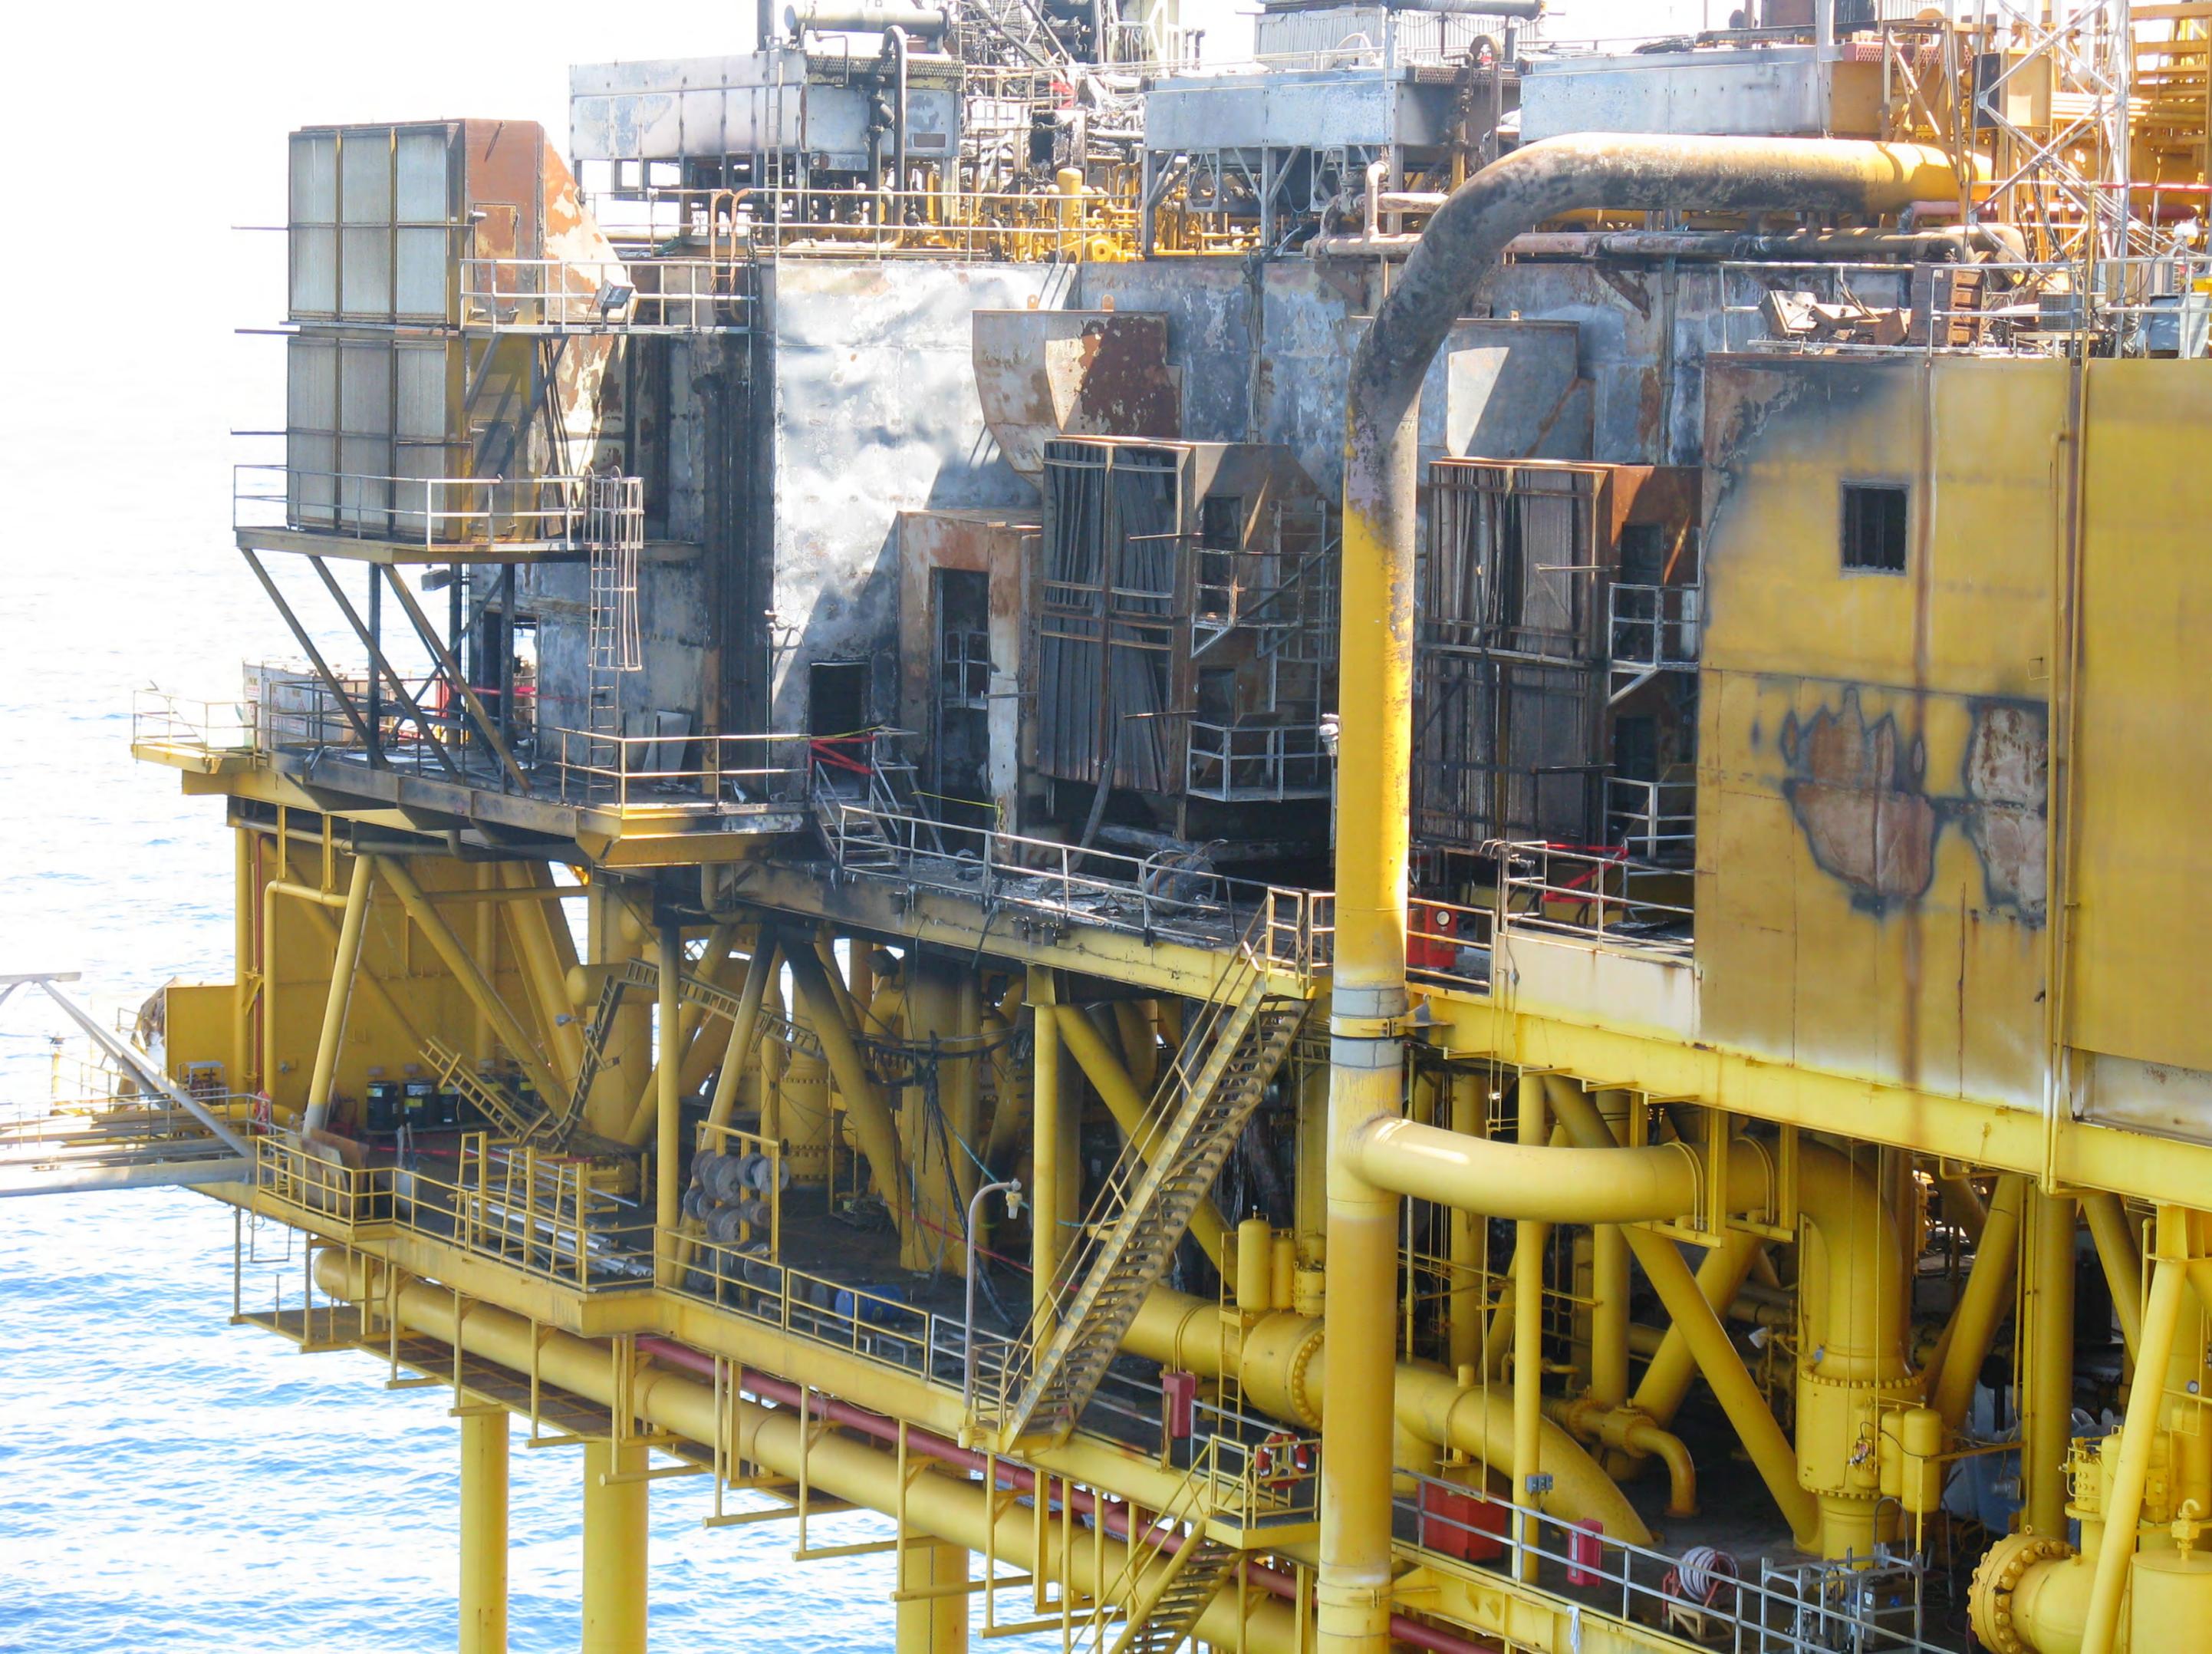
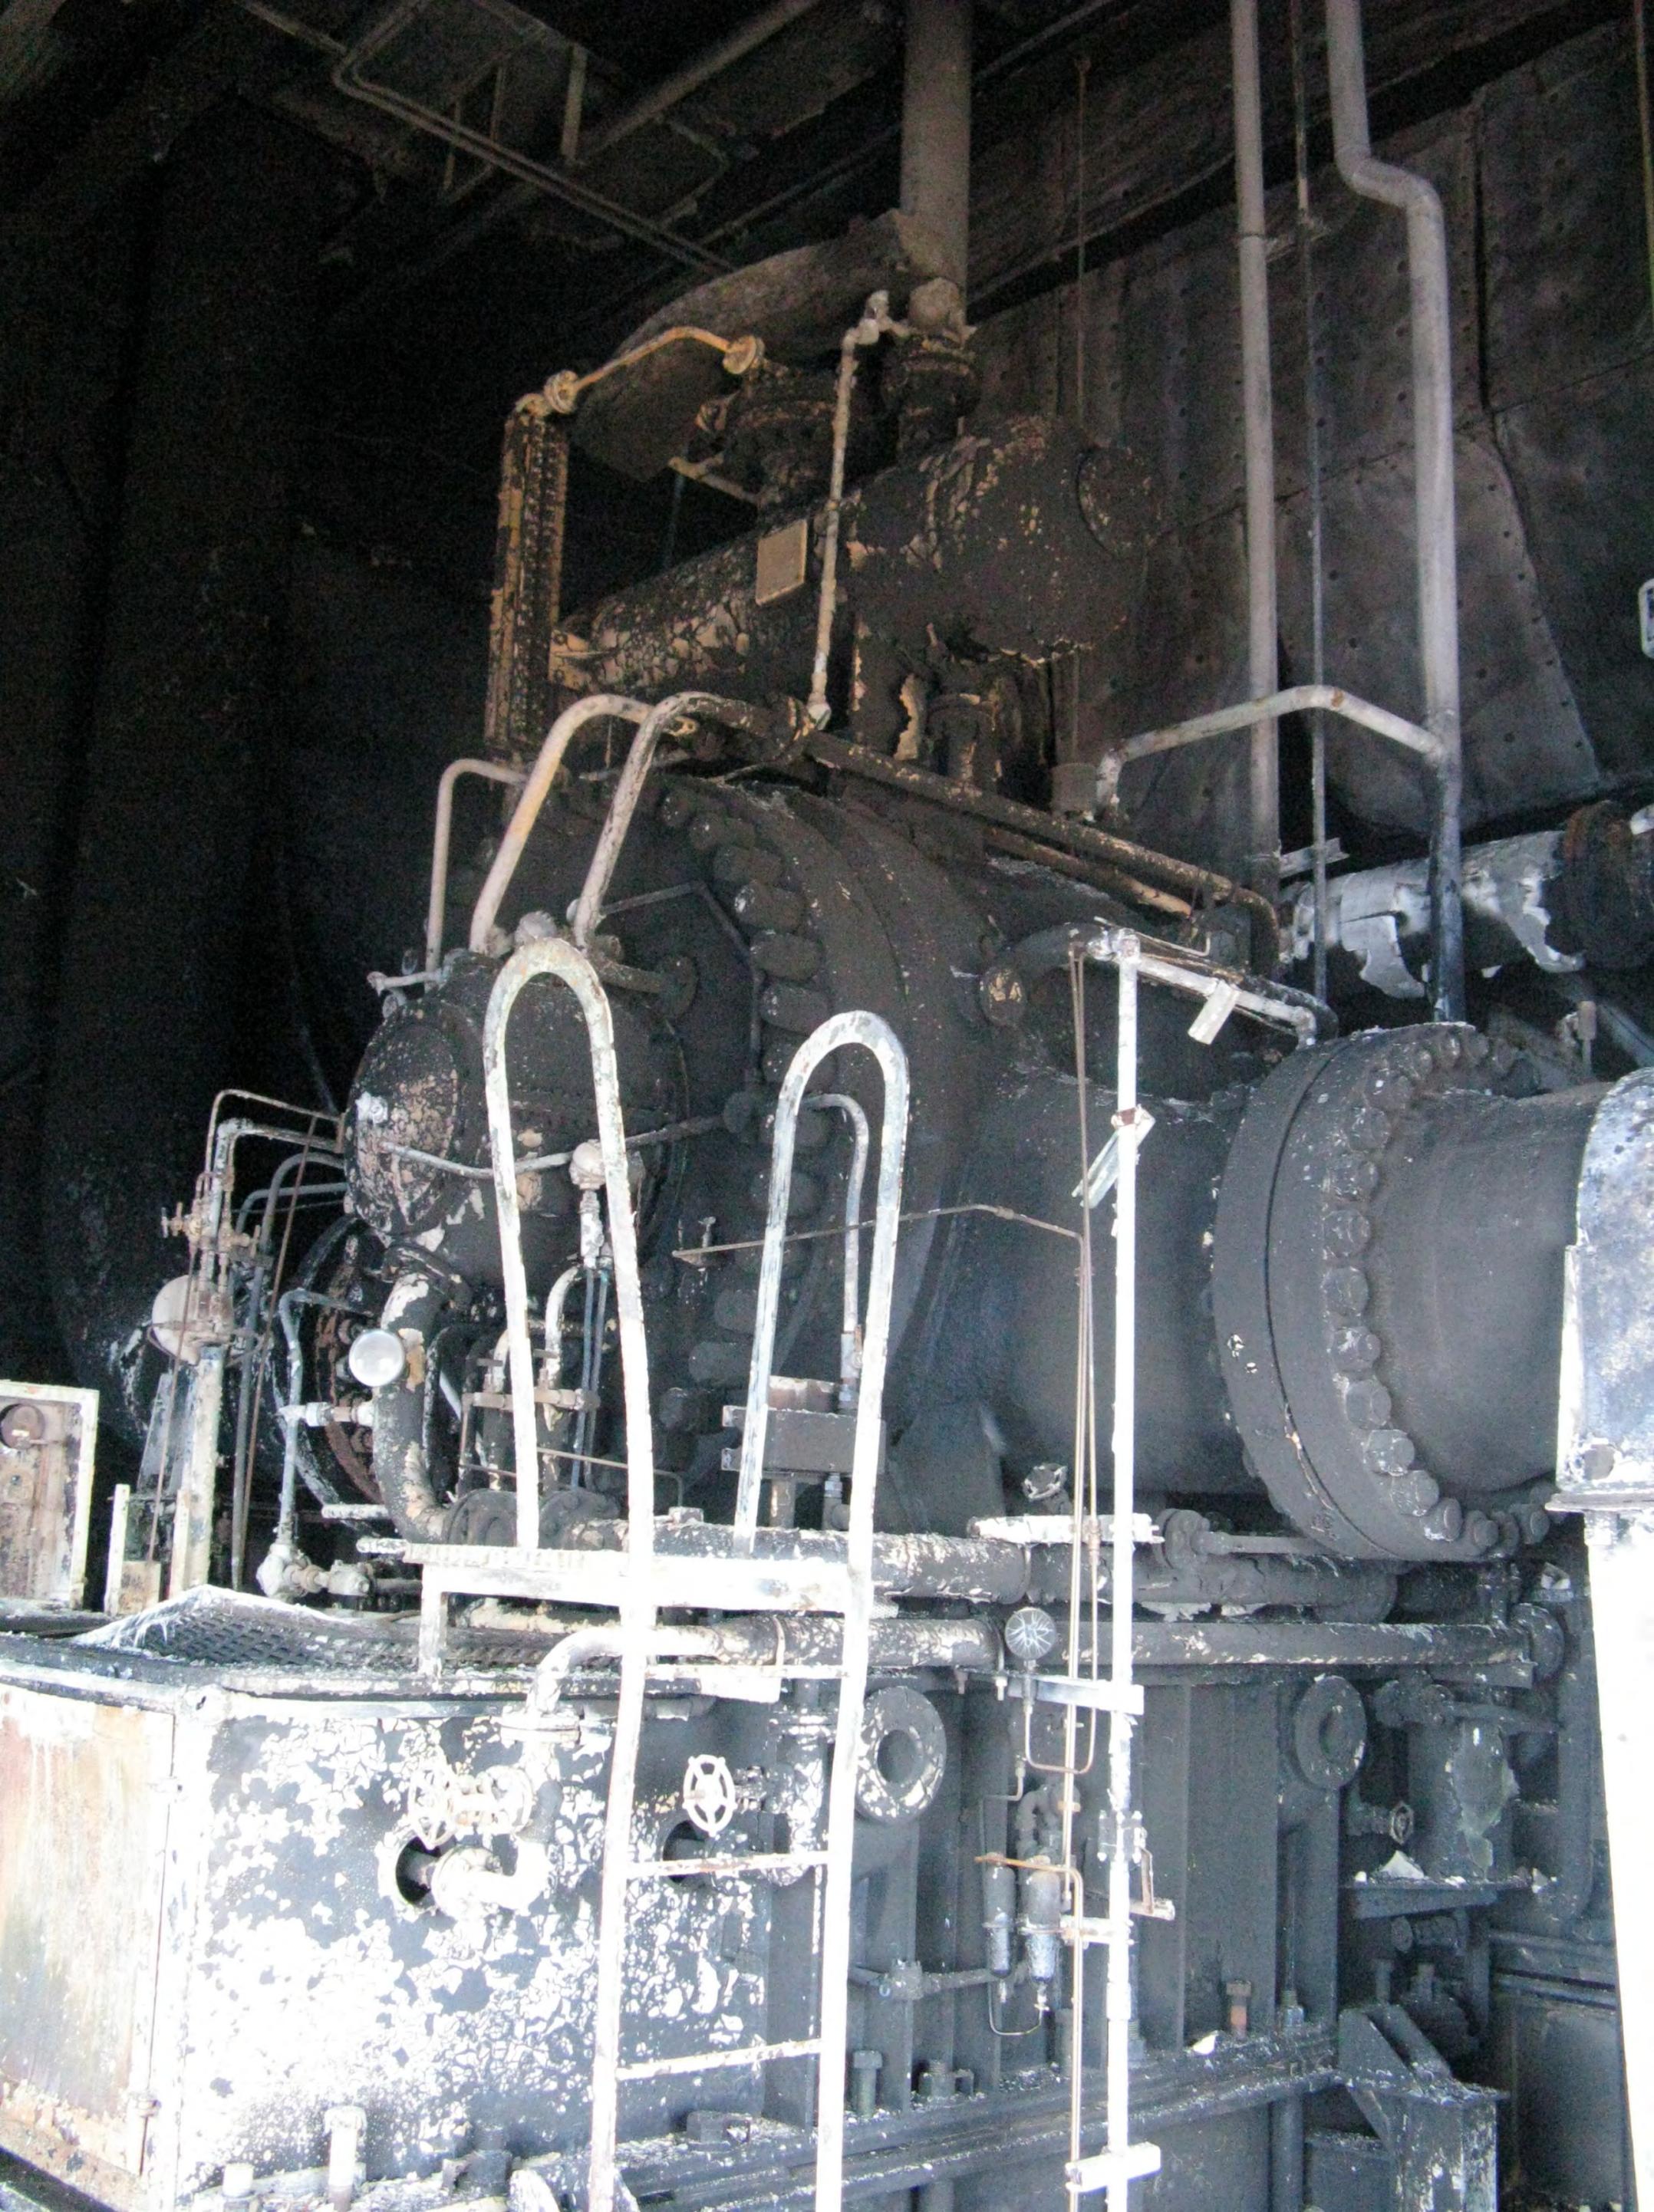
Appendix D - HIOS 264 Platform Photographs

The next series of events are not as certain, but the most probable scenario is that when the ESD system was activated high pressure gas back-flowed into the Number 1 Unit starter turbine through a malfunctioning check valve. The check valve was intended to isolate piping and equipment with a lower pressure rating from the high pressure ESD gas. The high pressure gas ruptured the starter case allowing gas to flow into the engine room. An explosion and second fire then occurred on the main deck. The explosion and fires on the main and upper decks resulted in extensive damage to the equipment and piping on the platform.

The incident occurred on the HIOS 264B platform located at Latitude 28.4115 degrees; Longitude 93.7393 degrees. Photographs showing the HIOS 264 platforms and incident damage on the HIOS 264B platform are included in Appendix A.
