Principal Investigator Jon Manning
Region Director R.M. Seeley
Date of Report 10/20/2011
Subject Failure Investigation Report – Enterprise Offshore Gas Platform Fire

Failure Investigation Report – Enterprise Offshore Gas Platform Fire

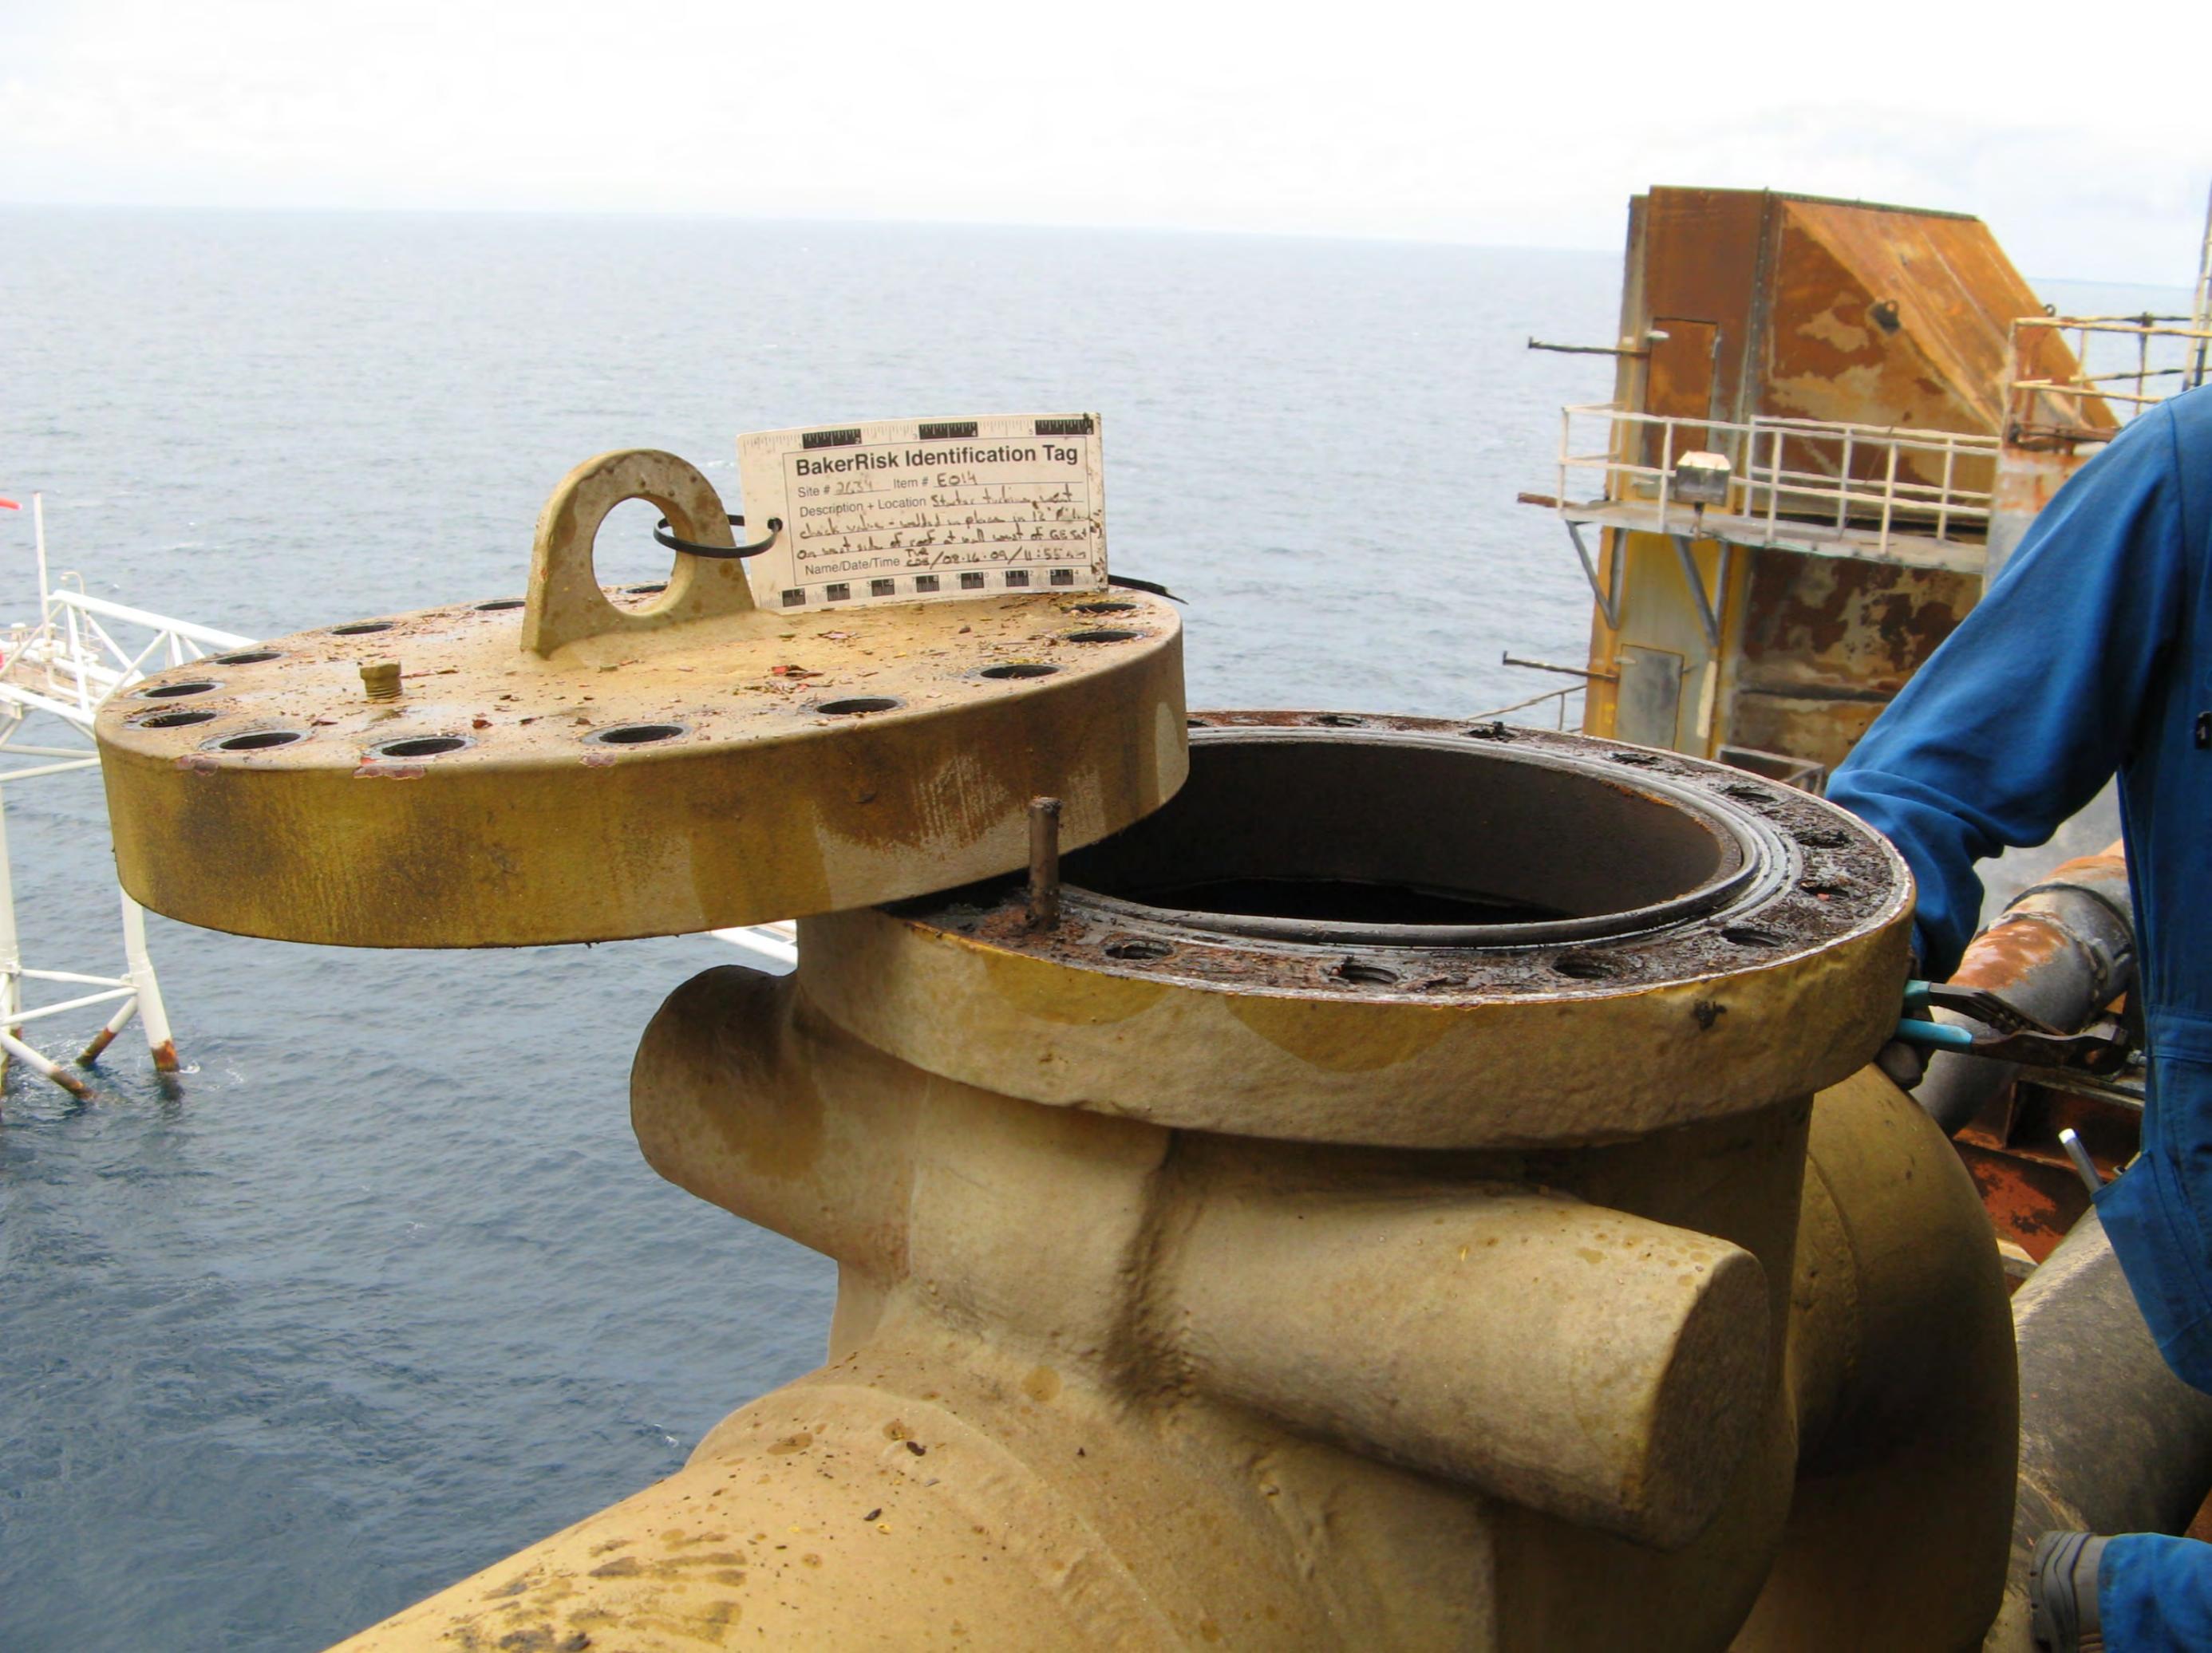
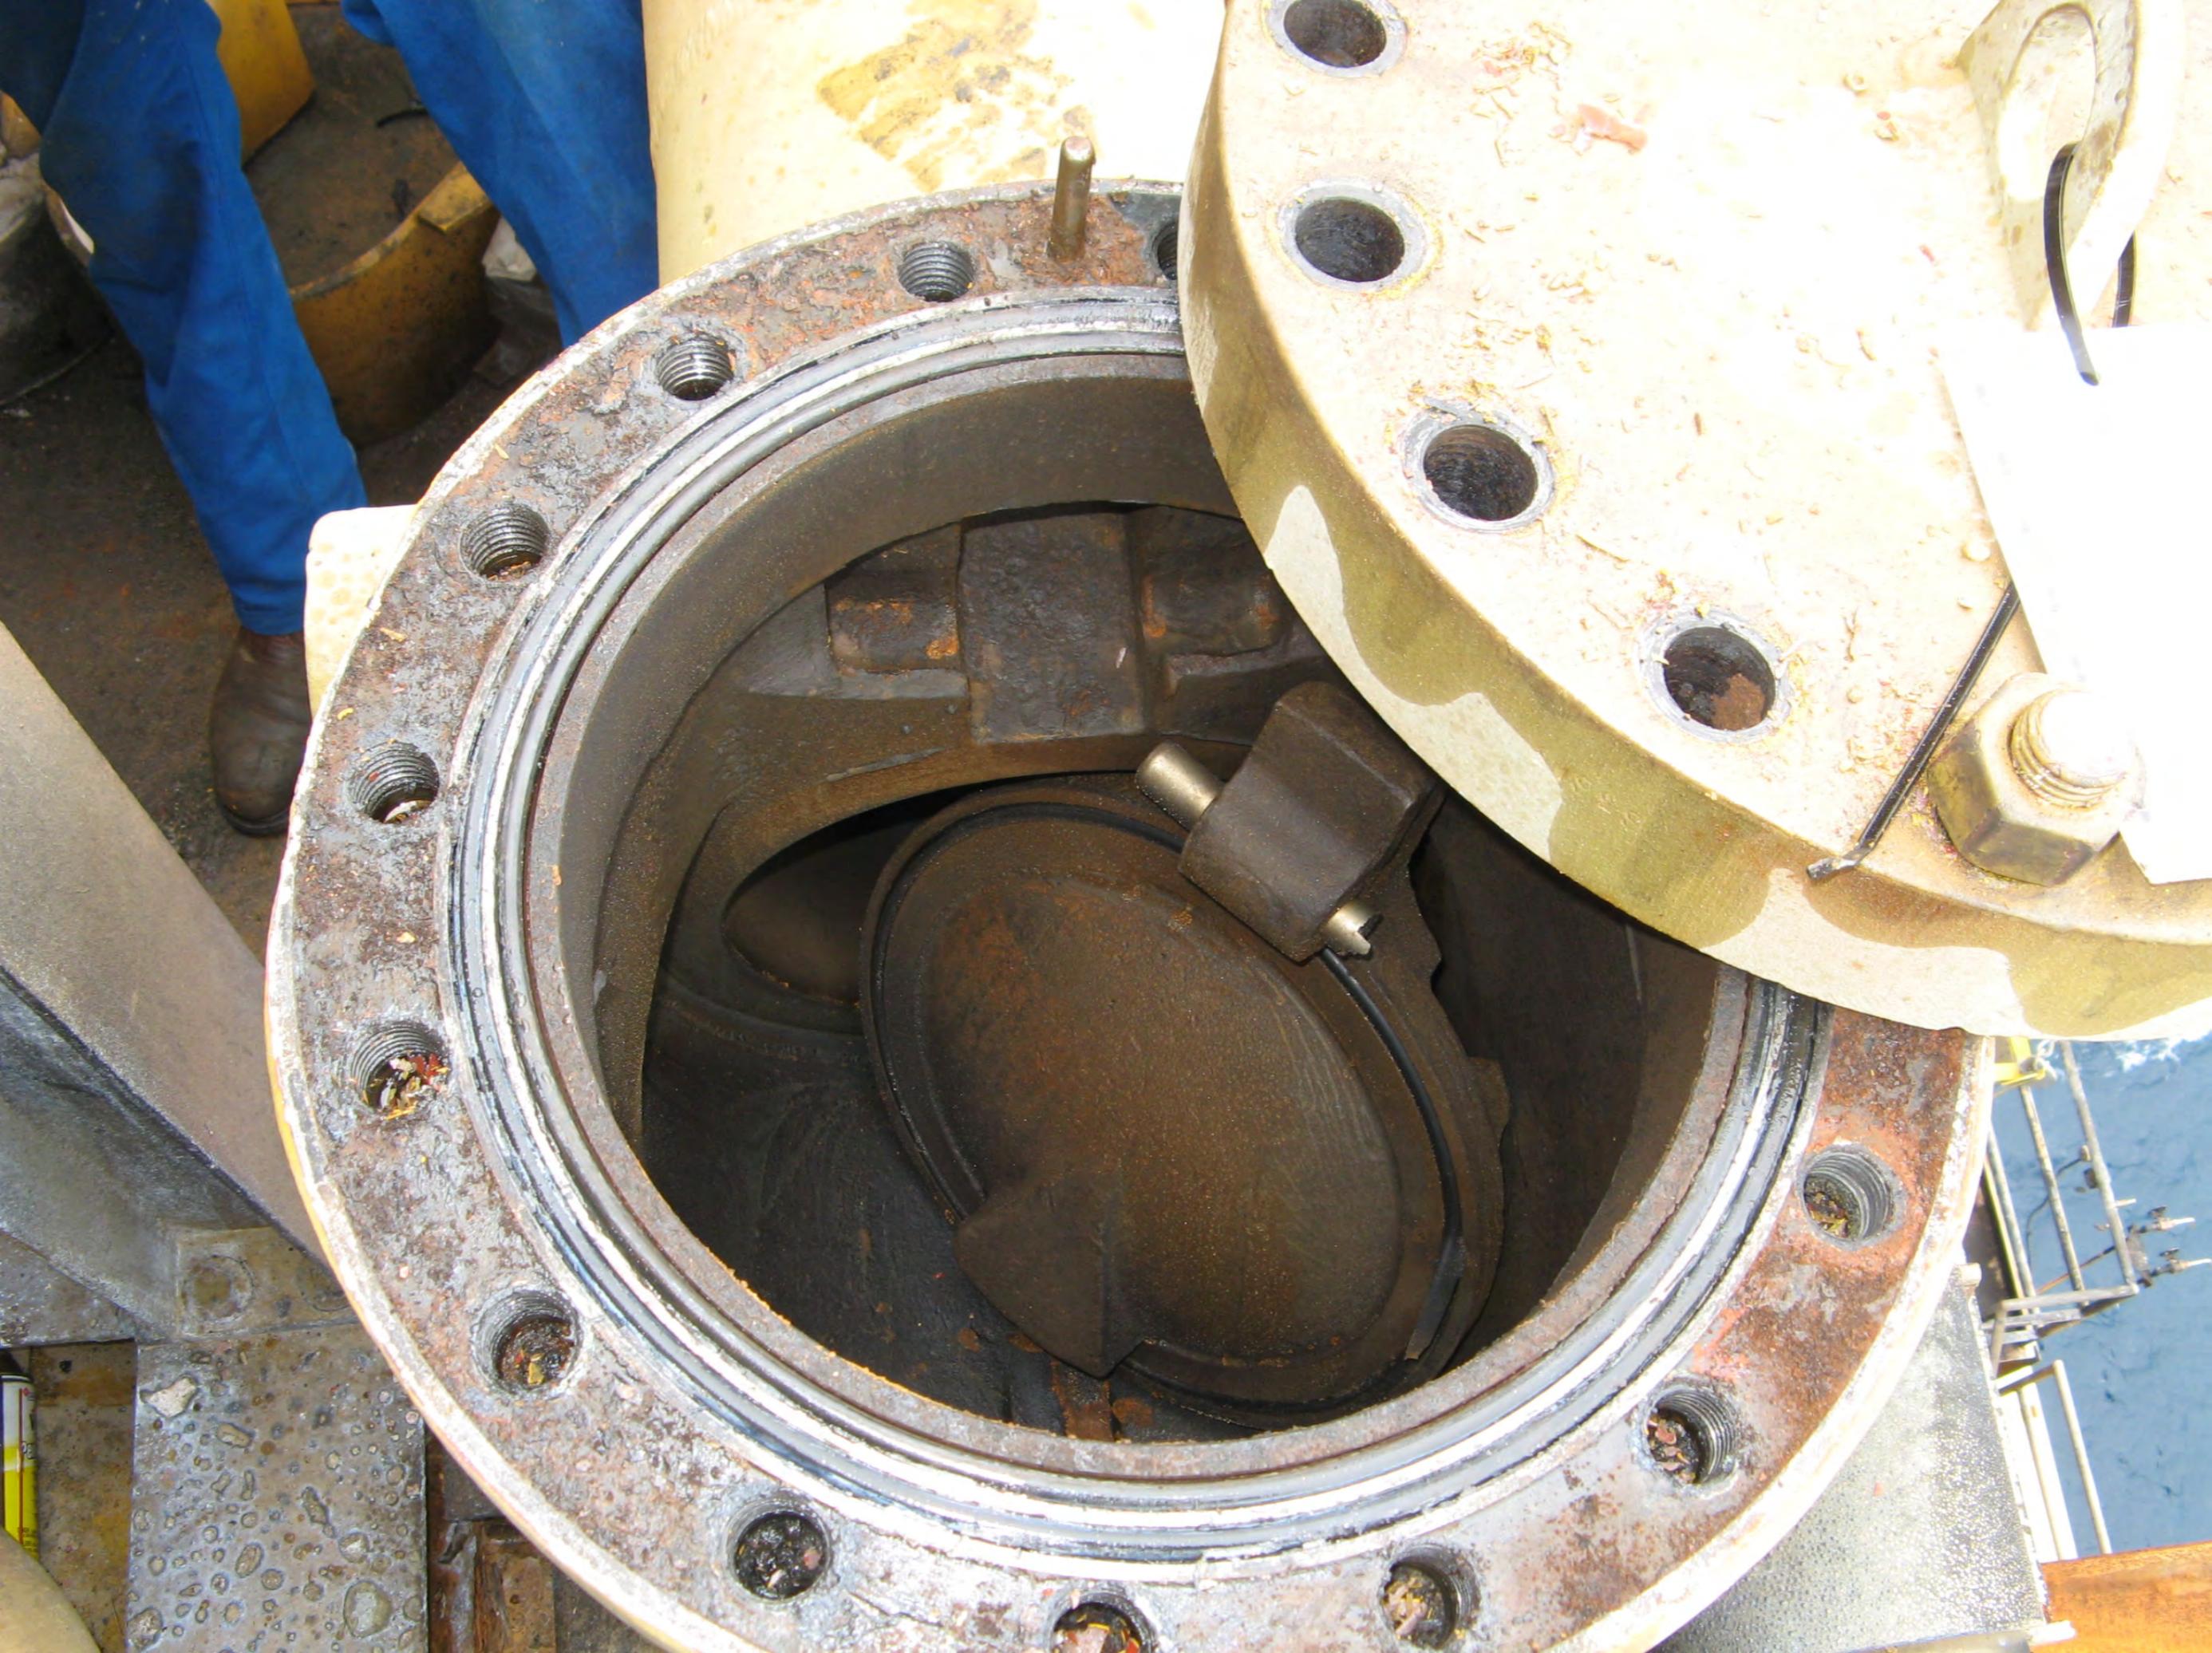
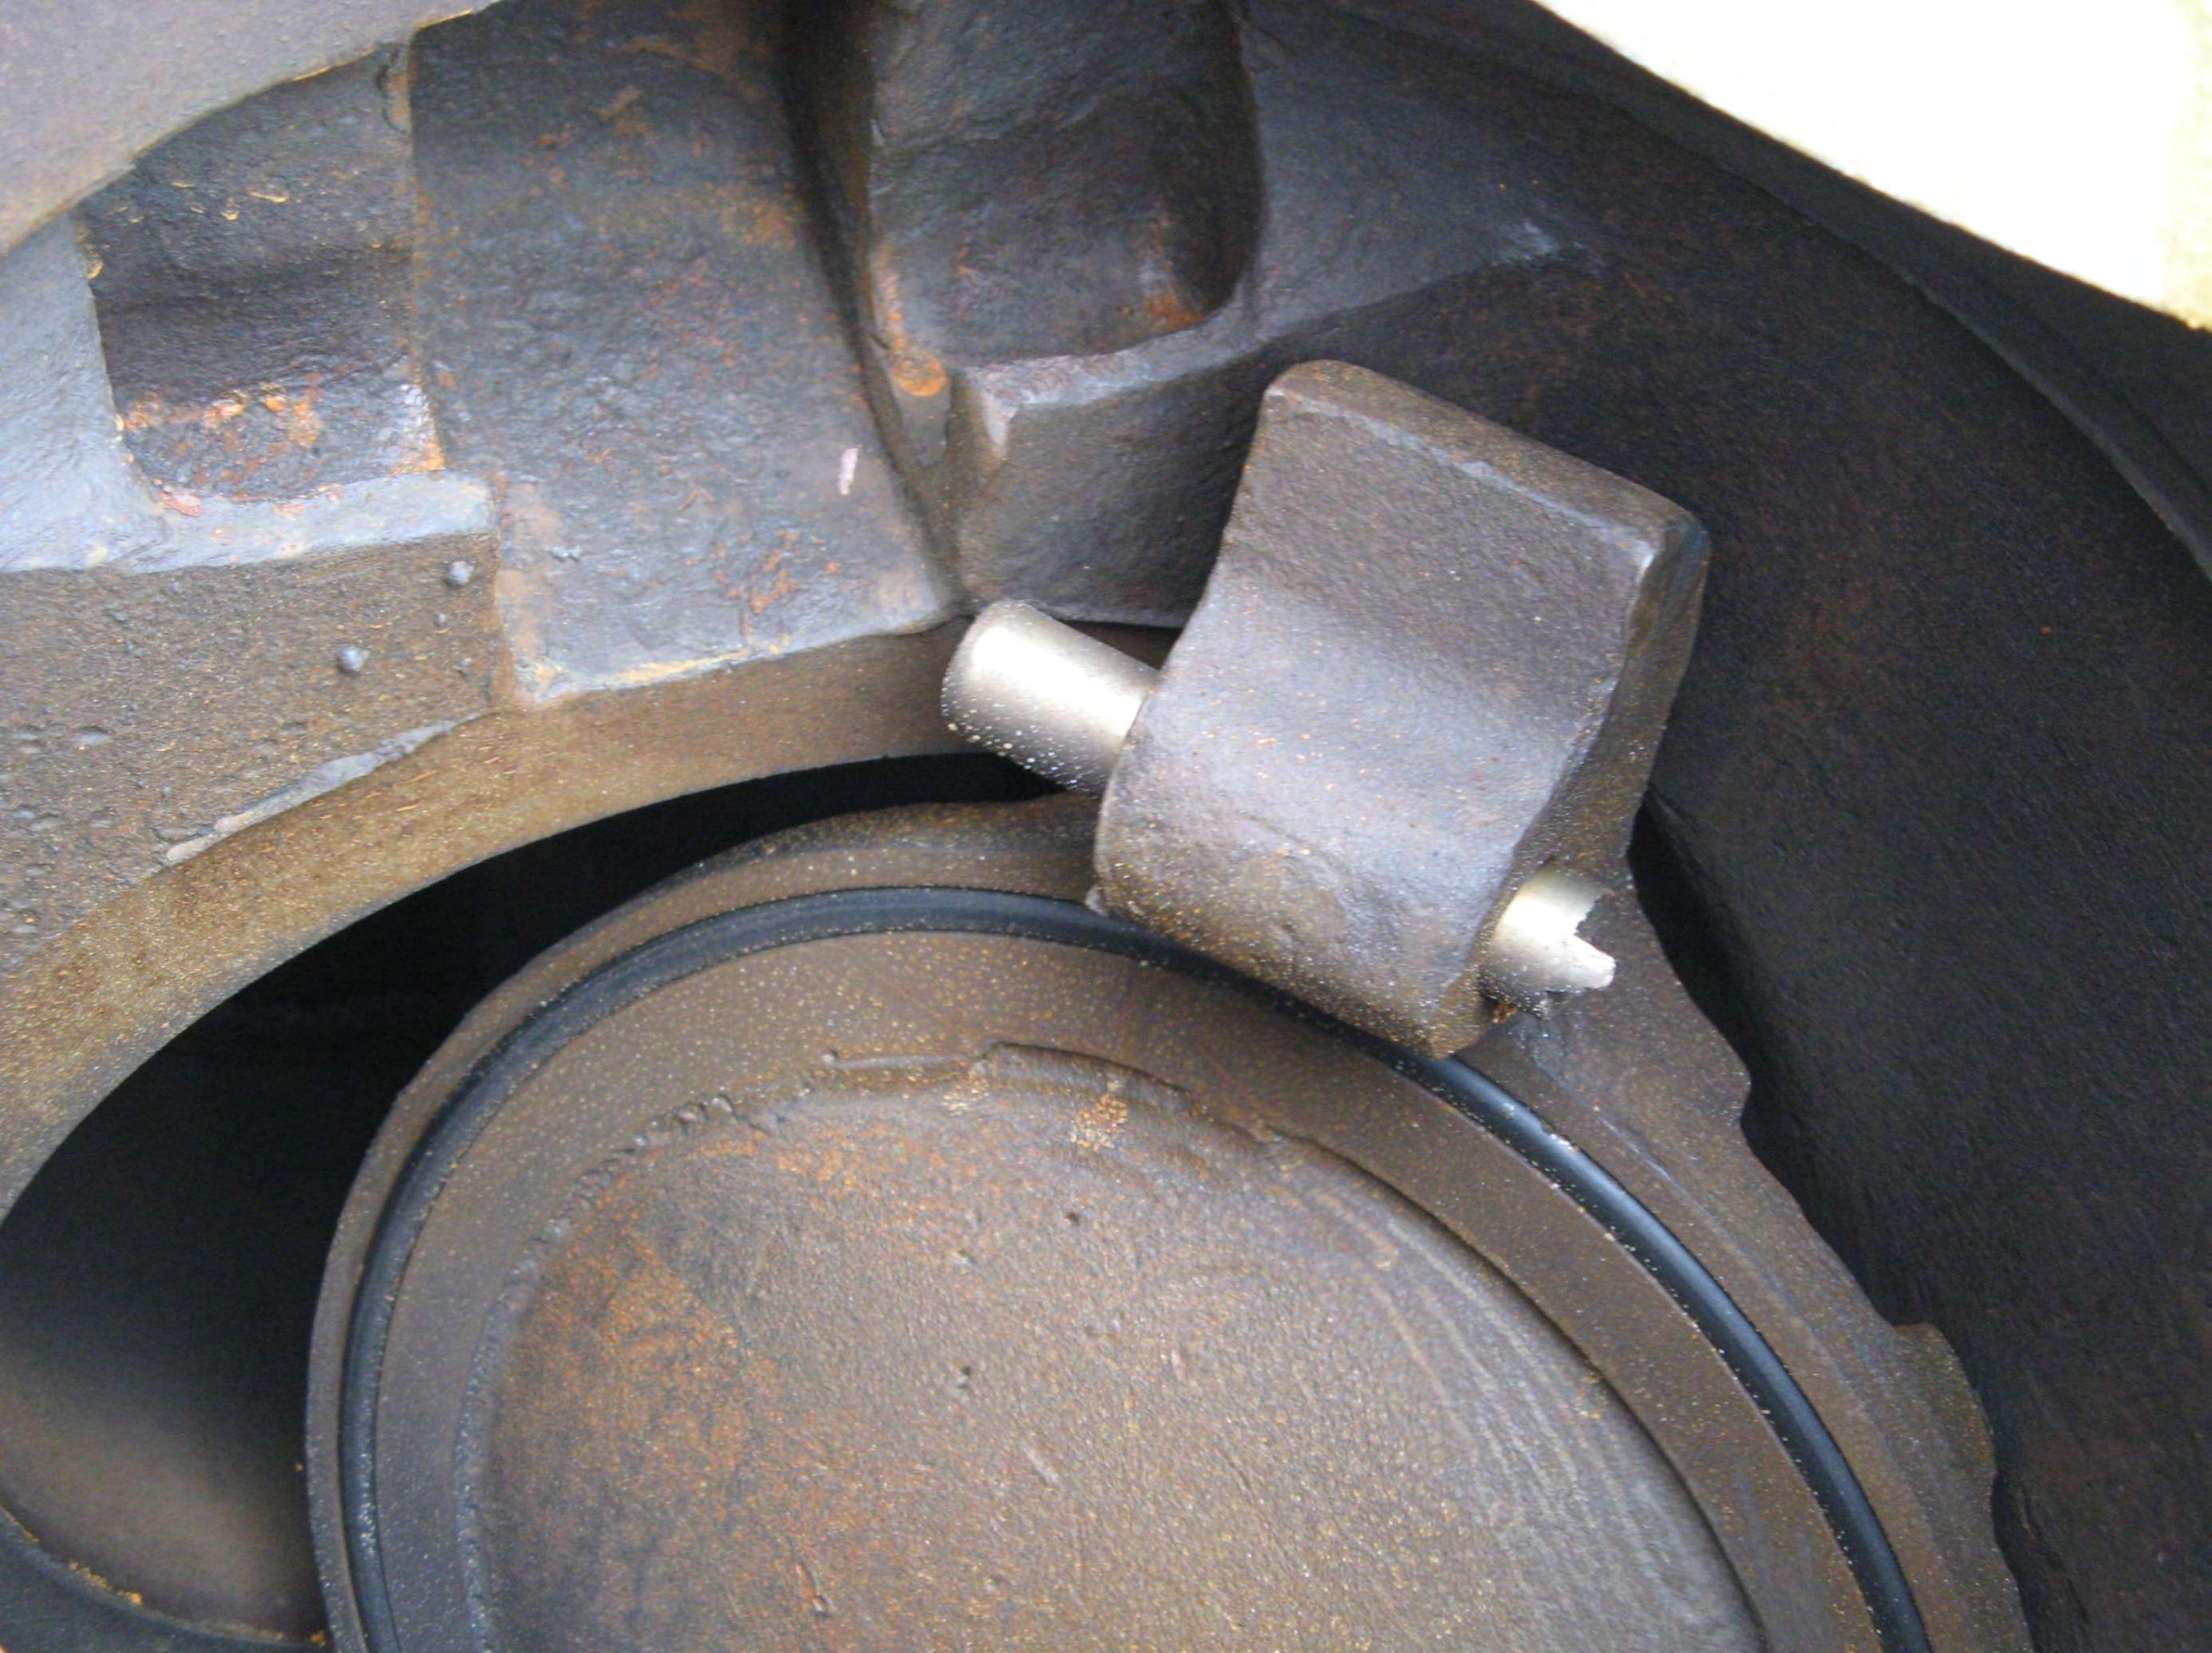
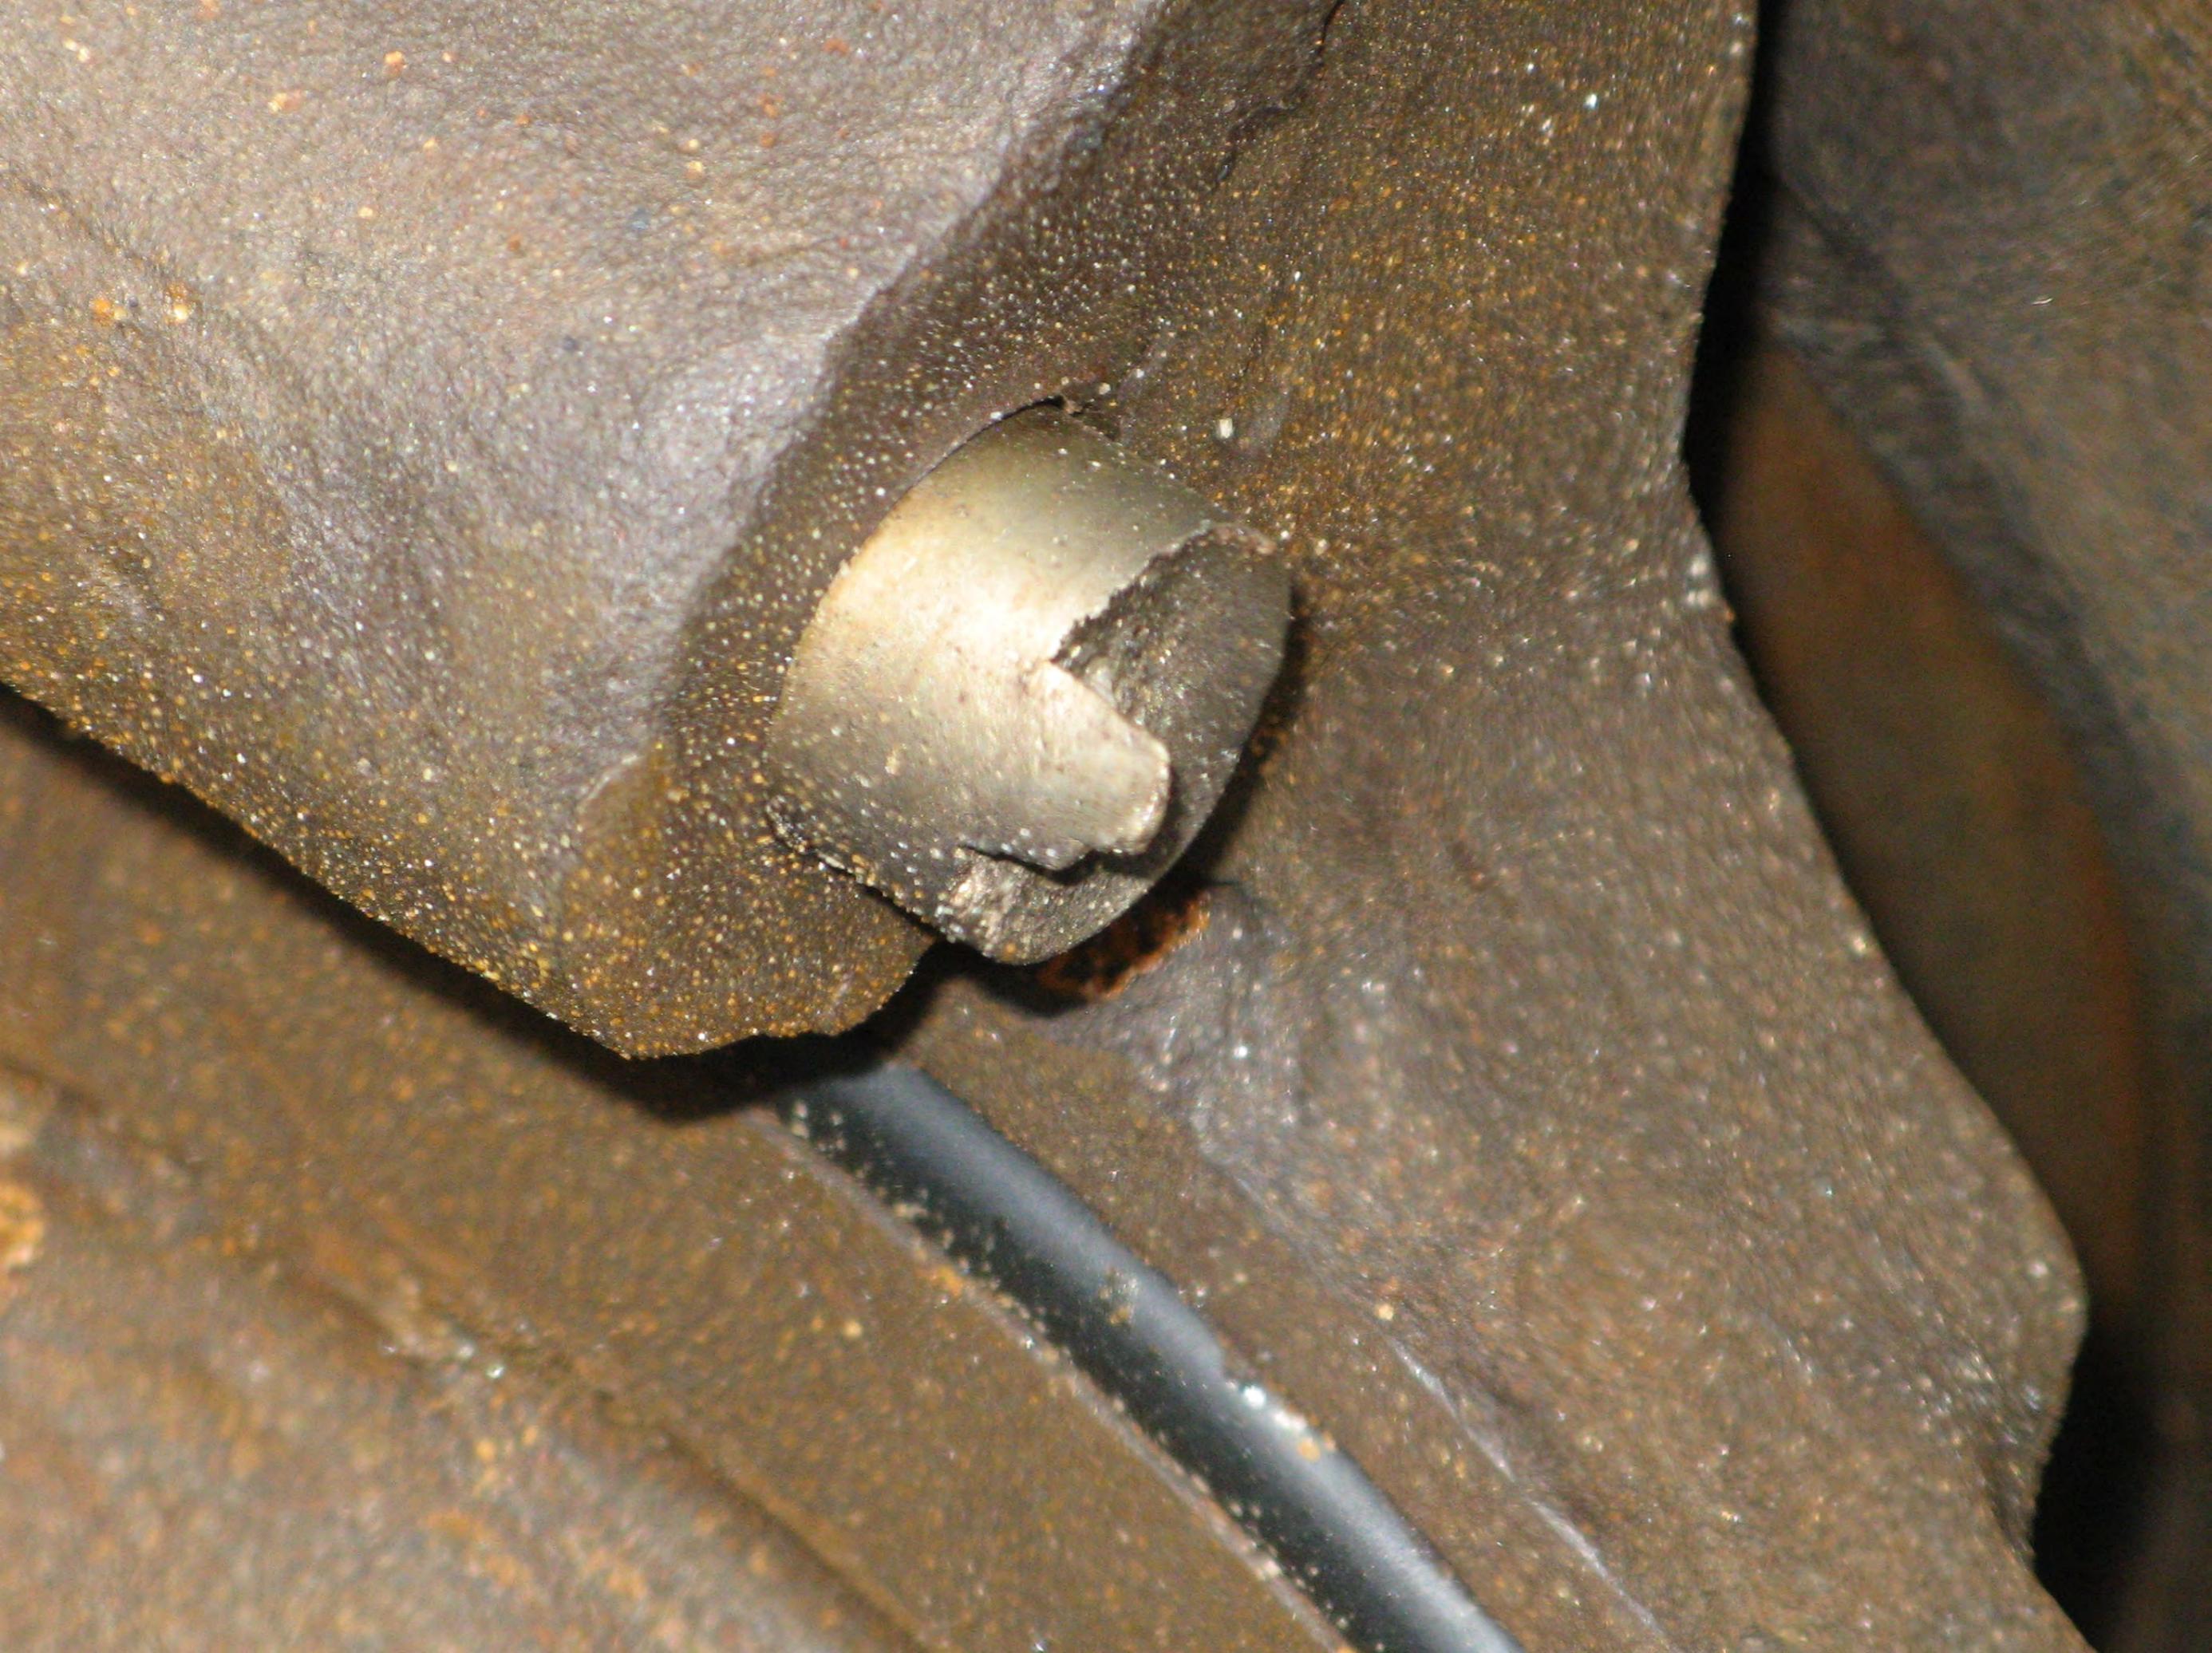
Appendix F – Check Valve Photographs

The forensic analysis concluded that rupture of the starter turbine case was caused by internal pressure rather than an external explosion. The starter piping is protected by a relief valve (PSV M838) that was tested and torn down after the incident. BakerRisk determined the relief valve was functioning properly. Analysis of the check valve (M805) found the check valve clapper had dislodged from its normal operating position and that the retainer pin had failed. The BakerRisk analysis determined that

the retainer pin was partially cracked prior to the incident and the sudden high pressure gas surge resulting from the ESD caused the remaining ligament to fail.

1. Tests performed by BakerRisk determined that the check valve clapper retaining pin was cracked prior to the incident and that the ESD event caused the remaining ligament to fail.
2. The fire water pump did not automatically start as designed so there was no fire water pressure on the upper deck during the initial fire.

Site # 2634 Item # E014
Description + Location *Stator turbine part*
check valve - welded in place for 12" dia
on west side of raft at wall west of G654
Name/Date/Time *TJA*
08/08/16/09/11:55 am
