Principal Investigator Jon Manning
Region Director R.M. Seeley
Date of Report 10/20/2011
Subject Failure Investigation Report – Enterprise Offshore Gas Platform Fire

Failure Investigation Report – Enterprise Offshore Gas Platform Fire

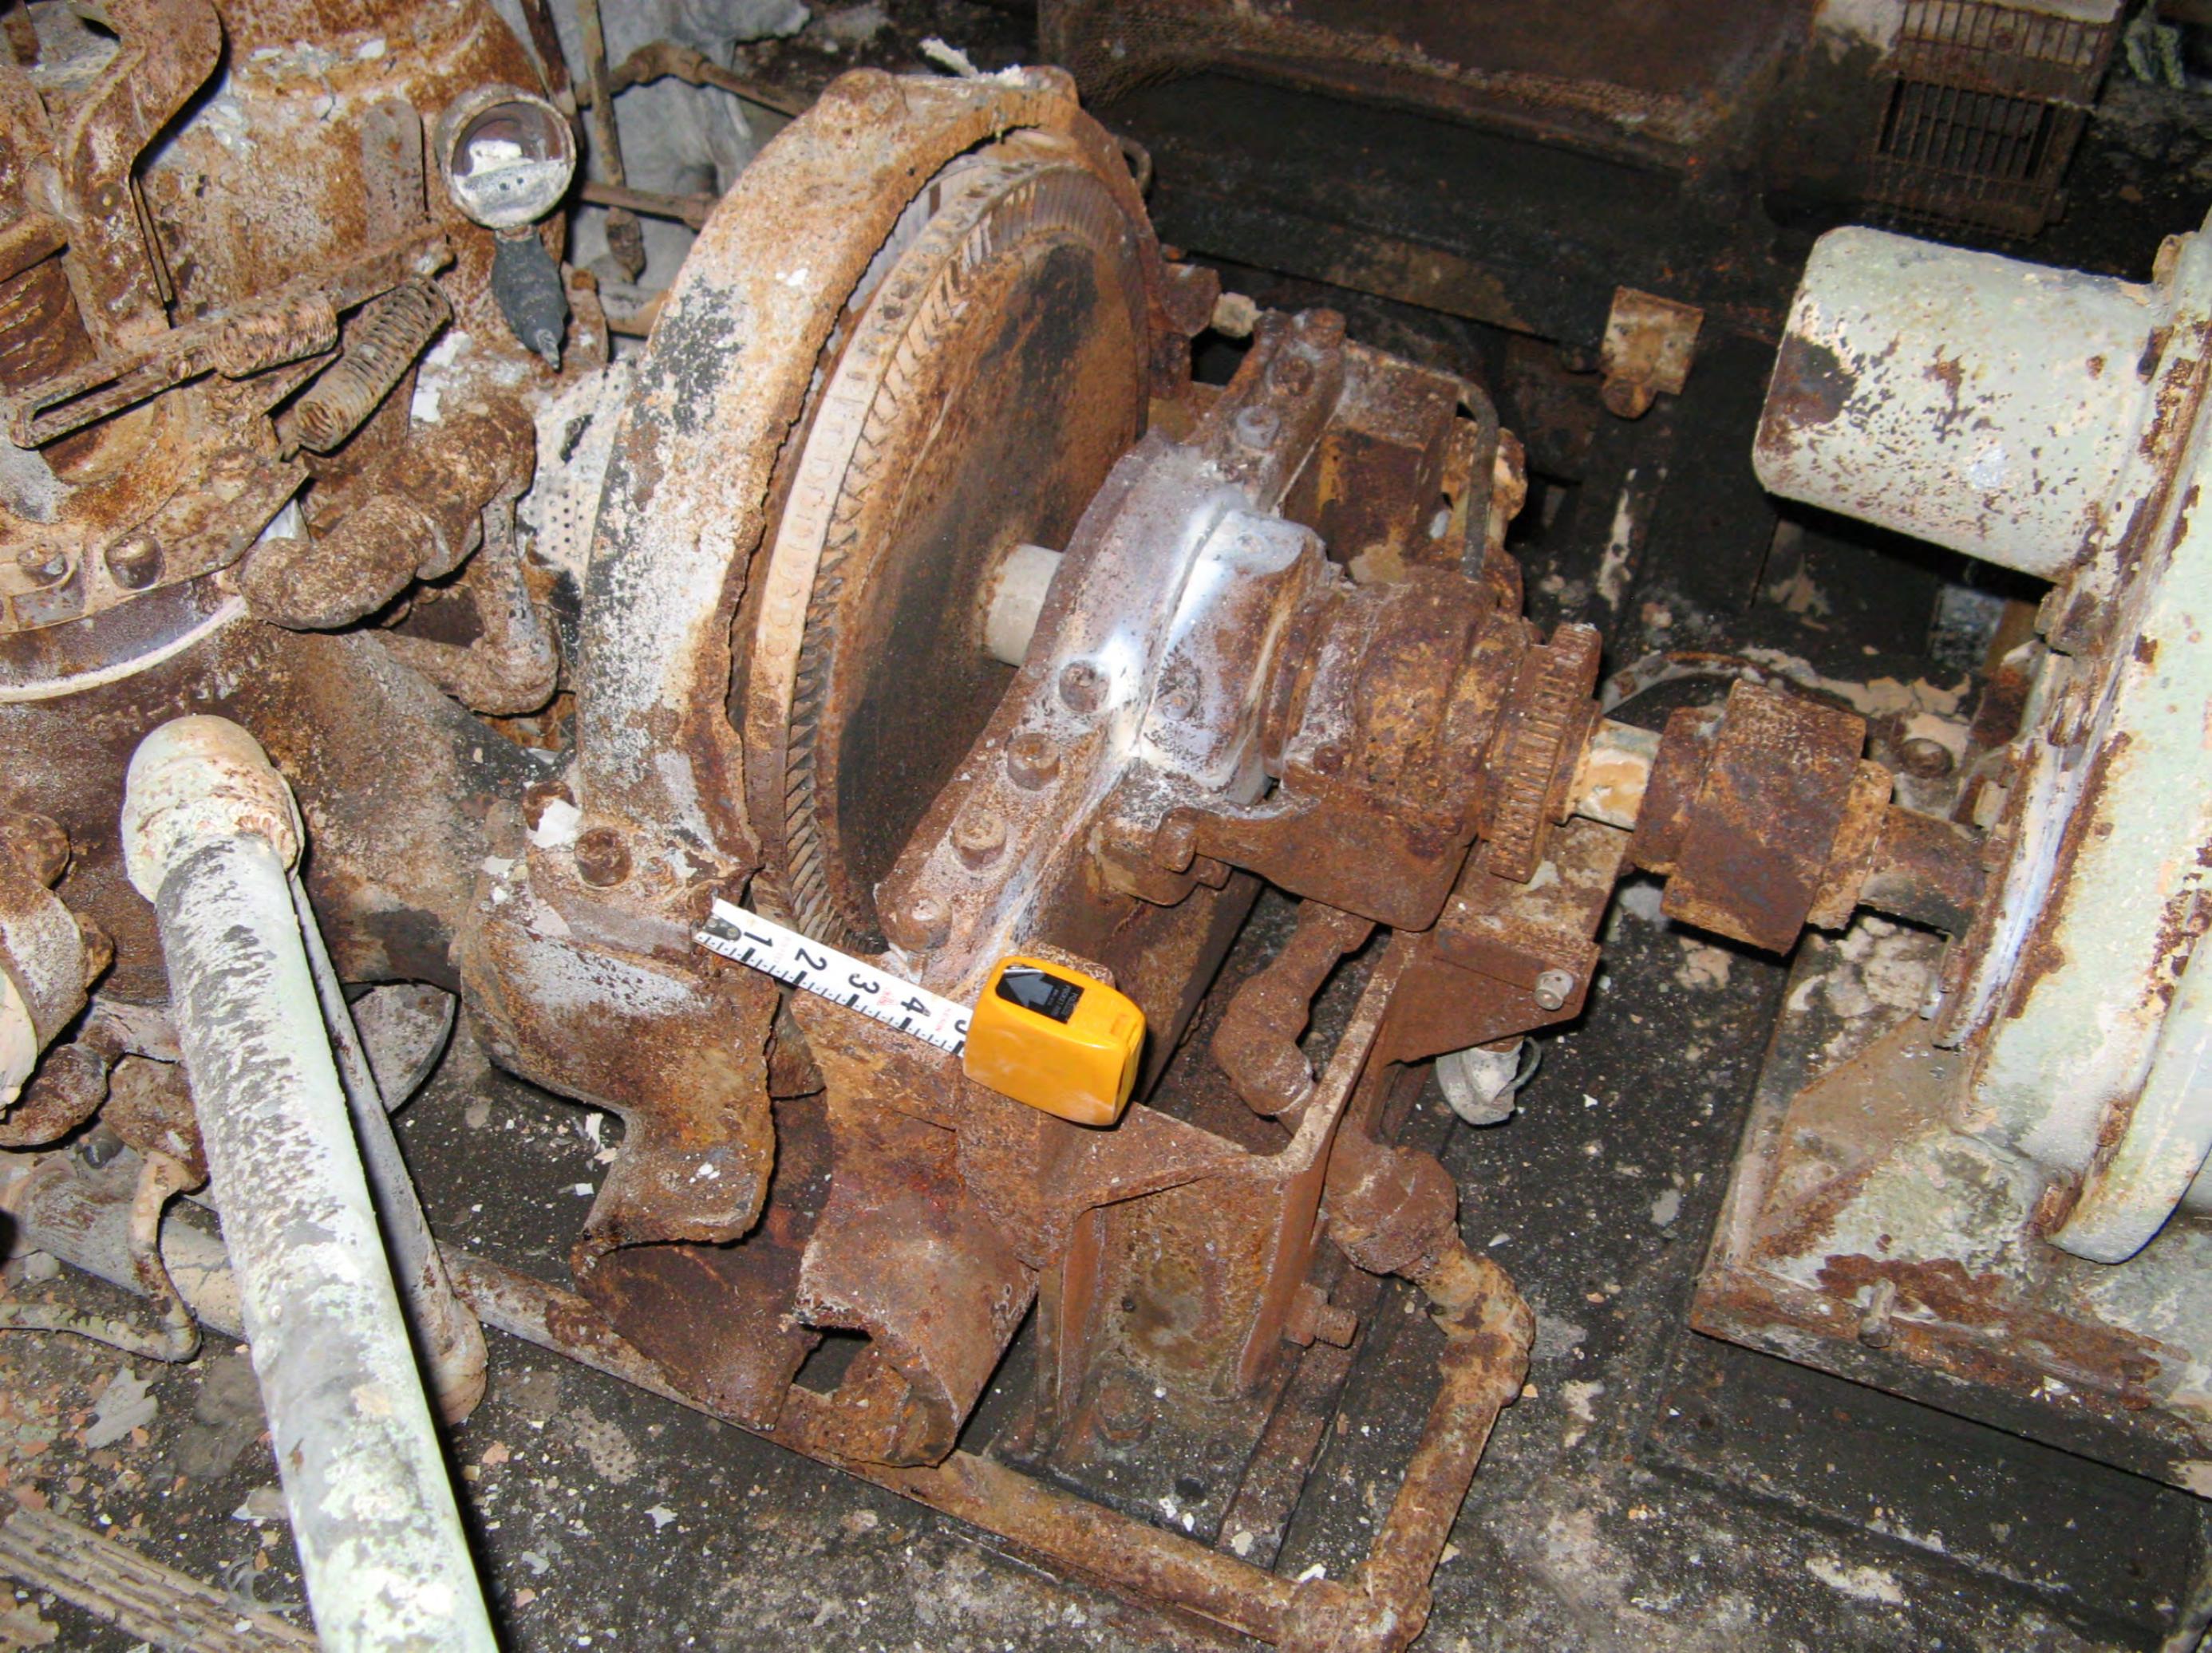
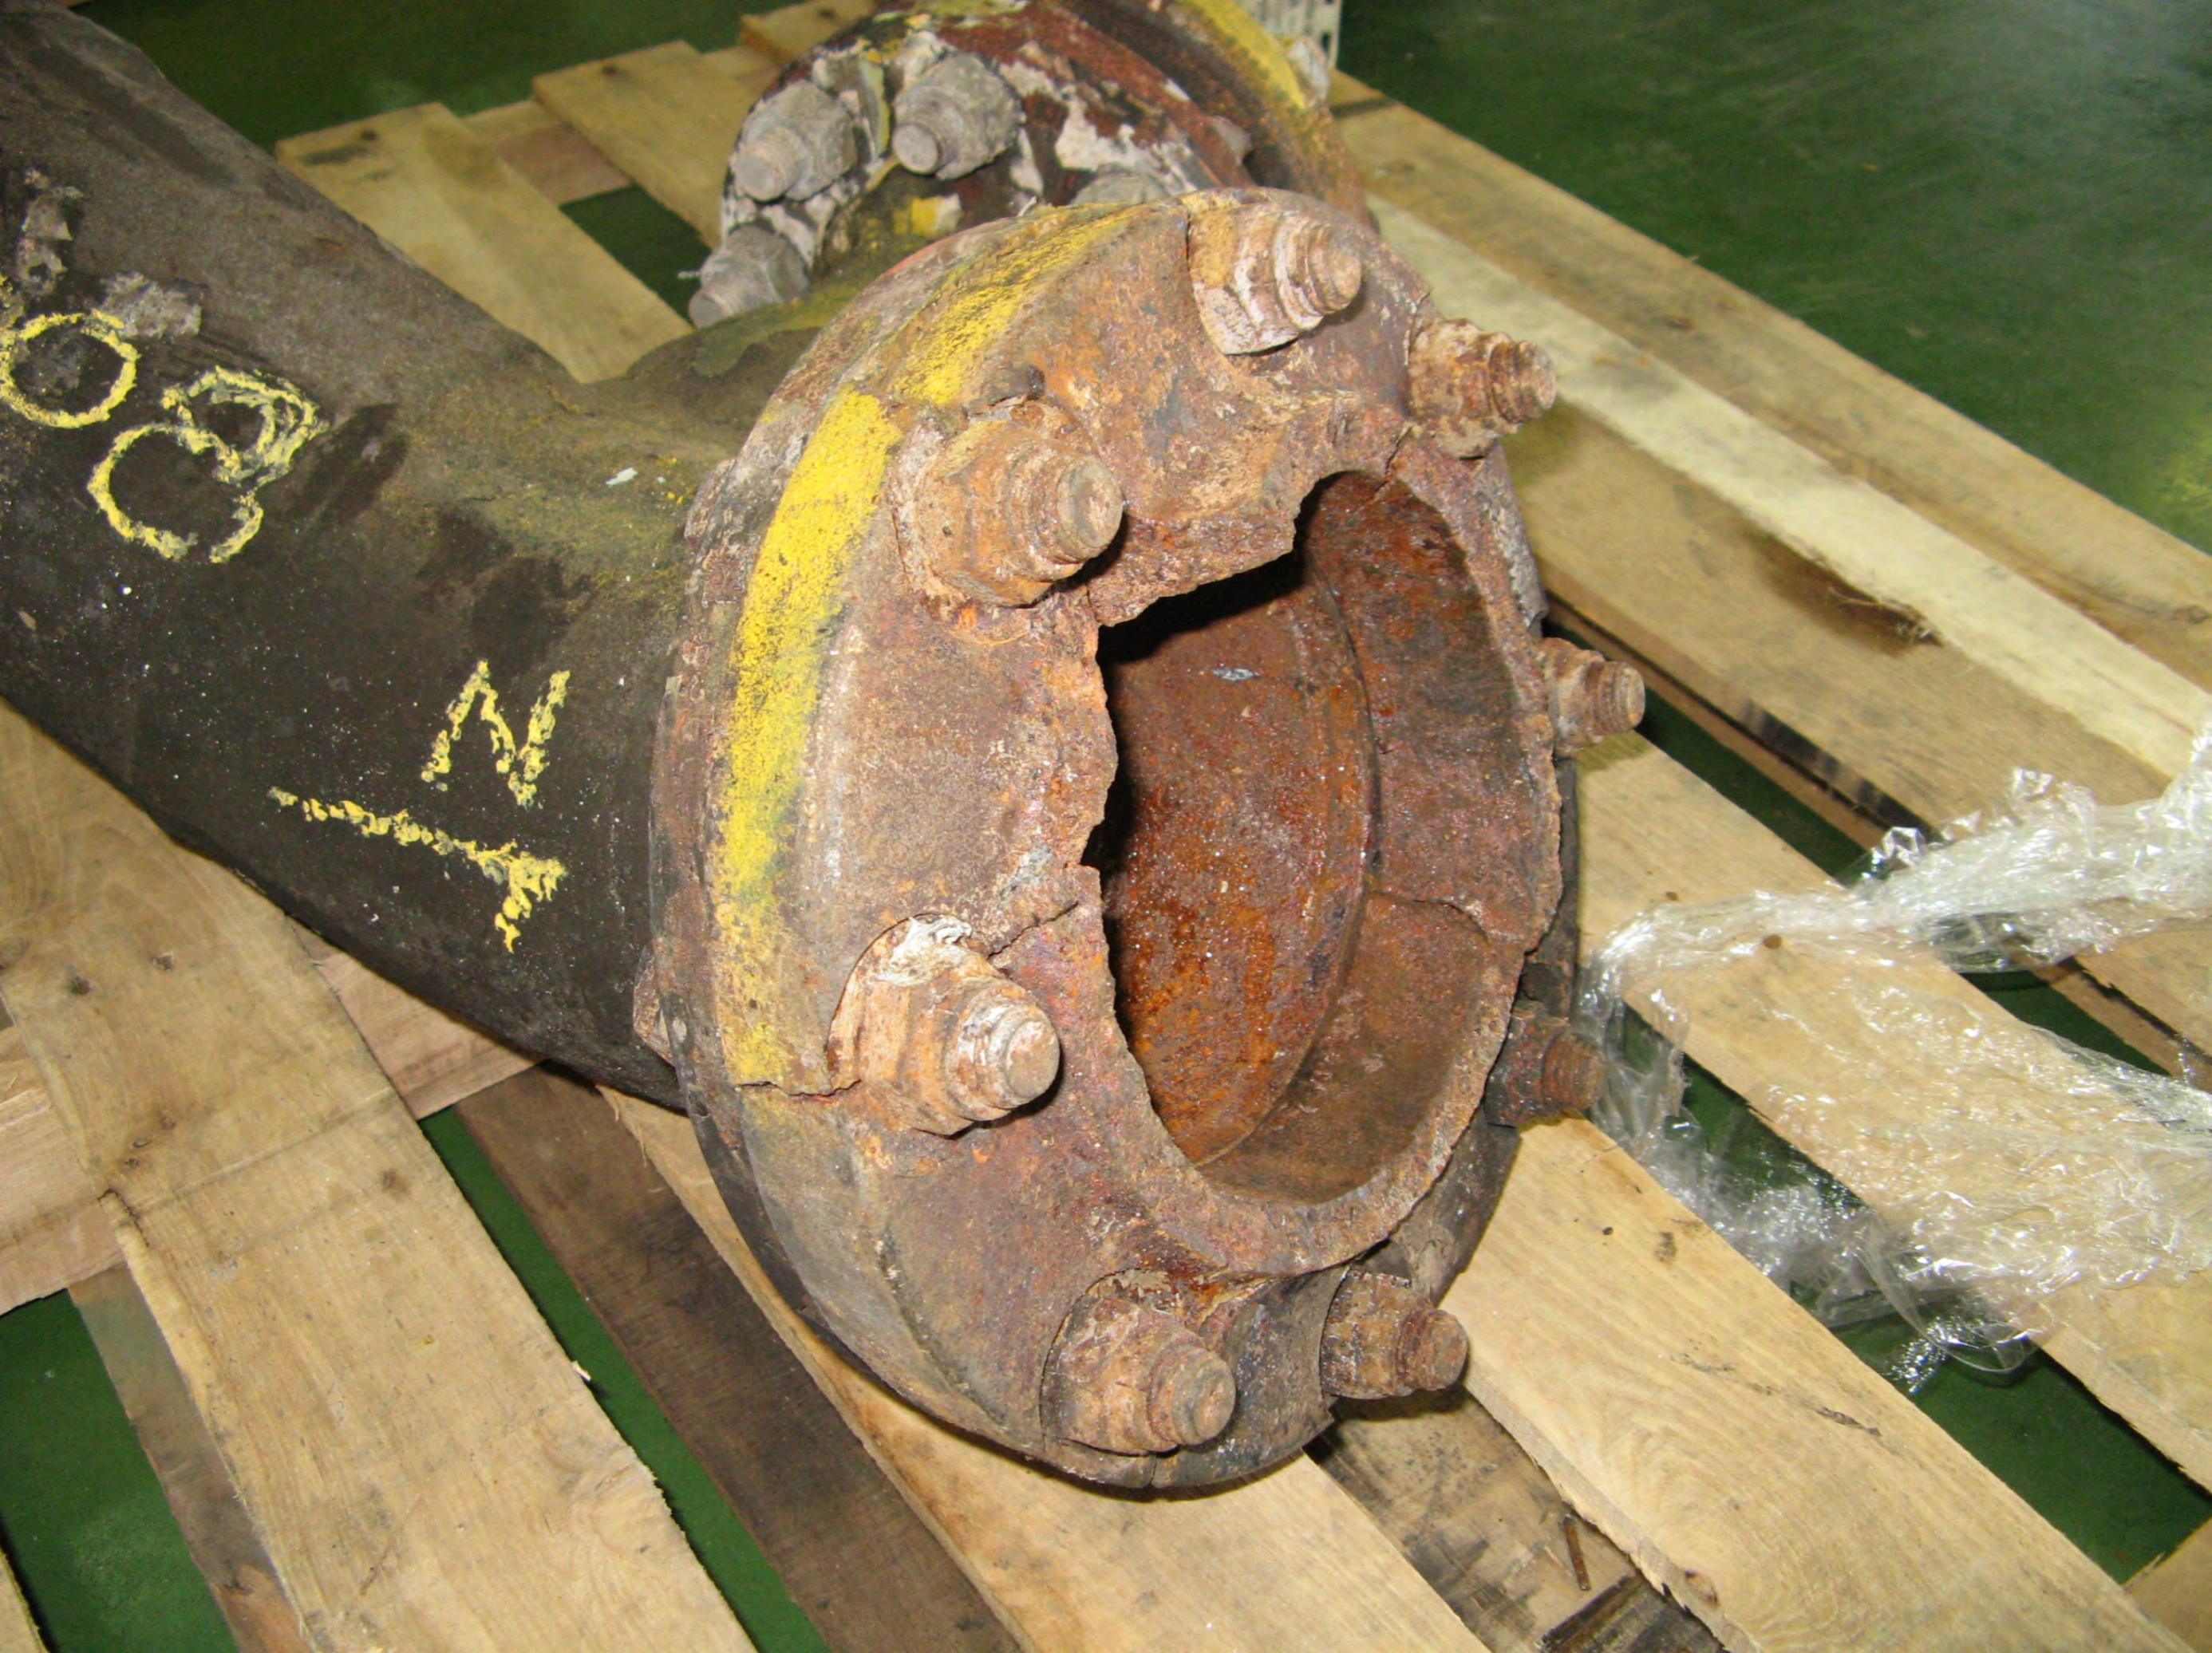
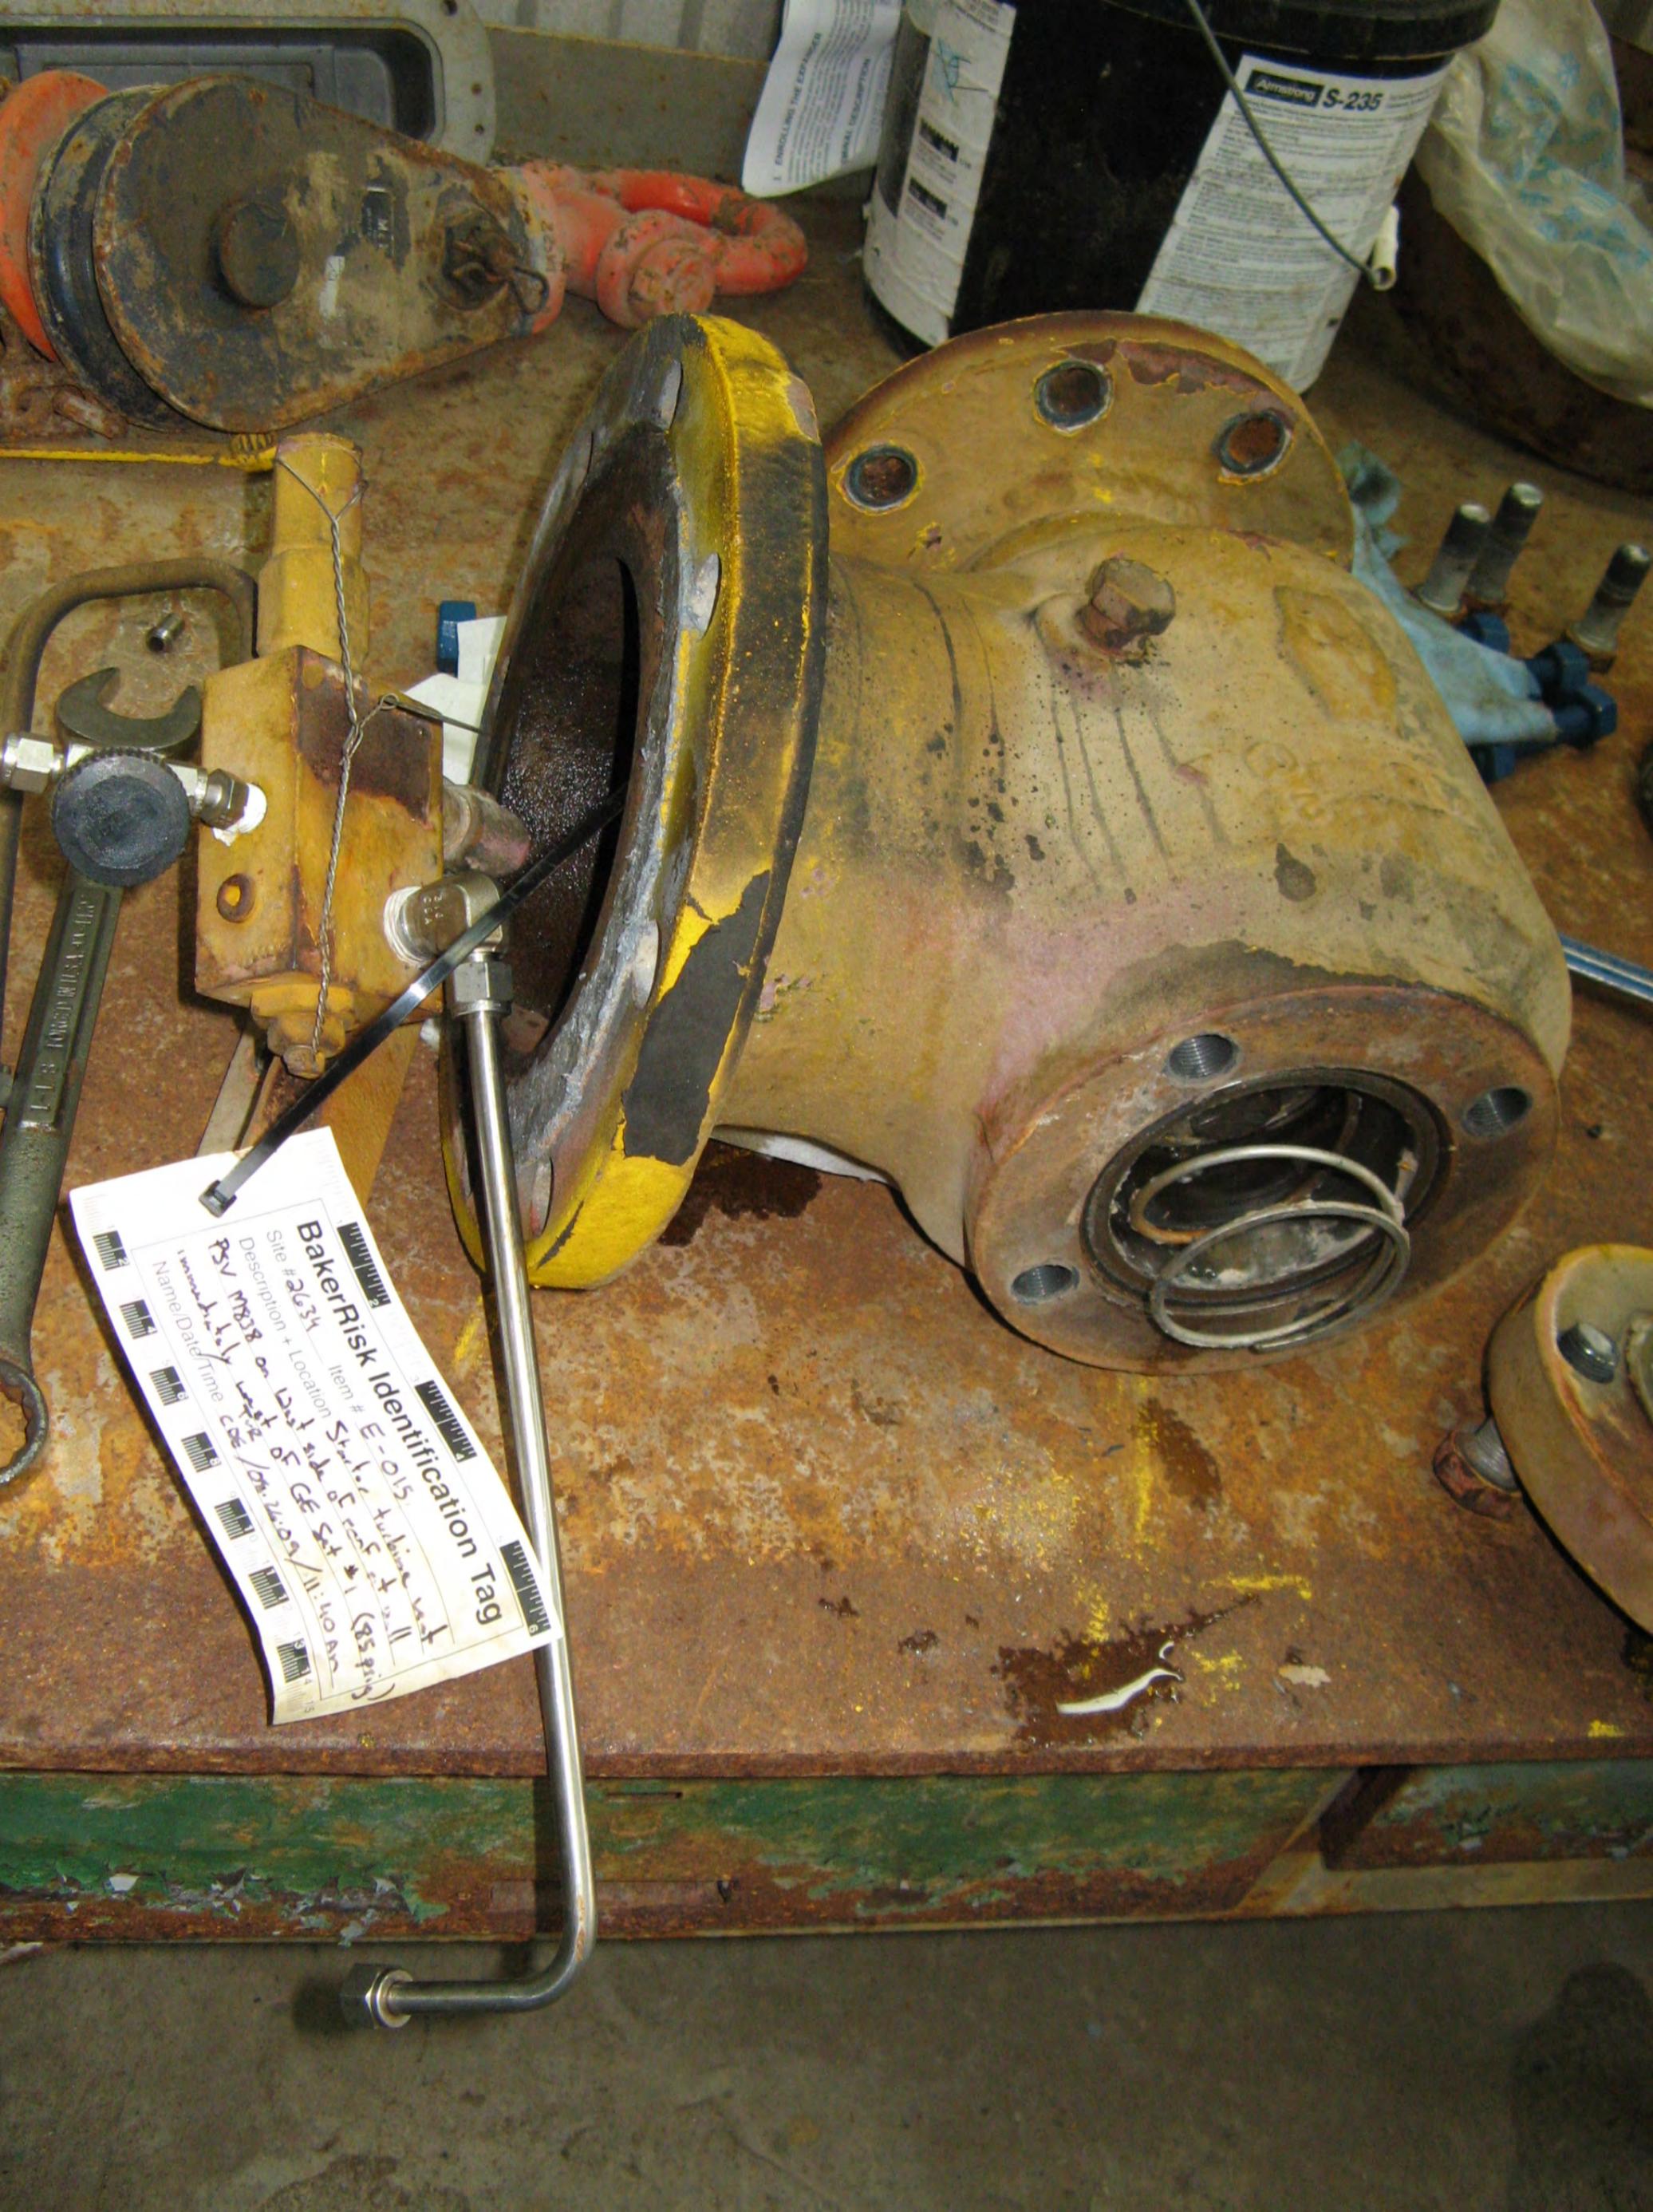
Appendix G – Starter Turbine, Piping, and Pressure Relief Valve Photos

The forensic analysis concluded that rupture of the starter turbine case was caused by internal pressure rather than an external explosion. The starter piping is protected by a relief valve (PSV M838) that was tested and torn down after the incident. BakerRisk determined the relief valve was functioning properly. Analysis of the check valve (M805) found the check valve clapper had dislodged from its normal operating position and that the retainer pin had failed. The BakerRisk analysis determined that

Site # 2634 Item # E-015
Description + Location *Shroud turbine work*
on Dist side of root seal
of GE Set # 1
on 2/20/09 11:40 AM
