DOT US Department of Transportation
PHMSA Pipeline and Hazardous Materials Safety Administration
OPS Office of Pipeline Safety
Southwest Region

Principal Investigator Richard J. Lopez
Region Director R. M. Seeley
Date of Report 05/30/2012
Subject Failure Investigation Report – Enterprise Cushing Terminal

**Failure Investigation Report – Enterprise Crude Pipeline LLC – Cushing East Terminal
February 21, 2011**

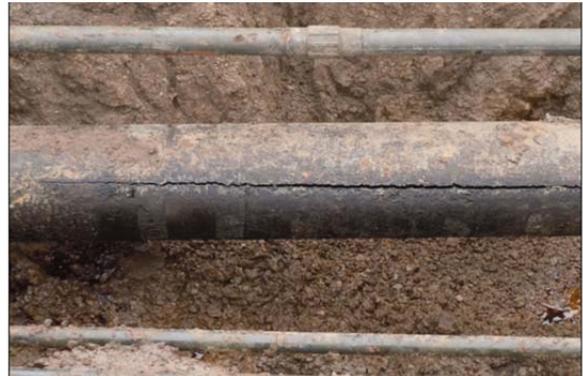
After the excavation of the pipelines it was discovered that the 8-inch line had a split down the seam approximately 49 inches long in the 3 o'clock position. The pipe segment was cut out and sent to Stork for analysis.

Figure 1 - Line split at the 3 o'clock position

The pipeline segment involved in the accident was shipped to Stork in Houston, TX for metallurgical analysis. Stork's analysis (Appendix C) determined that the probable cause of the failure was the result of overheating of the edges of the skelp during the lap welding process. The overheating of the edges of the pipe during the manufacturing process caused both grain growth and intergranular cracks in the

pipe. The service conditions of the pipeline caused the cracks to connect, over time, to the point where it was unable to withstand the hoop stress.

1. The 8-inch line had a split parallel to the seam of the pipe; it was approximately 49 inches long and in the 3 o'clock position.
2. The fracture was adjacent to a lap weld but it did not cross it or follow the fusion line.
3. The lap weld did not disbond or fail.
4. The ruptured pipe did not show brittle directional fracture marking to indicate an origin.

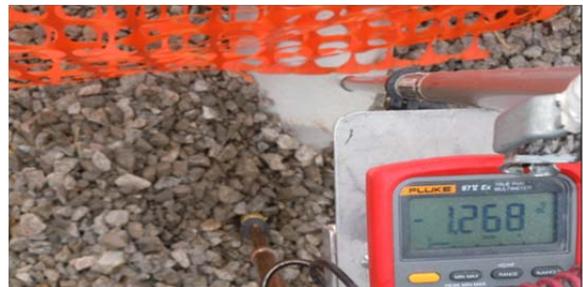
A cathodic protection potential survey was conducted during the investigation. Levels of protection met the protection criteria.

Figure 2 - Pipe to Soil Potential Measurement

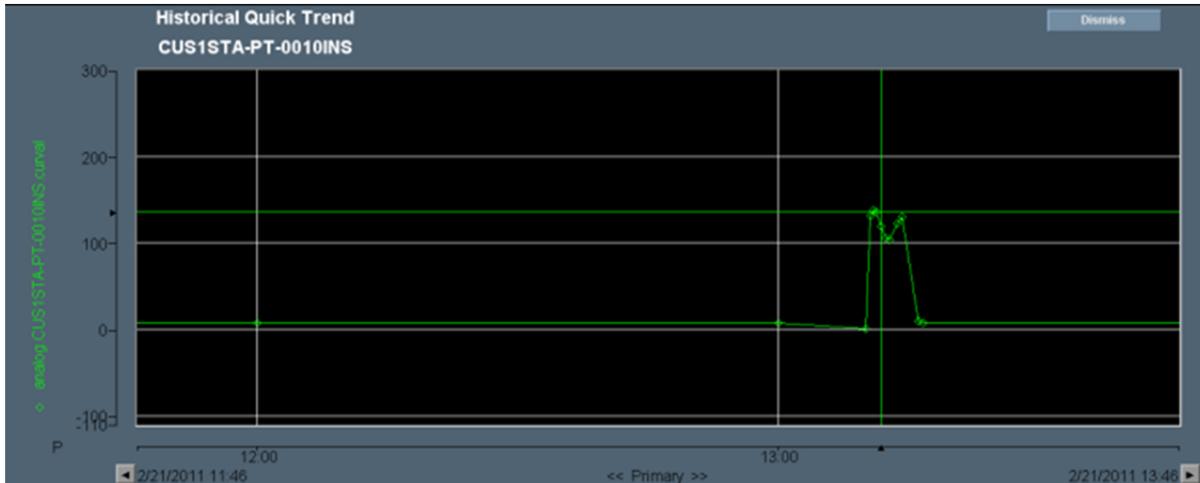
A review of the SCADA system indicated that the system had not been over-pressured. The maximum operating pressure (MOP) of the segment of the pipeline is 275 psig. Actual operating pressure of the pipeline segment at time of failure was 135 psig. As can be seen in the SCADA screen the accident occurred below the specified MOP.

Figure 3 - SCADA recording of the pressure at the time of the accident
