DOT US Department of Transportation  
PHMSA Pipelines and Hazardous Materials Safety Administration  
OPS Office of Pipeline Safety  
Western Region

**Principal Investigator** Peter J. Katchmar  
**Regional Accident Coordinator** Peter J. Katchmar  
**Region Director** Chris Hoidal  
**Date of Report** October 30, 2012  
**Subject** ExxonMobil Silvertip Pipeline Crude Oil Release into the Yellowstone River in Laurel, MT on 7/1/2011

## **Executive Summary**

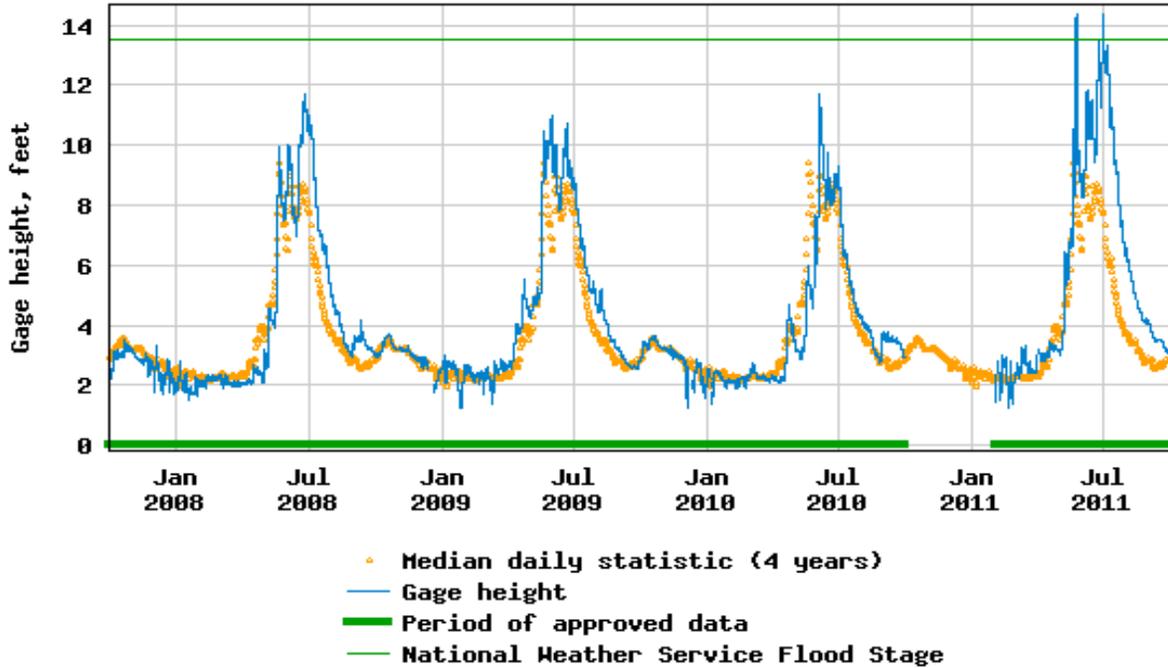
It appears that 2011 was the only year that the flood stage was exceeded at the gauge point. Of note is the fact that flood stage was exceeded 3 times in 36 days in 2011. In previous years the river would rise and then fall again in a relatively short time period and the water level did not rise above the twelve foot level. In 2011, the river rose and remained high for over a month. The prolonged high water level caused the river bottom downstream of the Highway 212 Bridge to scour and ultimately undermine the EMPCo pipeline.

Graph of gage height for 2008 through 2011 overlaid with the 4 year median statistic.

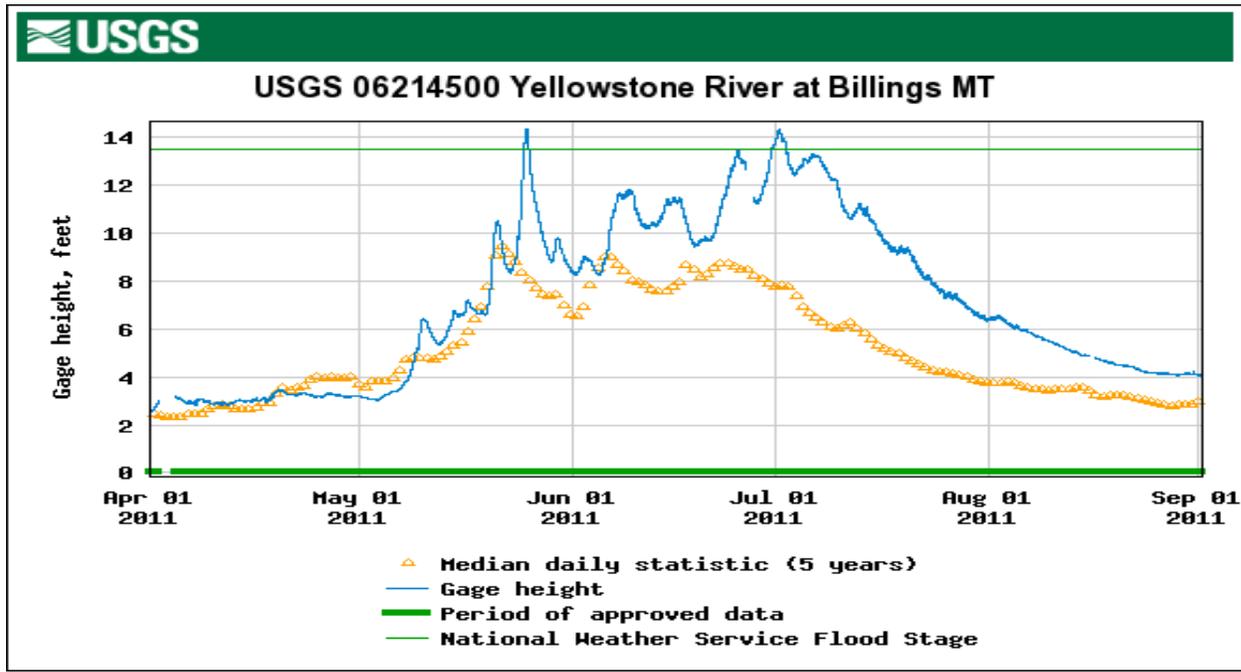
Graph of gauge height April 1, 2011 through September 1, 2011.

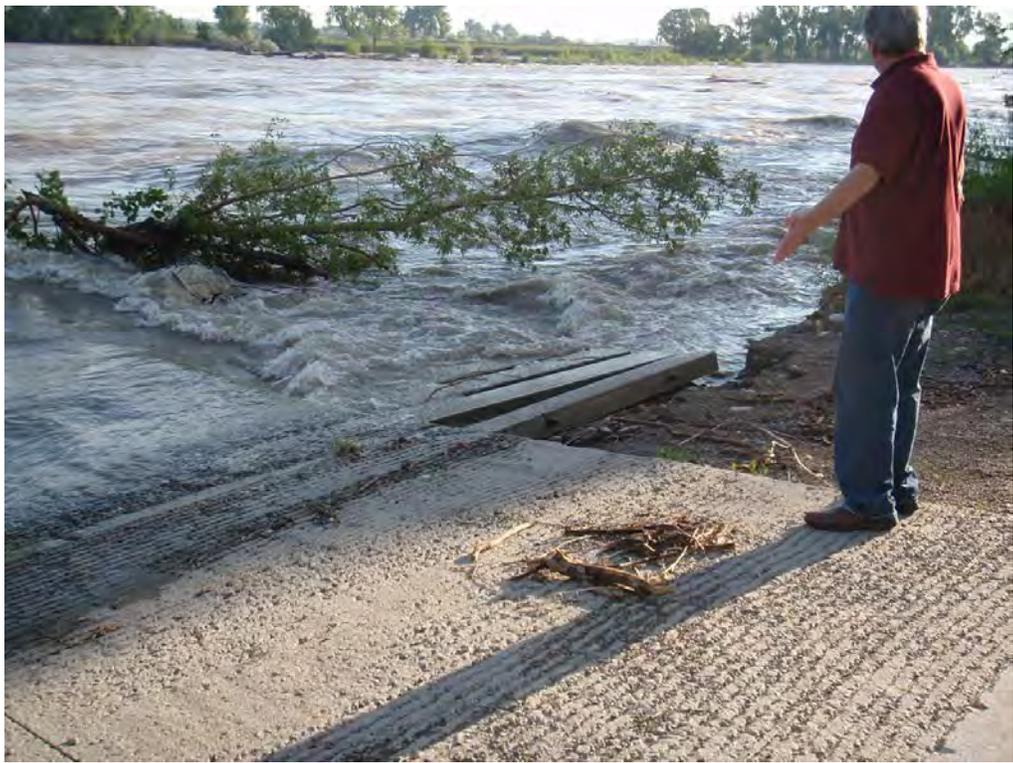
Looking NE from south bank of the Yellowstone River at the boat ramp just upstream of the EMCO crossing. Picture was taken Thursday, July 07, 2011, 9:24:08 AM 6 days after line rupture. The man is showing the location of the water on the south bank the day before. Notice the island is not visible. Also notice the debris pile in the river.

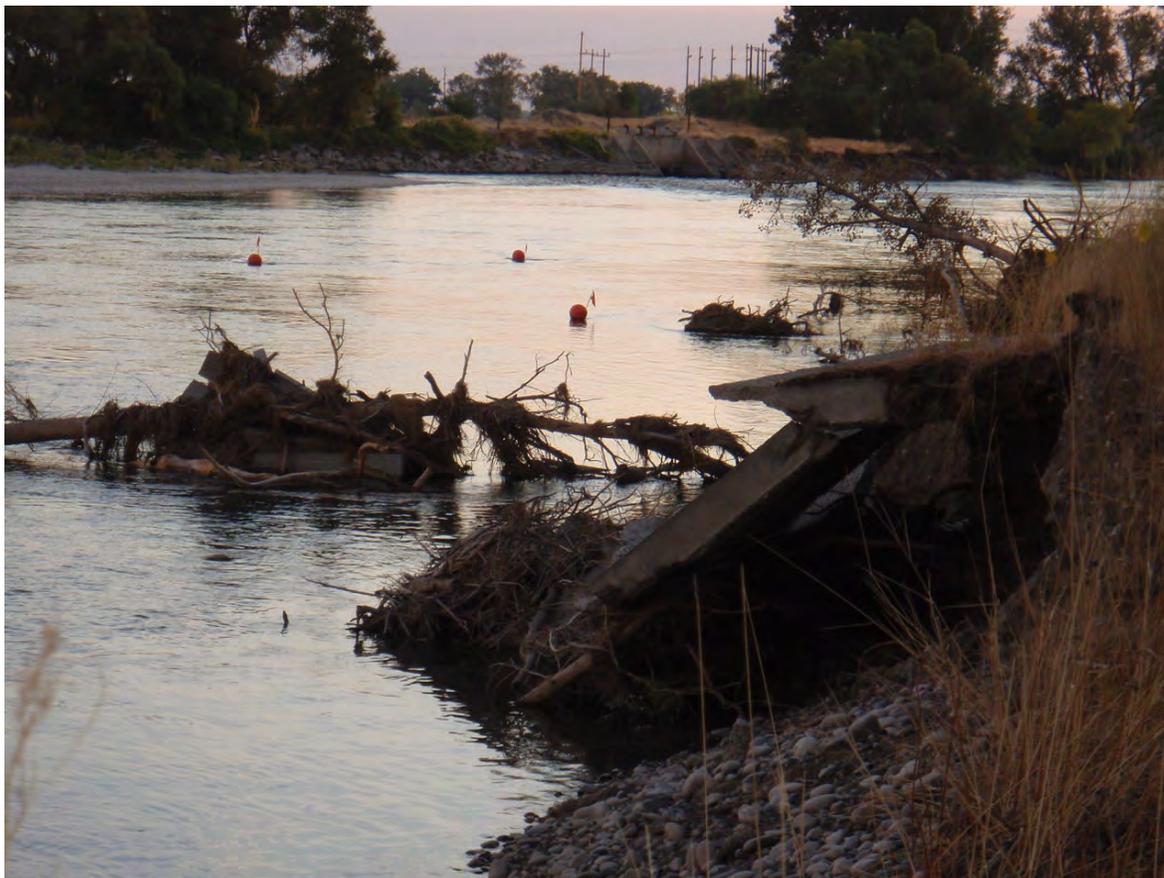
Looking NE from south bank of the Yellowstone River at the boat ramp just upstream of the EMCO crossing. Picture was taken Thursday, September 29, 2011, 2:52:11 PM after the river level dropped. One can see the same debris pile in the river as was in the last picture. The concrete seen in the foreground of this picture is the boat ramp in the previous picture. The buoy furthest to the right is marking the north end of the rupture from the south bank. The next buoy is marking the south end of the rupture from the north side of the main channel off of the island.

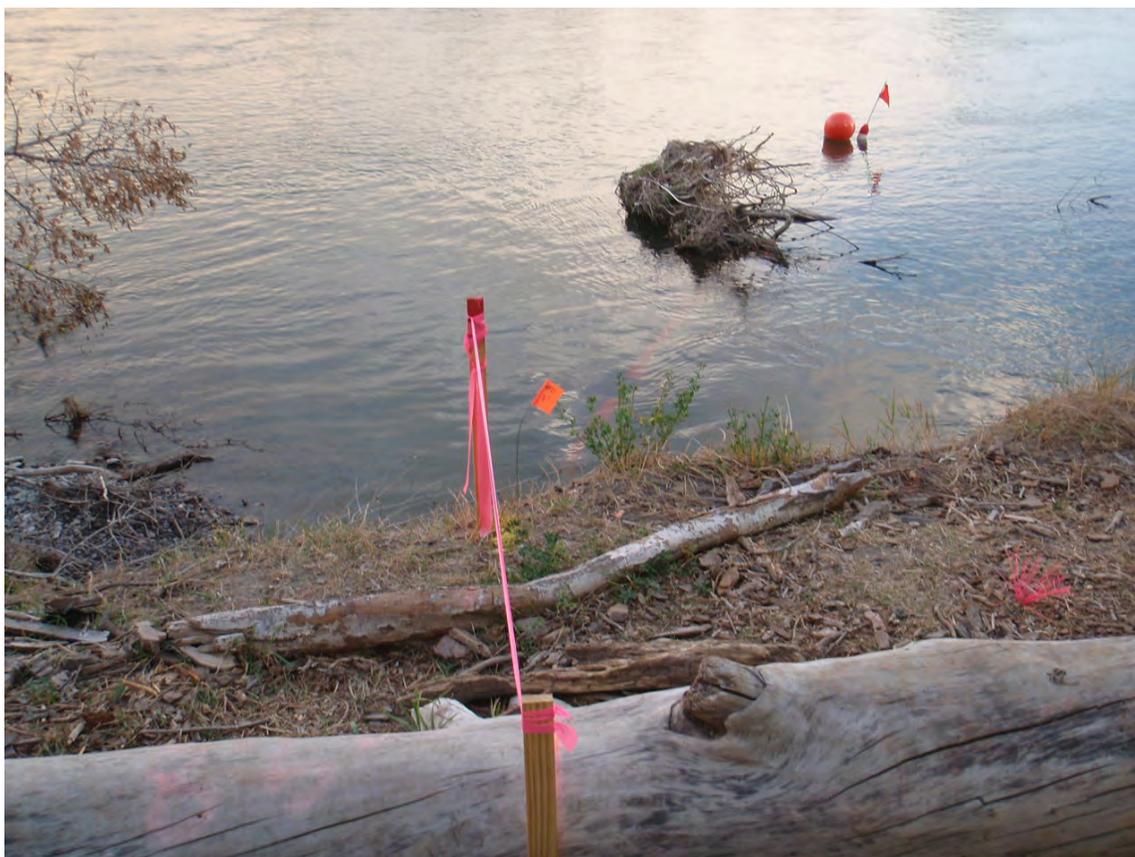
Picture taken from the south bank looking north on Thursday, September 29, 2011, 2:55:09 PM. One can see the pipe deflection downstream under the water. The buoy is marking the north end of the ruptured pipe from the south bank. The two lath tied together with pink ribbon are in line with the original pipeline right-of-way alignment from south to north. One can see a root ball that appears to be hung up on the pipeline. The red abrasive resistant fusion bonded epoxy (FBE) coating can be seen on the pipe. The pipe was originally concrete coated over the FBE coating.

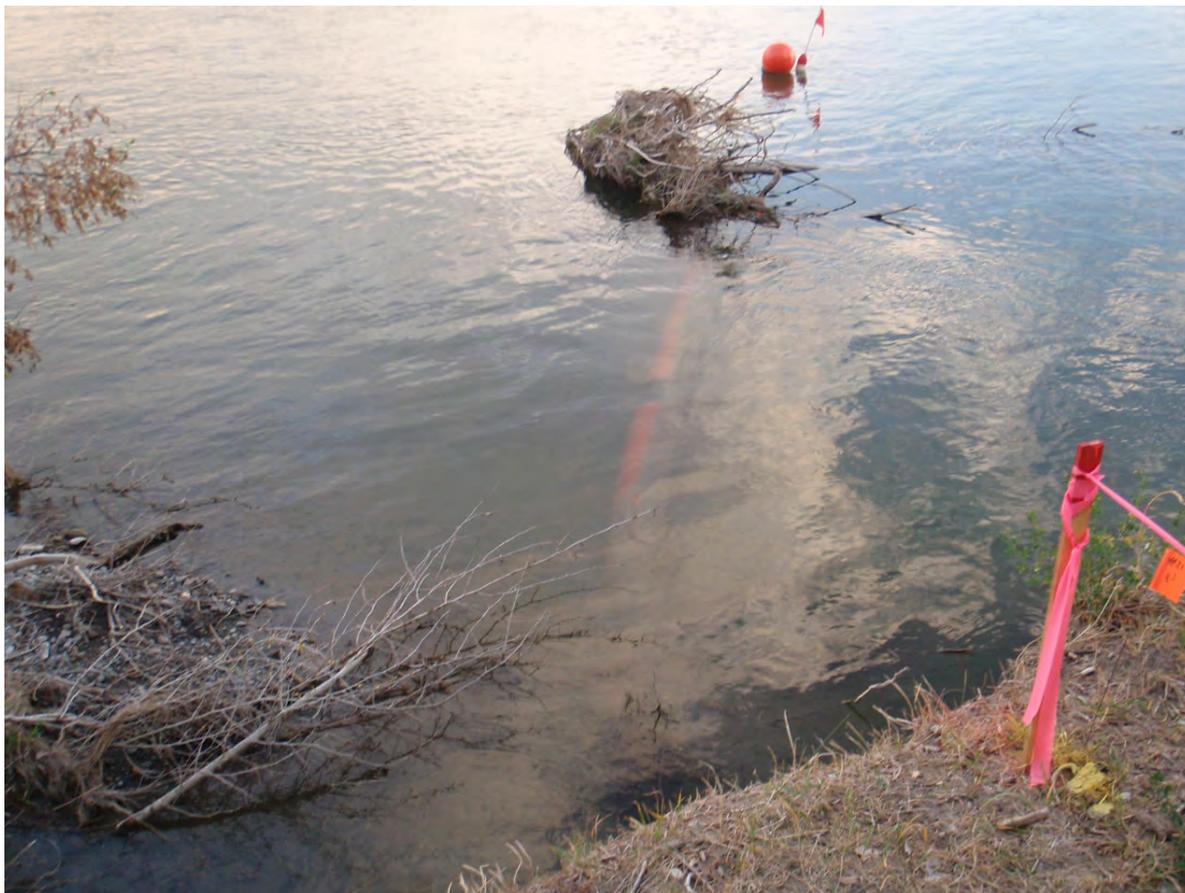
Picture taken on Thursday, September 29, 2011, 2:56:30 PM. Close up of the pipe from the south bank. Buoy is marking the north end of the rupture from the south bank pipe.

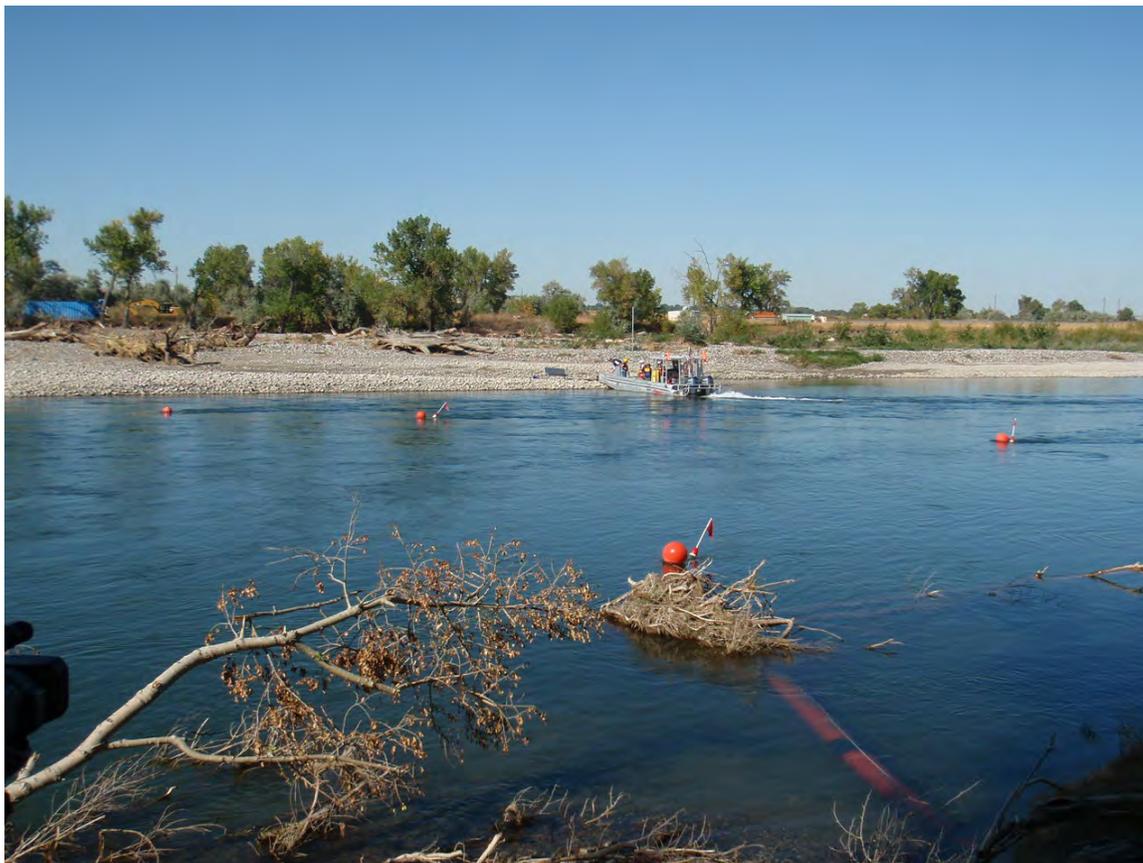
Looking NE from the south bank. Picture taken on Thursday, September 29, 2011, 2:59:16 PM. EMCO pipeline is visible under the water.

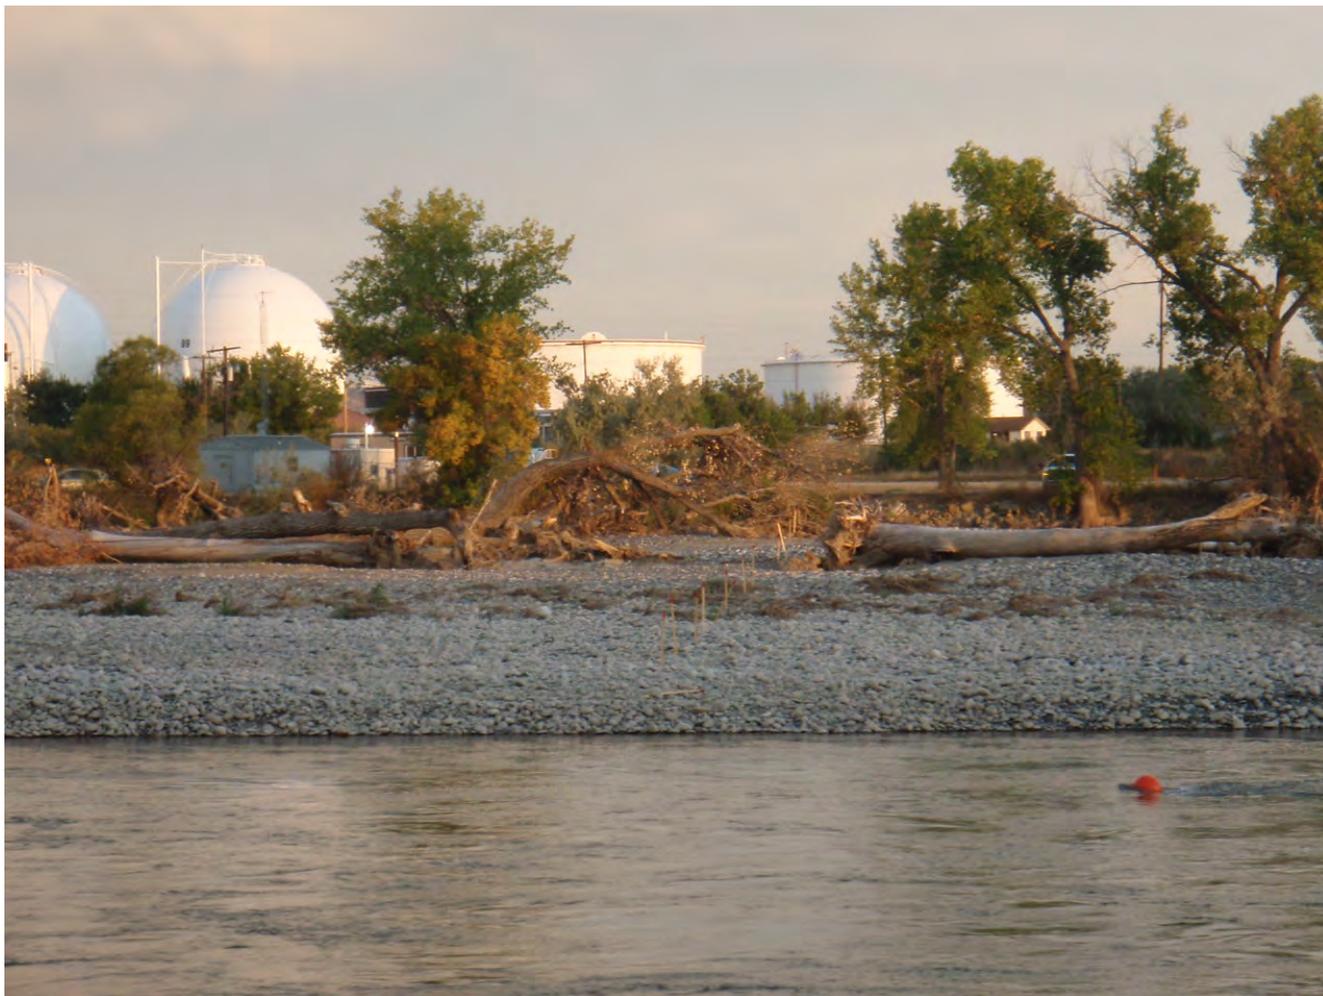
Looking north along original pipeline right-of-way alignment from the south bank taken Thursday, September 29, 2011, 2:55:19 PM. One can see the pipeline marked with lath and ribbon across the island and the first buoy to the south from the island that marks the pipe location being deflected downstream.

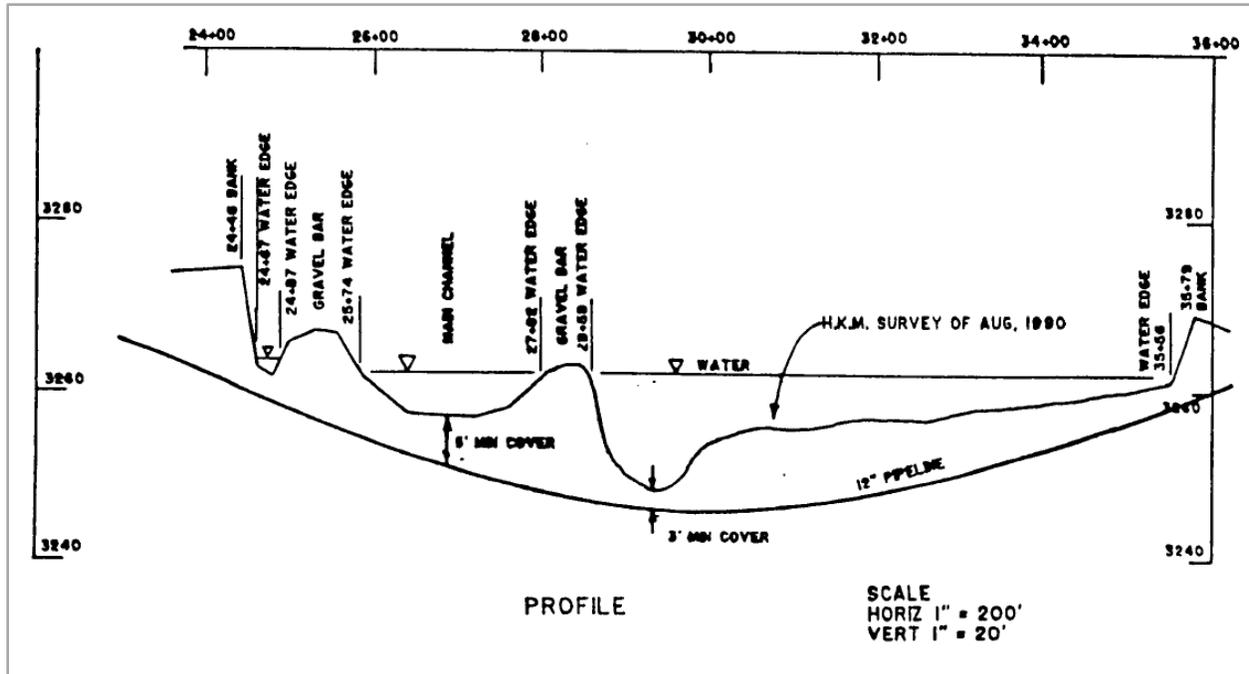
Figure 1. River Crossing Profile

The total length of pipe exposed by the flood was 207 ft. The failure occurred in the wider south channel, approximately 51 ft from the south bank.

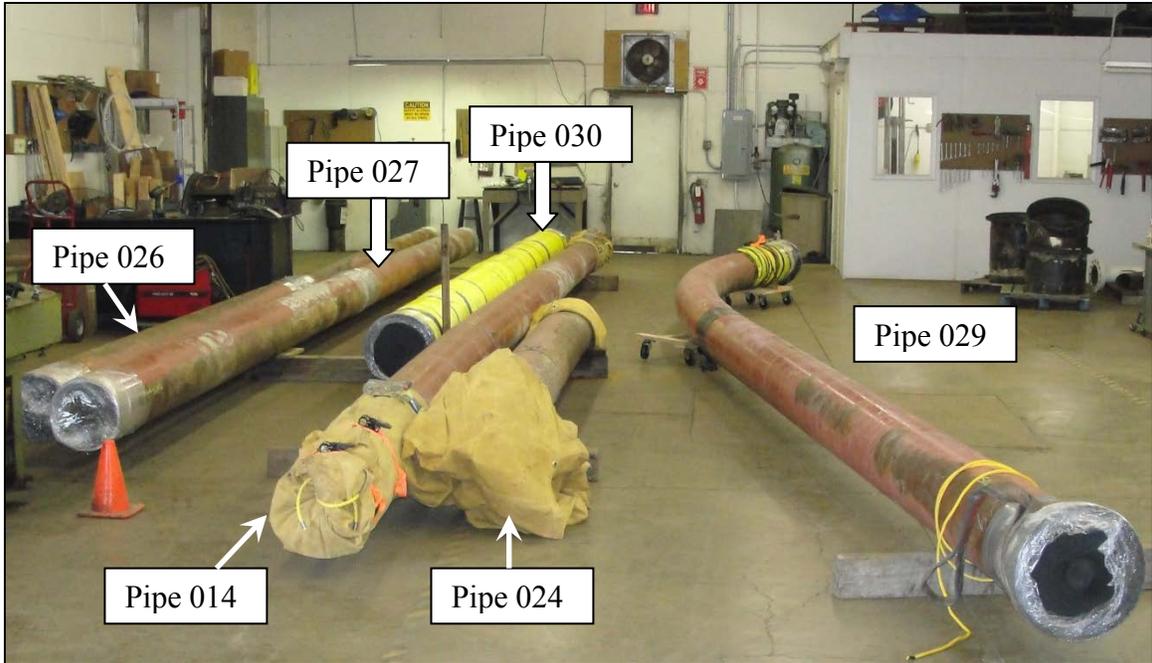
**Figure 2. Pipe samples in as-received condition**

The pipe samples as received are shown in Figure 2 below. The failure occurred at a girth weld joining Pipe 014 (Tag 014) and Pipe 024 (Tag 024). These two pipe samples arrived with the fractured ends covered with a heavy fabric tarp that was held in place with ratchet straps. The wrapping was removed from piece 024 to remove a rubber bladder that had been installed in the field during the removal process. The bladder had been frozen in place prior to shipment and KAI was requested to extract the bladder and return it to the field site. The removal of the bladder was also video recorded. Other than this activity, the pipe ends were not disturbed until the examination began on May 7. Select photographs from the investigation are presented below. All photographs taken during the investigation are presented in Appendix 4.

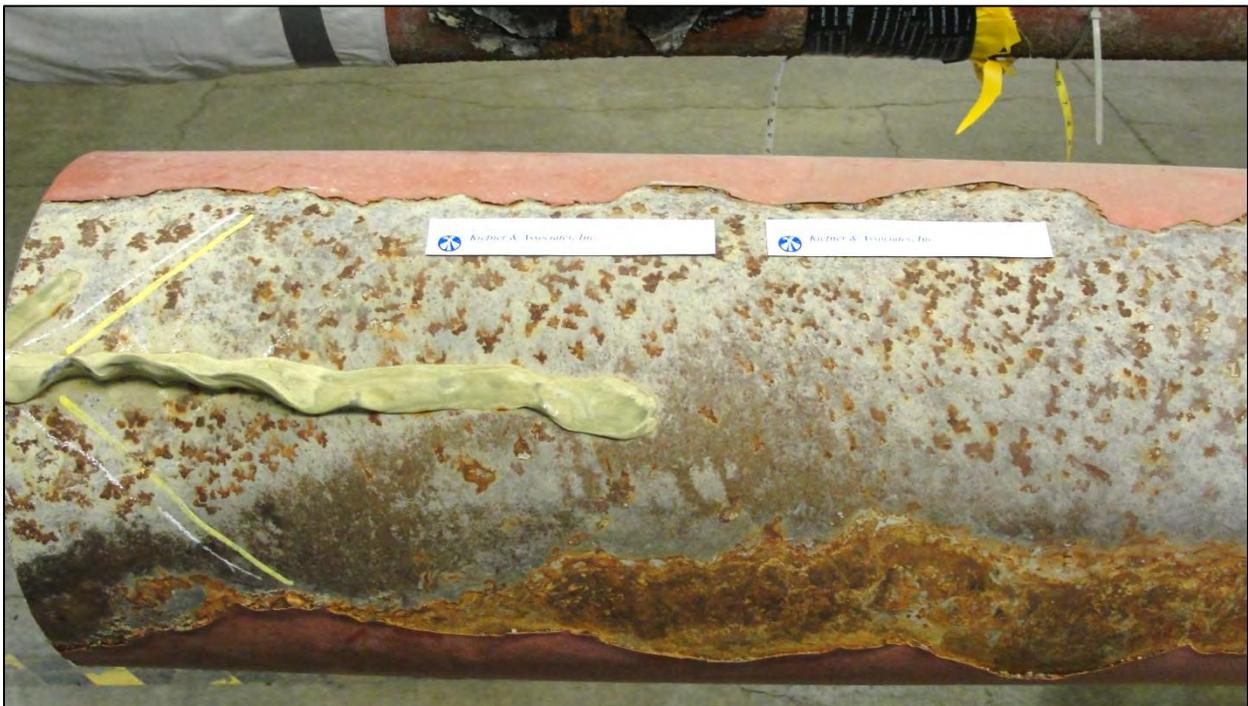
Both pipe samples were coated with red fusion-bonded epoxy (FBE) coating that had apparently been worn away to bare metal over large areas along the length of the pipe samples. For example, there were two bare areas on Pipe 024 that spanned the full length of the sample and measured 11 to 16 inches wide, separated by a strip of intact coating that measured 24 to 29 inches wide. Figure 4 shows a typical area of eroded coating on Pipe 024. Debris was impacted under the edges of the intact coating, as shown in Figure 5.

**Figure 4. Area of coating erosion on Pipe 024**

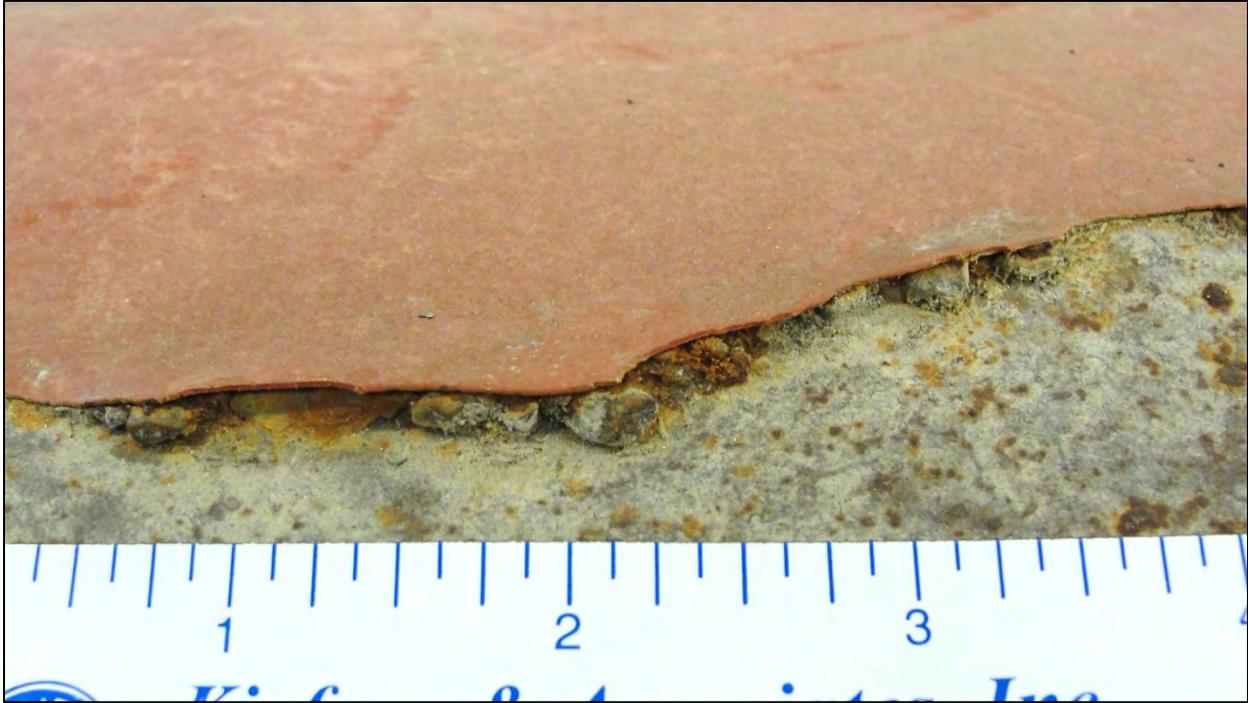
**Figure 5. Debris impacted under edge of intact coating**

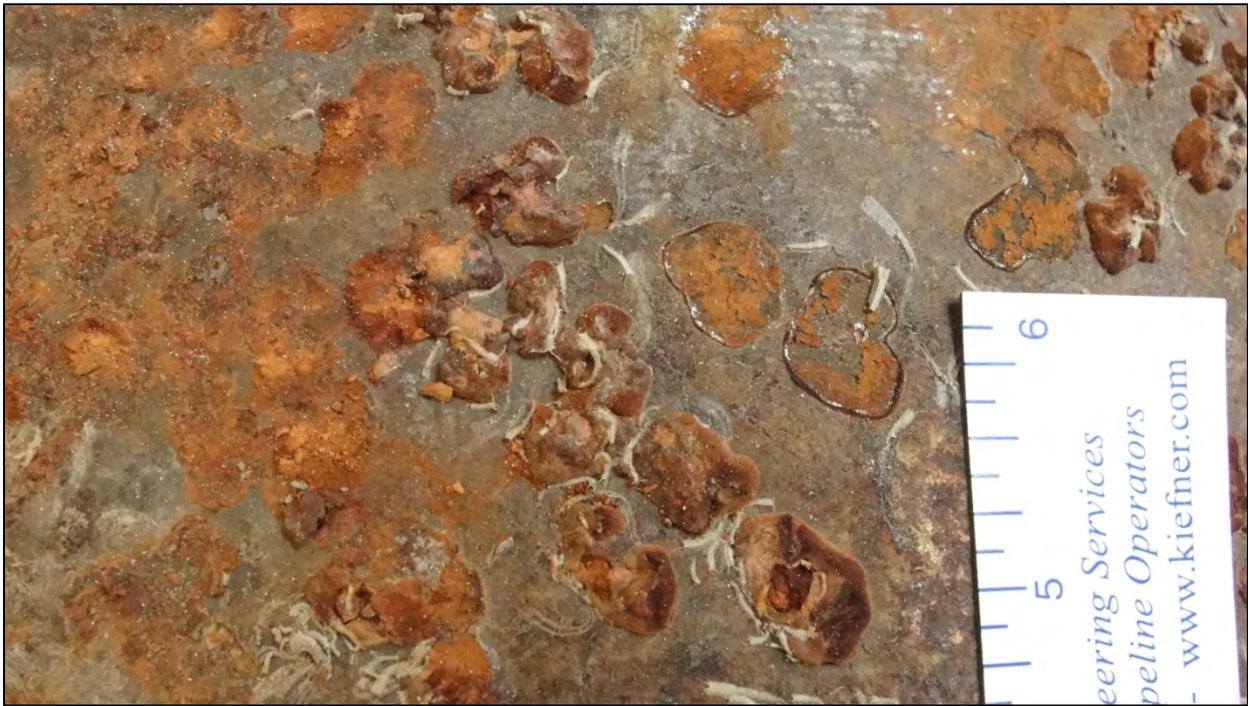
The bare steel surfaces were covered with numerous white colored elongated objects, each approximately 1/8 to 1/2 inch long, that appeared to be the remains of some type of fresh-water biota presenting worm-like or tube-like features emanating from adhered masses. We were unable to identify the species. The remains of the organisms (“worms”) were present in prolific quantities on most pipe exterior surfaces where the coating was absent, some interior surfaces, and the fracture surfaces of the failed girth weld. The adhered organisms are shown in Figure 6 through Figure 8 on the pipe exterior. The pipe surface was pitted underneath the individual masses associated with the organisms, as shown in Figure 9.

**Figure 9. Corrosion under biotic mass**

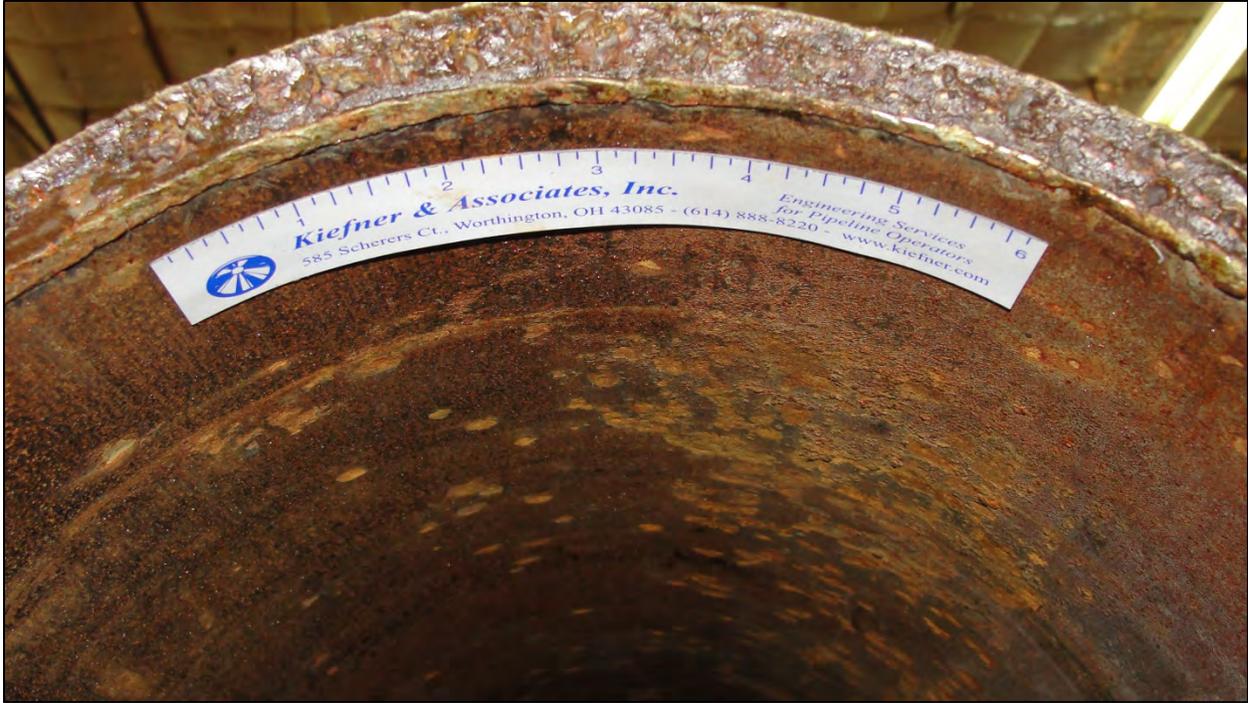
The protocol called for examining the interior surface of Pipe 014 and Pipe 024 near the fracture. The interior of the pipe was bare and was covered in a layer of orange-colored film, likely a surface rust from exposure to water and air, visible in Figure 10 as observed typically. The interior pipe surfaces exhibited light surface pitting, similar to the pitting observed on the exterior surface of the pipe where the coating had been removed. The metal loss was superficial in depth.

**Figure 11. Interior Surface Pitting**

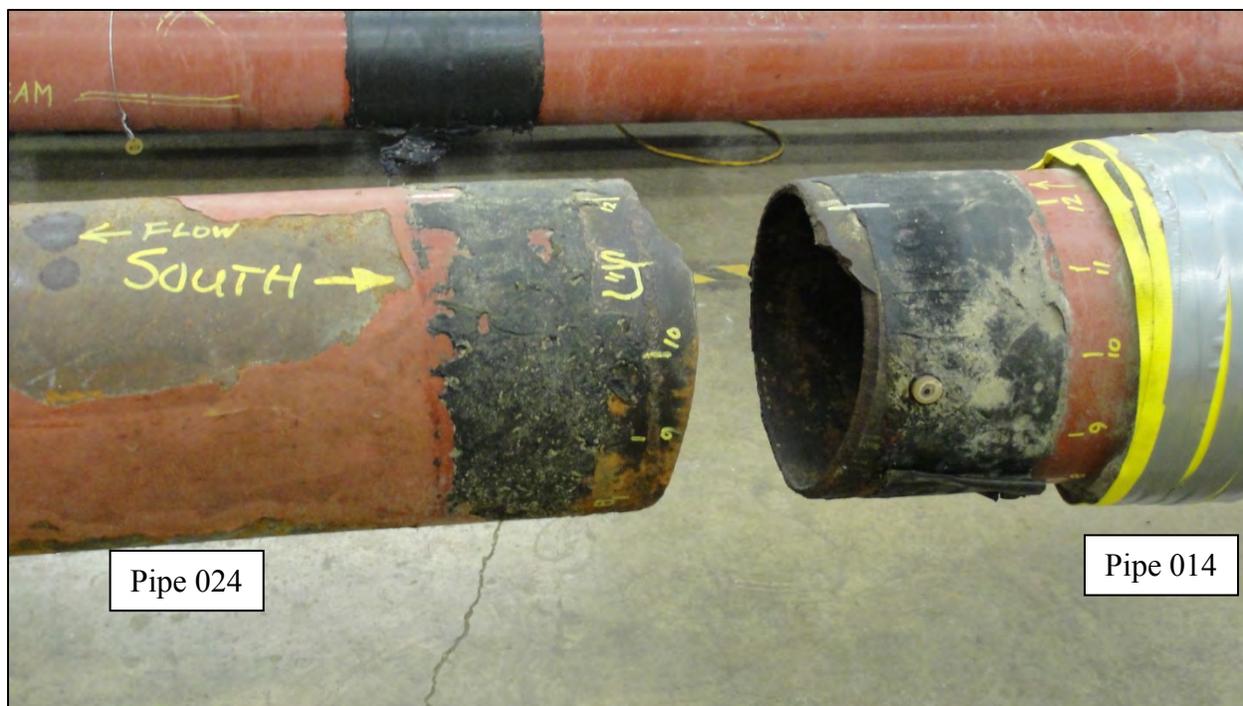
The failure occurred as a circumferential fracture in and adjacent to the girth weld joining Pipe 014 and Pipe 024. The fracture propagated in the girth weld for a distance of approximately 28 inches and in the adjacent pipe (Pipe 014) for a distance of approximately 12 inches. The fracture is shown in Figure 12 through Figure 14. The markings visible in the figures indicate the orientation of the pipe in service. The positioning in Figure 14 is approximately the same as in service.

**Figure 14. Fractured ends of the pipe aligned**

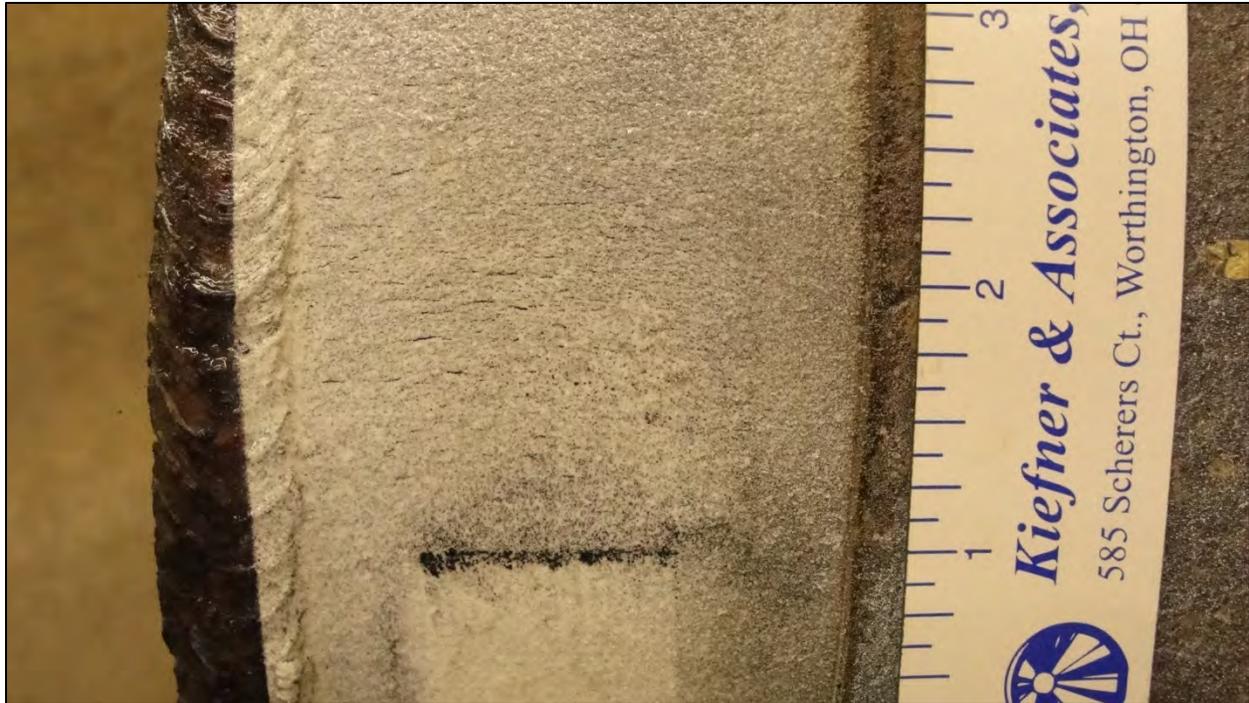
The ends of Pipe 014 and Pipe 024 were examined adjacent to the fracture with magnetic particle testing (MT) where the steel was bare. To prepare the exterior portions of the pipe ends for MT, portions of the black girth weld coating (which appeared to be the remnants of a shrink sleeve) were removed by cutting through them with a utility knife and peeling the coating off of the bare pipe steel at the FBE-cutback area of both pipes. No attempt was made to remove the intact FBE coating beneath the black girth weld coating. The pipe was cleaned with naphtha to remove any remaining adhesive that still clung to pipe surface. The ends were inspected inside and out first with dry MT. The ends were then coated with white contrast paint and were inspected by a wet, black on white contrast MT method. Several features were found on the external surface of both pipe ends. The features were oriented longitudinally and measured less than 1/8-inch long. Several typical features are shown in Figure 15. The features were not located adjacent to the fracture surface, were not of a significant length, and resembled artifacts of pipe manufacturing, and therefore were not evaluated further at the time of the investigation.

**Figure 15. Magnetic Particle Examination Surface Features**

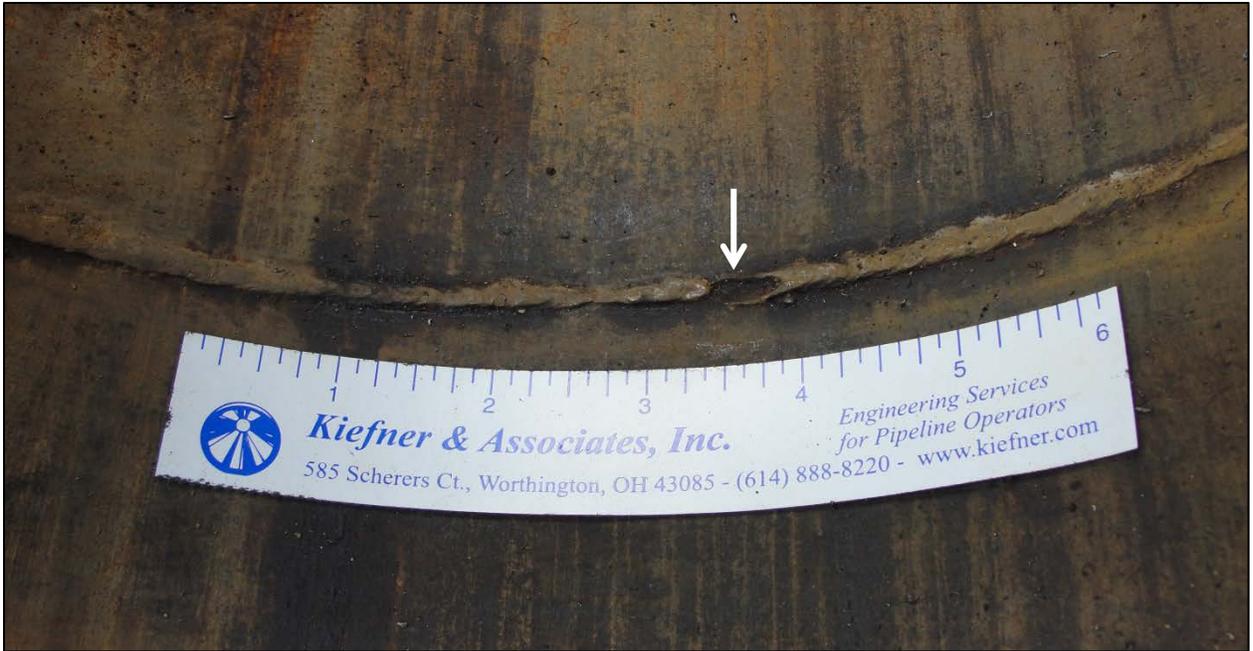
Figure 16 shows the burn-through feature in Weld 026. Figure 17 shows inadequate penetration in Weld 030. Minor interior beveling is shown in these views as well. Figure 18 exhibits the minor high-low across Weld 030, typical also of the failed weld.

**Figure 16. Burn-through Feature, Weld 026**

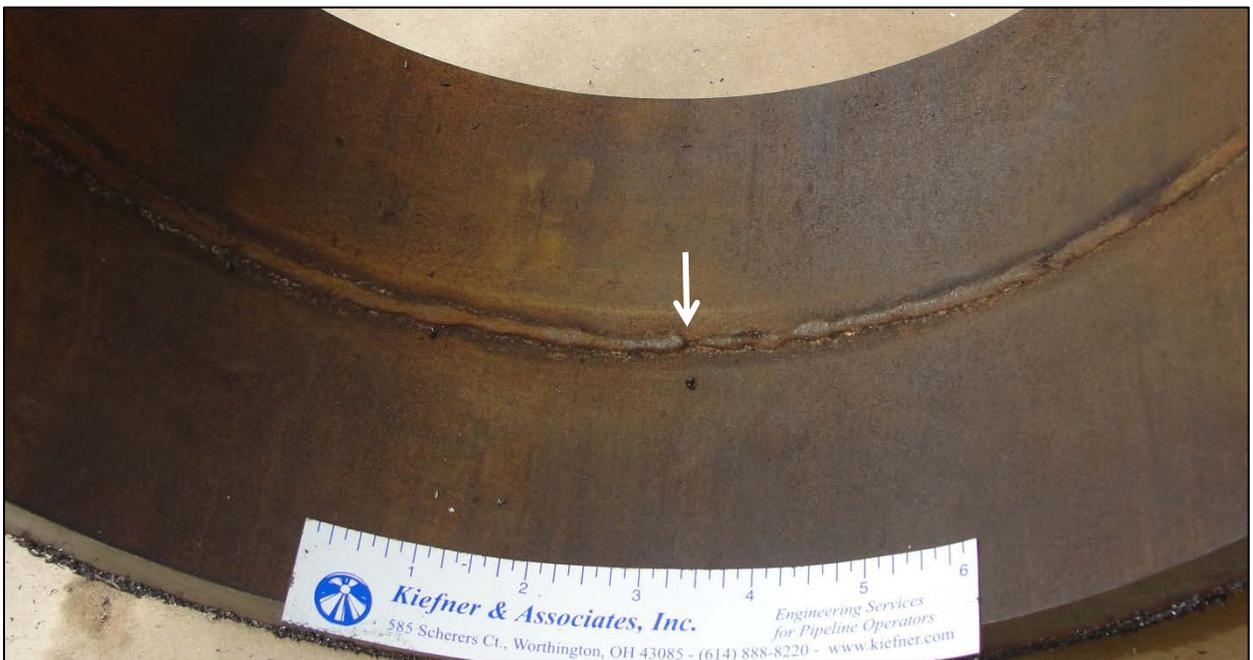
**Figure 17. Inadequate Penetration Feature, Weld 030**

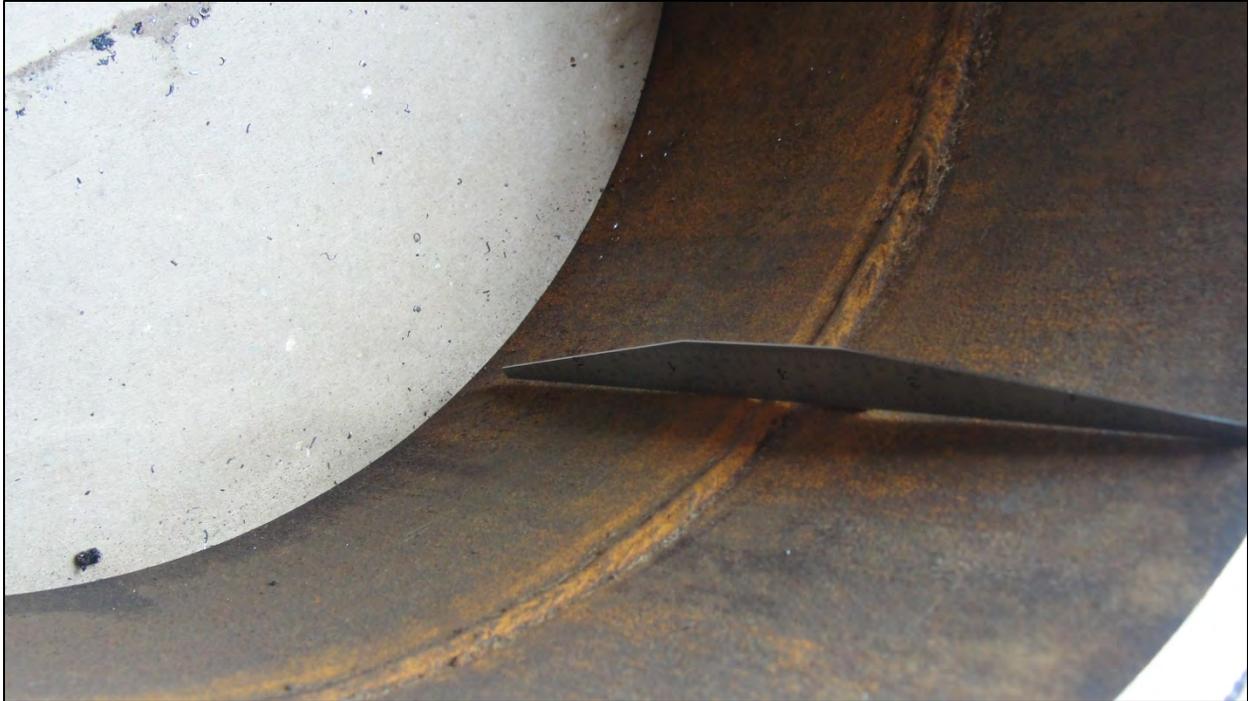
**Figure 18. Fit-up Across Weld 030**

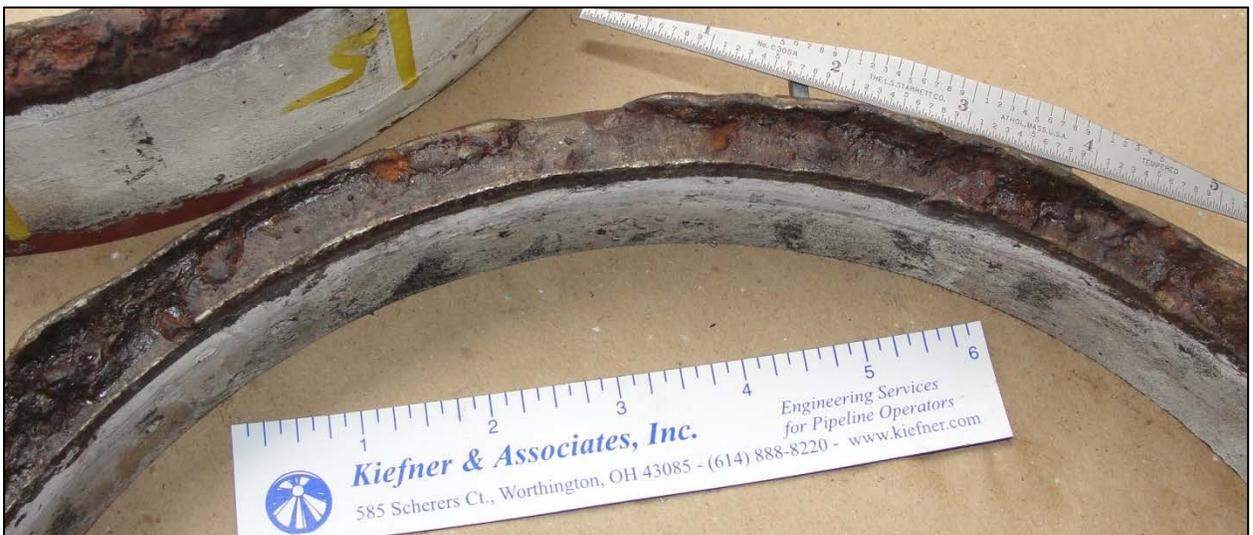
Two areas of relatively flat fracture were present on the fracture surfaces. The areas were not in equal condition, such that one feature was more visible on one side of the fracture, and the other feature was more visible on the opposite side. The larger of the two features, labeled feature “L”, is shown in Figure 20 and measured 10.5 inches long on the interior pipe surface. This feature was through-thickness near the mid-length. The smaller of the two features, labeled feature “S” is shown in Figure 21 and measured 3.1 inches long by approximately 70% of the wall thickness in depth.

**Figure 23. Fracture surface of Pipe 024 showing Feature “L”**

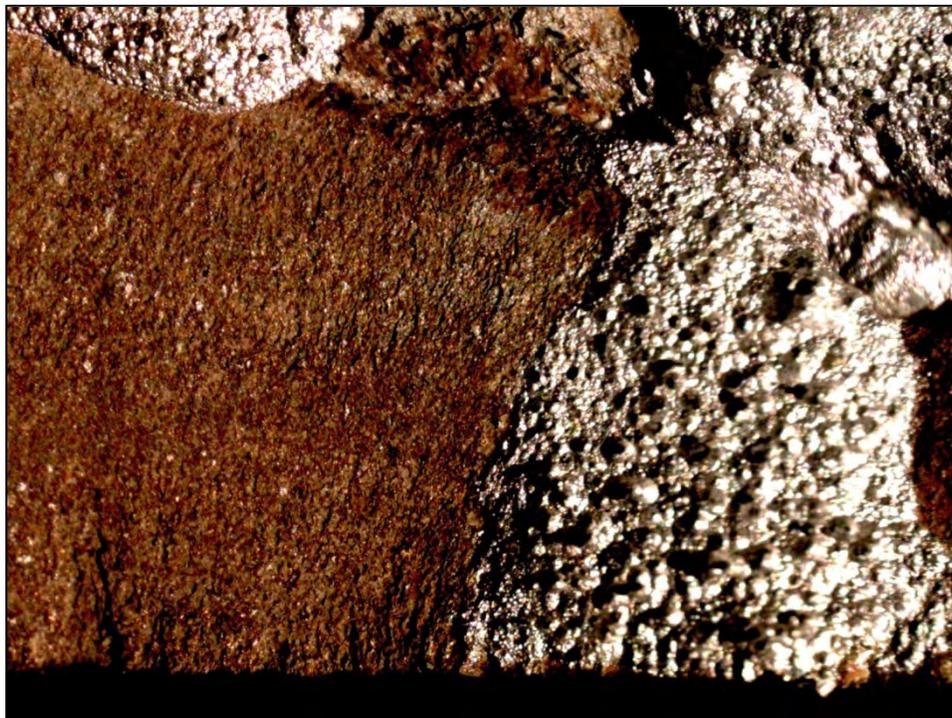
The samples were examined in an optical microscope after cleaning. The original fracture surface had a medium brown color. After cleaning, small light gray areas were visible. These light gray areas exhibited evidence of pitting when viewed on an optical microscope. A detail of pitting adjacent to the flat feature on specimen S1 is shown in Figure 28.

**Figure 28. Detail of Pitting Under Biotic Adherent**

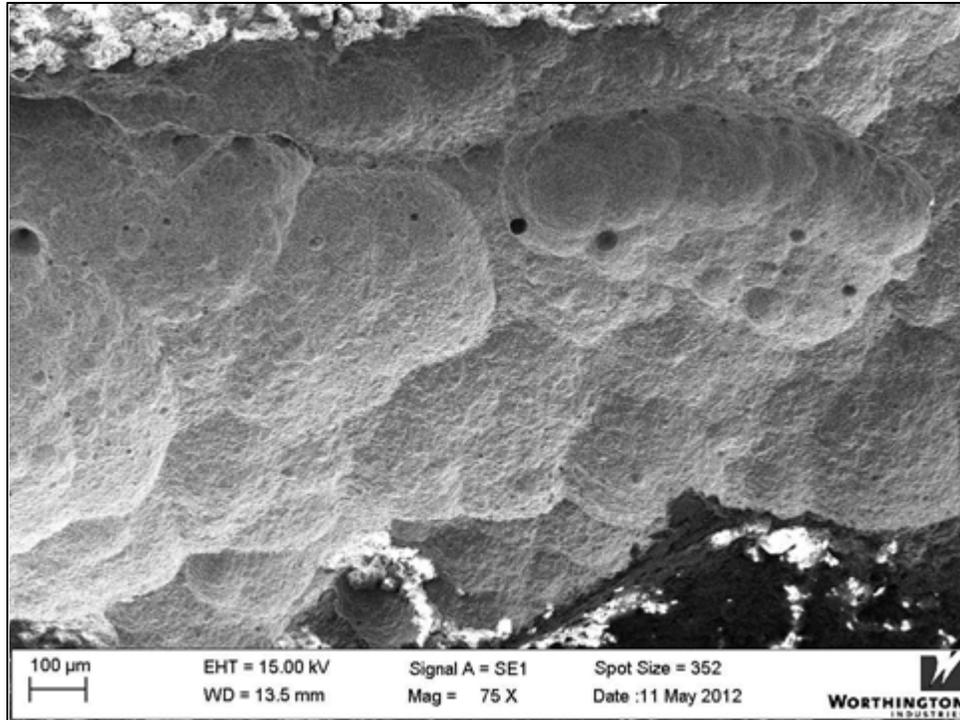
**Figure 36. SEM Image, Pitting on Flat Feature**

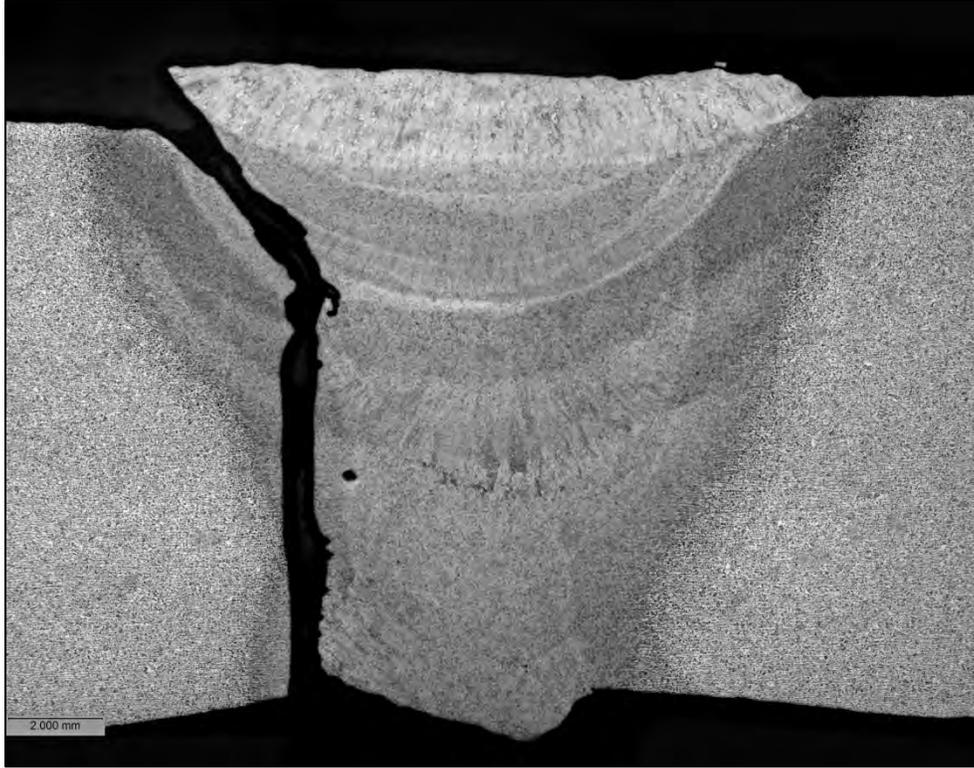
The metallographic section through Feature S is shown in Figure 50. The feature, a crack, is seen to initiate at the toe of the root pass and propagate into the weld metal. The crack is relatively flat and straight (radial) through about 75% of the pipe wall thickness, and exhibits ductile shear fracture in the remaining 25% of the wall thickness.

**Figure 50. Metallographic section through Feature S**
