DOT US Department of Transportation  
PHMSA Pipelines and Hazardous Materials Safety Administration  
OPS Office of Pipeline Safety  
Western Region

**Principal Investigator** Peter J. Katchmar  
**Regional Accident Coordinator** Peter J. Katchmar  
**Region Director** Chris Hoidal  
**Date of Report** October 30, 2012  
**Subject** ExxonMobil Silvertip Pipeline Crude Oil Release into the Yellowstone River in Laurel, MT on 7/1/2011

## **Executive Summary**

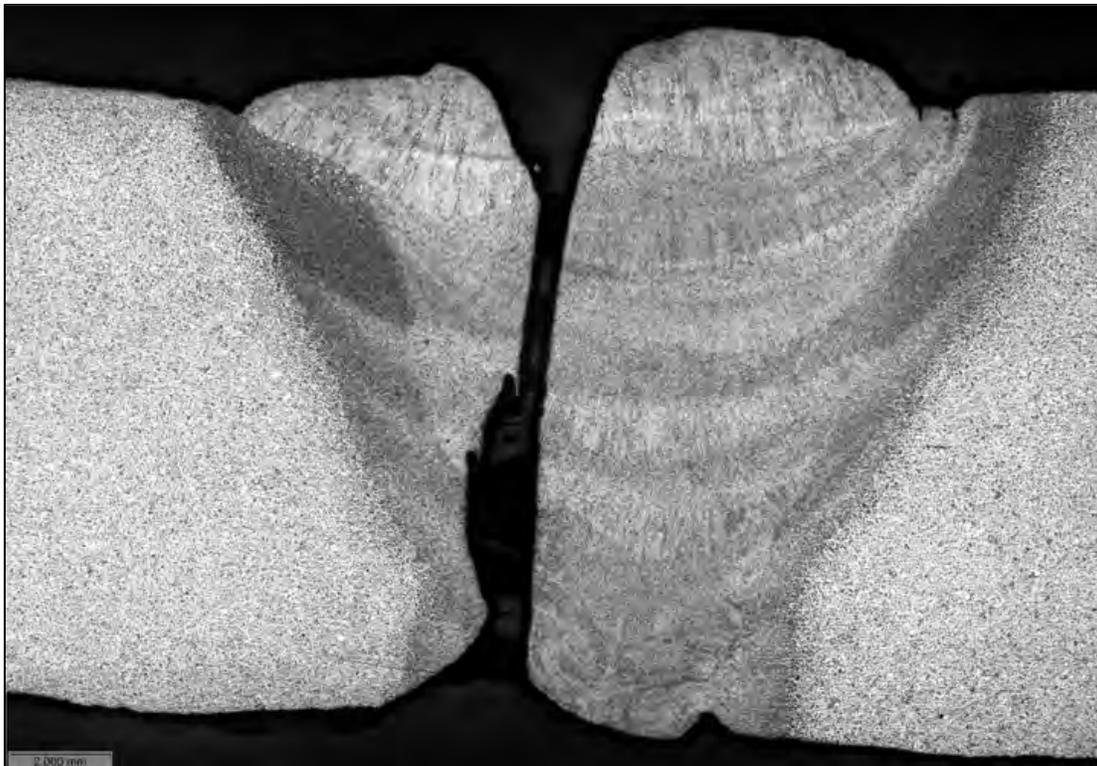
The second metallographic section through Feature L, shown in Figure 52, was taken where the feature propagated completely through the weld thickness. In this section, the crack is seen to propagate flat and straight through the weld metal. The metal on the left hand side of the figure shows evidence of damage near the surfaces and metal loss due to corrosion near mid-wall. However, the metal on the right hand side of the figure appears to be unaffected by such damage.

**Figure 52. Metallographic section through Feature L (at through thickness location)**

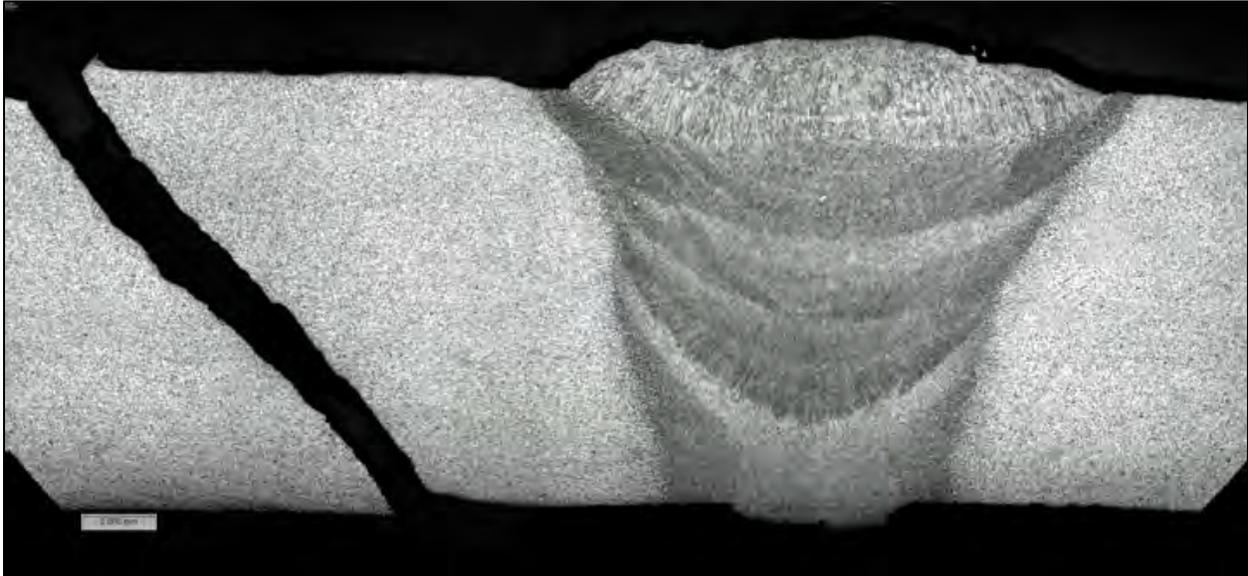
The metallographic section taken through the portion of the fracture that exhibited ductile shear in the pipe wall is shown in Figure 53. In this location, the weld is unaffected by the failure. No defects are present in the pipe wall thickness. The fracture in this location is oriented at approximately 45 degrees to the pipe surface, and the deformation at the surfaces, both internal and external, indicates a tearing (e.g., arrest) shear as opposed to a propagating shear mode.

**Figure 53. Metallographic section through shear area of fracture**

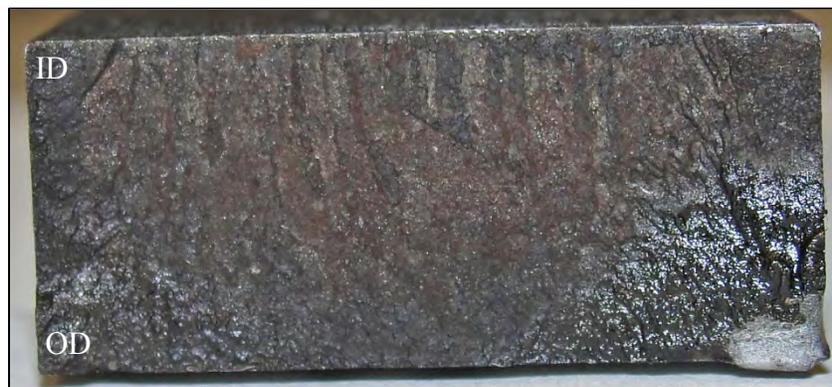
The surface of the crack in the CTOD specimen is shown in Figure 55. The crack surface is relatively smooth and flat and exhibited characteristics similar to features S and L in the failed girth weld. Weld 26 was exposed during the flooding event but remained intact during the failure.

**Figure 55. Crack surface of Weld 026 CTOD specimen**

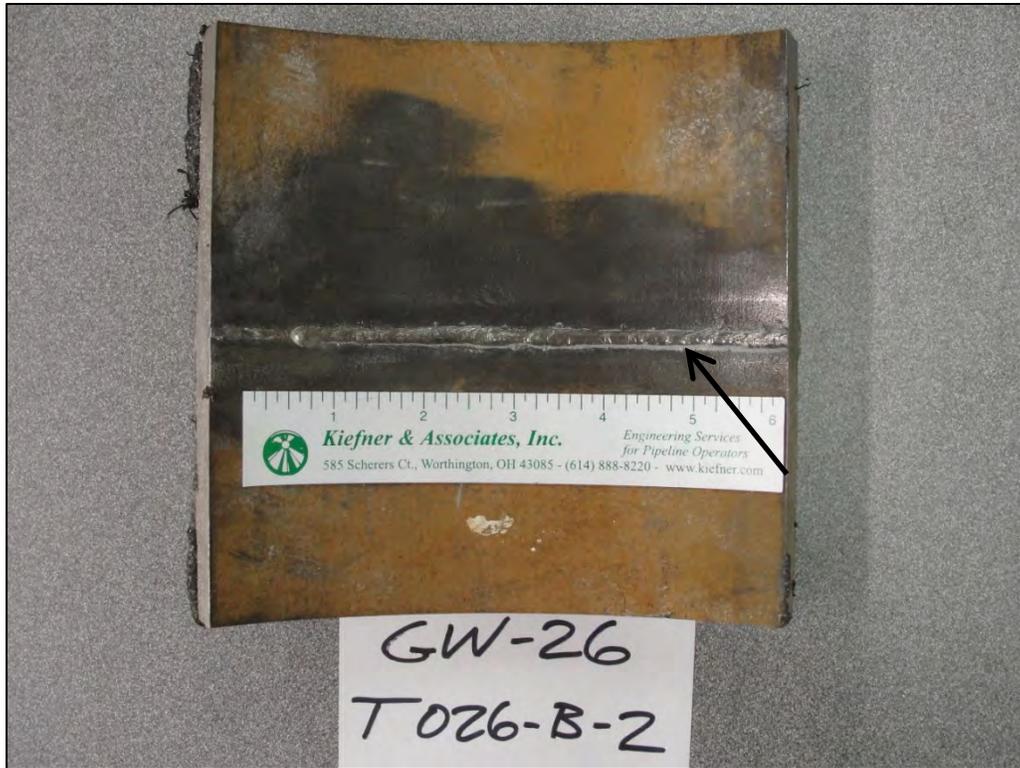
The remaining material coupon adjacent to the location where the CTOD specimen was taken was examined by MT. An indication was detected on the pipe interior that followed the toe of the root pass. The indication in the coupon is shown in Figure 59.

**Figure 59. Internal surface of Coupon T026-B-2 showing MT indication**

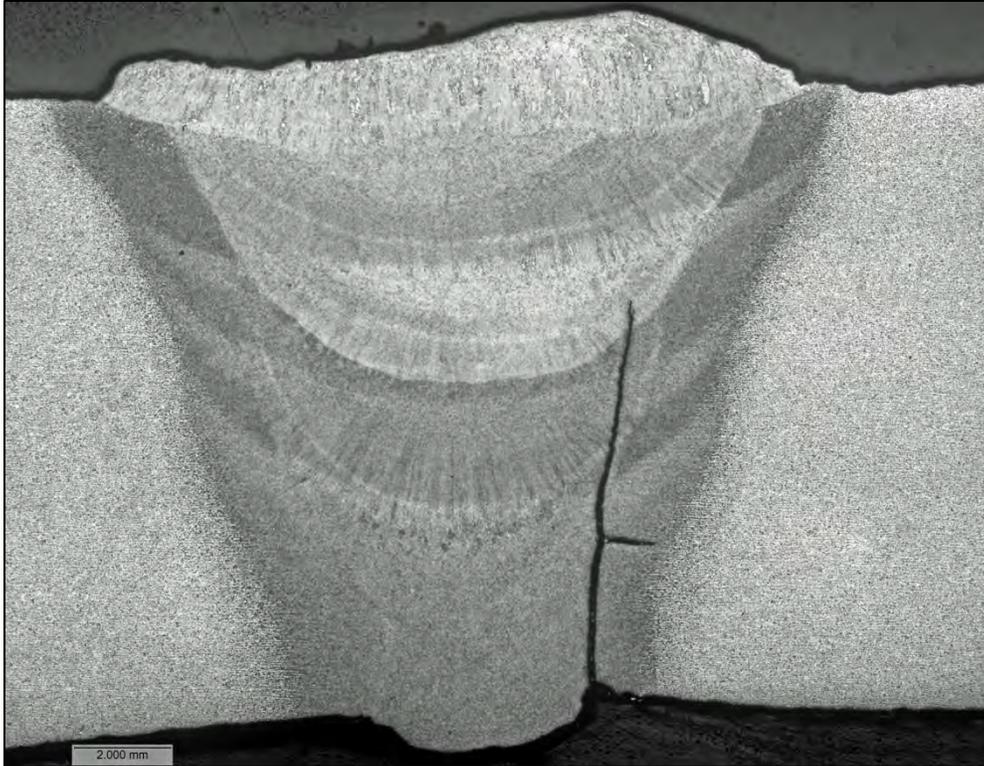
**Figure 61. Metallographic section through crack in Coupon T026-B-2**

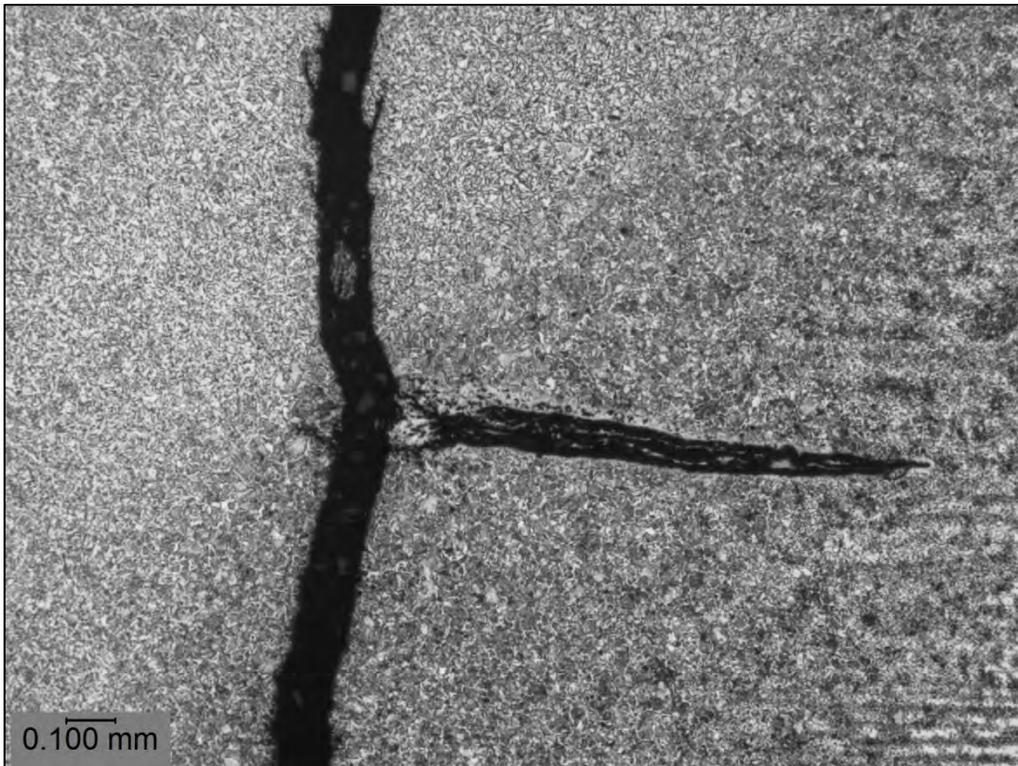
**Figure 62. Detail of flaw along crack path in Coupon T026-B-2**
