Principal Investigator Al Schoen
Region Director Byron Coy
Date of Report 7/5/2012
Subject Failure Investigation Report – Harbor Pipeline Fire Incident, Mansfield Township, NJ

Failure Investigation Report – Harbor Pipeline Co – Pipeline Fire Incident

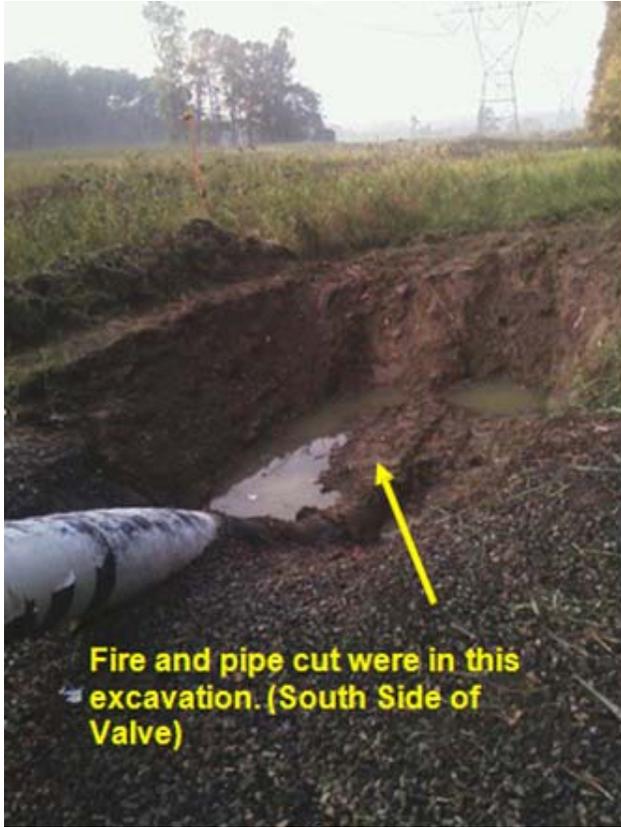
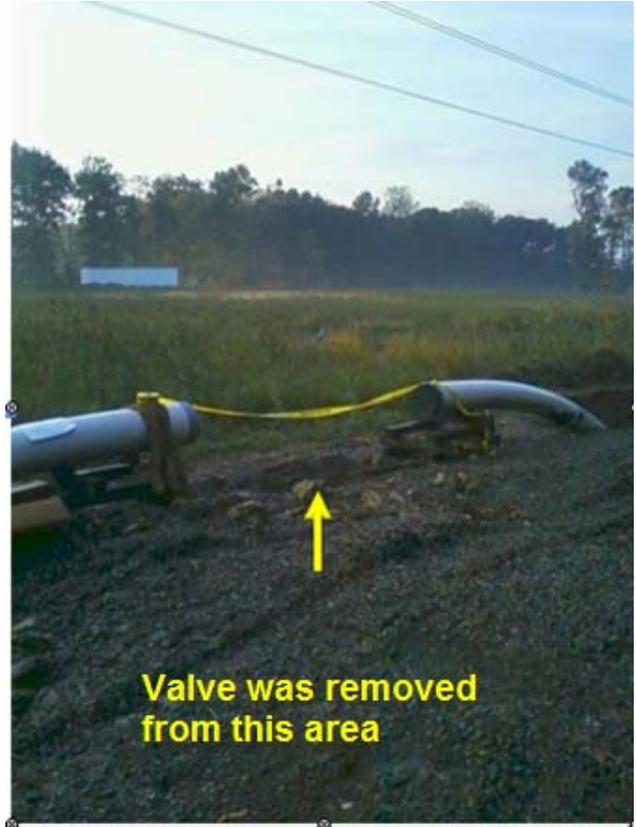
135547 Appendix B - Photographs

The fire was caused because there was product present in the pipe where hot work was being performed. Based on work at other locations on the pipeline, the operator did not anticipate product. The procedures called for mechanical cutting of the pipe. The pipe was being cut out with an oxy-acetylene torch. The personnel performing the work did not follow the hazard assessment or work permit process. There was no work permit issued for the pipe cutting and removal. The work permit referenced was written for a different job site with different tasks. No gas testing was performed prior to performing the hot work. Sunoco concluded that an immediate cause of the incident was less than adequate supervisory oversight regarding hazard assessment, work permit, excavation, hot work and gas monitoring practice and equipment availability. Personnel knew, but didn't follow details of safety procedures or OQ procedures that require hazard assessment, work permit and gas monitoring.
