DOT **US Department of Transportation**
PHMSA **Pipelines and Hazardous Materials Safety Administration**
OPS **Office of Pipeline Safety**
 Southwest Region

Investigators Jon Manning, Noah Matthews
Region Director R.M. Seeley
Date of Report June 29, 2012
Subject Failure Investigation Report – Shell Houma to Houston (Ho-Ho) Pipeline

Failure Investigation Report – Shell Pipeline Company LP, Houma to Houston (Ho-Ho)
Failure Date 11/16/2010

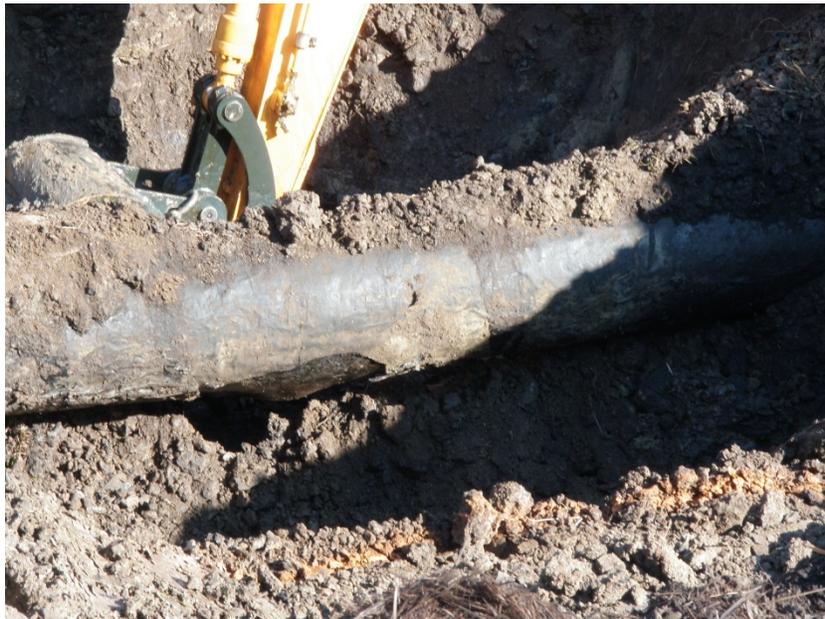
Photo 1: Failed Section with Opening at 6 o’clock position

The failed pipeline segment was removed by cold cutting, packaged for transport, and shipped to Stork Testing & Metallurgical Consulting, Inc., in Houston, TX for analysis. The failure occurred in an under bend at approximately the 6 o'clock position where, according to the Stork metallurgical analysis, the coating likely disbonded allowing the onset of corrosion. Evidence was also found of multiple fatigue cracks that initiated in the deeper corrosion pits. The operational history of the pipeline indicates that the pipeline is subject to cyclical loading due to batched shipments of crude oil. The metallurgical analysis concluded the fatigue cracks that initiated in the corrosion pits weakened the wall of the pipe so that it could not withstand the hoop stress created by the internal pressure, resulting in the rupture. A copy of the Stork metallurgical report is included in Appendix G.

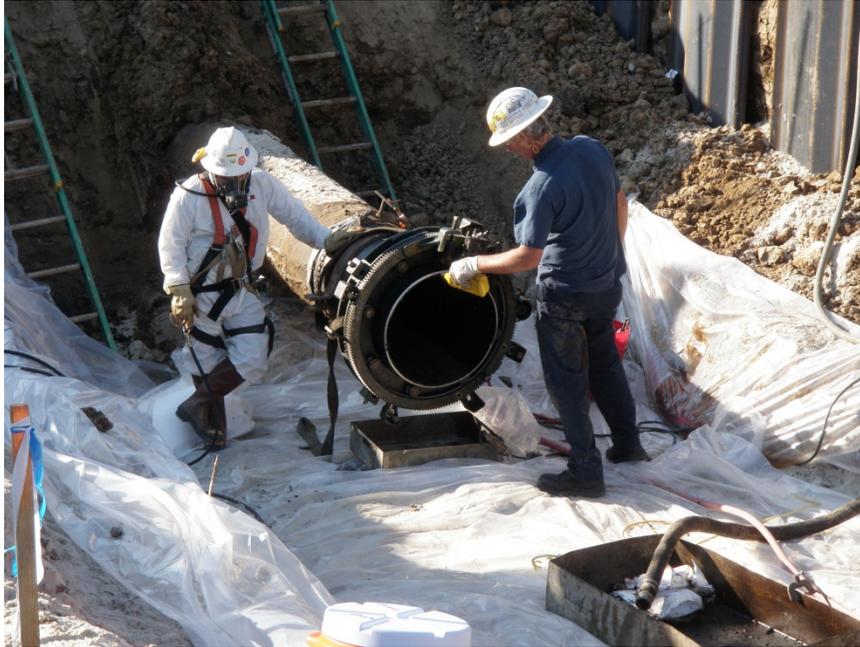
Photo 2: Flanged Repair

ILI with a tool more capable of detecting longitudinal flaws. Pipeline repairs were completed on November 21 and the pipeline was refilled and restarted on November 24, 2010.

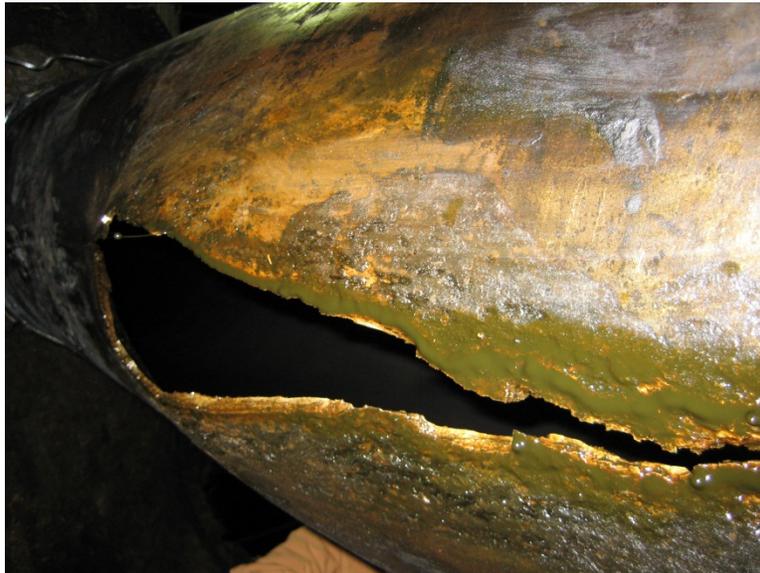
A “fish mouth” rupture occurred at the 6 o’clock position on the pipeline and was approximately 36.25 inches long with a width of 4.75 inches at the widest point and was 90 degrees from the longitudinal weld. The Stork metallurgical analysis determined that the rupture occurred approximately 15-1/2 inches from the apex of an under bend in the pipeline. Circumferential wrinkles at regular intervals on the inside surface of the pipe indicated that the bend was likely made in the field which may have caused the coating to disbond at the failure location. Heavy corrosion was found on the outside surface of the pipe at the failure site and semi-elliptical crack surfaces characteristic of fatigue cracks were found the fracture faces. The operational history indicates that the pipeline has been subjected to cyclic loading. Testing of the pipe materials did not reveal any manufacturing defects and showed satisfactory tensile properties consistent with the grade of pipe. Tests of the corrosion deposits were found to have bacteria that can result in Microbiologically-Influenced Corrosion (MIC) but the metallurgical analysis did not make any conclusions as to whether MIC contributed to the external corrosion. The metallurgical analysis concluded that the failure resulted from fatigue cracks that initiated in the corrosion pits reducing the strength of the pipe so that it could not contain the hoop stress resulting from the internal pressure.

Photo 3: Failed “fish-mouth” section of pipe

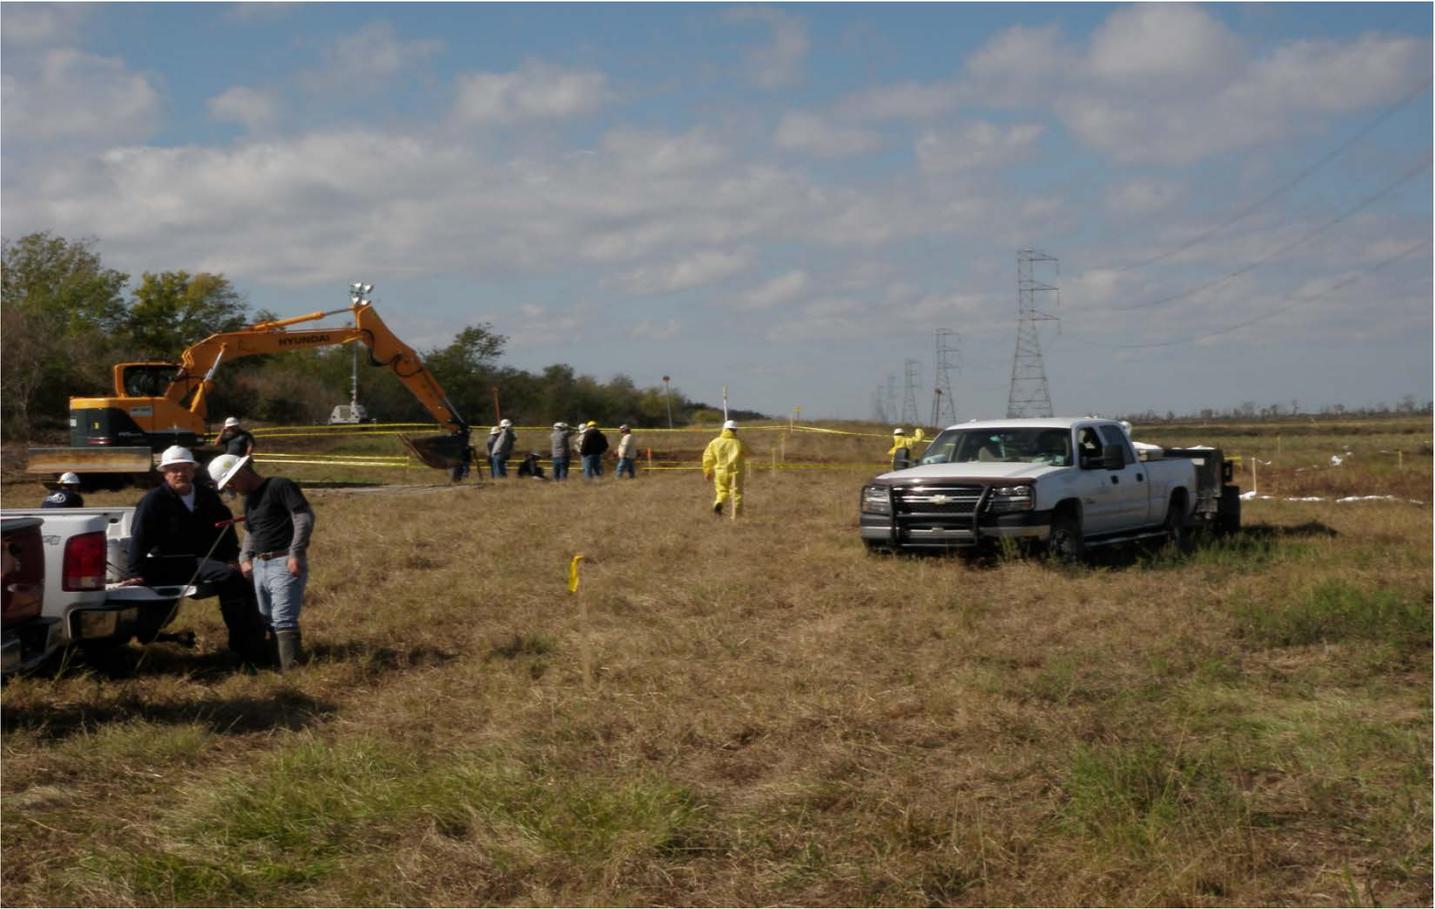
Shell Ho-Ho Pipeline Release Site near Vinton, LA 11-17-2011 11:38AM

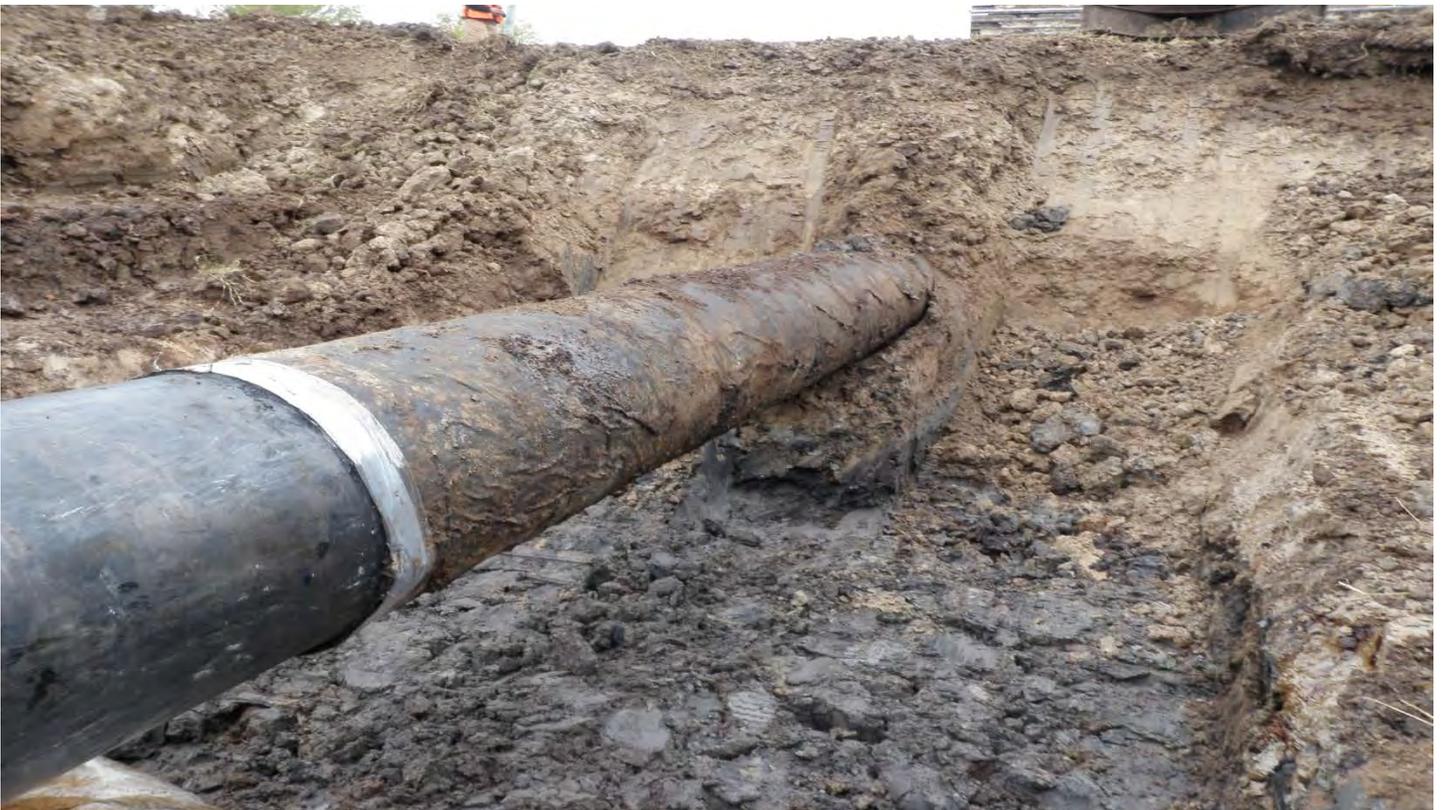
2/1/2011 - The corrosion of the outside surface occurred at a bend in the pipe at which the corrosion coating was compromised. Circumferential wrinkles at regular intervals on the inside surface of the pipe indicated that the bend had been made in the field. Field bending of coated pipe could have disbonded the coating, eventually allowing contact with wet soil and allowing corrosion. Disbonded coating further reduces pipeline integrity because the cathodic protection of the pipeline to prevent corrosion is not effective at disbonded locations.

Shell Ho-Ho Pipeline Showing Coating on Pipeline 11-19-2010 11:43AM

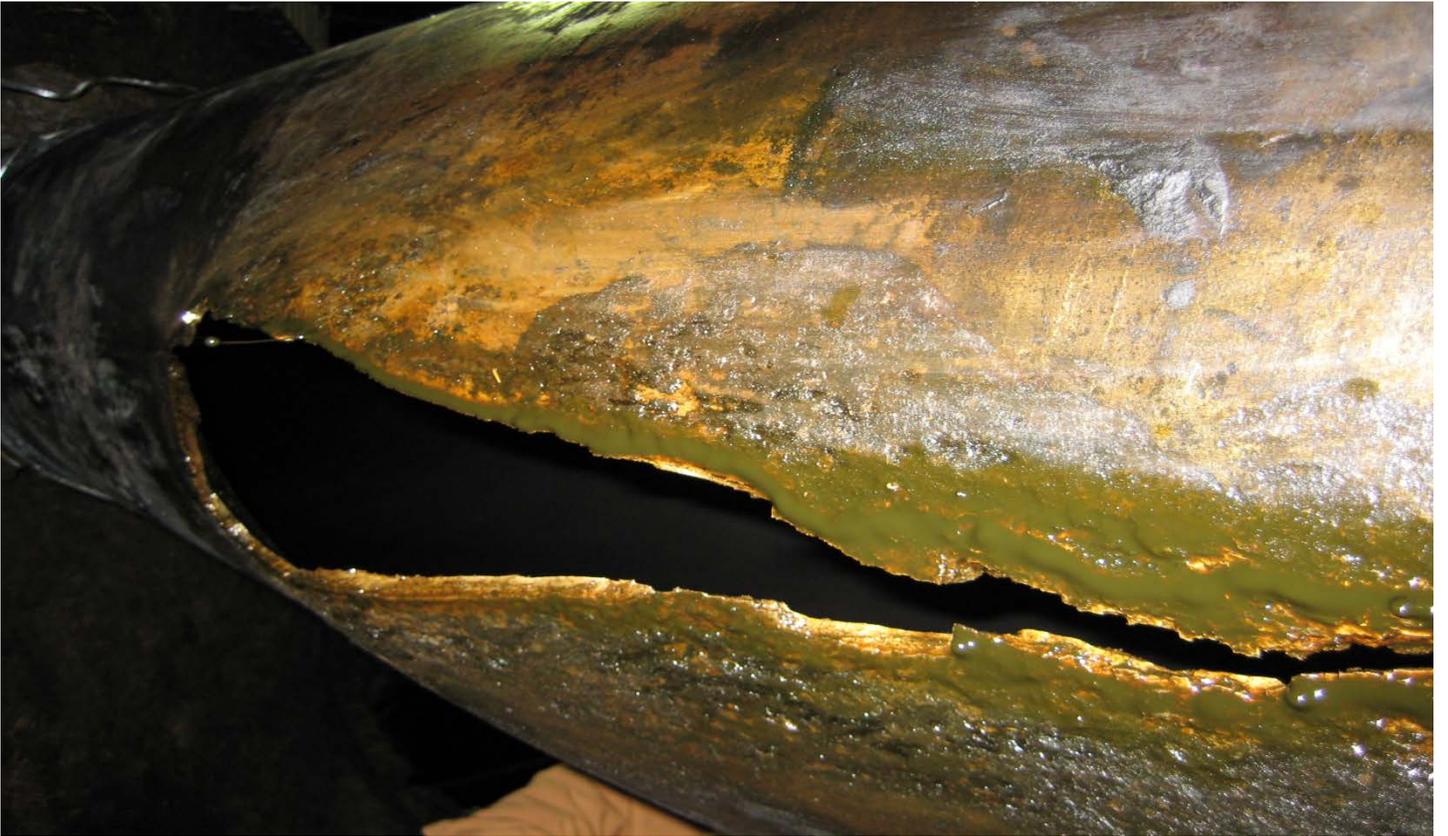
Shell Ho-Ho Pipeline Failed Pipeline Segment 11-19-2010 2:20PM

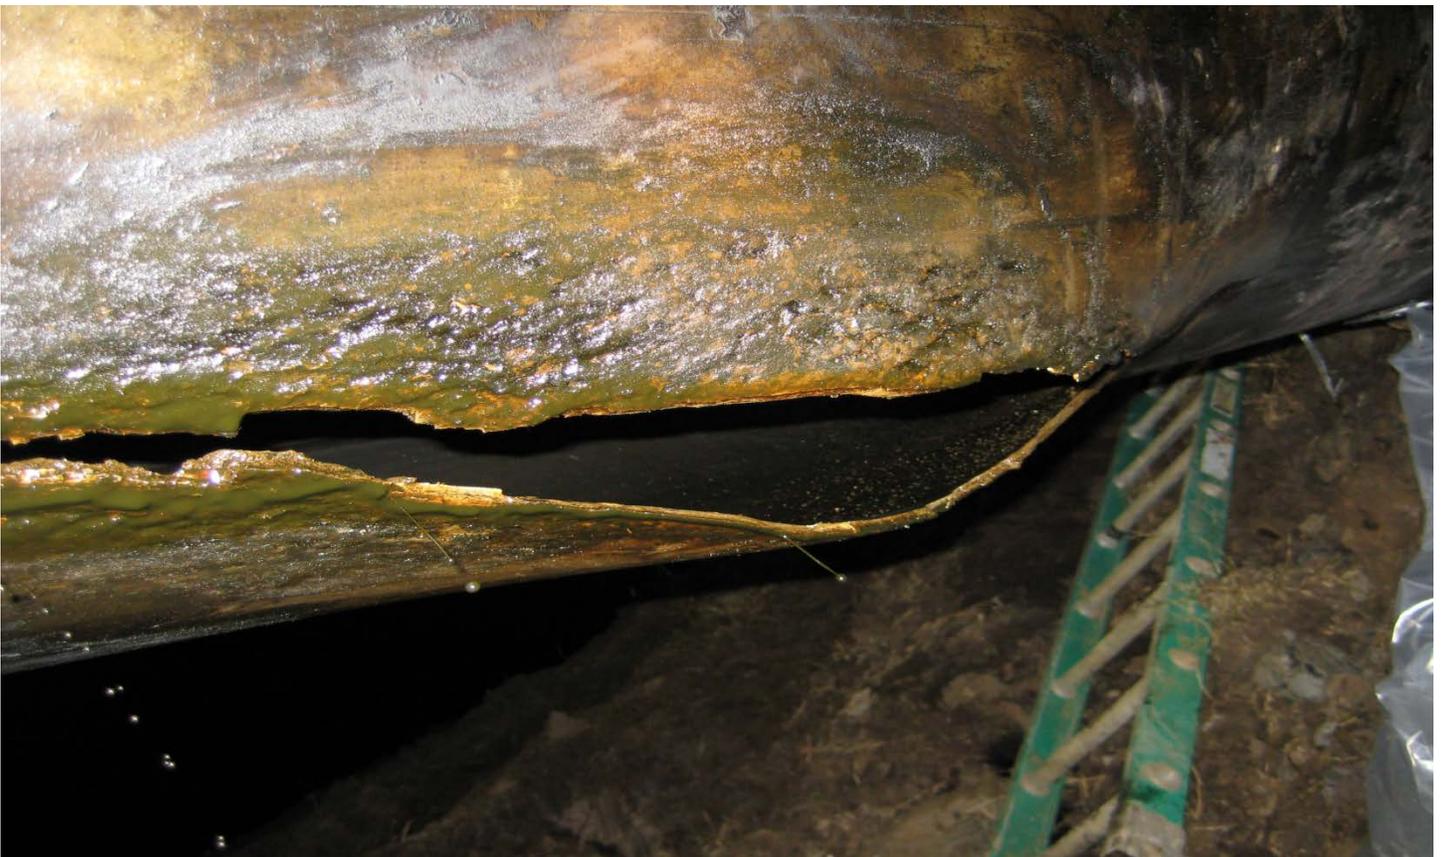
Shell Ho-Ho Pipeline Failed Pipeline Segment 11-19-2010 2:21PM

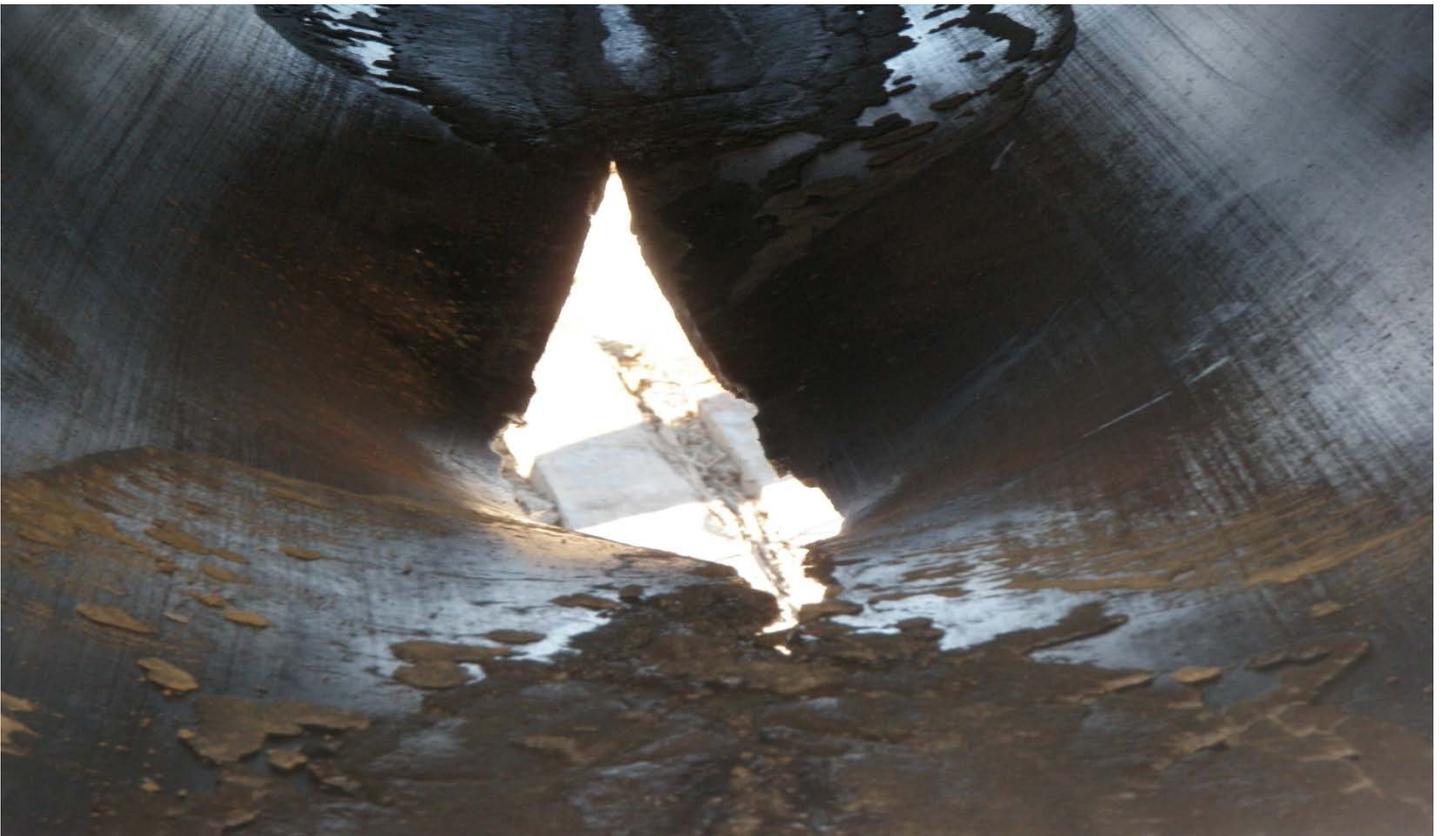
Shell Ho-Ho Pipeline Inside View of Failed Pipeline 11-20-2010 3:42PM

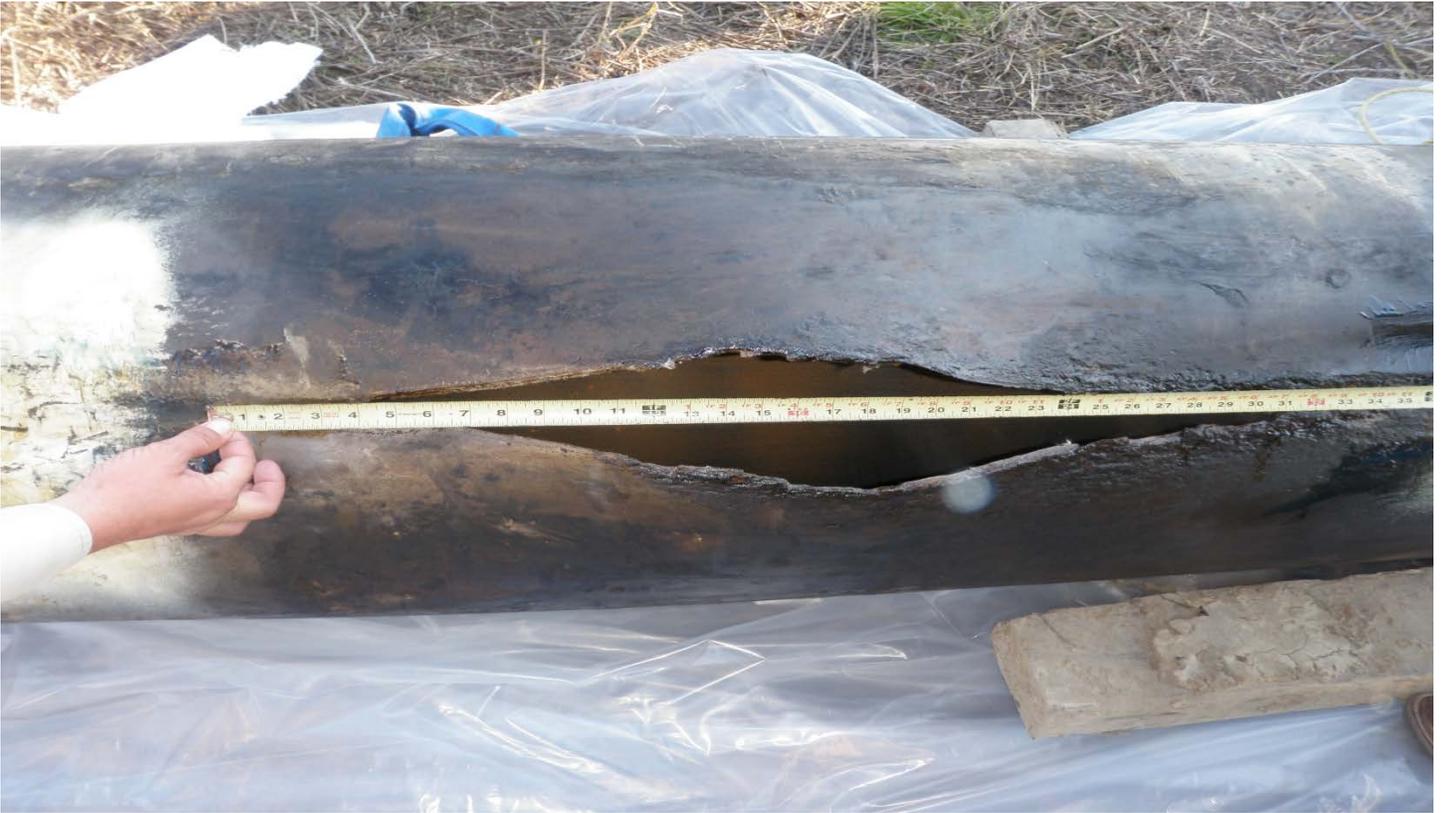
Shell Ho-Ho Pipeline Measurement of Ruptured Section 11-20-2010 3:49PM

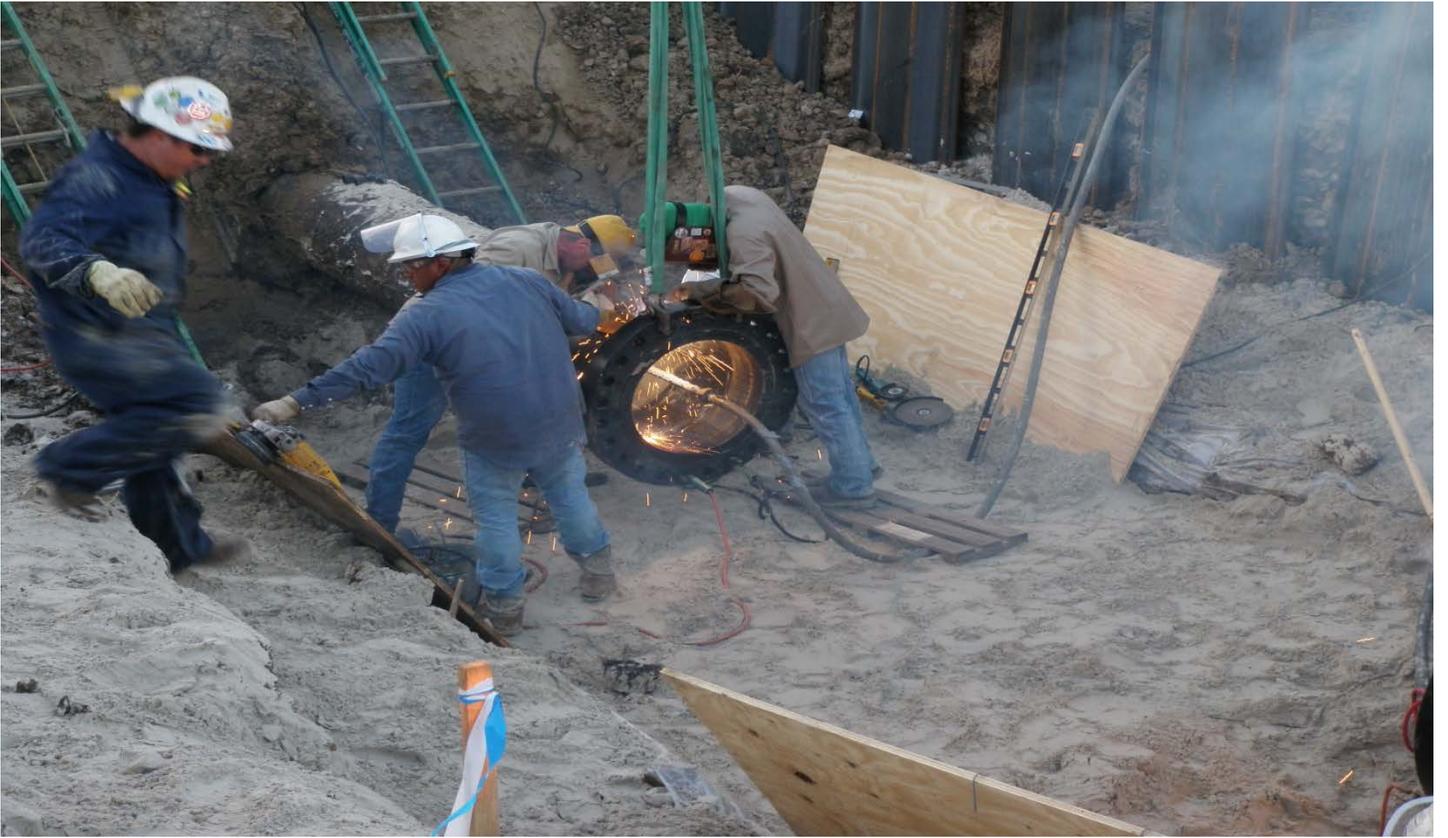
Shell Ho-Ho Pipeline Welding Flange for Spool-Type Repair 11-20-2010 5:51PM
