DOT US Department of Transportation
PHMSA Pipeline and Hazardous Materials Safety Administration
OPS Office of Pipeline Safety
Eastern Region

Principal Investigator Robert Burrough
Senior Accident Investigator Michael Yazemboski
Region Director Byron Coy
Date of Report 07/25/2013
Subject Failure Investigation Report
Buckeye Partners Pipeline Gasoline Leak

Line 620 Gasoline Leak

Hillsborough, NJ

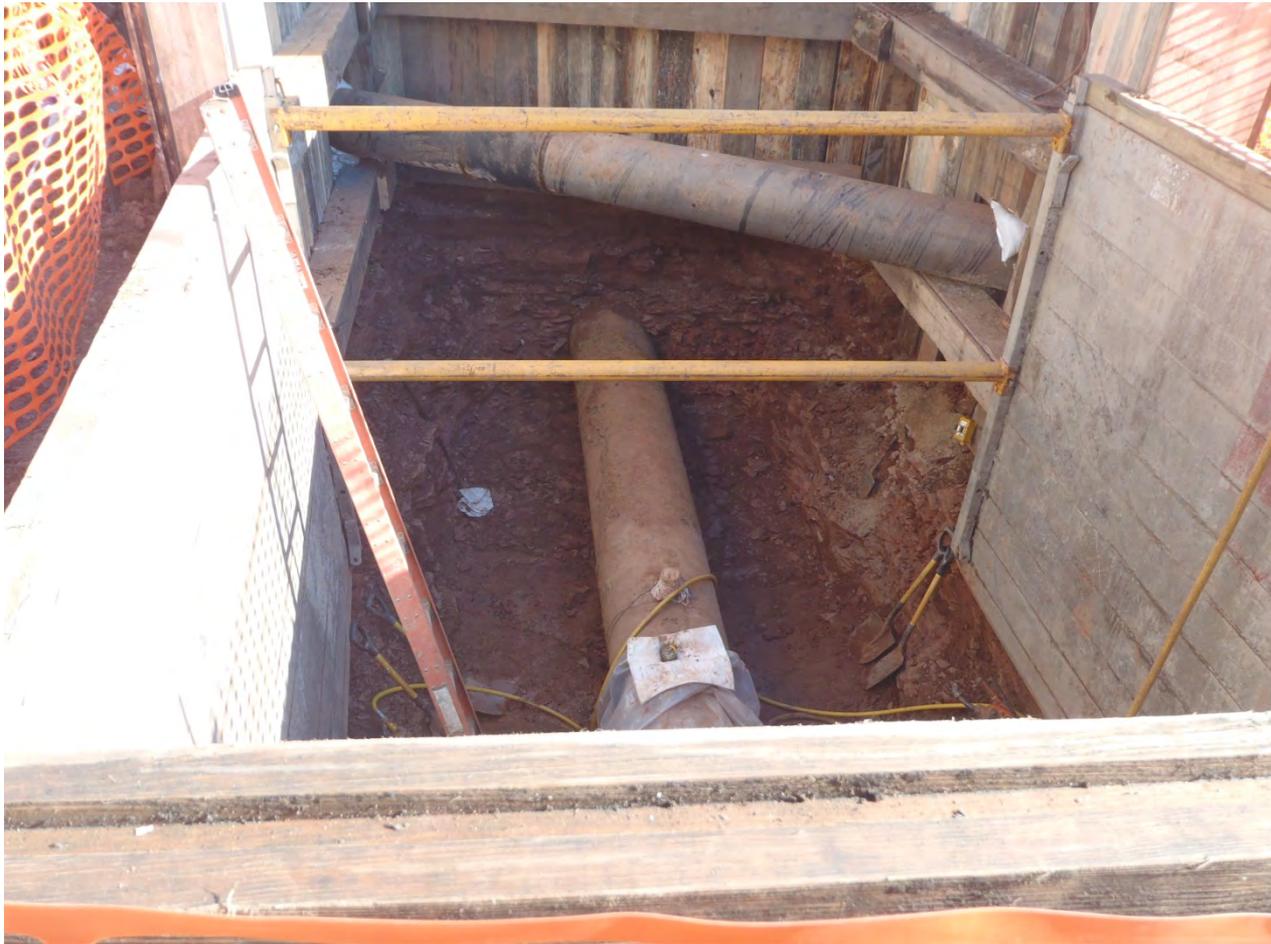
West Side of Rt 206. Excavation of Line 620. PSE&G Nat Gas Distribution pipeline crosses above BPL's line at an angle. Looking from west to east under Rt 206. 20" pipeline with 24" casing. Date 12/13/2012

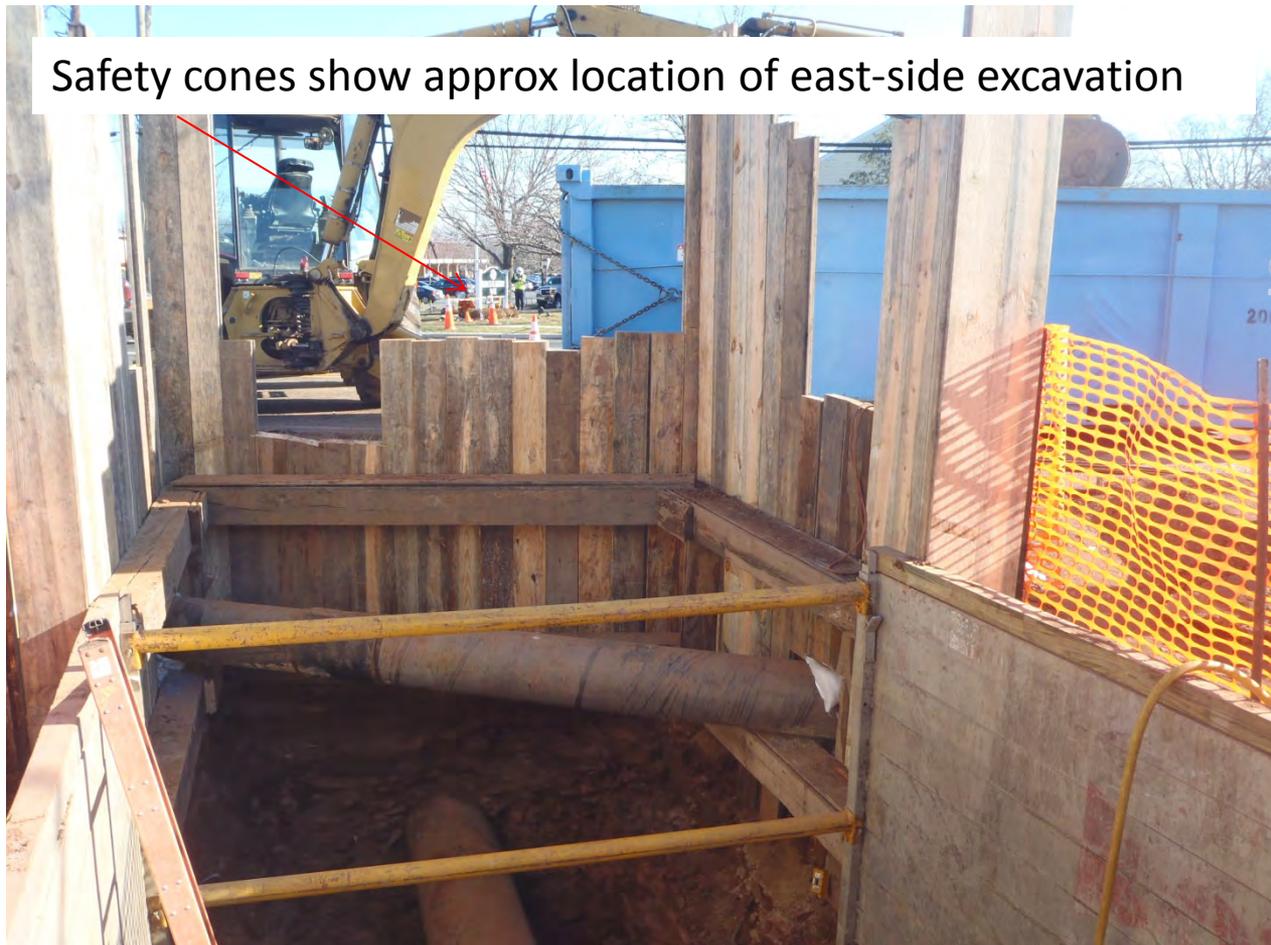
Same excavation, top of road view. Backhoe is on Rt 206. Date 12/13/2012

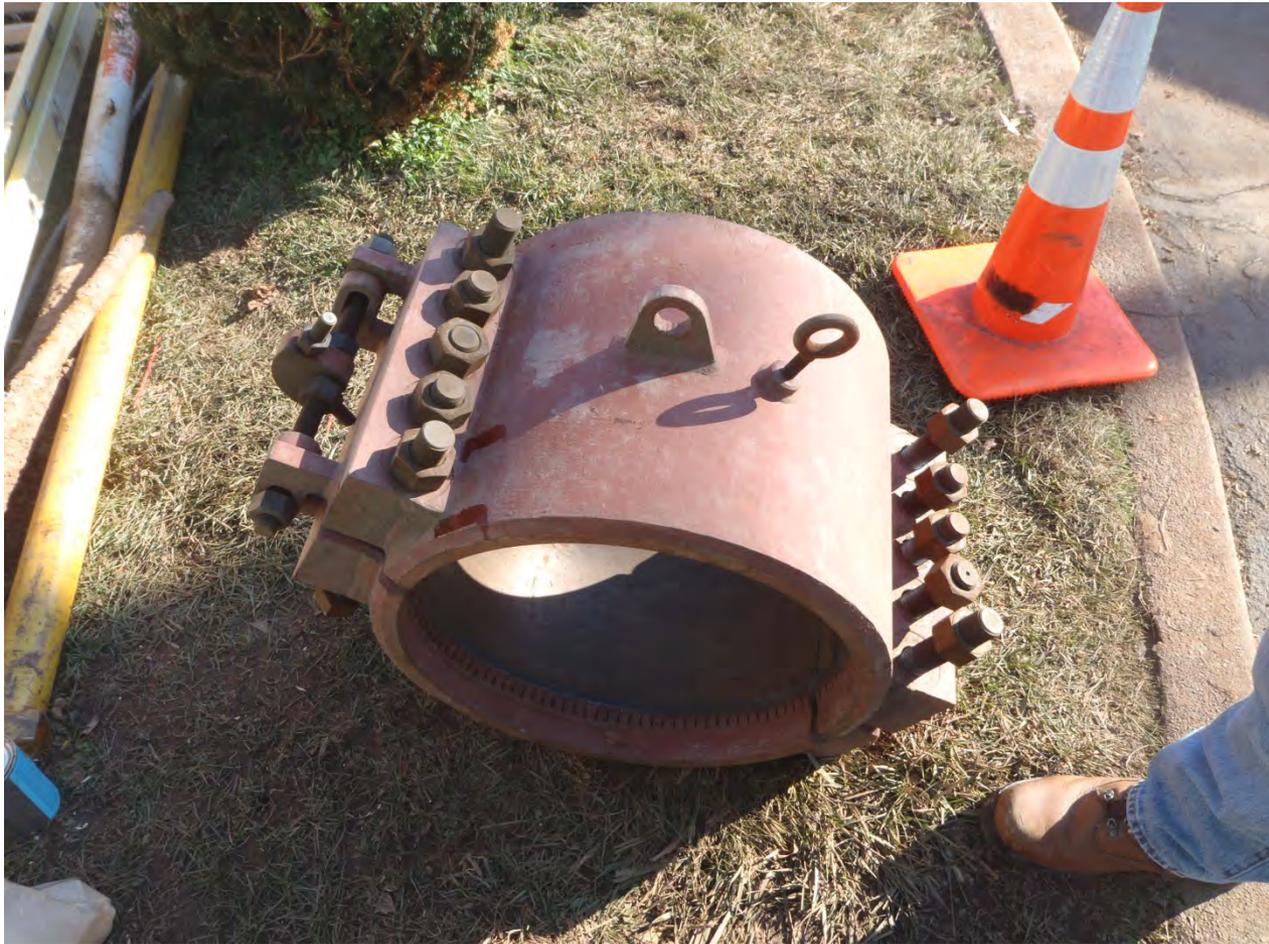
20" Plidco-style clamp repair fitting (was installed on 12/17/2012). Picture taken 12/13/2012

On December 17, 2012, the PHMSA inspector observed the installation of a temporary PLIDCO-style repair sleeve on Line 620. Line 620 was restarted on December 18, 2012, and the excavation area was backfilled.

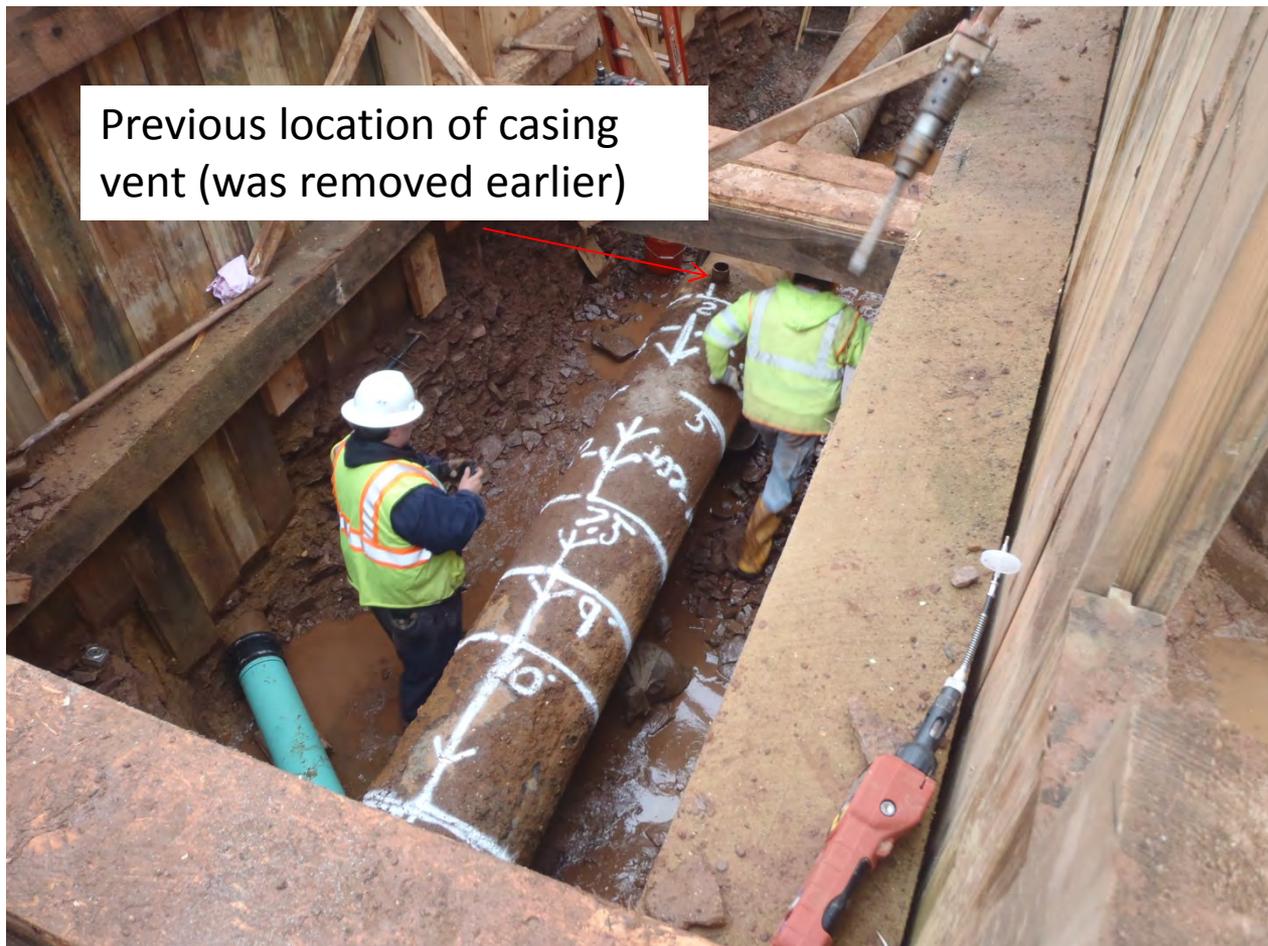
On December 15, 2012, using a remote camera, Buckeye discovered a pinhole leak on Line 620. The pinhole leak was found on the east side of the Line 620 crossing at Route 206, approximately 6 feet from the end of the casing, near the 12:00 position (top) of the pipeline.

Excavation on east side of Rt 206. Workers are facing east. Arrows on casing are pointing west, under Rt 206. Taken 12/17/2012.

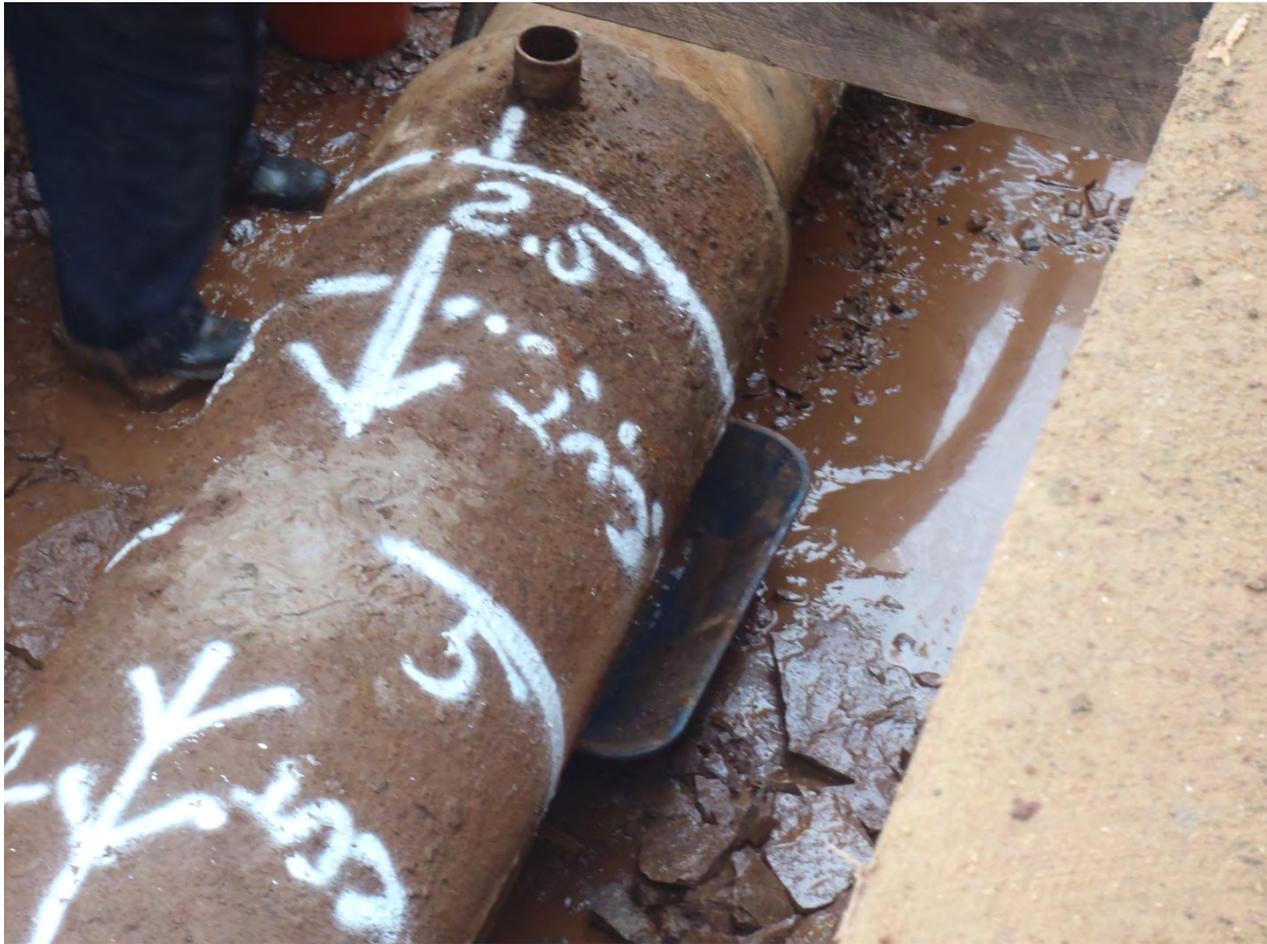
Close-up of casing pipe and casing vent. Drip pan for collecting water, water/gasoline mixture shown under the pipeline. Vac Truck hose is present, but hard to see. Taken 12/17/2012.

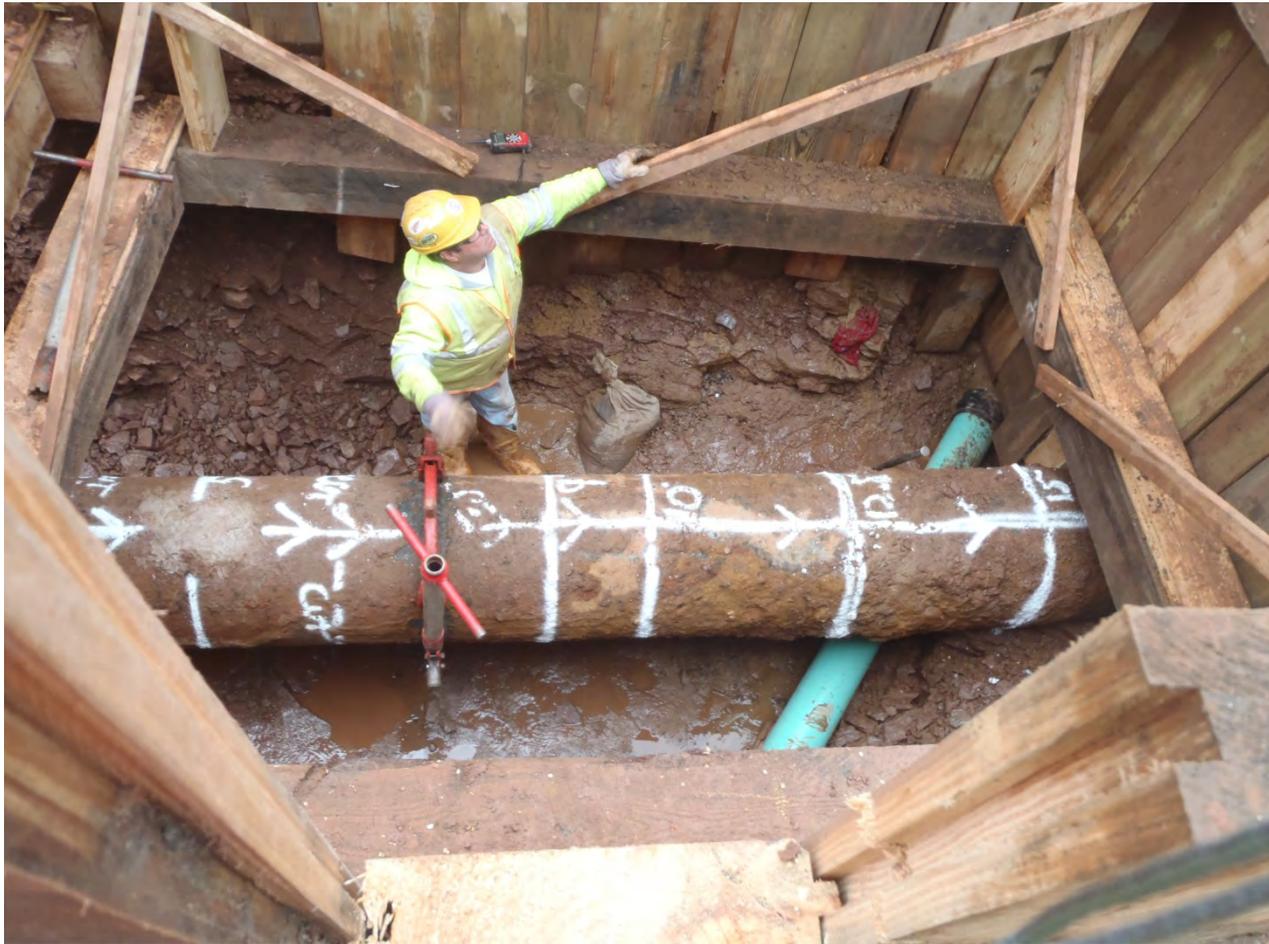
Picture taken from north side of excavation. Picture shows cold cutting tool on casing. Blue pipe (under Line 620) is a sewer pipeline that was believed to be abandoned, but was found to be active when it was hit. The blue pipe is the replacement section that was installed early 12/17/2012. Taken 12/17/2012
