DOT US Department of Transportation
PHMSA Pipelines and Hazardous Materials Safety Administration
OPS Office of Pipeline Safety
Southwest Region

Date of Report October 23, 2013
Subject Failure Investigation Report – Mobil Pipe Line Company; Pegasus Pipeline, Mayflower, AR

Failure Investigation Report – Mobil Pipeline Pegasus Rupture
March 29, 2013

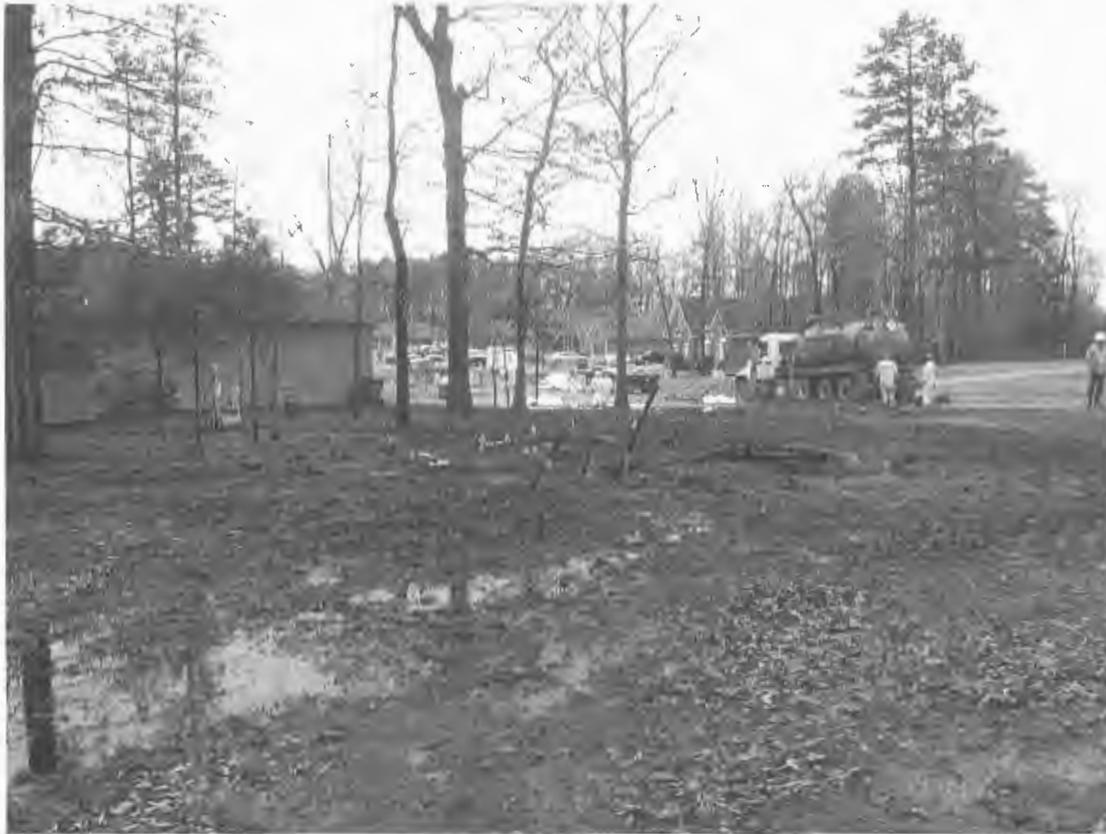
Figure 4 Accident Site March 30, 2013, Looking to the Southwest – Northwoods Subdivision, Mayflower, AR

The accident site was in a Mayflower, Arkansas subdivision, approximately 25 miles north of Little Rock, Arkansas at Latitude 34° 57' 49.1" N and Longitude 92° 25' 43.6" W. The leak site was on the pipeline right of way between two single family dwellings. The released crude oil flowed downhill along the right of way to the street as well as further south between two adjacent houses into the street, into the stormwater drains, and ultimately to Dawson Cove south of Lake Conway. The released product did not reach Lake Conway or impact any drinking water supplies. Twenty-two households were evacuated, and there were minor impacts to flora and fauna in the immediate area. There were no reported injuries or fatalities related to the release.

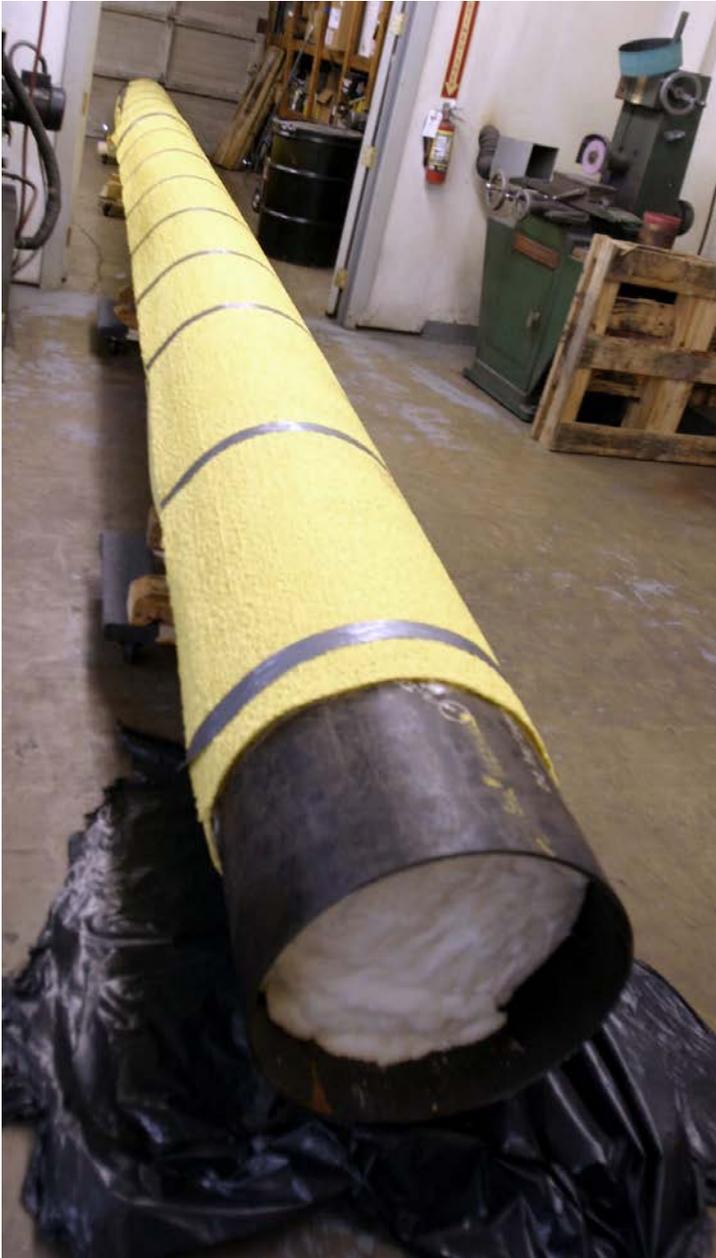
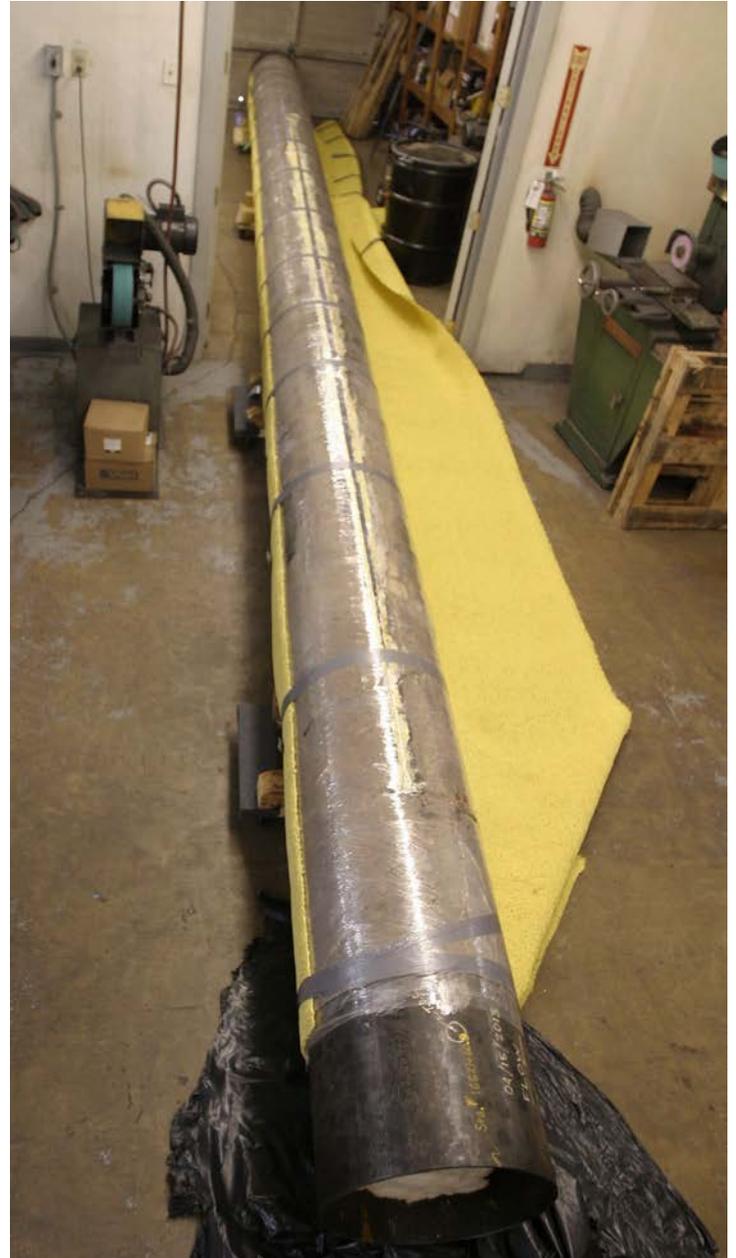
The photographs display the fractured section of the pipe in the as-received condition and following removal of the outer protective wrapping material.

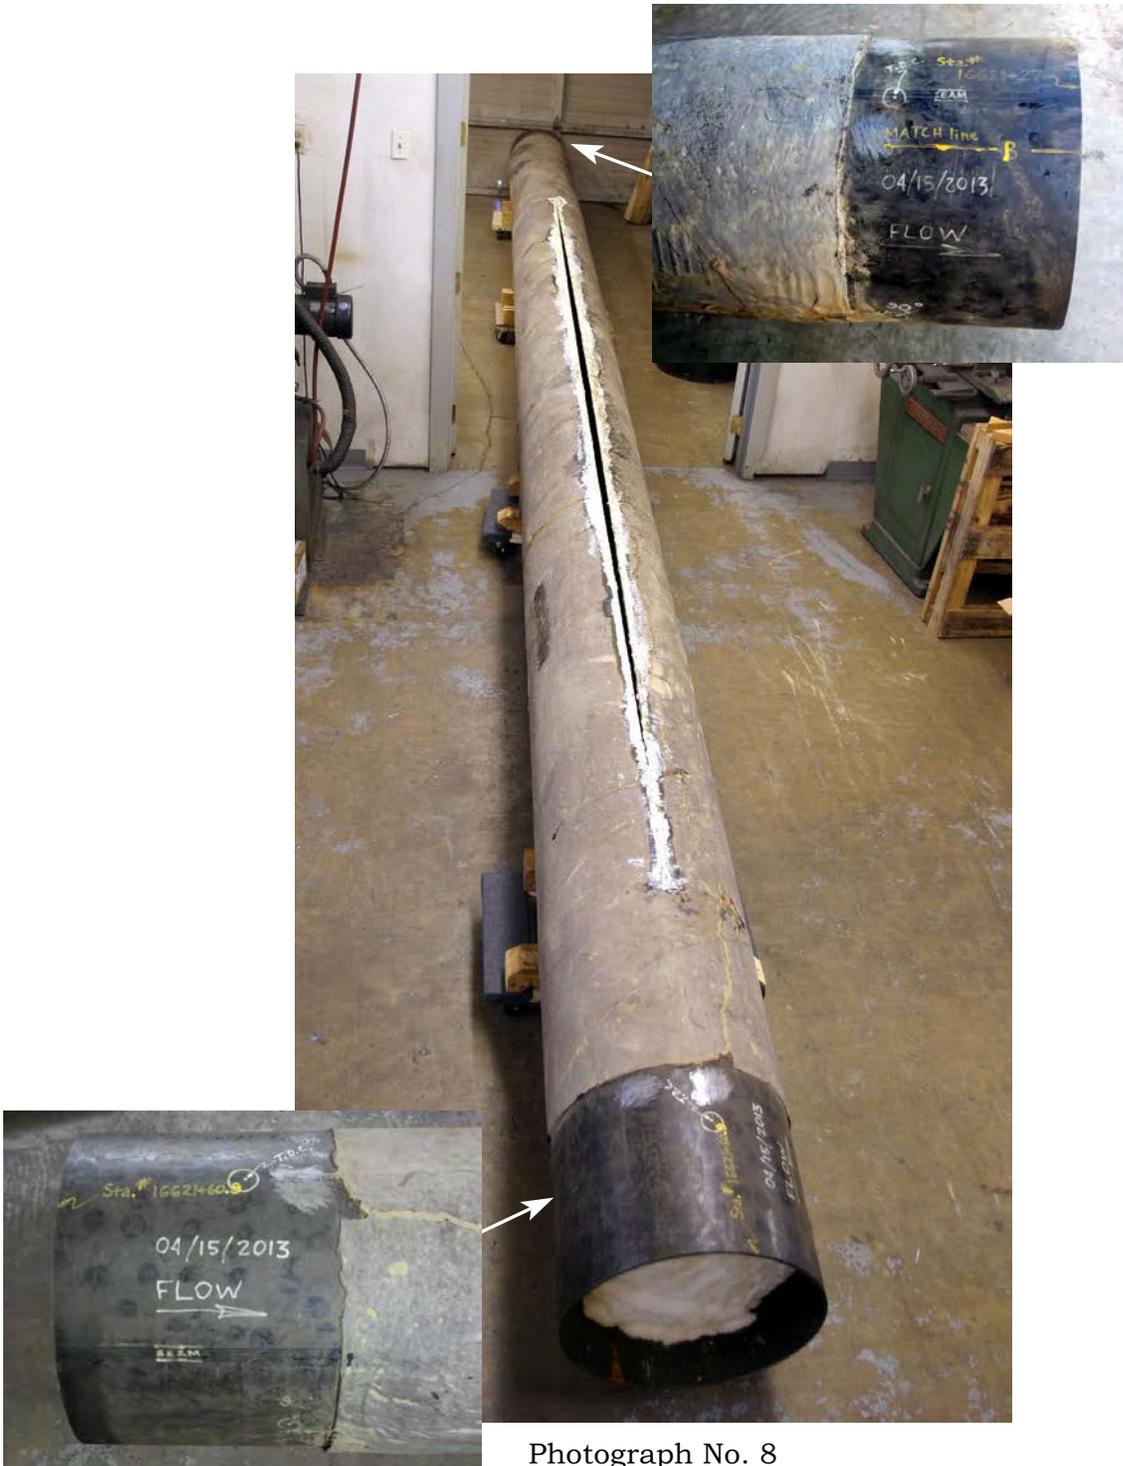
Photograph No. 8

The photograph displays the fractured pipe section following removal of the 2nd wrapping material, revealing the fracture faces coated with grease to protect from post-incident corrosion.

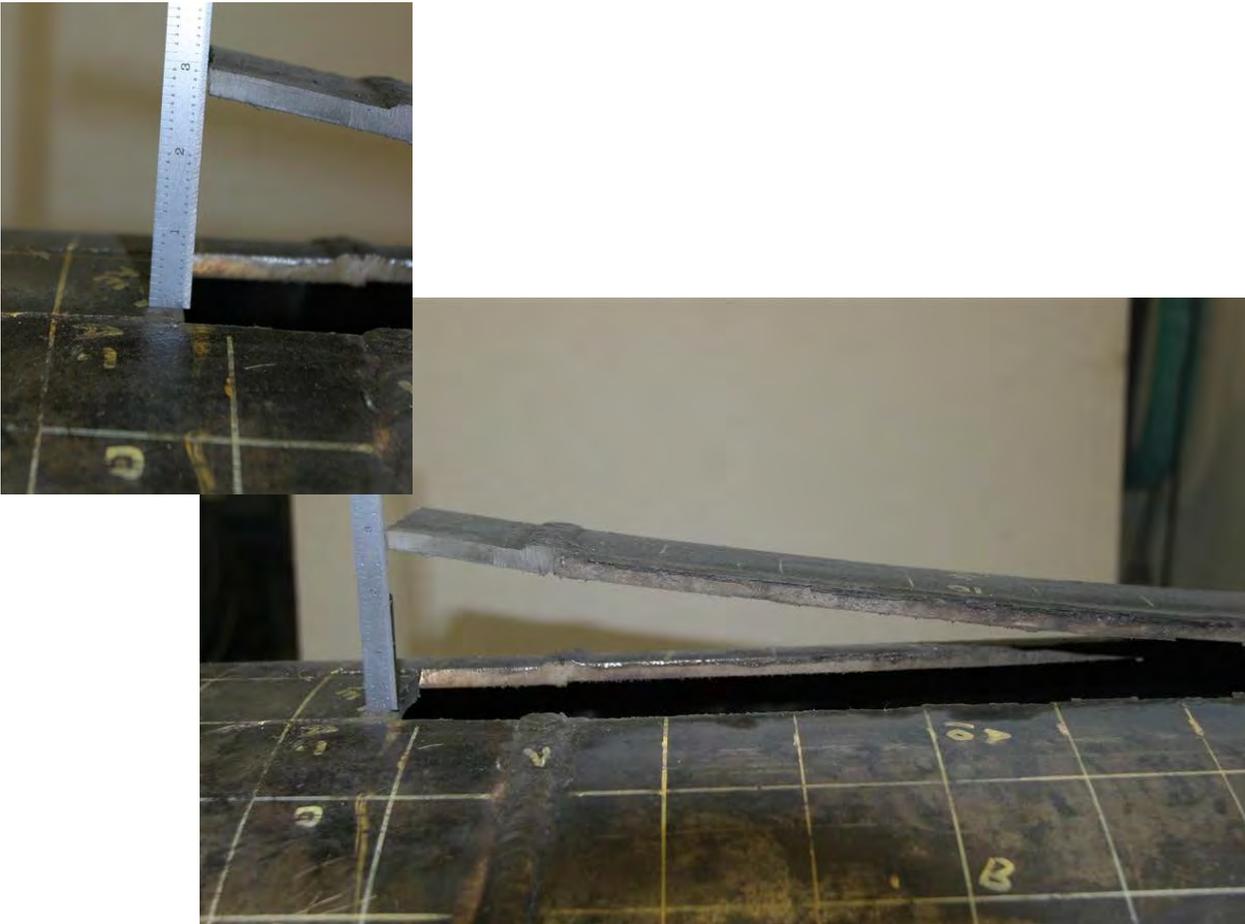
Photograph No. 85

The photograph shows the displacement of the pipe by approximately 2-31/32" following sectioning through the intact portion of the adjoining pipe, indicative of the presence of significant residual stress.

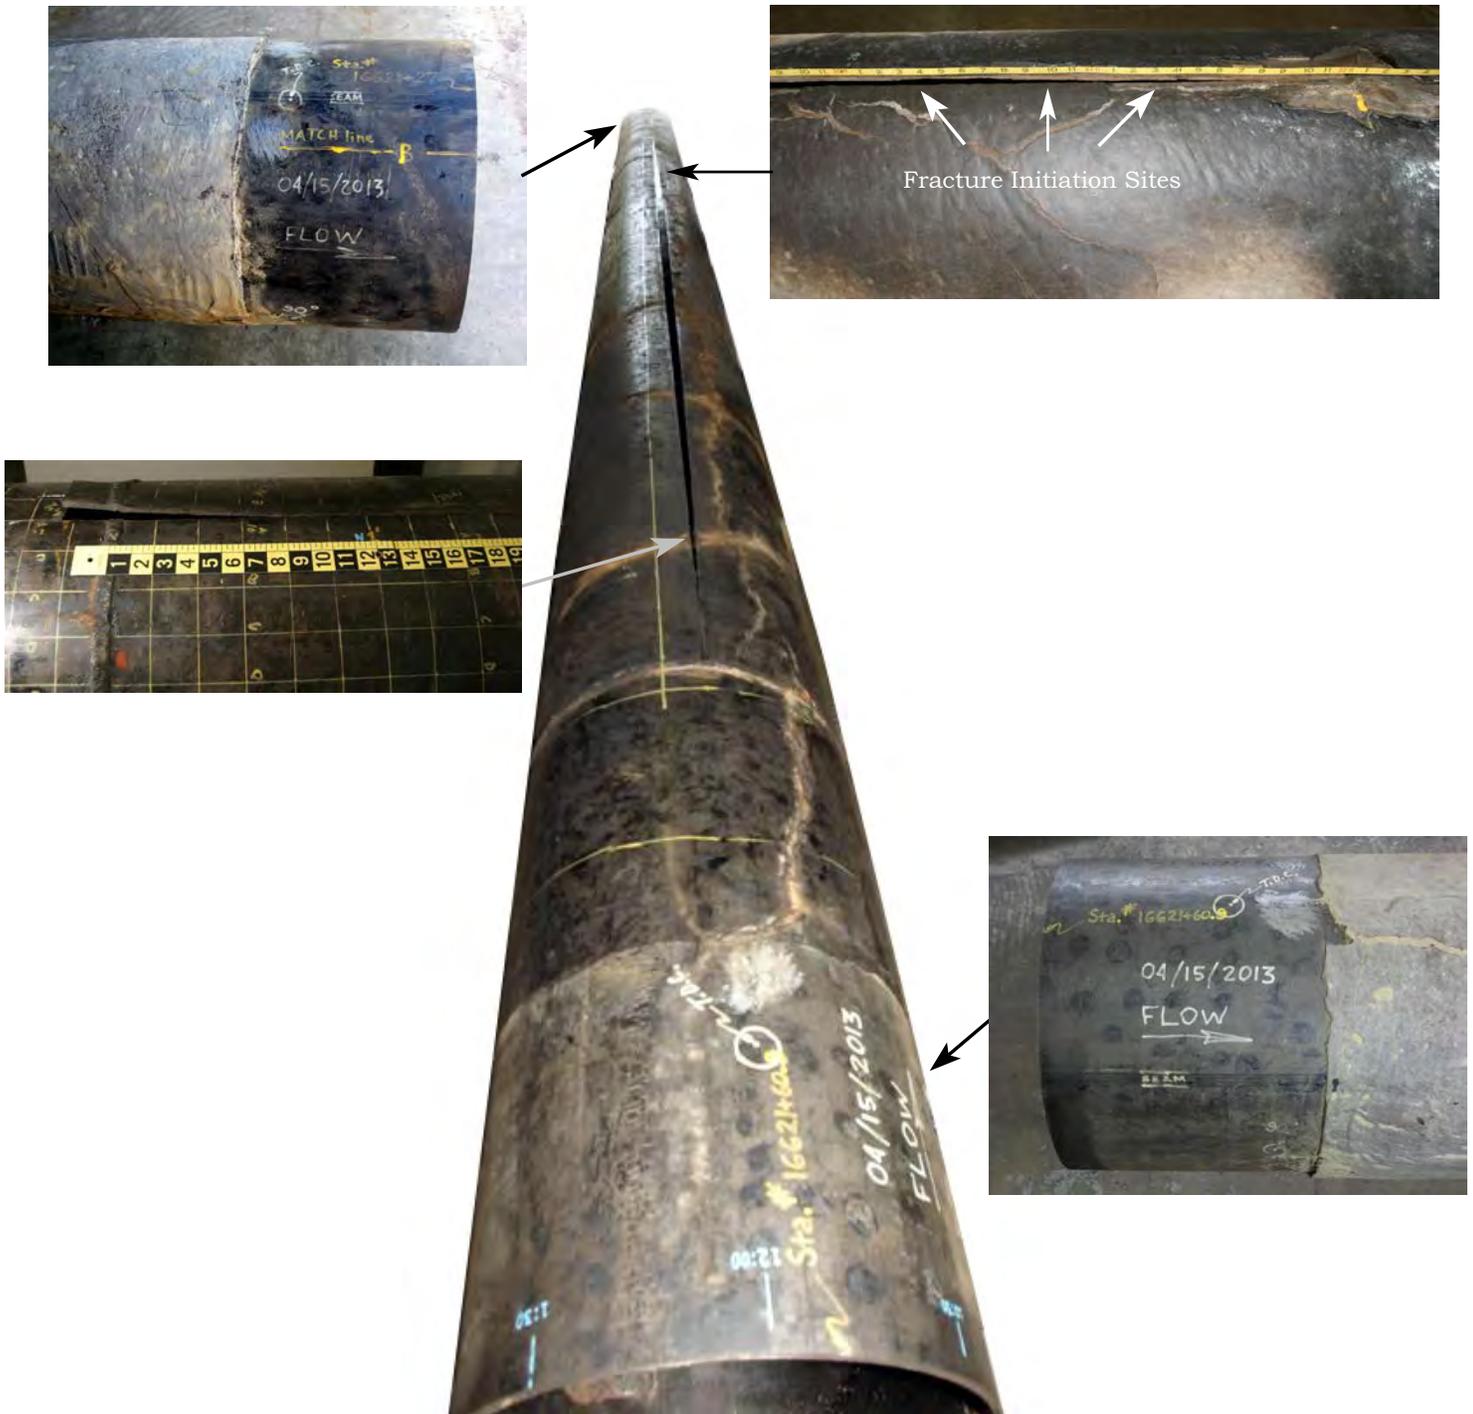
Photograph No. 86

The detailed results of the metallurgical evaluation are found in Hurst's Report Number 64961, Rev. 1³. There were no definitive signs of fatigue failure exhibited in the prior hook crack areas above the final failure origin area(s) due to the brittle nature of the low toughness material and the presence of the scale or oxidation products which obscured the fracture morphology, specifically the possible presence of any microscopic fatigue striations. Brittle materials are not typically subject to high cycle fatigue failures, as they tend to fail relatively quickly from smaller defect sizes when subjected to cyclic loading. Larger defects in brittle materials typically result in rapid overload failure during testing such as the hydrotesting performed in 1991 and 2006 on this line. It may be surmised from the results of the investigation conducted by Hurst Metallurgical Research Laboratory, Inc. that the areas of relatively more ductile material interspersed within the brittle zones of the ERW seam could have fractured intermittently over time and connected with the brittle areas containing the hook cracks. The resultant crack, while shallow and tight enough to be undetectable at the time by the ILI tools used for inspection of the line, eventually reached a critical length, resulting in the failure of the low toughness ERW seam.¹³

"that some micro-cracking within the upset/heat-affected zones might have occurred immediately following the pipe manufacturing. The micro-cracks then likely would have merged by further cracking through the adjacent areas in the localized upset/HAZ zones during service, forming a continuous hook crack in each of the localized areas to the critical depths, at which point the remaining wall thickness, combined with the localized stress concentration and residual stresses, could no longer support the internal hoop stresses and resulted in the final failure."

The photographs display overall and close-up views of the 33' 11-1/2" long section of a fractured 20" O.D. x 0.312" wall pipe, which was removed from the Conway to Corsicana section of the Pegasus Crude Oil Pipeline at Milepost 314.77 in Mayflower, Arkansas.

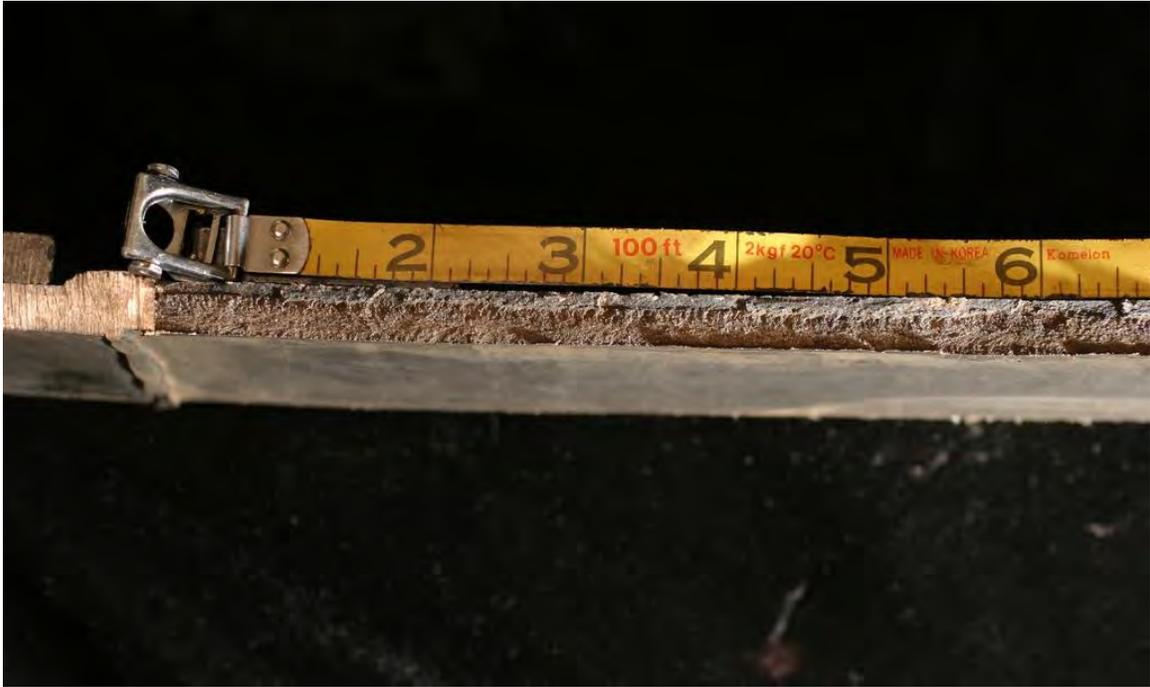
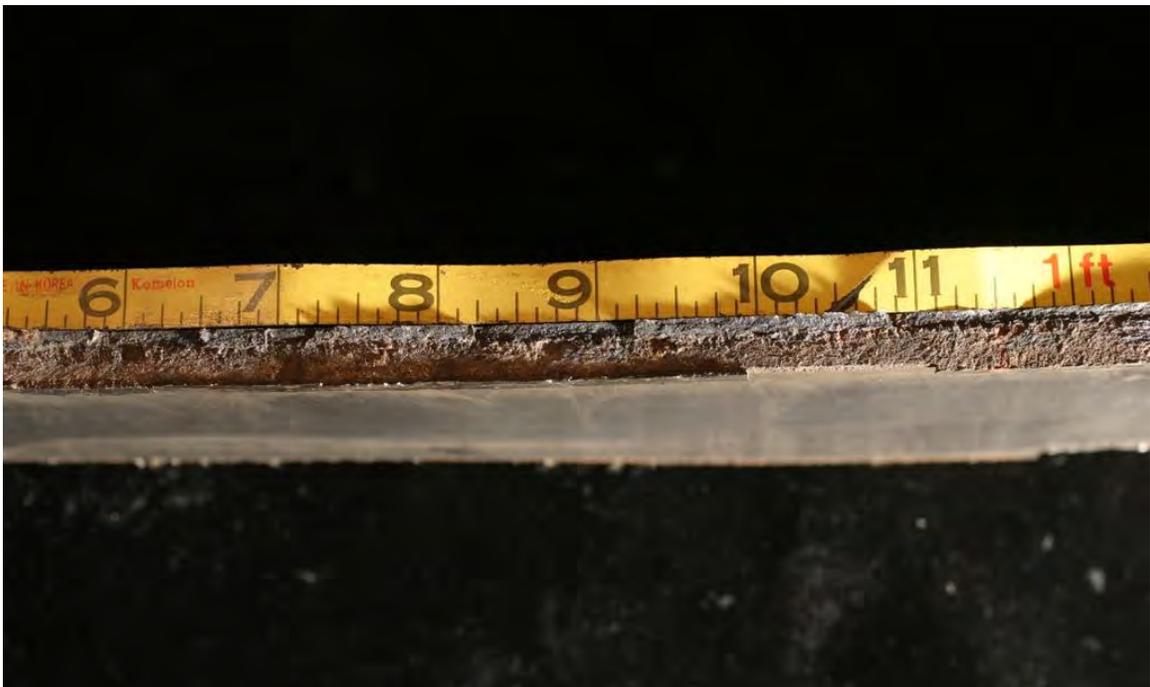
The photographs display evidence of manufacturing imperfection, i.e. the upturned bands near the O.D. in the fracture path of the final fracture.

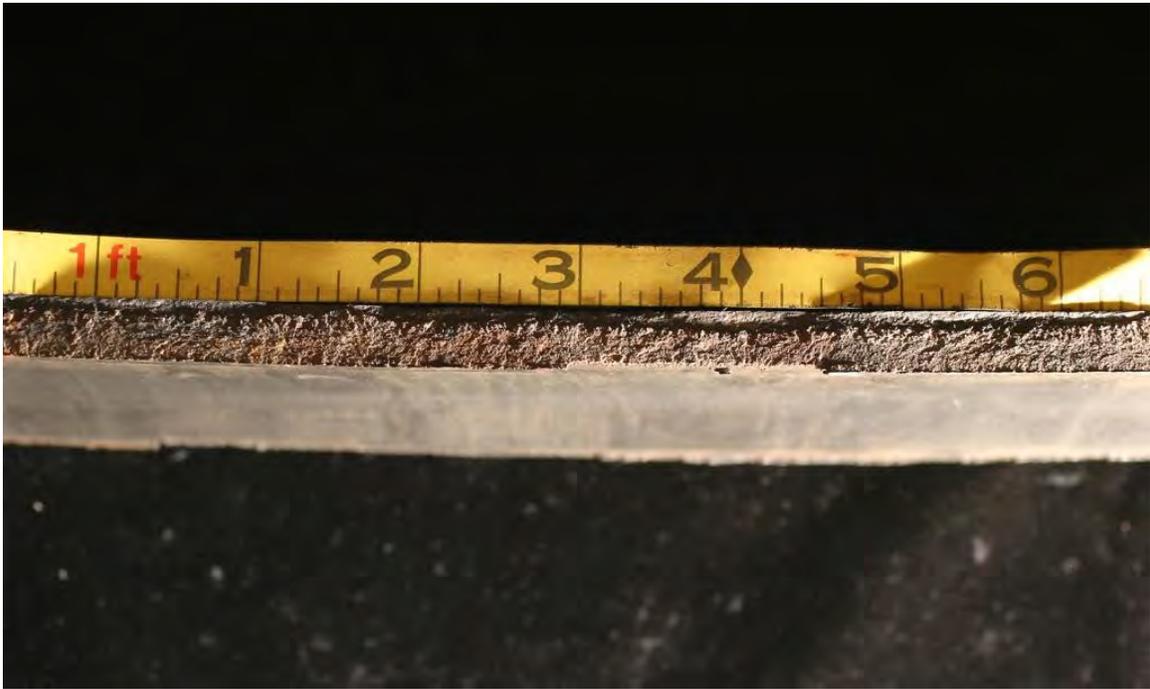
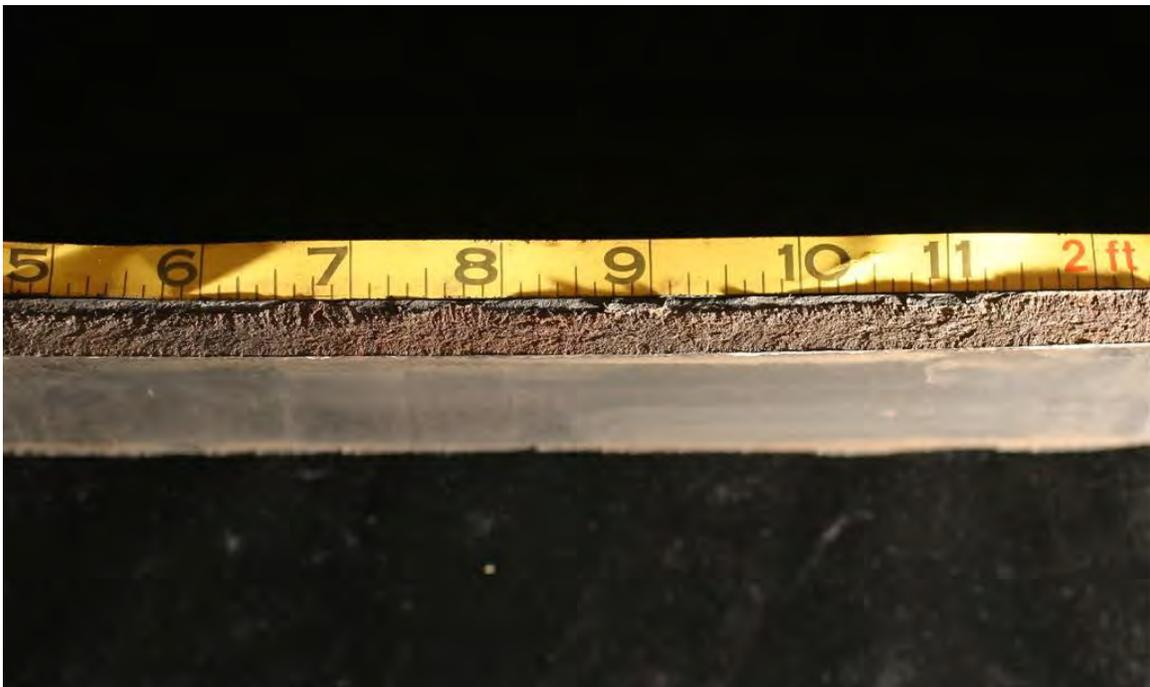
The photographs display the continuation of the manufacturing imperfections in the path of the final fracture.

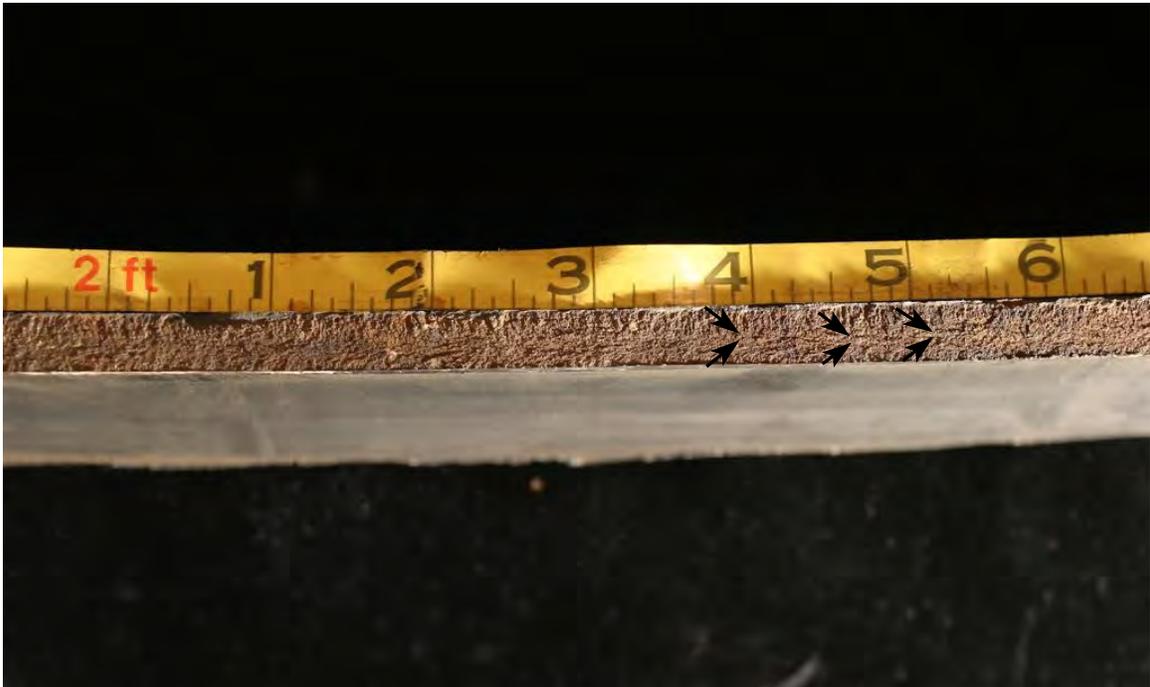
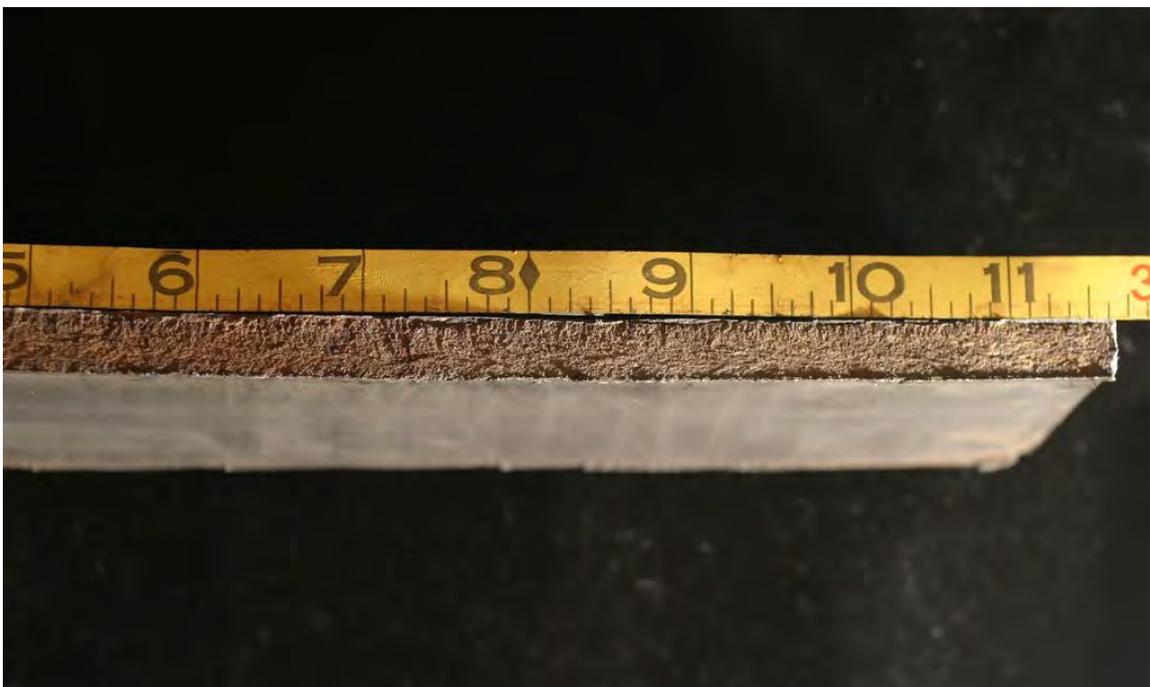
The photographs display evidence of chevron marks pointing downstream toward the fracture origins. The arrows point to some of the fine chevrons.

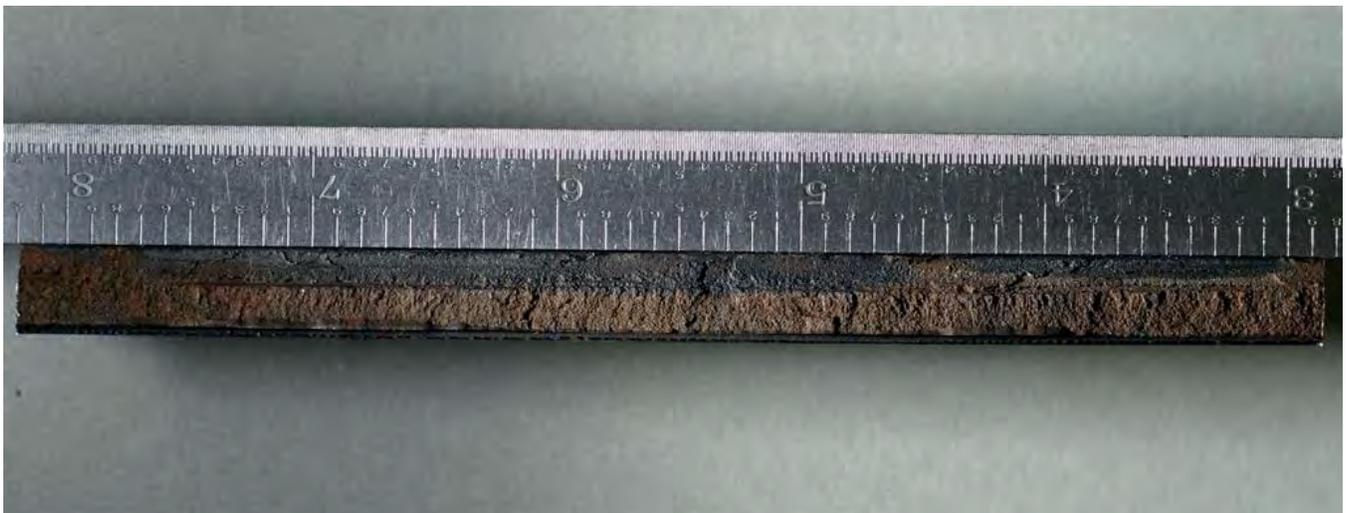
Photograph No. 118

The photographs display the mating fracture faces between a distance of approximately 20' 2-1/2" and 20' 8" from the north girth weld, revealing hook cracks in the heat-affected zone of the ERW seam to a maximum depth of 0.150" as measured from the O.D. surface, and vertical lines emanating from the tips of the hook cracks, indicative of the final fracture origin sites.

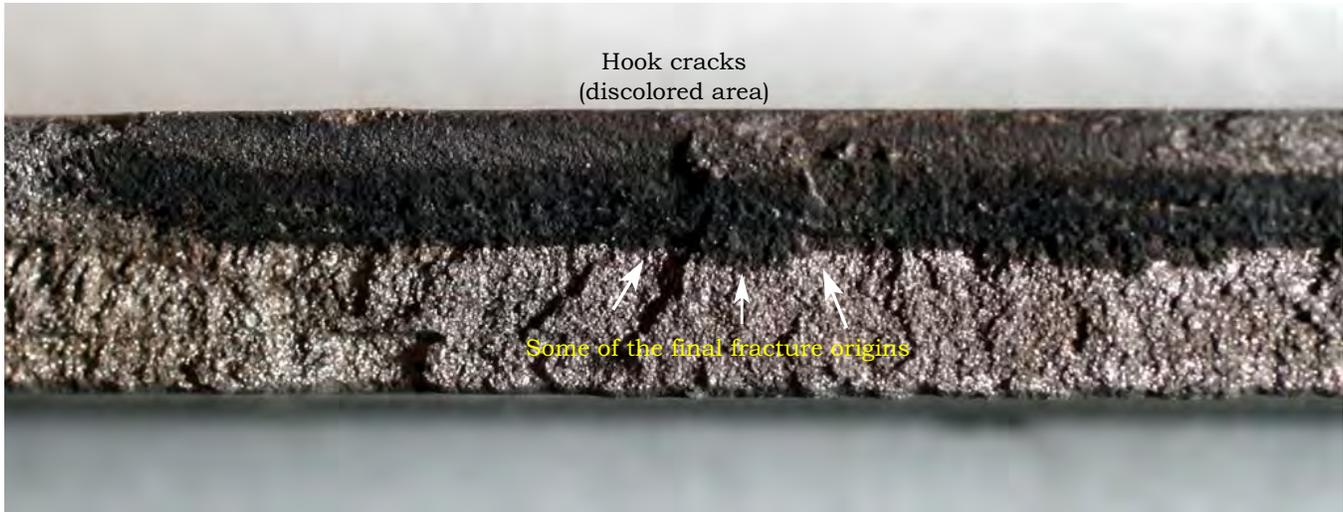
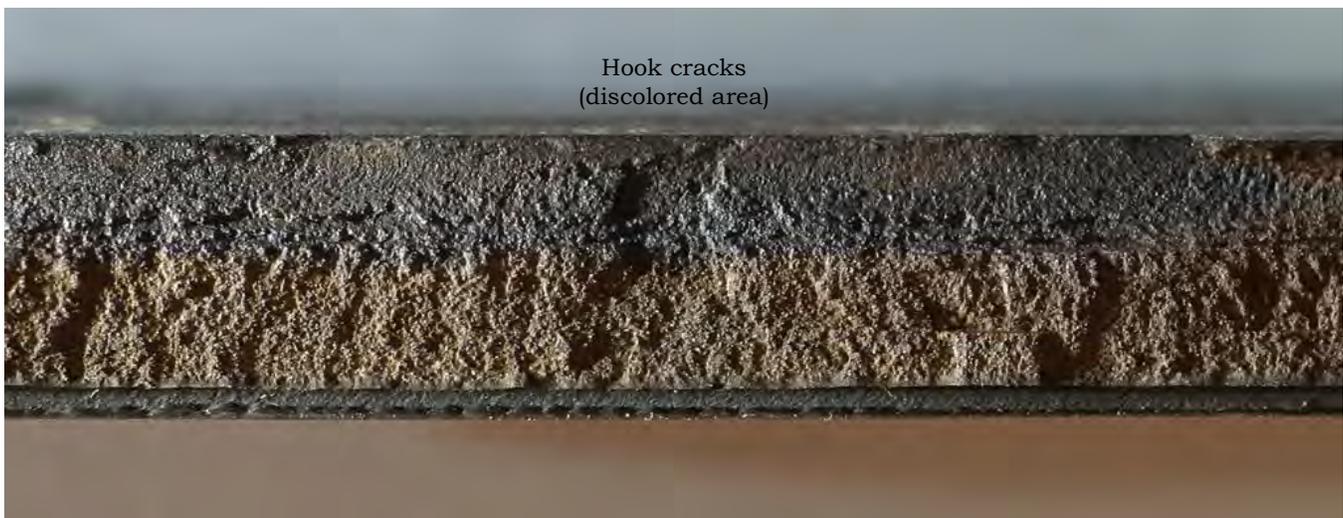
The photographs display the mating fracture faces revealing some of the fracture origin site(s) at a distance of approximately 20' 5-5/16" from the north girth weld, which were later examined at higher magnifications using a Scanning Electron Microscope (SEM) to characterize the fracture morphologies.

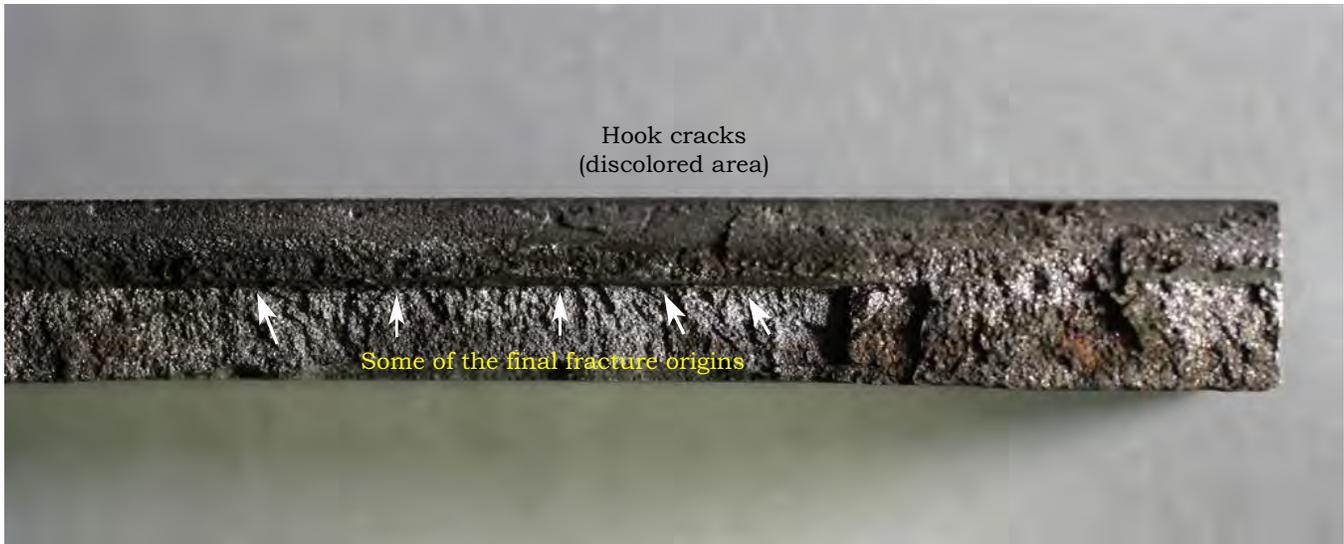
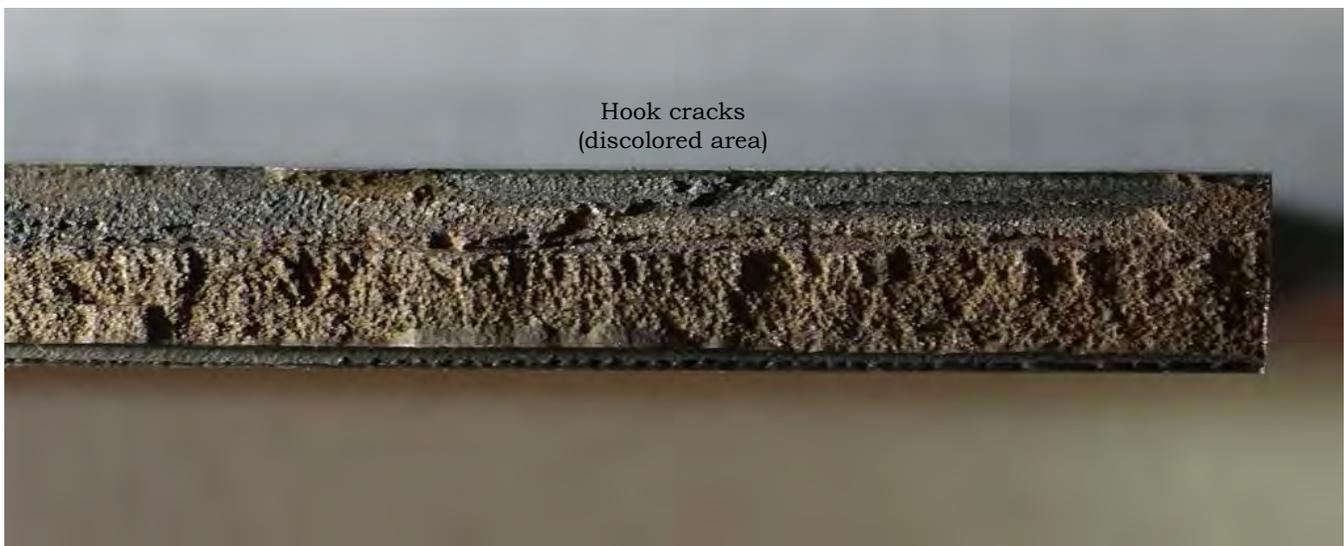
The photographs display the mating fracture faces revealing some of the fracture origin sites at a distance between 20' 5-3/4" and 20' 7-1/2" from the north girth weld, which were later examined at higher magnifications using an SEM to characterize the fracture morphologies.

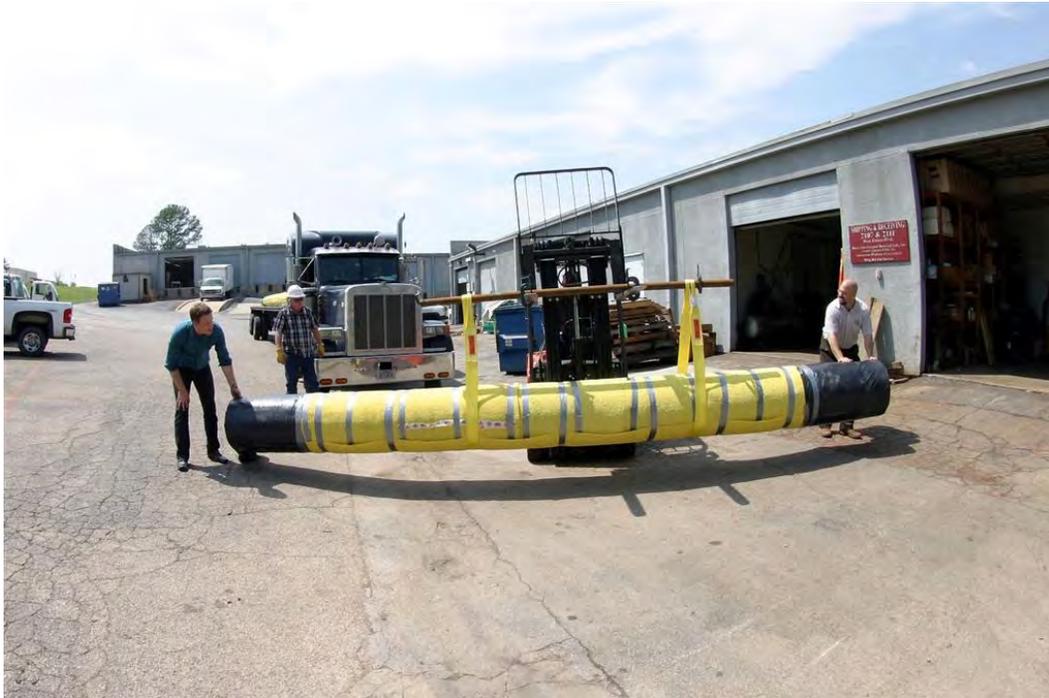
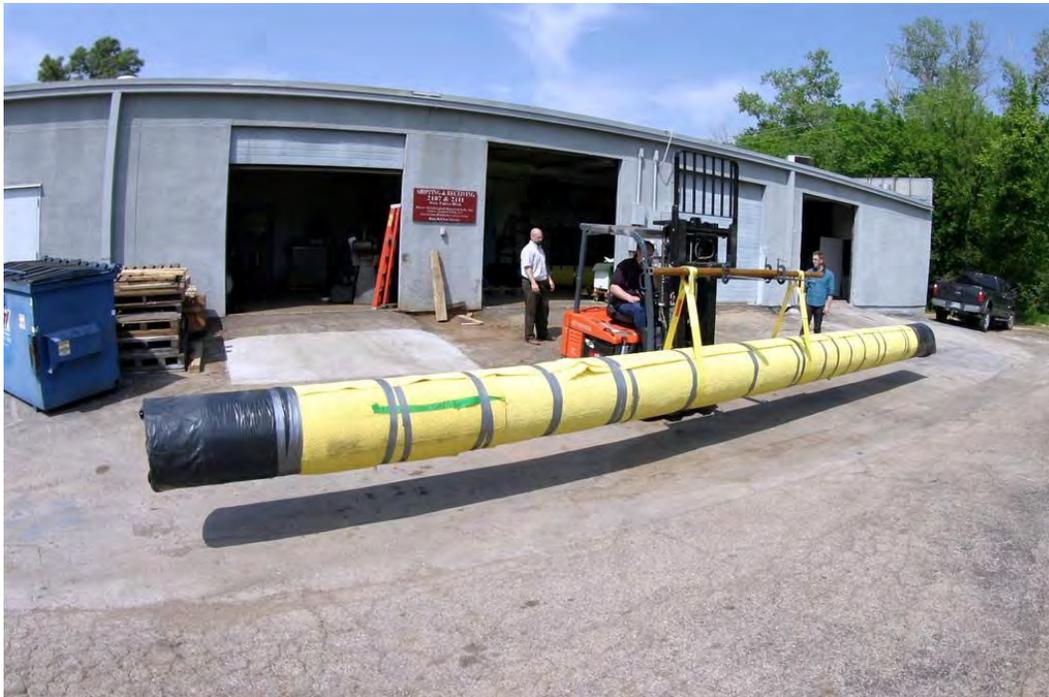
The photographs display two (2) pipe sections during the unloading process. There was no evidence of any transportation related damage to the pipe sections.
