DOT US Department of Transportation  
PHMSA Pipelines and Hazardous Materials Safety Administration  
OPS Office of Pipeline Safety  
Southwest Region

**Principal Investigator** Gene Roberson  
**Region Director** R. M. Seeley  
**Date of Report** 9/12/2013  
**Subject** Failure Investigation Report – Lion Oil Trading & Transportation, Inc.  
Suction Strainer Failure - Magnolia Tank Farm

**Failure Investigation Report – [Lion Oil Trading & Transportation, Inc.– Suction Strainer Failed]**  
[Failure Date 03/09/2013]

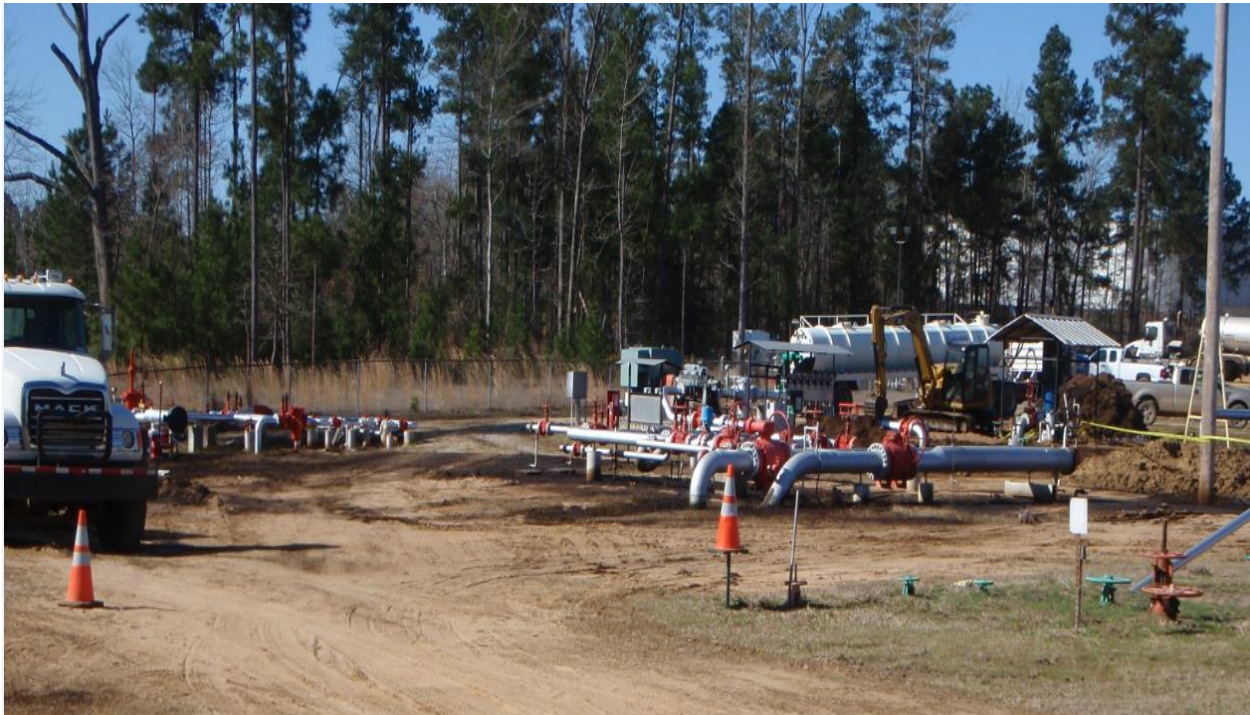
Figure 1 Release Site

PHMSA's Southwest Region traveled to the accident site to investigate the accident. A buried strainer upstream of Pump #6 was identified as the source of the release. The spill was located in a rural area, affecting the pump area, the inline inspection device trap area of the pipelines, a site retention pond, and approximately 2.5 miles offsite in an area that included the Little Cornie Waterway. No local emergency personnel responded to the scene. There were no injuries, road closures, or resident evacuations associated with this accident.

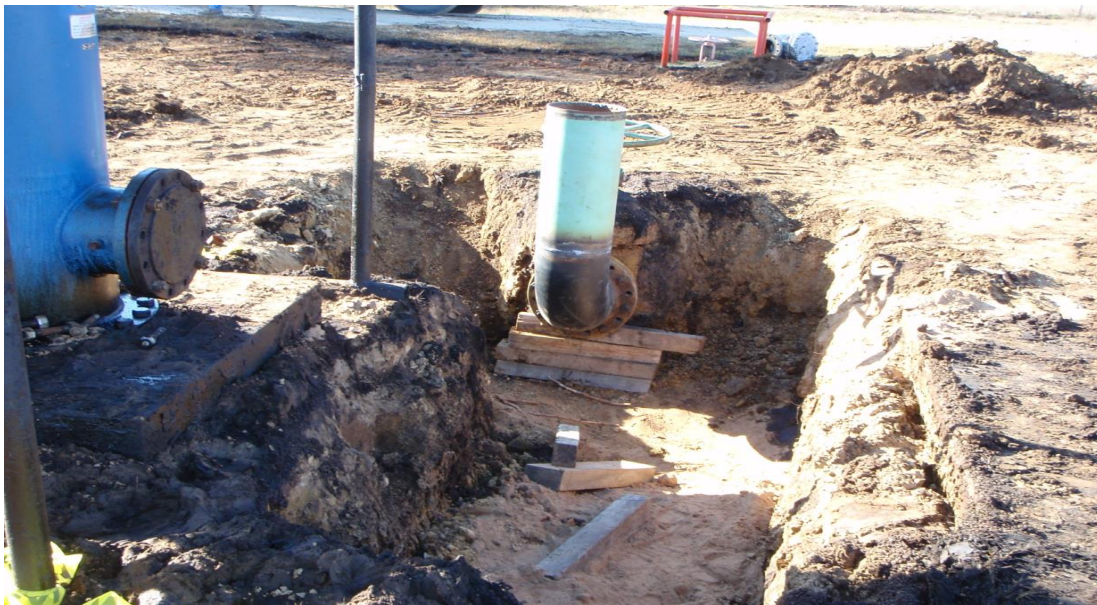
**Figure 2 Strainer Site with start of replacement piping**

The failure occurred in the suction side of the strainer vessel inside the station. No previous failures have been reported in the station.

The strainer and pump suction piping were removed to allow soil removal for clean-up. The strainer was sent to a lab for analysis to validate the cause of failure. Lion Oil installed new pipe in place of the removed strainer and suction piping. No corrosion was observed in the piping removed with the strainer.

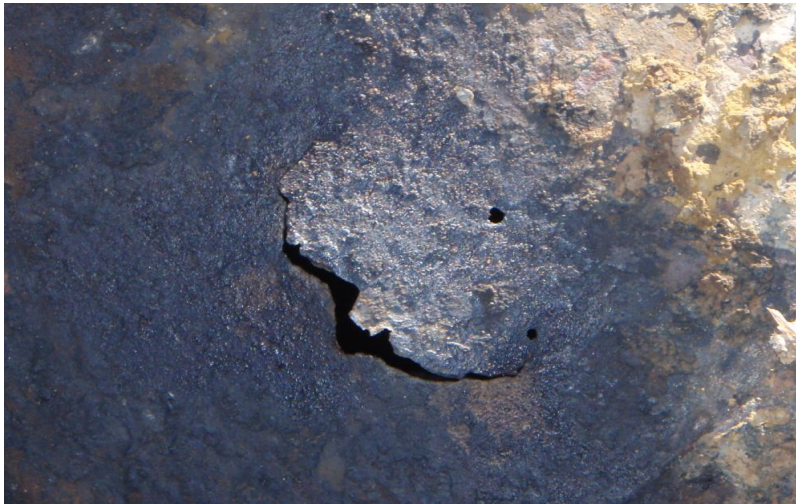
**Figure 3 Failed Strainer (external view)**

A failure occurred in the side wall of the Pump #6 suction strainer due to internal corrosion.

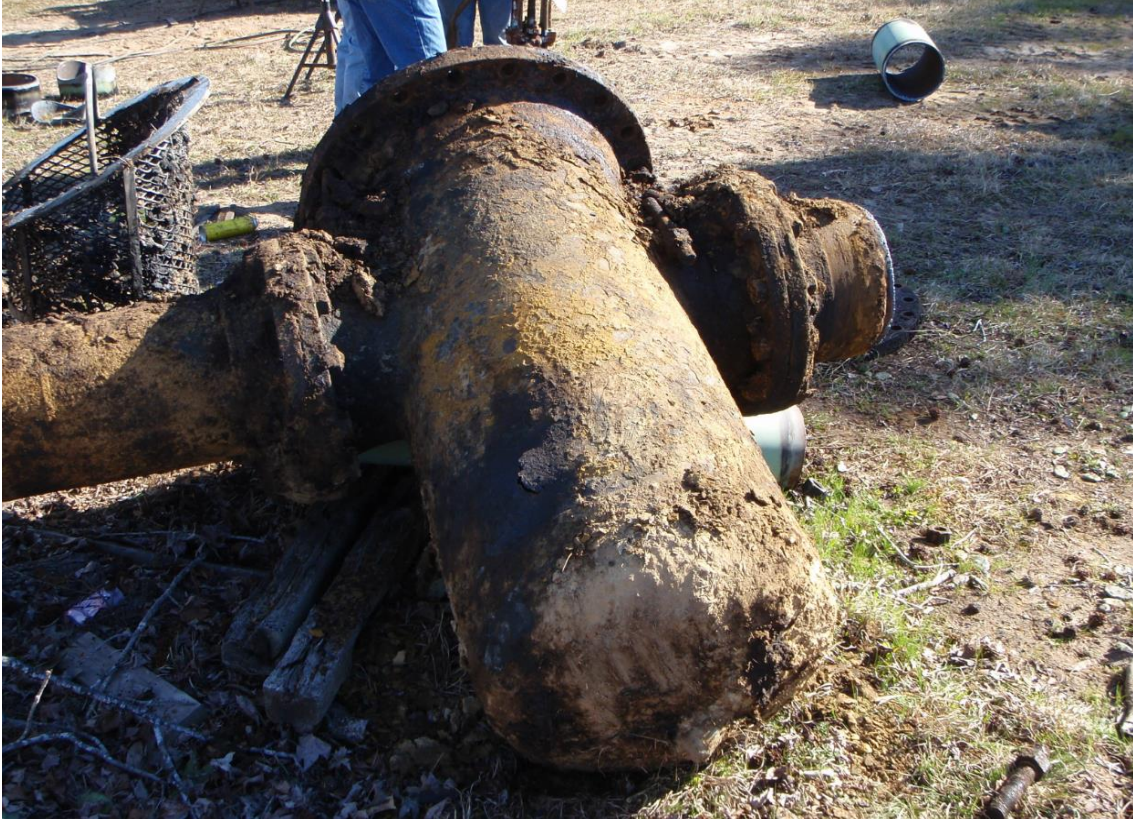
**Figure 4 Failed Strainer**

- The strainer failure was caused by extreme, localized internal corrosion (IC).
- IC was caused by an acidic environment, most probably naphthenic acid (normal in crude).
- There was no evidence of microbiological corrosion.
