Failure Investigation Report – Sunoco Pipeline L.P., Darby Creek Tank Leak

Principal Investigator Christian Sellu
Senior Accident Investigator Michael Yazemboski
Region Director Byron Coy
Date of Report 7/12/2013
Subject Failure Investigation Report – Sunoco Pipeline L.P.,
Darby Creek Tank Leak

Failure Investigation Report – Sunoco Pipeline L.P., Darby Creek Tank DC9 Leak

Failure Date 02/08/2011

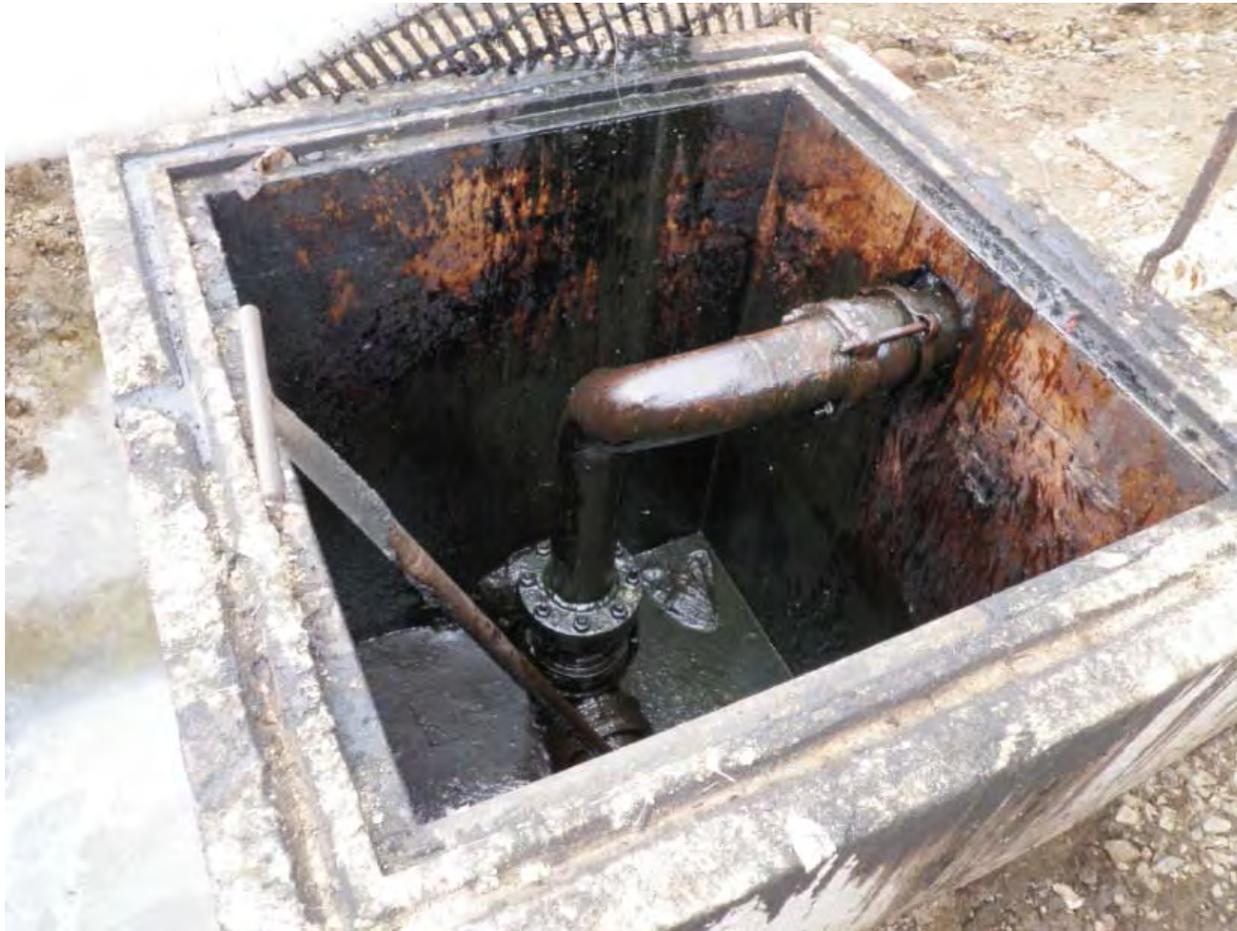
Photo 1 – Oil Water Box

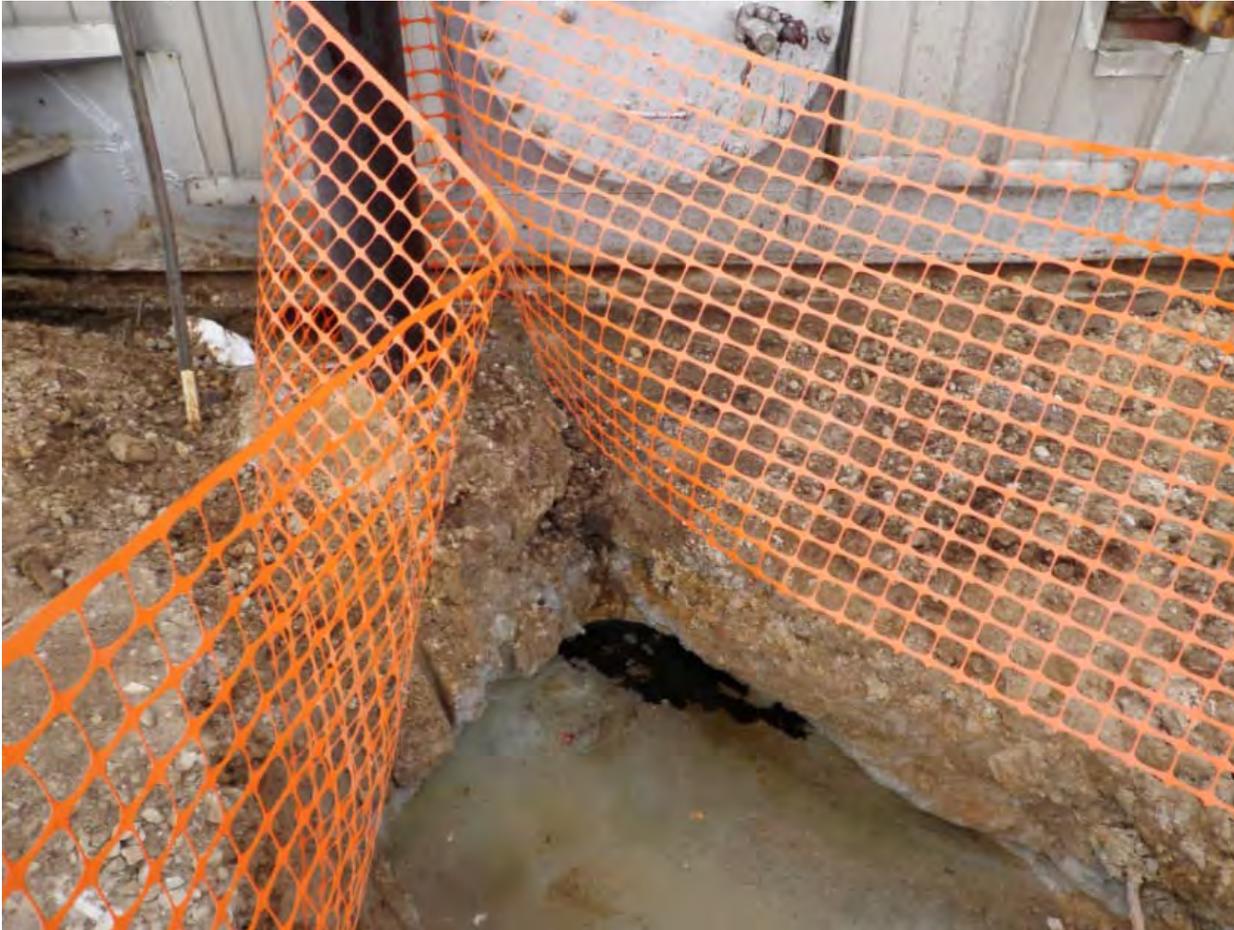
Photo 2 - Apparent Leakage from tank bottom

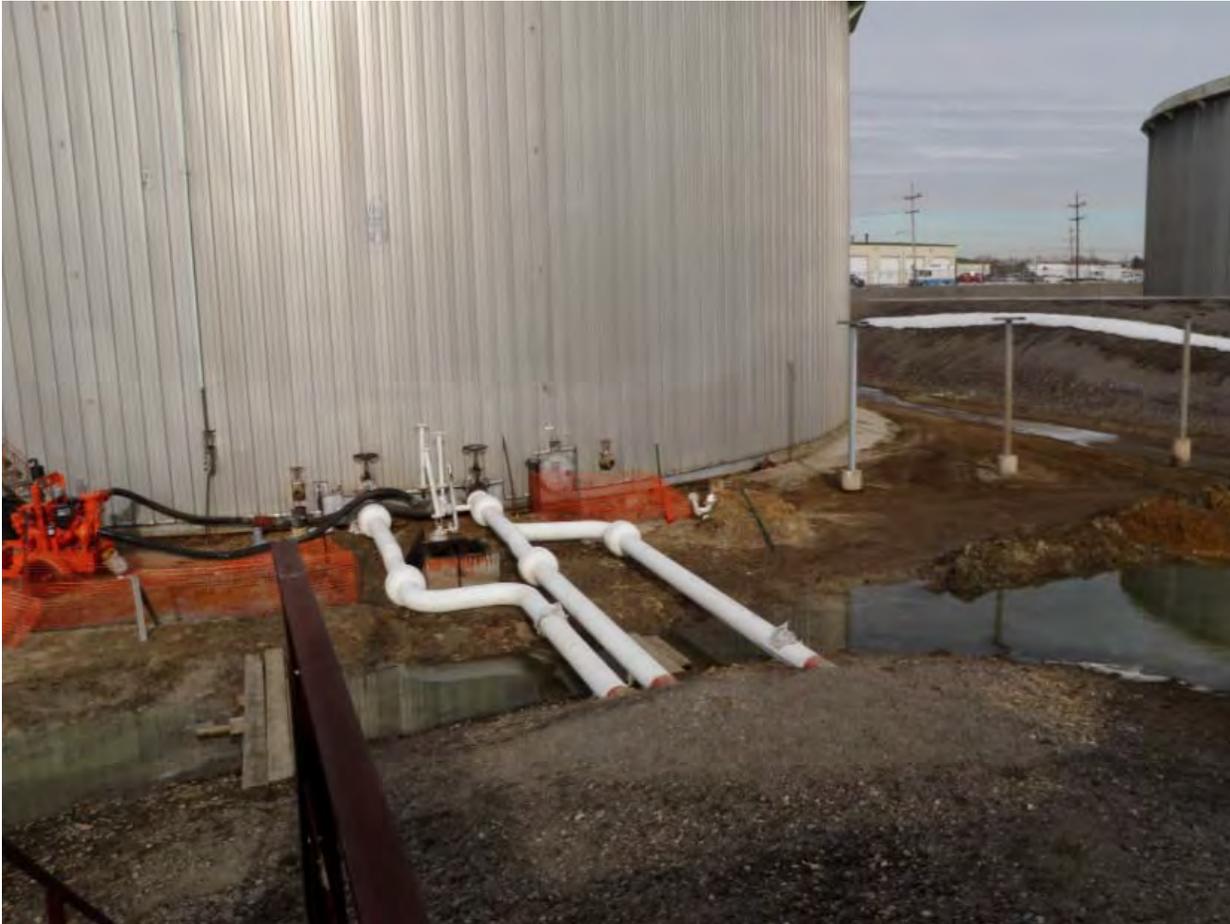
Photo 3 – Tank Piping

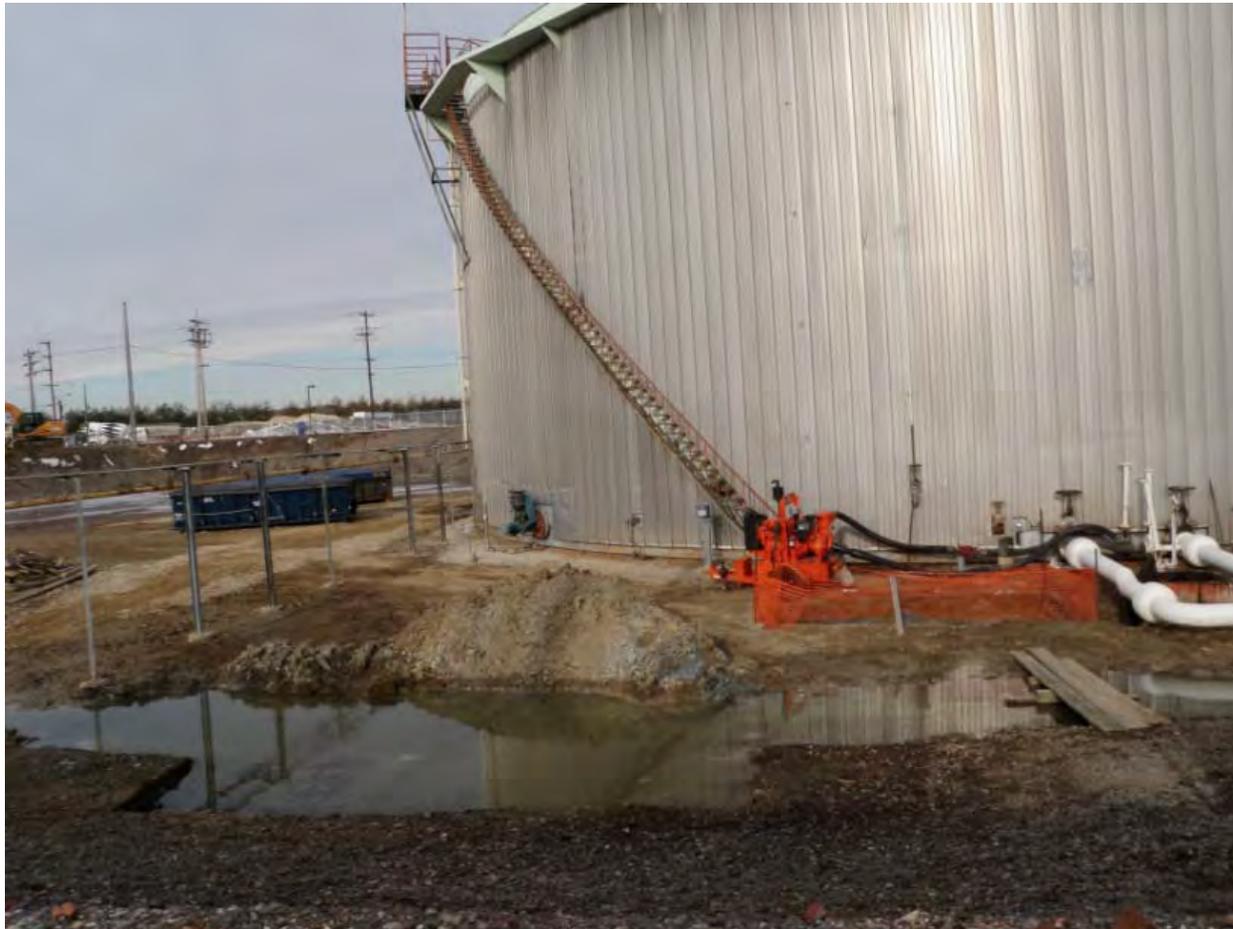
Photo 4 – Tank Dike

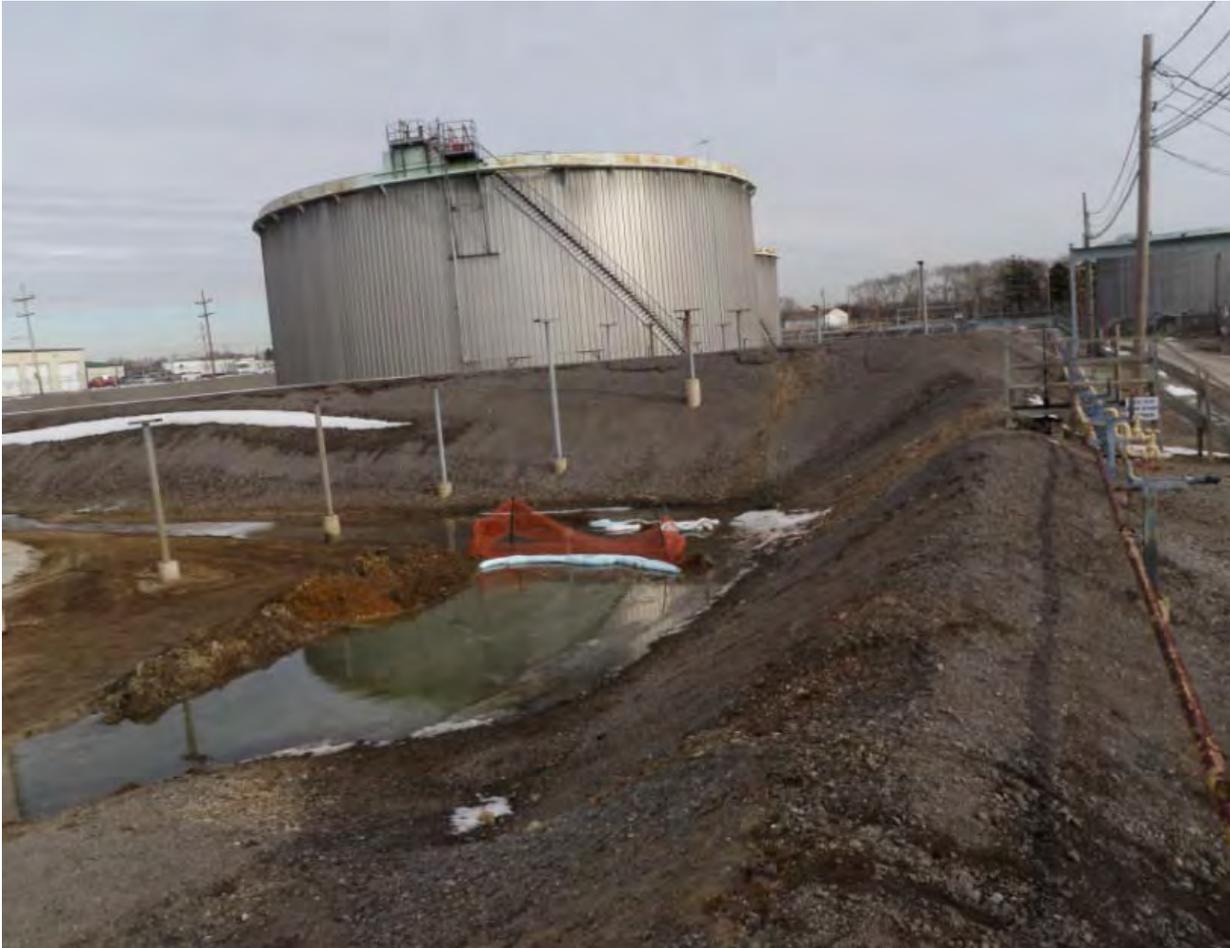
Photo 5 – Traces of Crude – Tank Dike

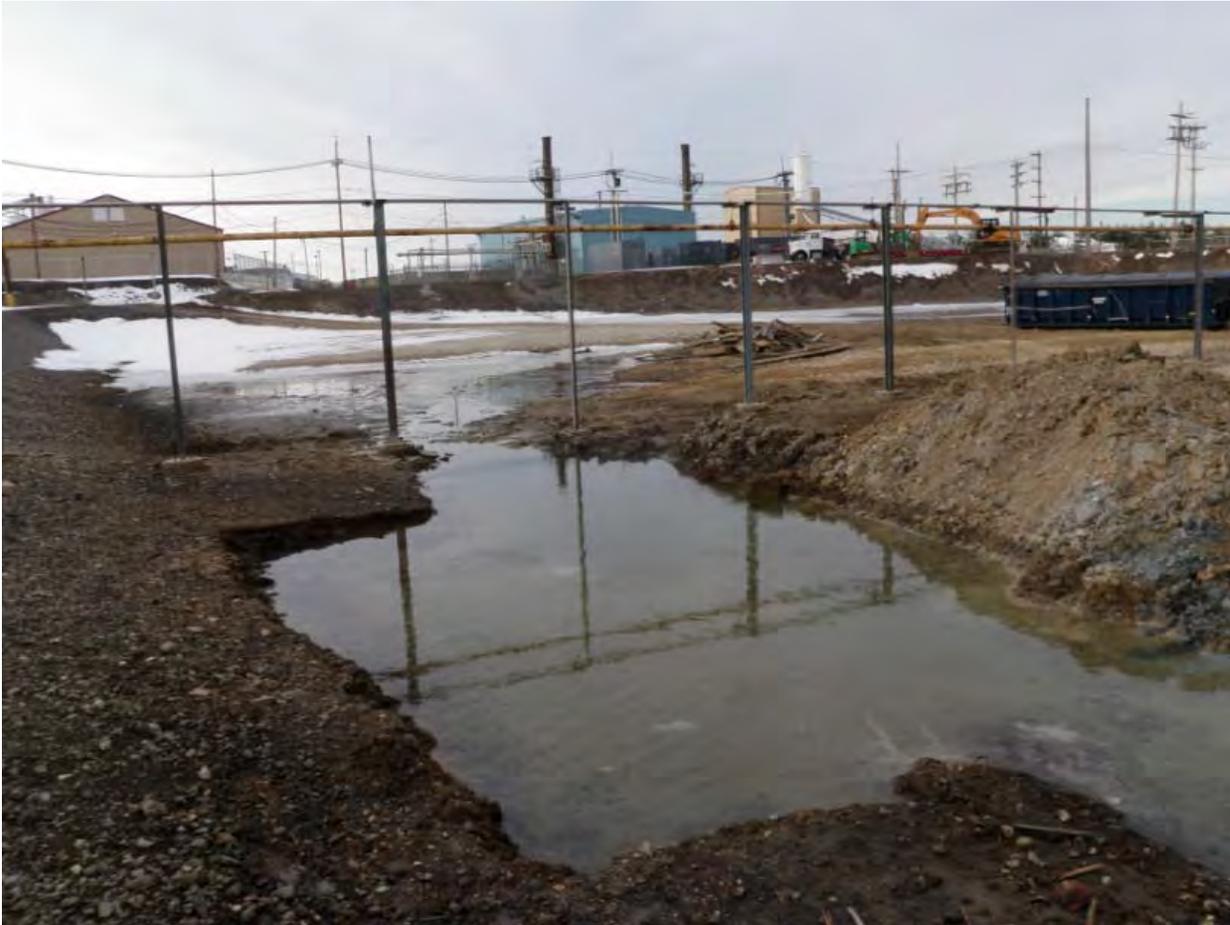
Photo 6 – Tank Dike

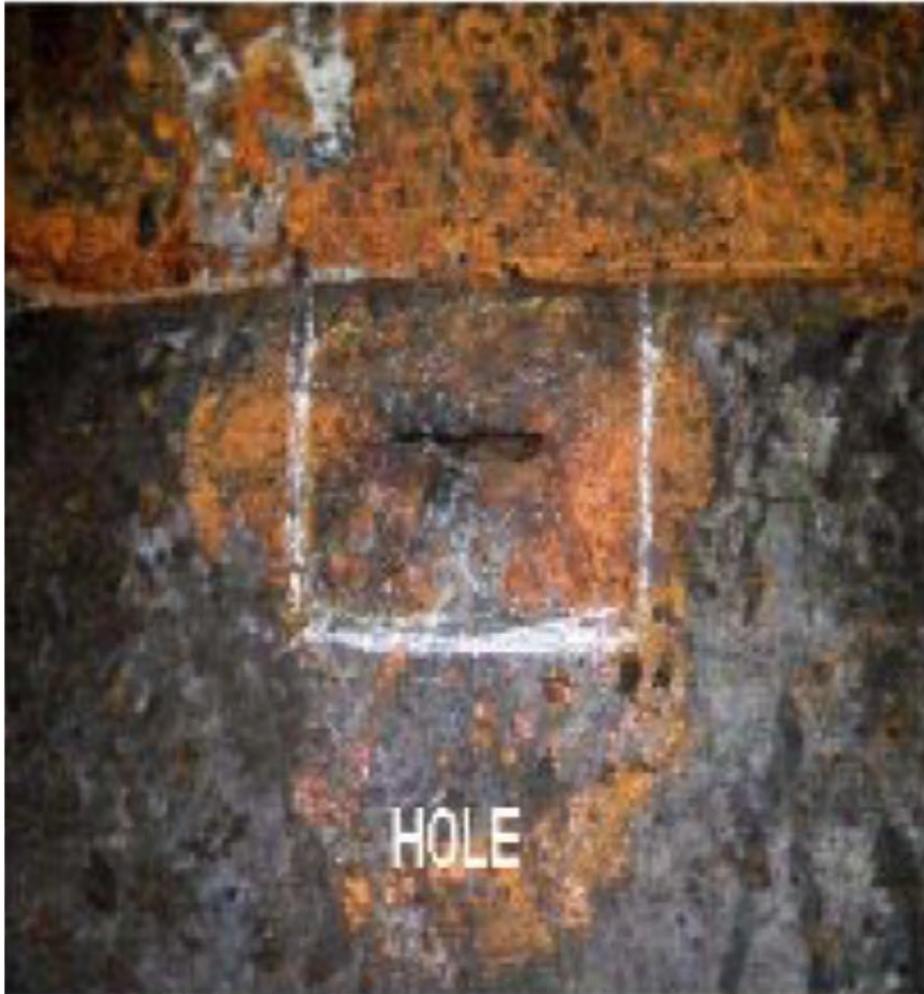
A post-accident inspection conducted by DJA Inspection Services, dated April 20, 2011, identified significant topside corrosion on the floor plates in tank DC9 due to a failure of the FRP coating that was applied in 1992 (Appendix E). The report also indicated that approximately 60 percent of the floor could not be accurately MFE scanned during the post-accident inspection due to the severity of the topside corrosion and the FRP disbondment. The report also indicated that minor soil-side corrosion was found around the outside of the inner bottom plates against the annular ring. The report recommended replacing the entire bottom of the tank or repairing the tank by replacing approximately 60% of the bottom and performing various other procedures. The report also recommended that all of the annual rings be re-welded due to the amount of corrosion that was identified in these locations.

The primary immediate cause of this release was due to a hole in the tank bottom caused by a combination of internal topside corrosion and external underside soil-side corrosion. The topside corrosion was due to the failure of the FRP protective coating material that was applied when the tank bottom was replaced in 1992.

Photo 7 – Hole on bottom of tank DC9. Floor Plate #35.

Tank DC9 will remain out of service until Sunoco can complete the repairs as outlined in the out of service inspection report, dated April 20, 2011, and provided by DJA Inspection Services.
