Principal Investigator MNOPS/James Bunn/Karen Butler
Region Director Allan Beshore
Date of Report 11/14/2014
Subject Failure Investigation Report – Northern Natural Gas Co (NNG) –
Natural Force Damage

Failure Investigation Report – Northern Natural Gas Co – Natural Force Damage

Failure Date 05/23/2008

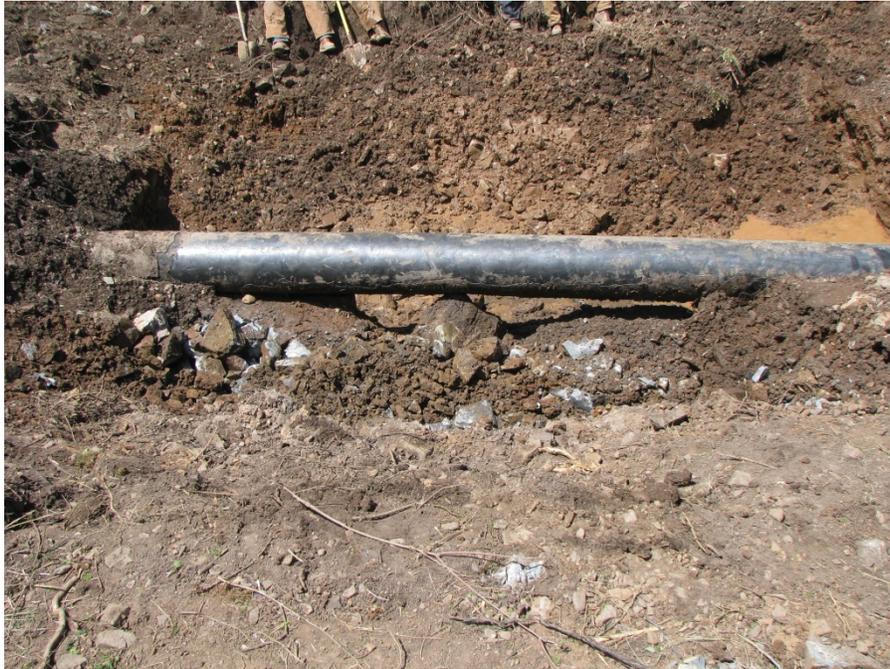
bottom of a dent that measured approximately 11 inches in length, 7 inches circumferentially and 0.903 inches deep. A rock that was impinging on the pipeline at the 6 o'clock position caused the dent. Ground subsidence, combined with the impinging rock, caused the dented pipe to fail.

Wide-angle image showing impinging rock

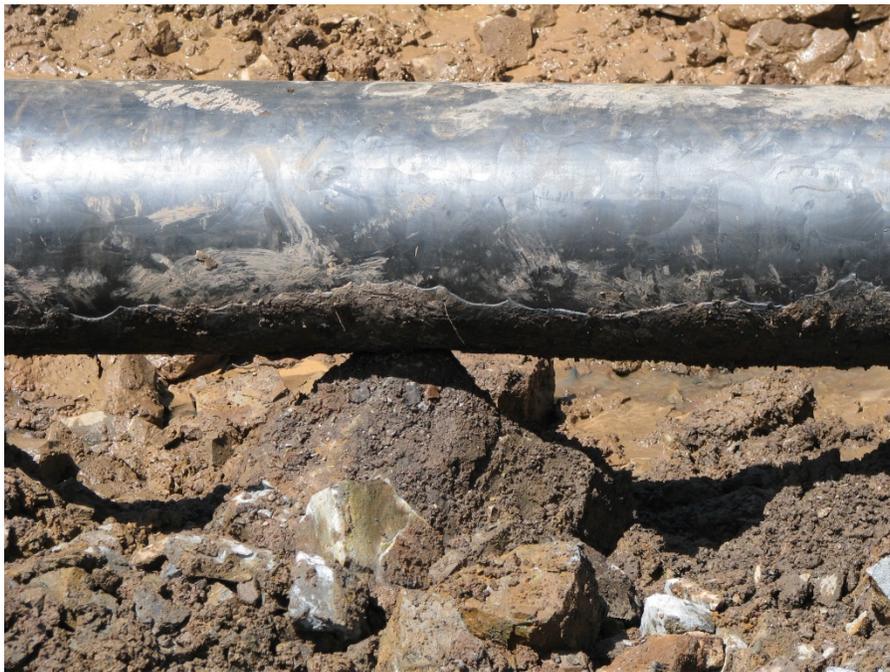
Closeup of impinging rock

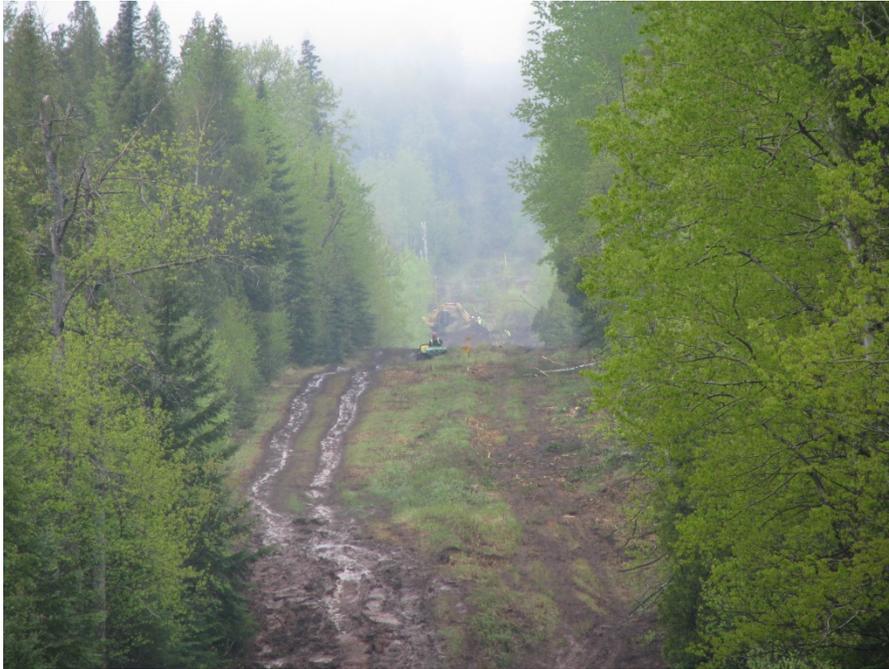
Hilly area leading up to failure site

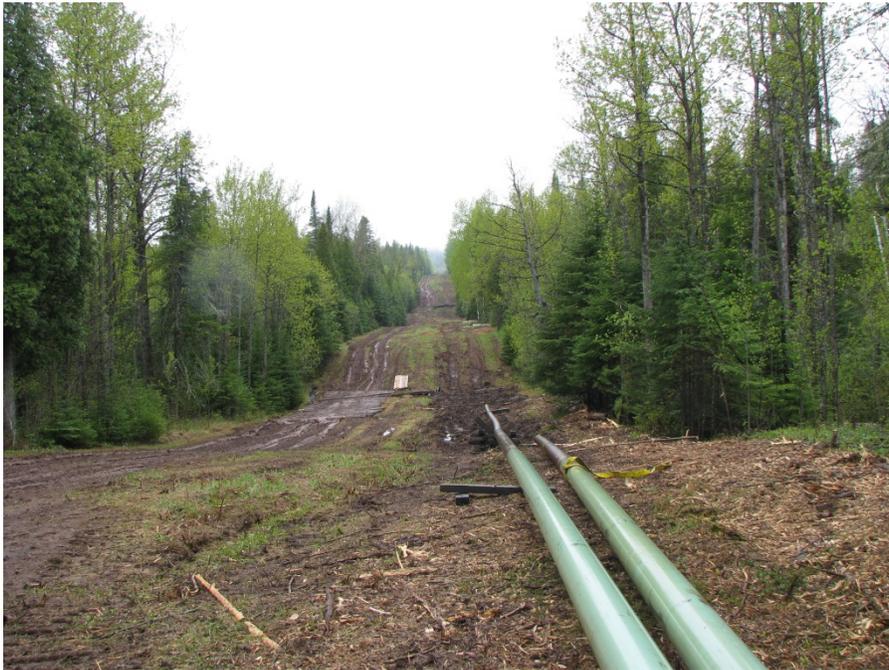
Additional broad view of site

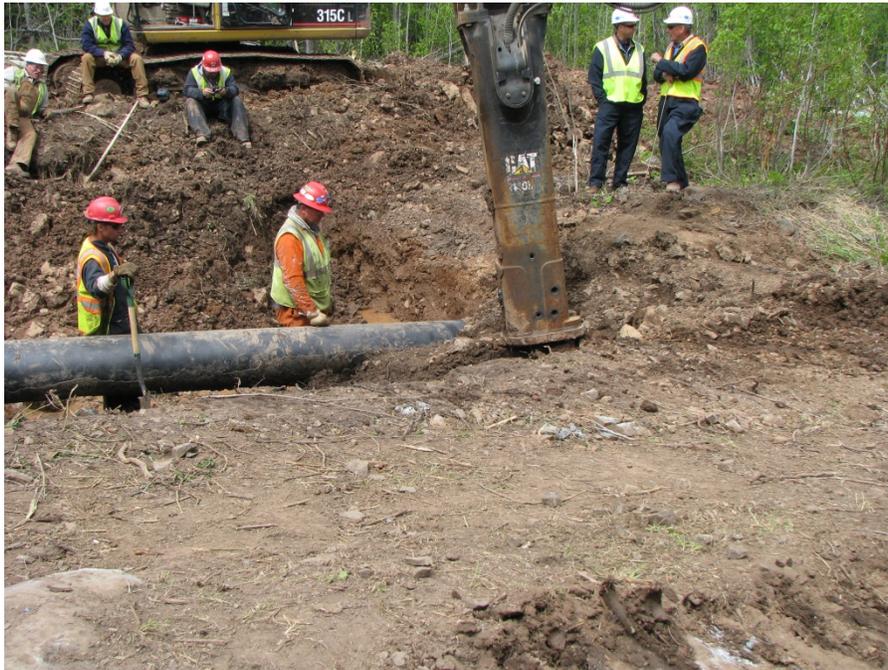
Excavation site

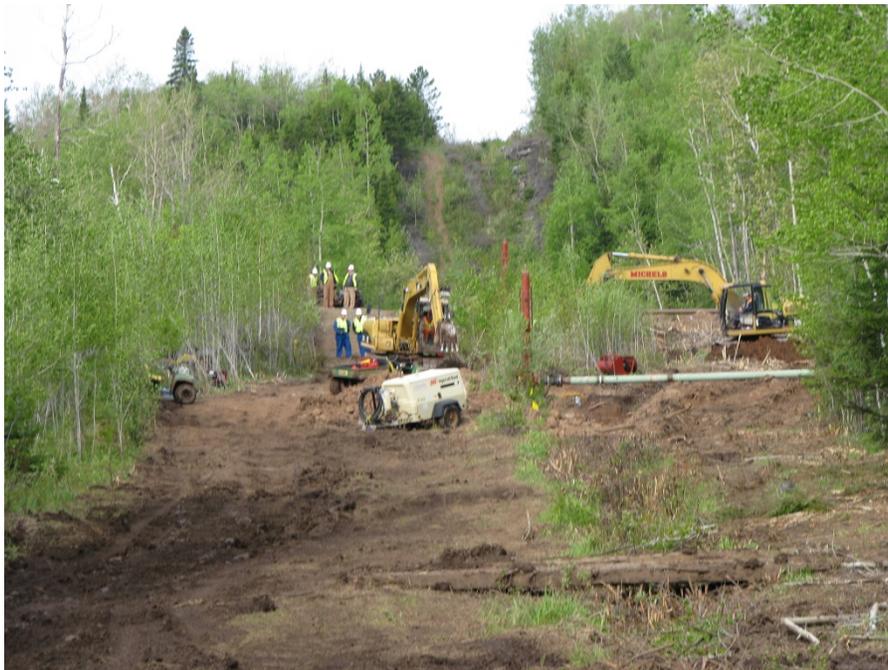
Alternate angle

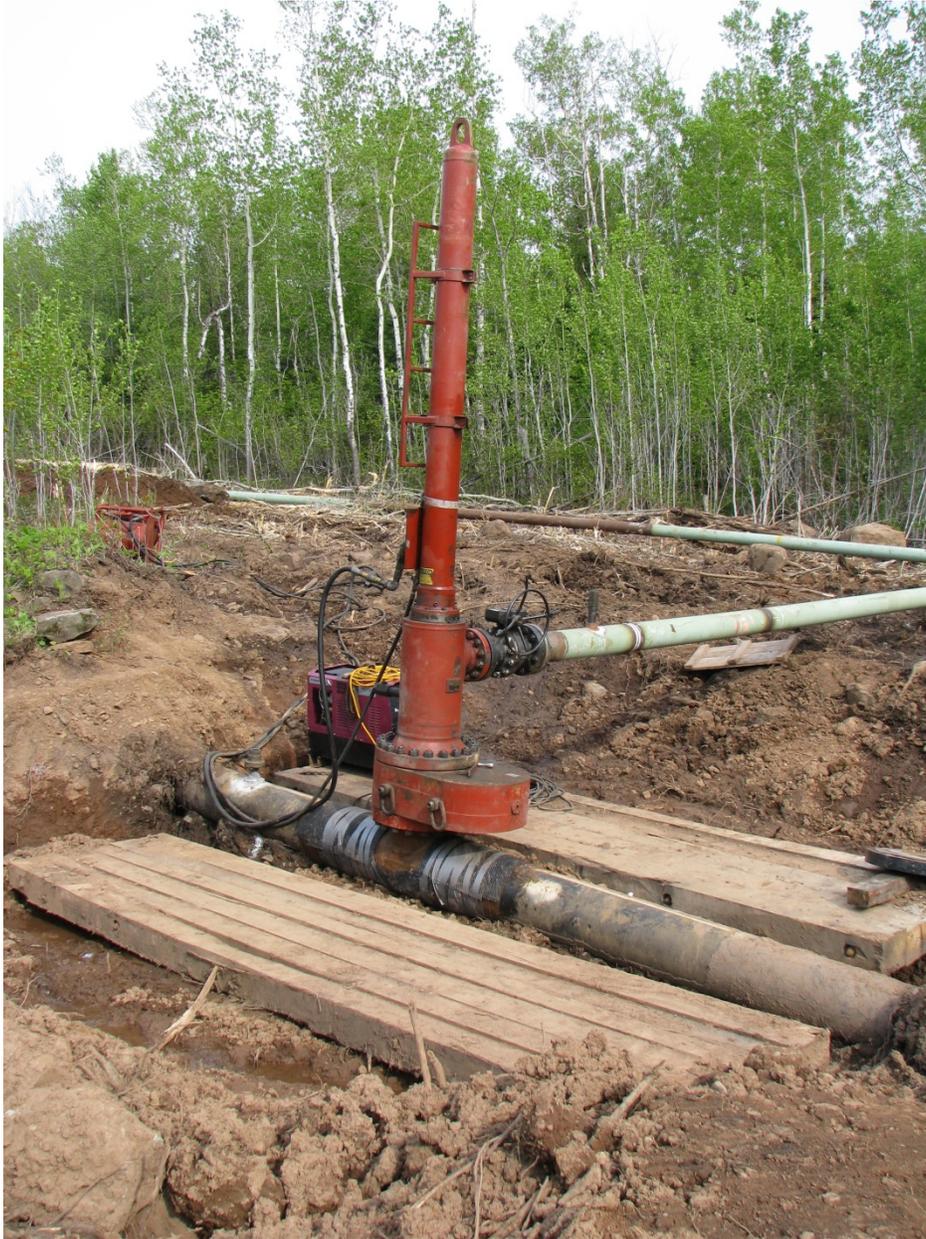
Constructing bypass

Between May 23, 2008, and May 29, 2008, delays to repair activities occurred due to weather and contract resource availability. On May 29, 2008, NNG began excavation activities in order to install stopple fittings. After the fittings were installed, a bypass was constructed around the leak area. The section of the line that contained the leak was blown down and the line was excavated to expose the leak. The pipe was resting on a piece of granite at the leak location. A dent had formed in the pipe where it was resting on the rock. The dent was approximately 11 inches long, 7 inches wide and 0.903 inches deep. The bottom of the dent contained a thru-wall crack that was approximately 1 inch long. The repair to the failed section of pipe was made with a 16-inch Type B weld sleeve approximately 24 inches long. On June 3, 2008, repair work was completed and the pipeline returned to normal service.

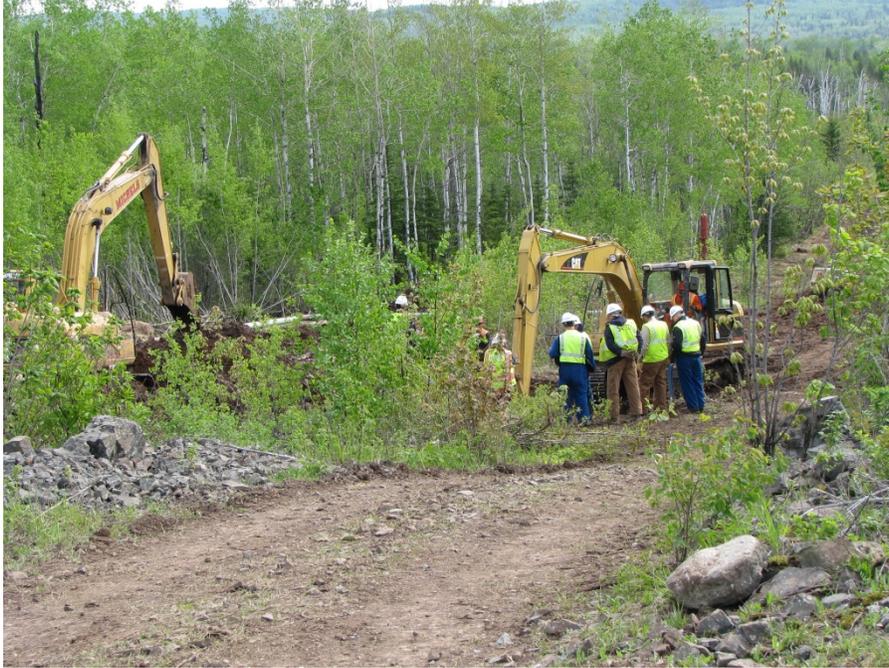
Bypass from alternate angle

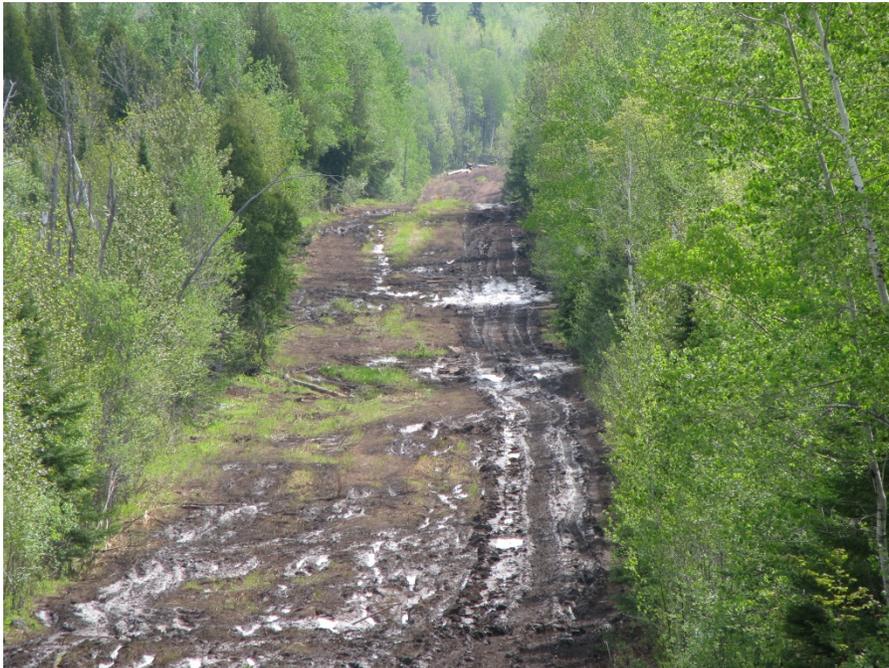
Area after rain

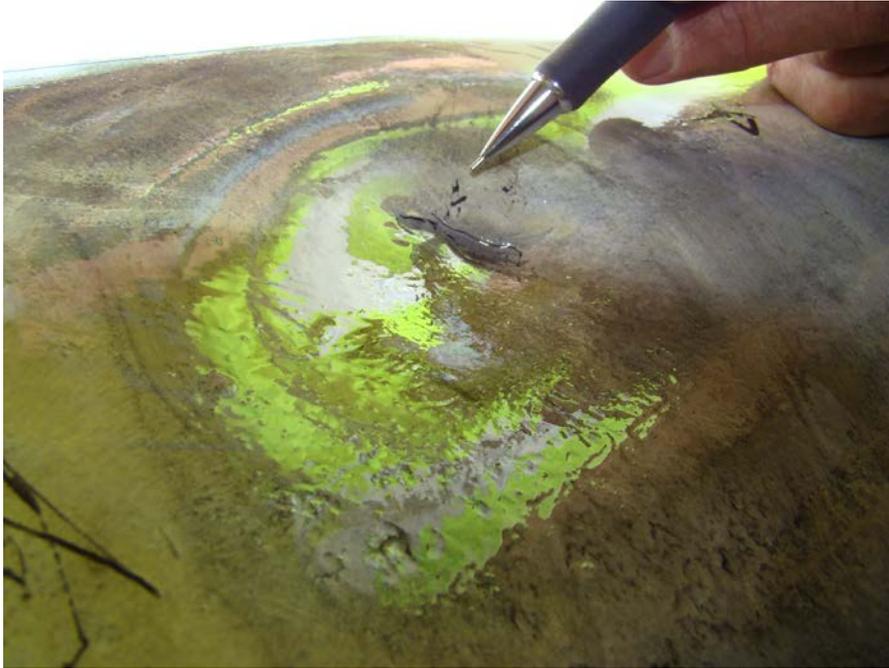
The failure origin was a 1-inch crack located in a dent in the pipe body. The crack was located in the

Closeup of damage to pipe wall

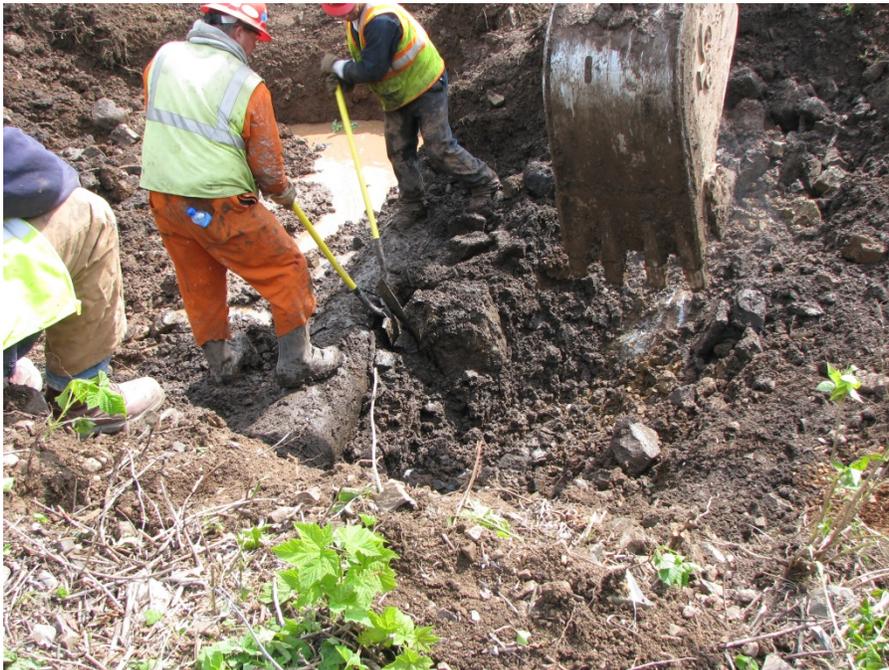
Hand excavation

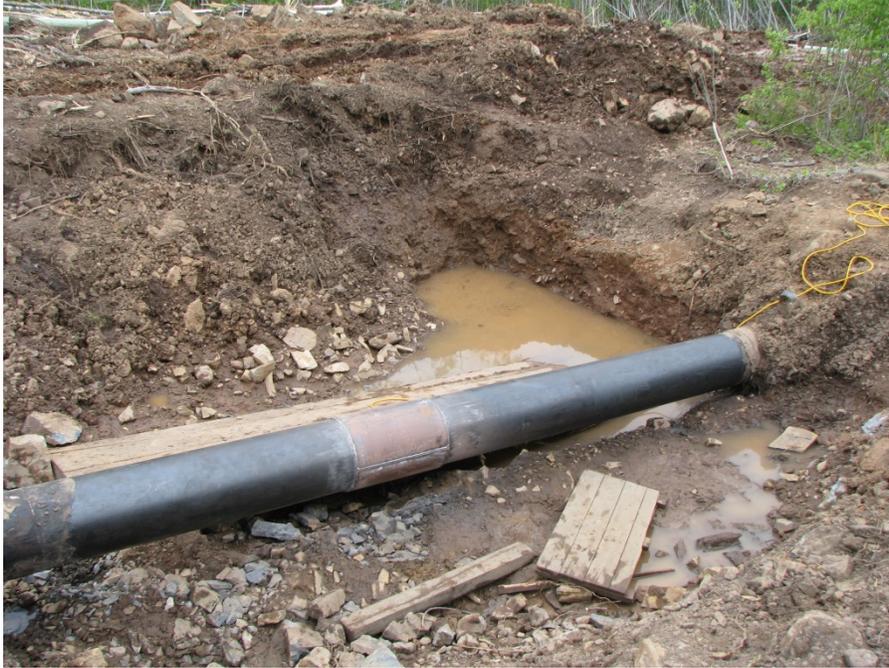
Completed repair
