DOT US Department of Transportation
PHMSA Pipeline and Hazardous Materials Safety Administration
OPS Office of Pipeline Safety
Central Region

Principal Investigator Judy Johnson
Region Director David Barrett
Date of Report 12/15/2011
Subject Failure Investigation Report – KMIGT 16” Franklin to Hastings Line

Failure Investigation Report – KMIGT 16” Franklin to Hastings Line

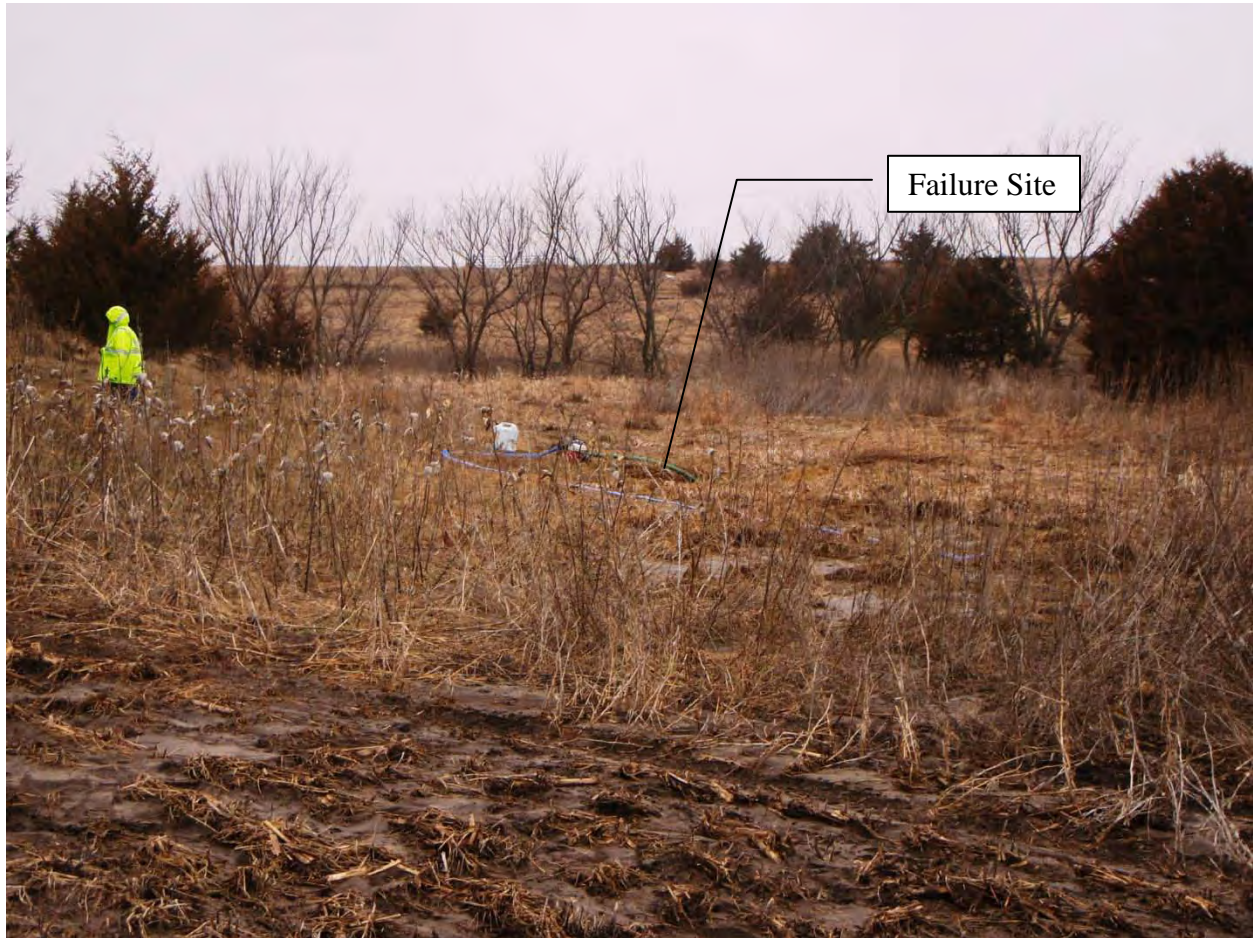
Failure site, looking west toward Roseland Avenue. Tree line in background marks the location of Scott Creek.

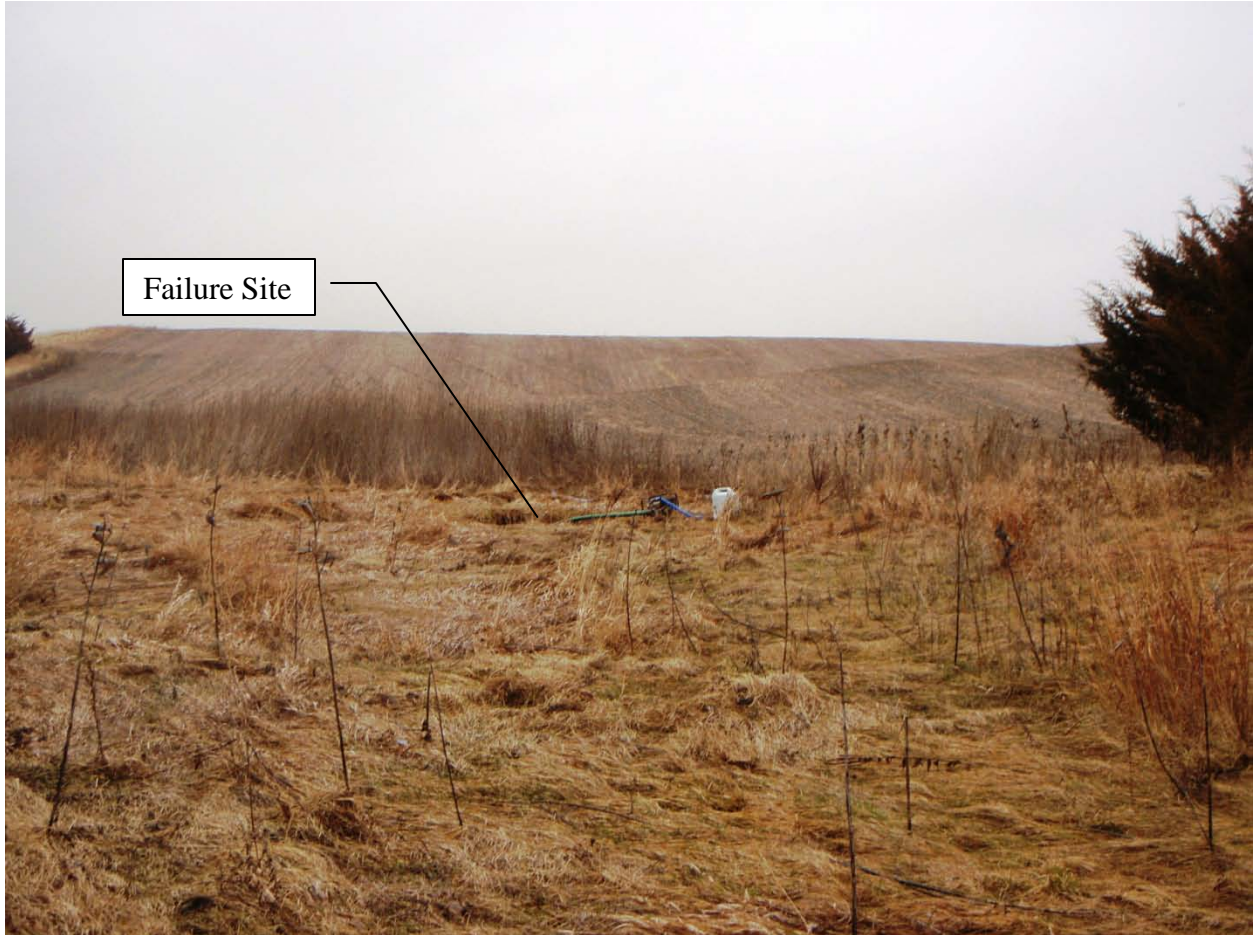
Failure site, looking east. Grasses laid over in foreground due to flooding of Scott Creek.

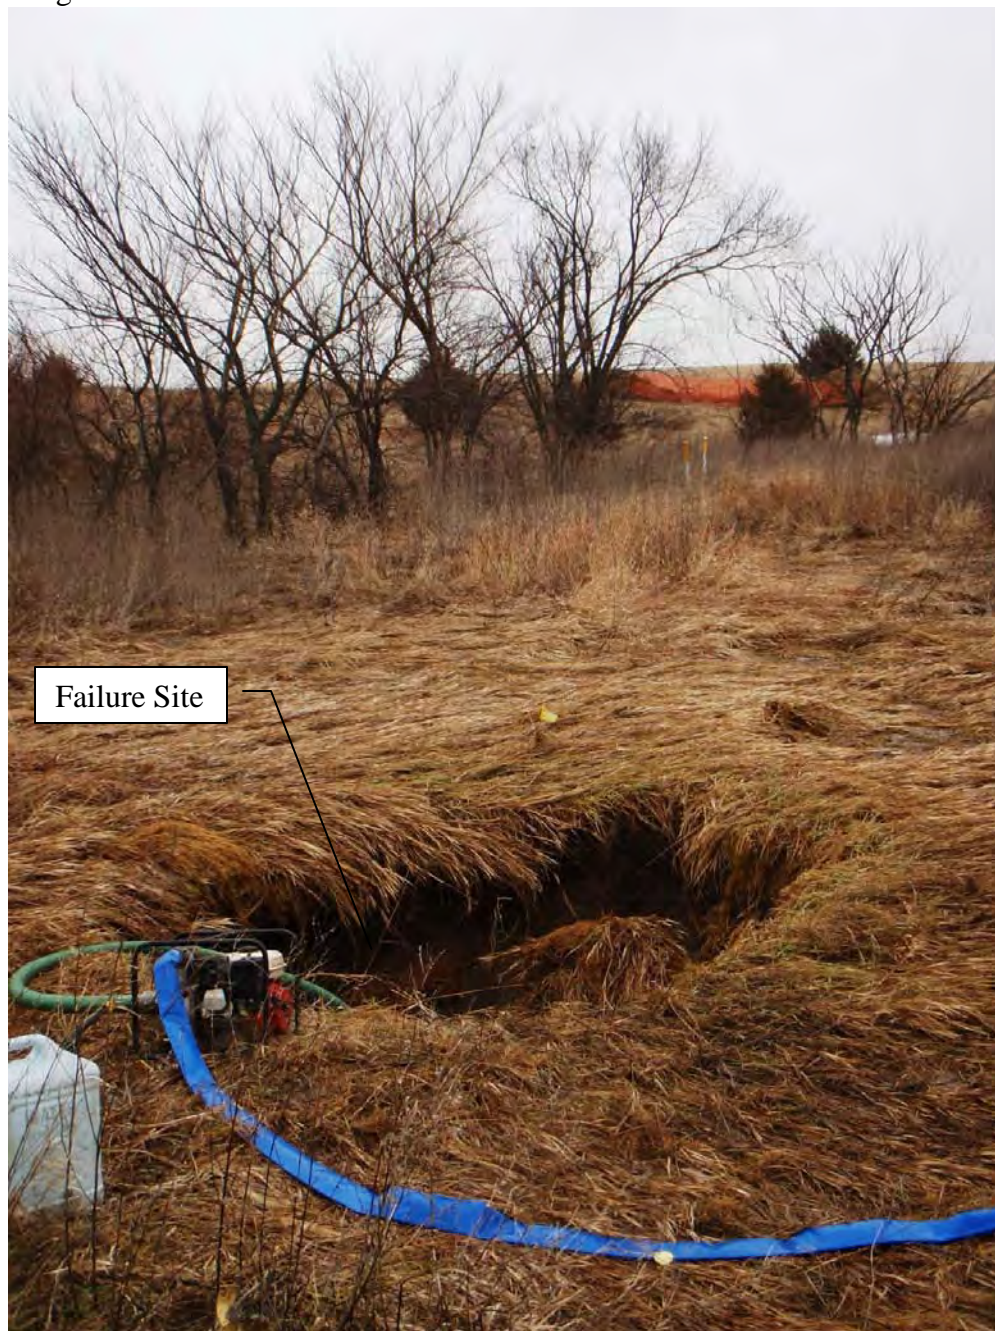
Failure site, looking northeast (downstream). Pipeline markers in background indicate Scott Creek crossing.

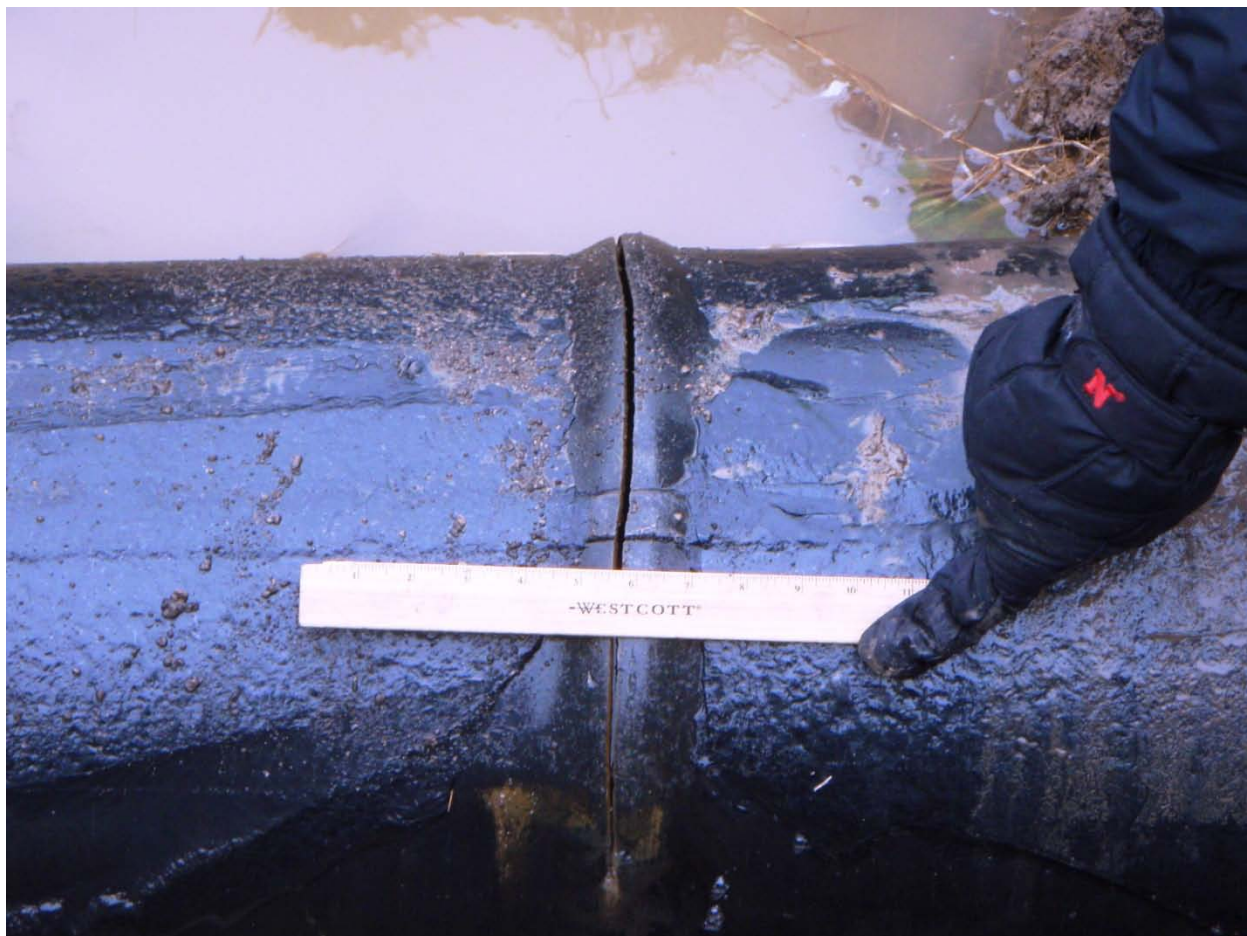
On March 11, 2010, a PHMSA Central Region inspector conducted an on-site investigation of the Incident. In situ visual inspection of the damaged pipe joint revealed a circumferential fracture located near the centerline of a wrinkle bend. The fracture extended circumferentially from the approximate

9:00 o'clock position, around the top of the pipe, to the approximate 3:00 o'clock position. The fracture was approximately 24 inches in length and approximately ¼ inch wide. The pipeline longitudinal seam was located between the 11:00 and 12:00 o'clock circumferential position. The wrinkle bend was part of an under bend in the pipeline.

The KMIGT 16-inch diameter Franklin to Hastings Incident was caused by weld defects in the pipeline longitudinal weld seam at the location of a wrinkle bend. The weld defects consist of slag inclusions and non-fusion. A wrinkle bend located two feet downstream of the failure also contained circumferential cracks in the wrinkle bend initiating at the longitudinal weld seam.

Pipeline rupture at wrinkle bend (underbend), looking southeast.

After the field investigation was complete, replacement pipe was installed in the area where the Incident occurred.
