Principal Investigator Roger Sneegas
Region Director David Barrett
Date of Report July 1, 2011
Subject Failure Investigation Report – Magellan Ammonia Line 501 Buckle

Failure Investigation Report – Magellan Ammonia Pipeline Line 501 Buckle
July 23, 2010

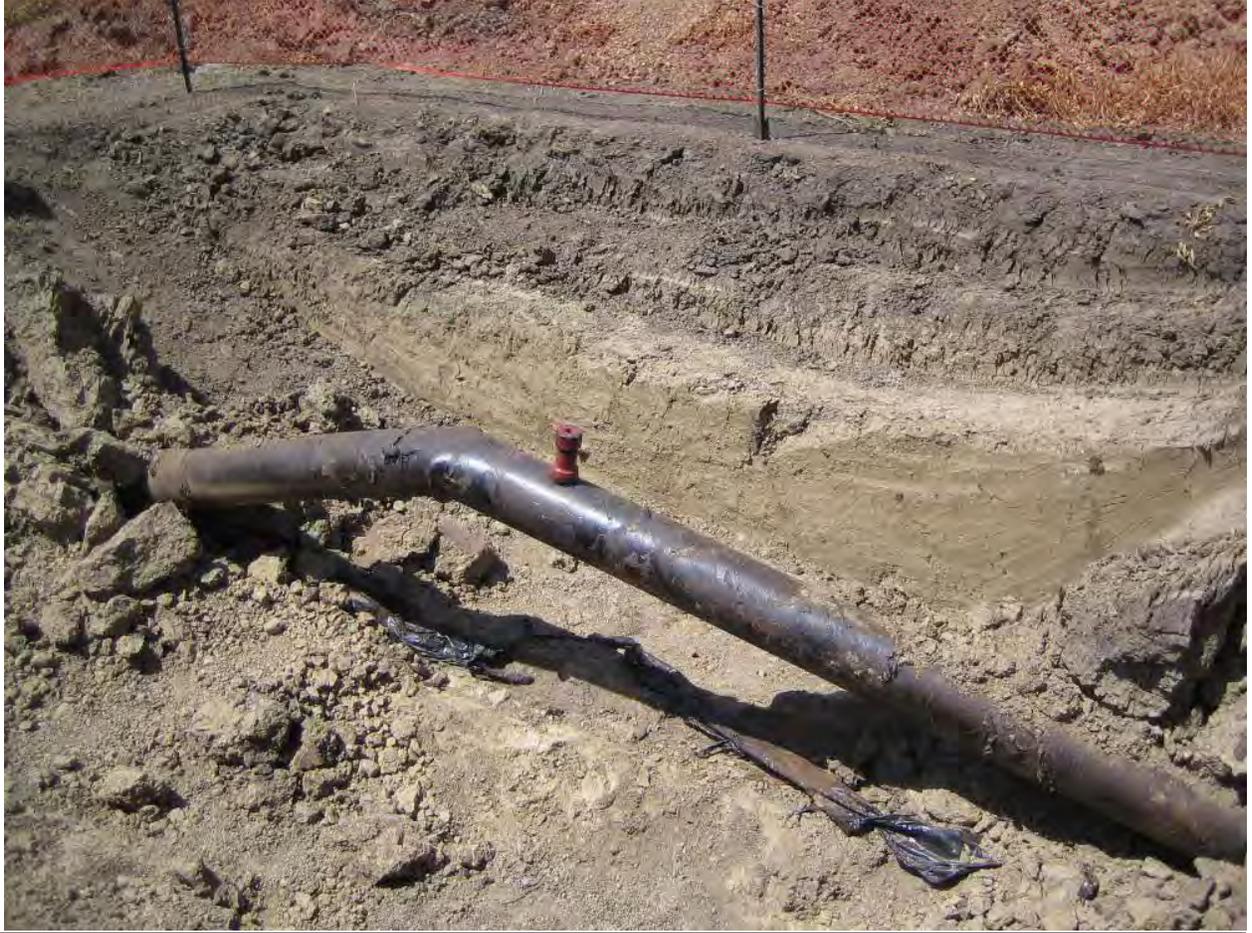
Photo No. 1
Failure Location Looking North
July 24, 2010

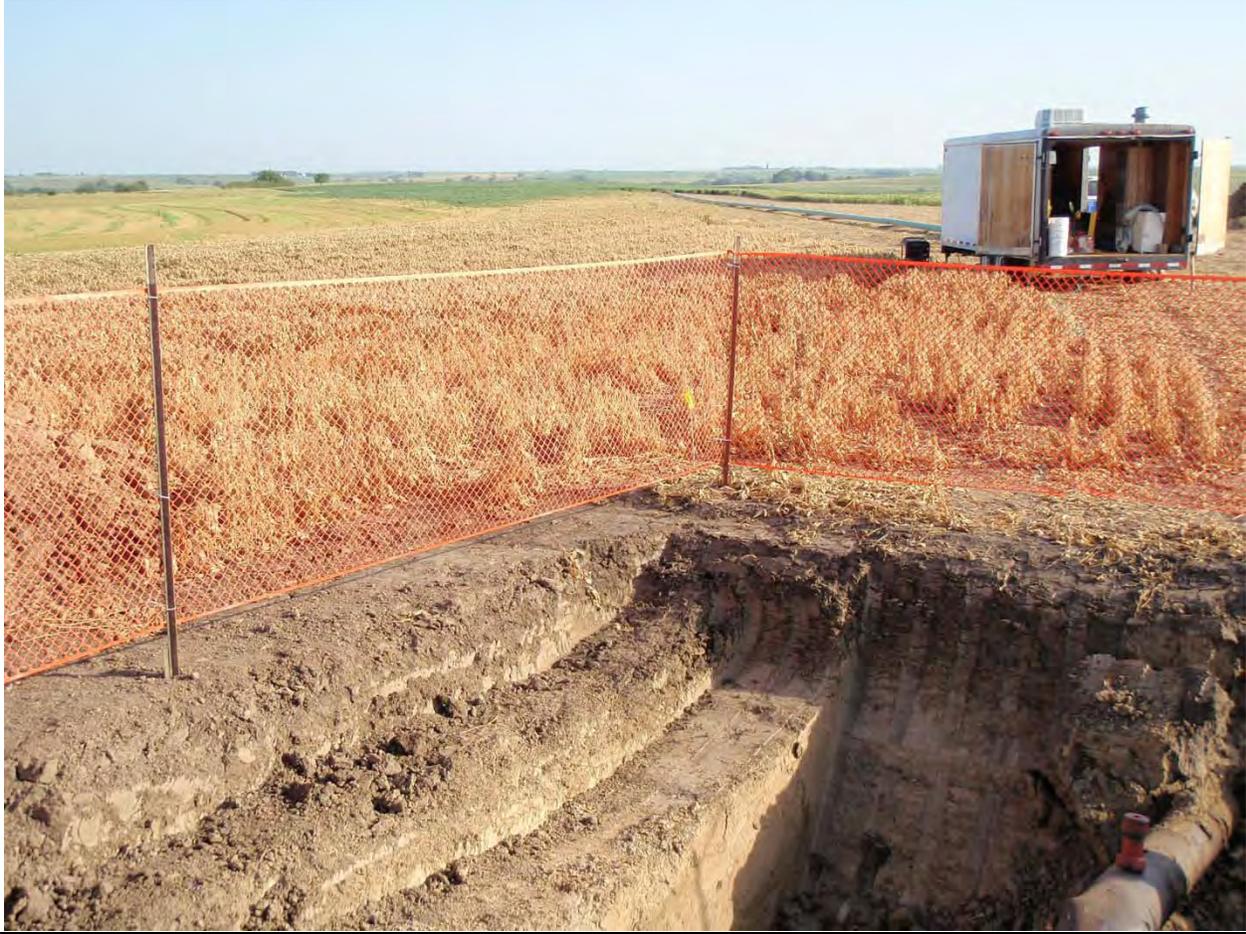
The accident occurred in an agricultural area (corn and soy beans) and about 4 acres of crops were damaged by the vapor cloud which identified the wind pattern. The wind was gusting up to 20 mph according to weather data. The mean temperature on this day was 84 degrees F with a high of 92 degrees F.

Photo No. 2
Crop Damage From Failure Site Looking East
July 27, 2010

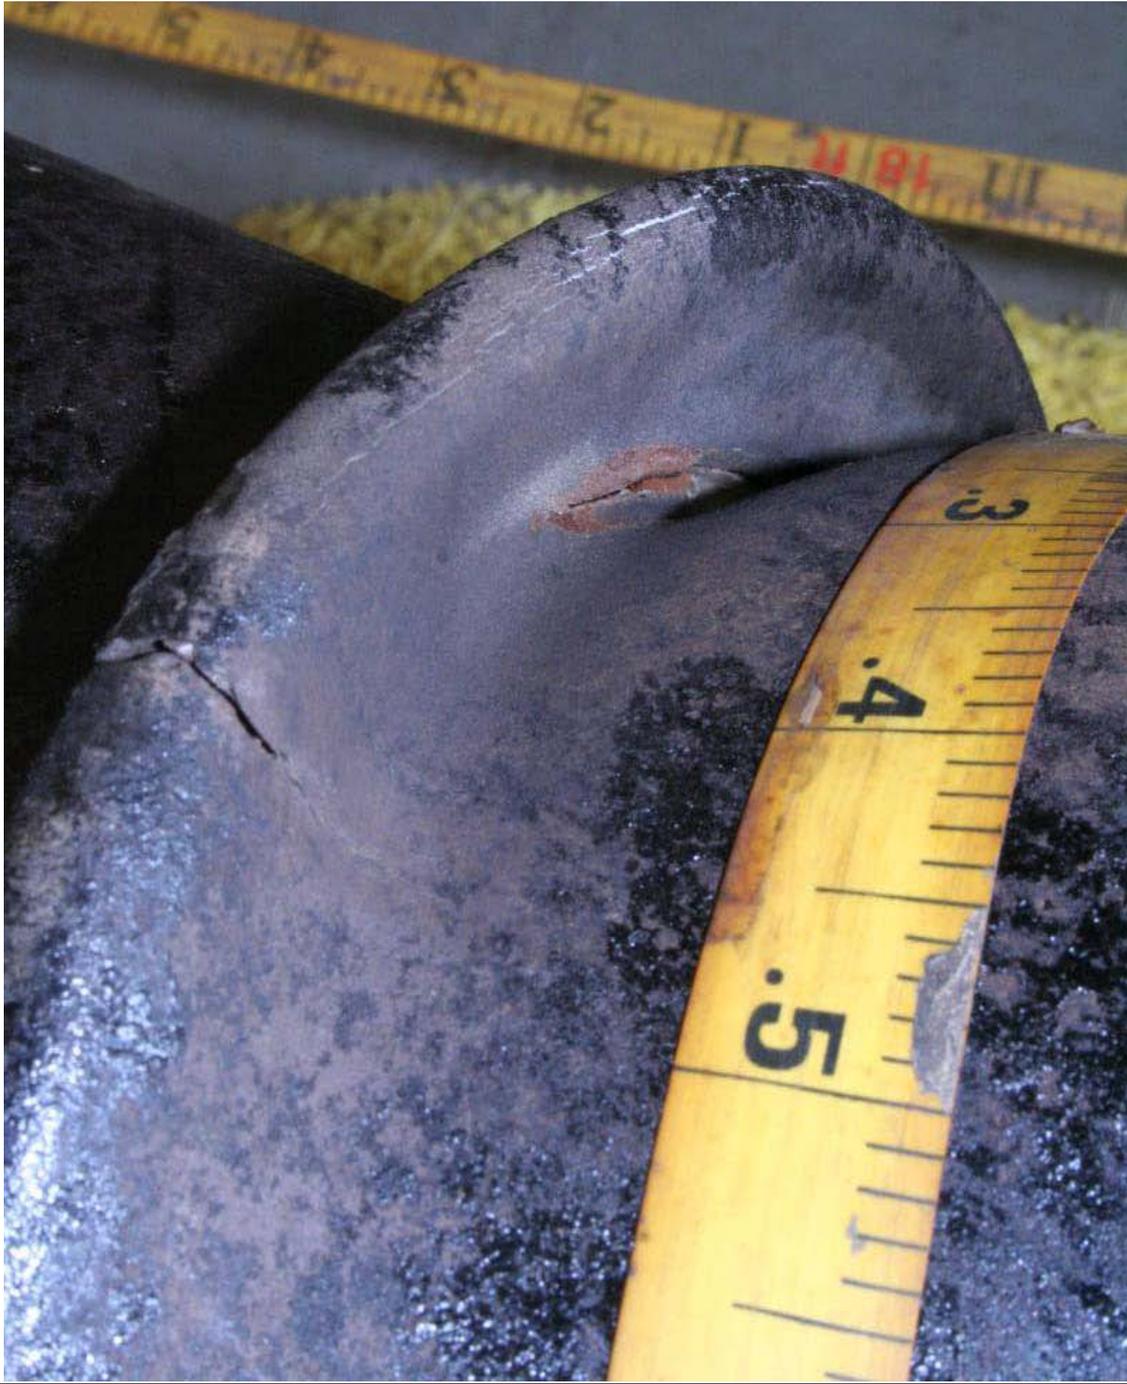
Metallurgical analysis of the buckle and wrinkle revealed several cracks in the buckle area: a through wall axial crack; a through wall circumferential crack; and several other circumferential cracks. All were indicative of overload conditions. The cracks did not cross a long seam or a girth weld.

The release of anhydrous ammonia was caused by through wall axial cracks in the pipe (centered at the 6:00 orientation) resulting from a pipe buckle at a high point that had recently been excavated. The pipe moved and buckled due to unstable compressive overload. The tensile properties of samples removed from the pipe met the specifications of carbon steel, API 5L, Grade X46 line pipe at the time of manufacture. The failure was not due to a pre-existing pipe defect.

Photo No. 3
Buckle and crack
July 24, 2010

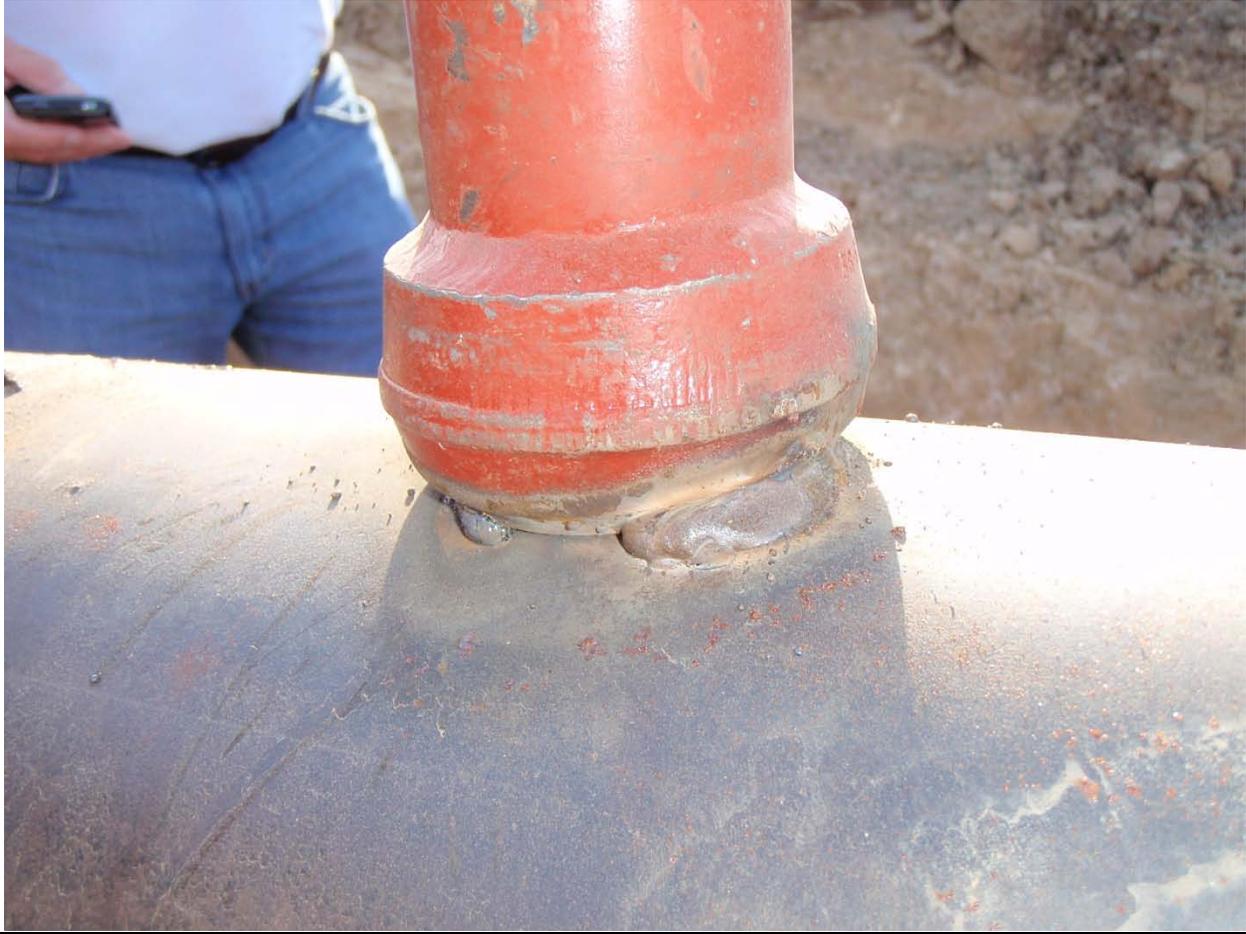
Photo No. 4
TOR Fitting 1' Upstream From Failure
July 27, 2010
