*NTSB Advisory*

December 14, 2010

**NTSB ISSUES UPDATE ON INVESTIGATION INTO FATAL PIPELINE RUPTURE IN SAN BRUNO, CALIFORNIA**

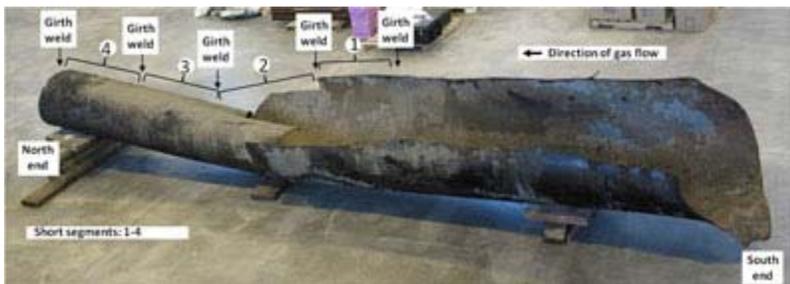
The outer surfaces of the ruptured pipe pieces revealed no evidence of external corrosion. No dents, gouges, or other physical indications consistent with excavation damage were observed. Additionally, no physical evidence suggests that a pre-existing leak occurred in the ruptured pipe pieces.

28-foot-long ruptured section of pipeline at laboratory facilities at the NTSB Training Center, Ashburn, VA ([Download full-sized version of image](#))

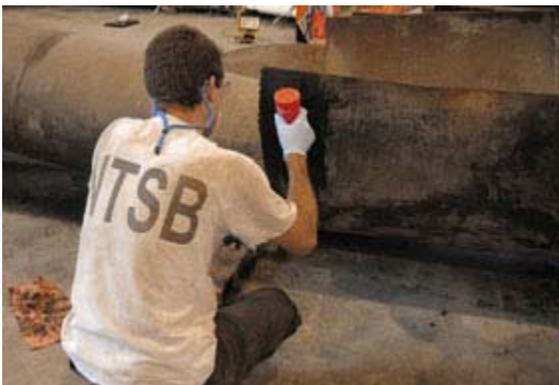
NTSB investigator examining fracture surfaces ([Download full-sized version](#))

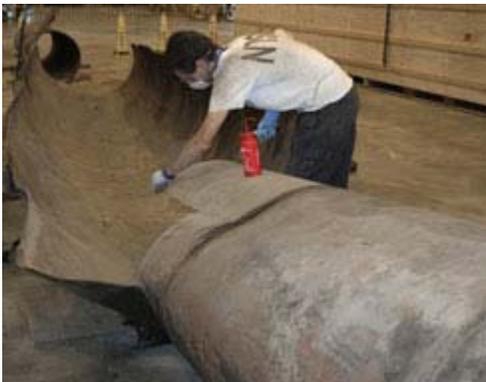
View of ruptured section of pipeline with investigator cleaning a fracture surface ([Download full-sized version](#))

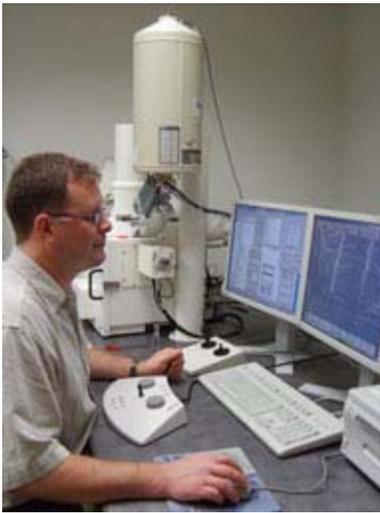
NTSB investigator using a scanning electron microscope to examine a pipeline fracture surface  
([Download full-sized version](#))
