**U.S. Department
of Transportation**

**Pipeline and
Hazardous Materials
Safety Administration**

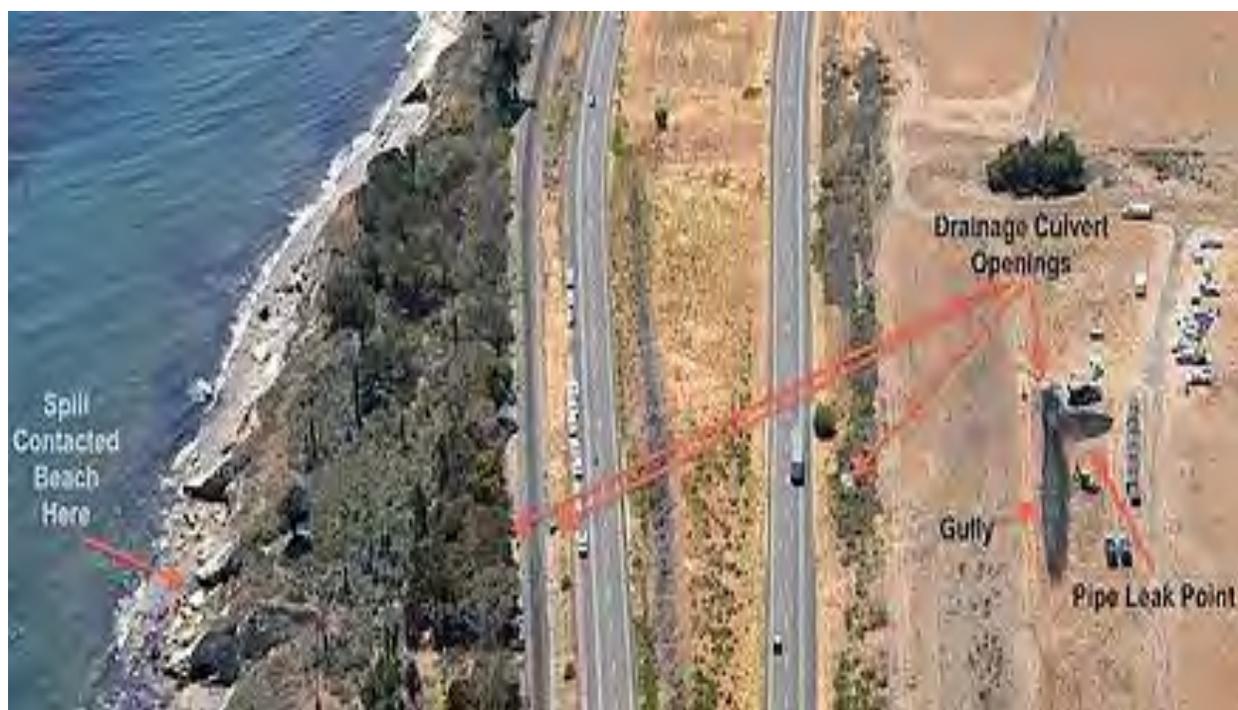
Figure 3. Spill location relative to Refugio Beach in Santa Barbara County, CA. Photo: John L. Wiley <http://flickr.com/jw4pix>

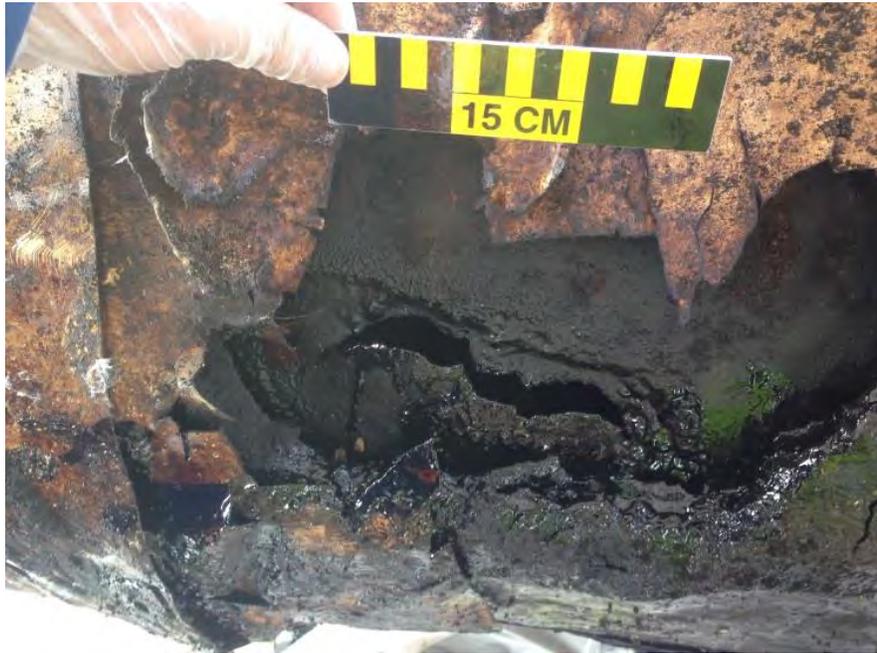
Figure 4. The failed pipe and surrounding insulation and coating.

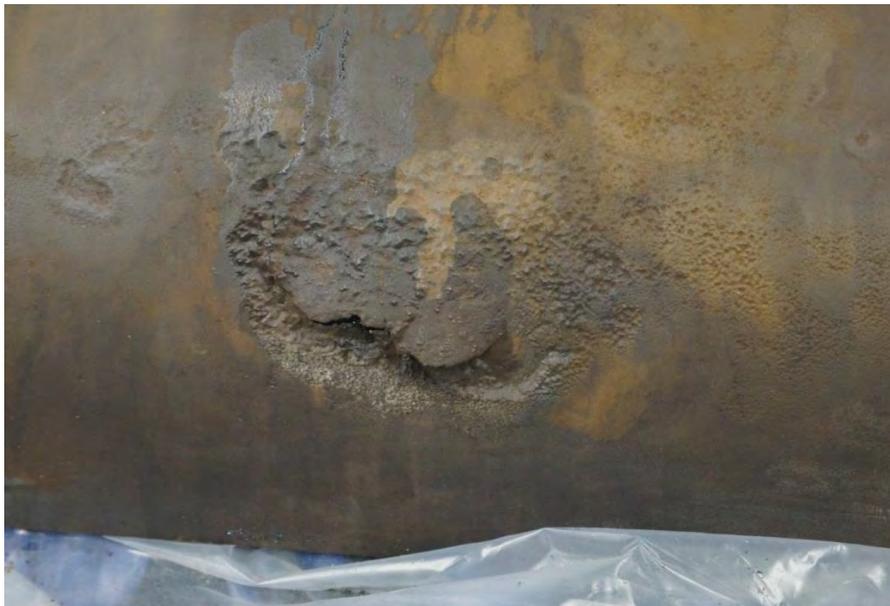
Figure 5. Pipe External Surface at the Line 901 failure site after cleaning.

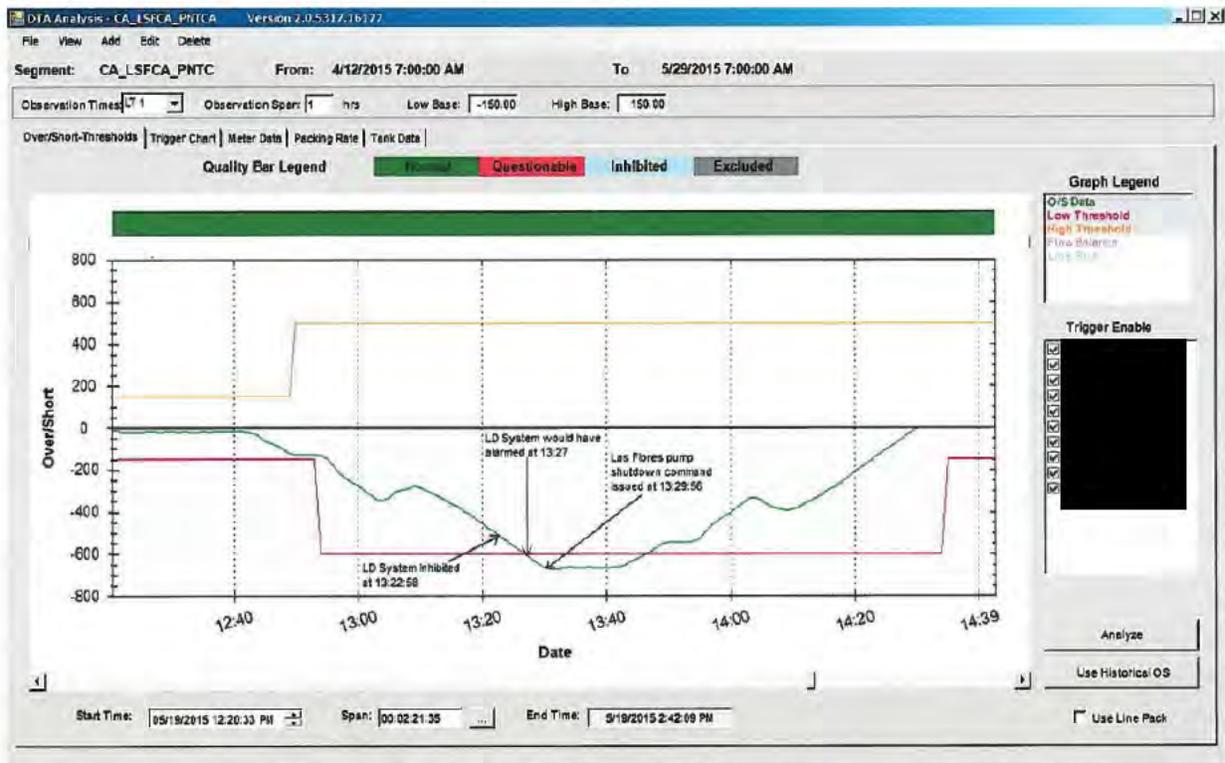
Graphical Representation of when the PLM System would have alarmed had it not been “inhibited”. Times in the graph and explanation are in Central Time. Pacific Time is two hours earlier.

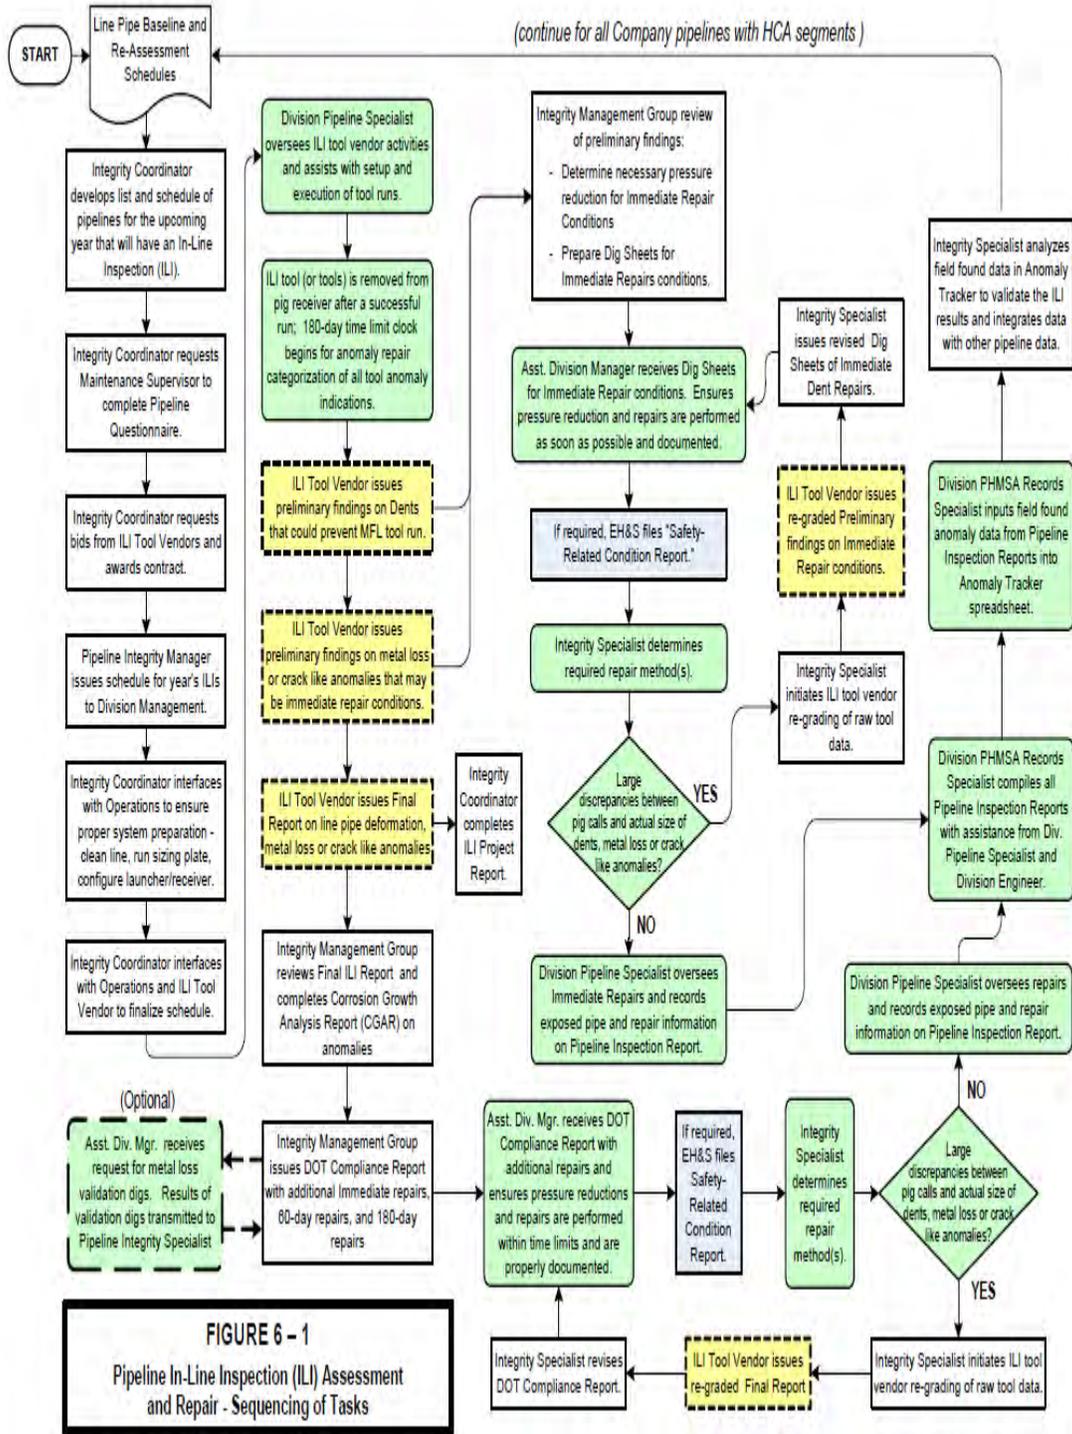
An enlarged portion of Figure 6-1, from the bottom right quadrant is copied below.

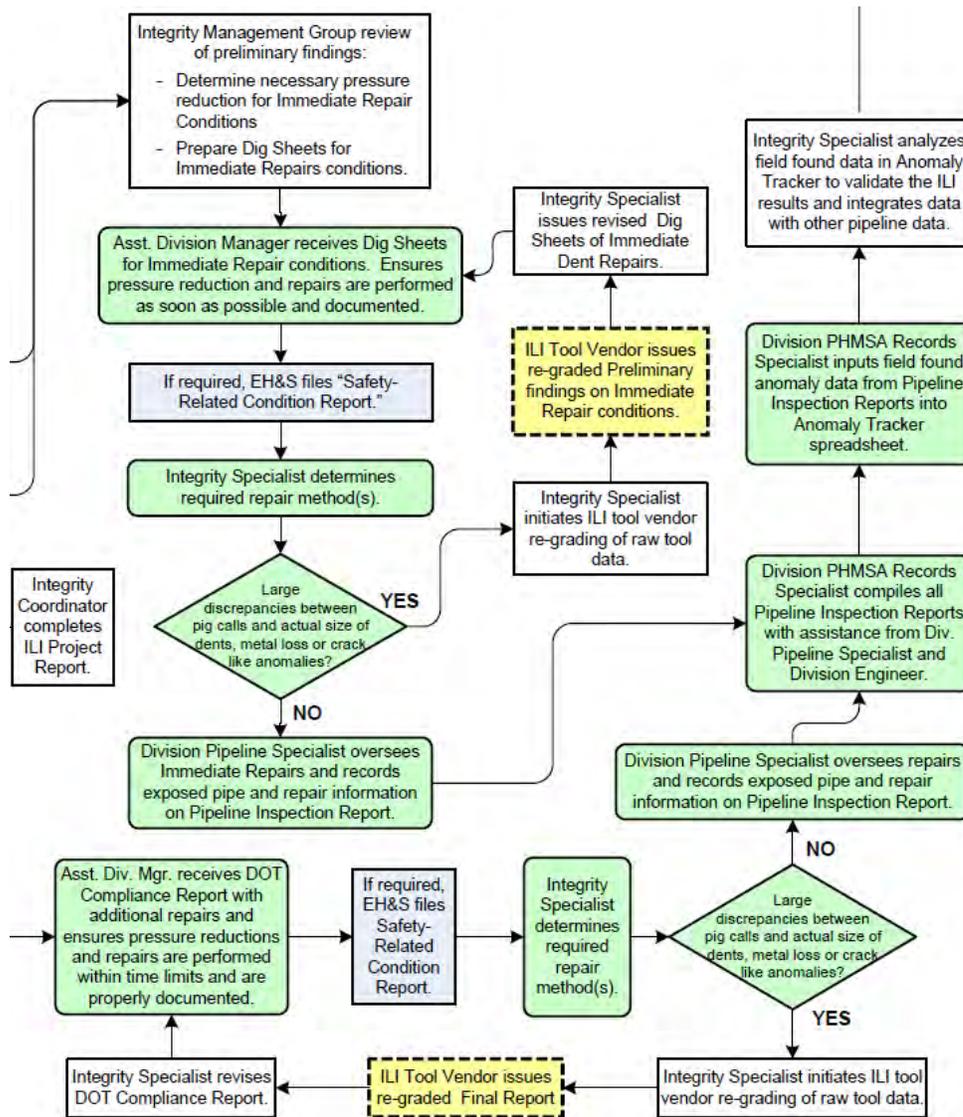
The two diamond shapes in the flowchart state the same decision point:

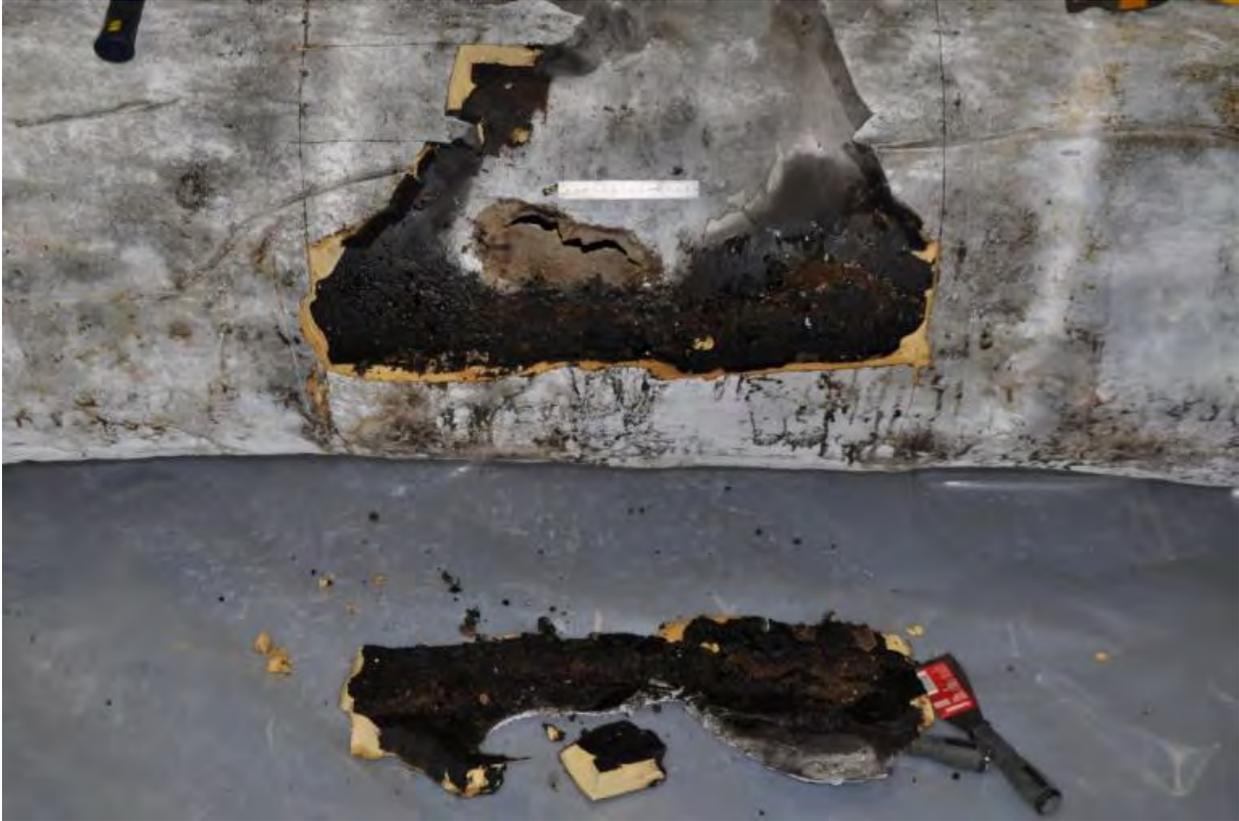
This picture is excerpted from the final metallurgical report. “Figure 16. Photograph showing a piece of insulation removed from adjacent to the failure location; near 4:30 orientation.”

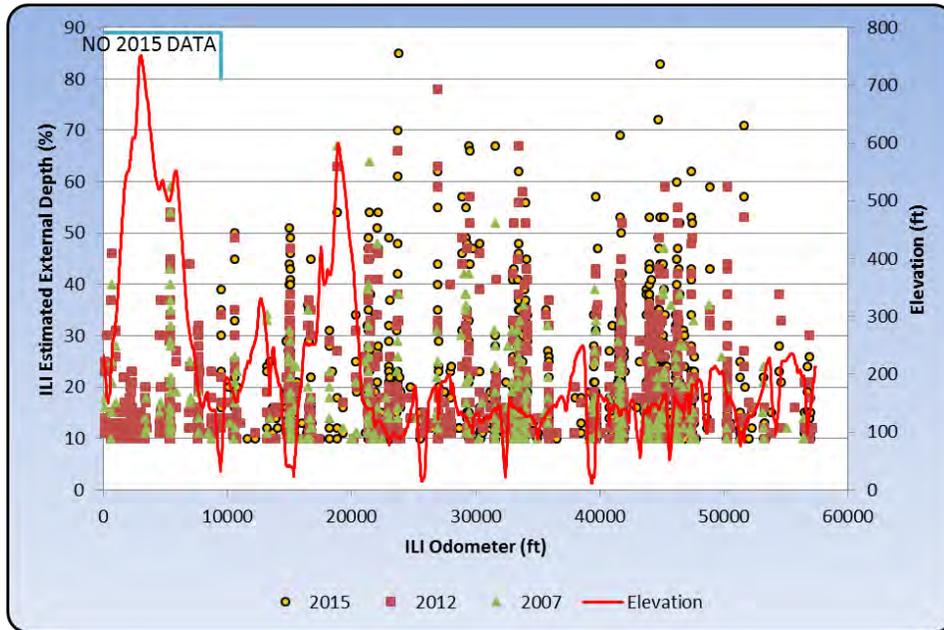
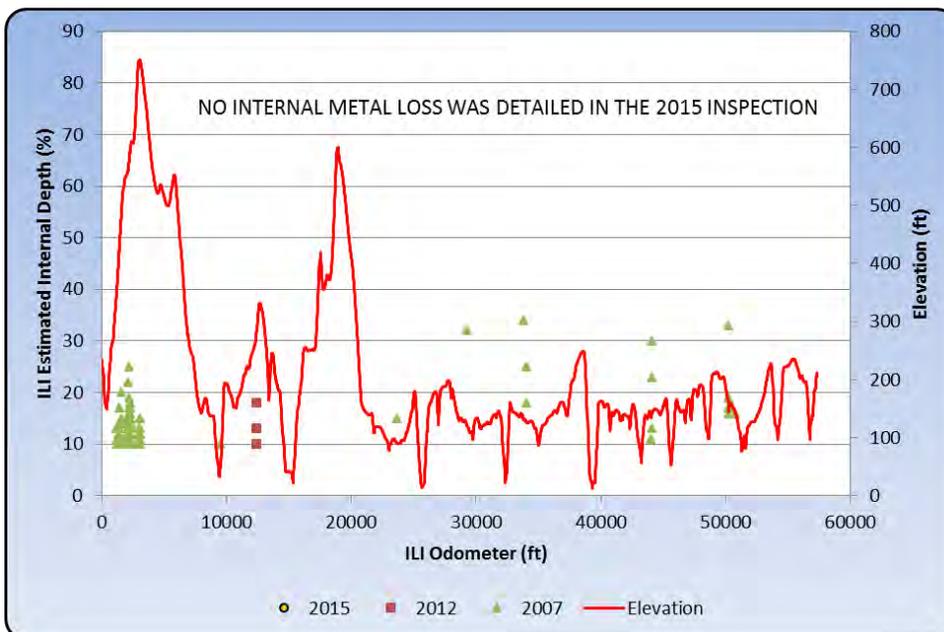
The in-line inspection results from the 2007, 2012, and 2015 MFL runs were examined. The vast majority of the corrosion is external and distributed throughout the length of the segment. The distribution of the external metal loss, in general terms, can be said to predominate in localized low elevations. Previous to the 2015 inspection, the majority of the internal anomalies were found in the first 3000'. This data was not collected in 2015. All three inspections were completed by Rosen USA with different tool designations and modifications employed for each run, either in hardware or software.

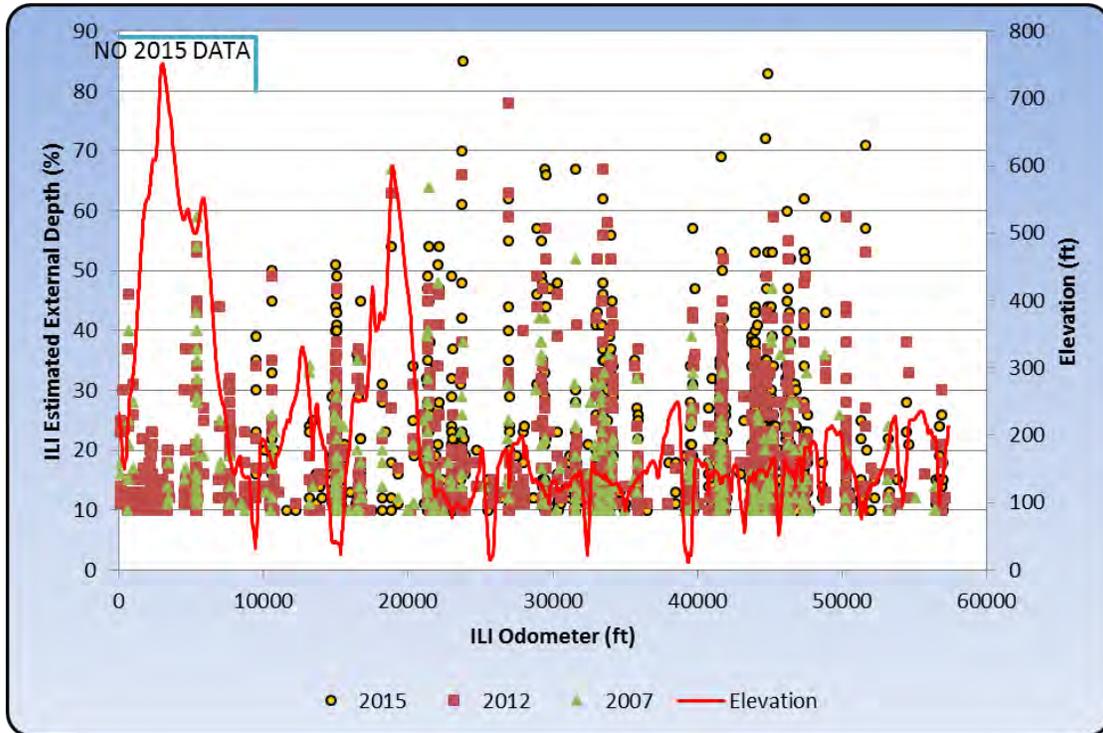
Figure 1. Distribution of external metal loss anomalies.

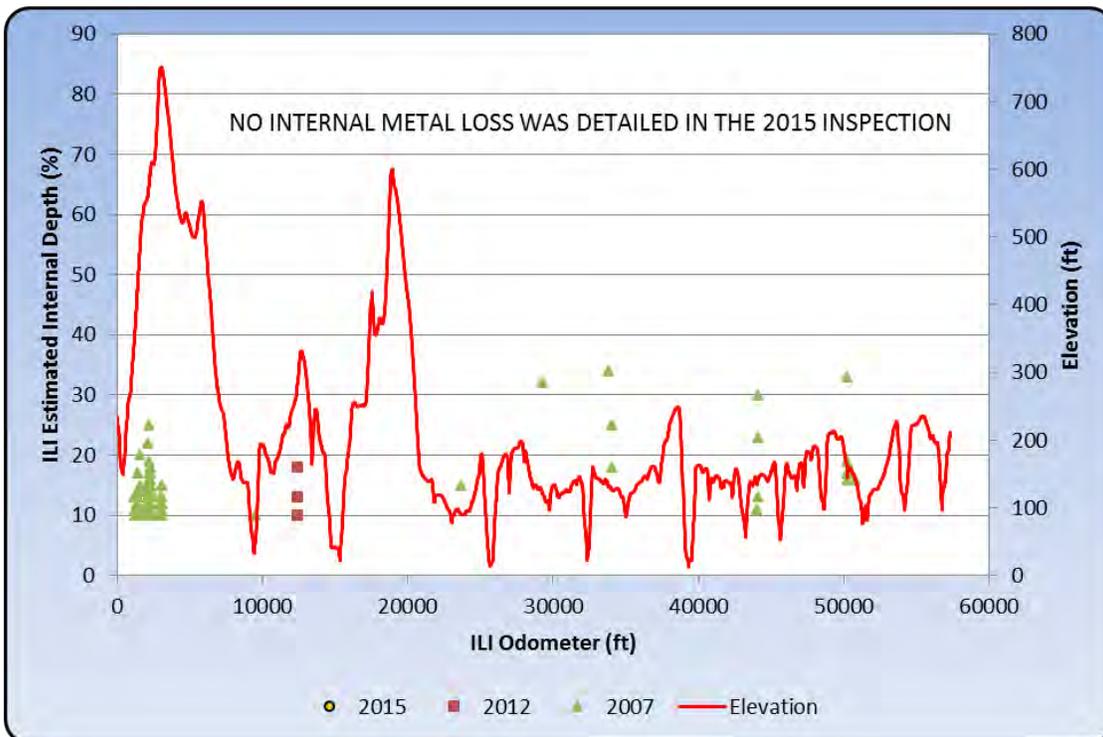
Figure 2. Distribution of internal metal loss anomalies.

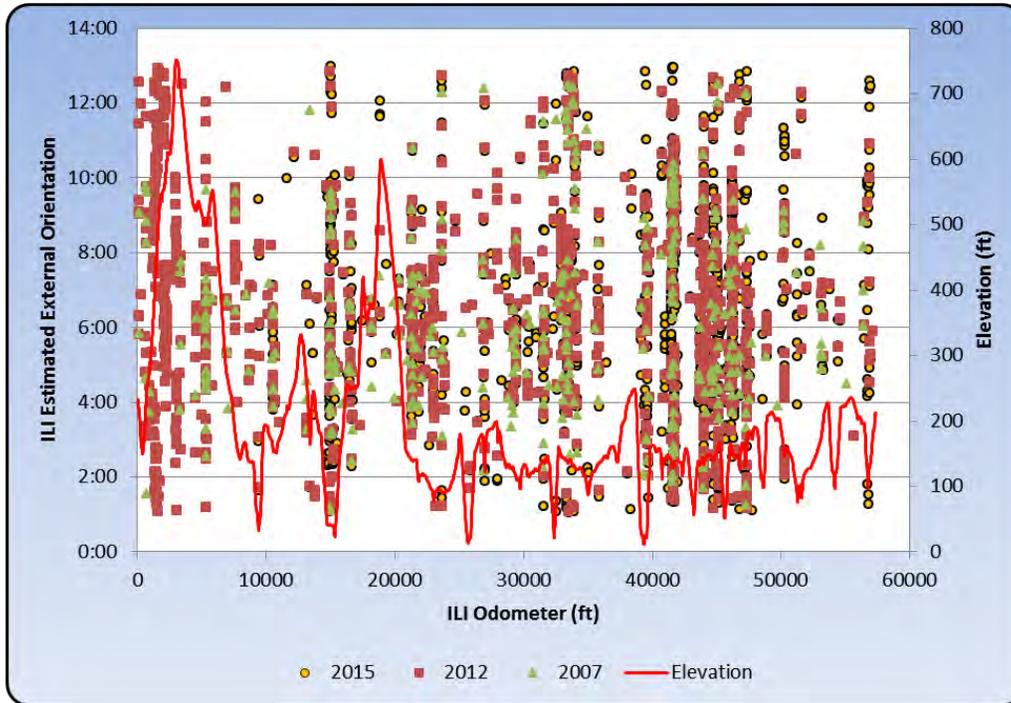
Figure 3. Distribution of external metal loss anomalies by clock position.

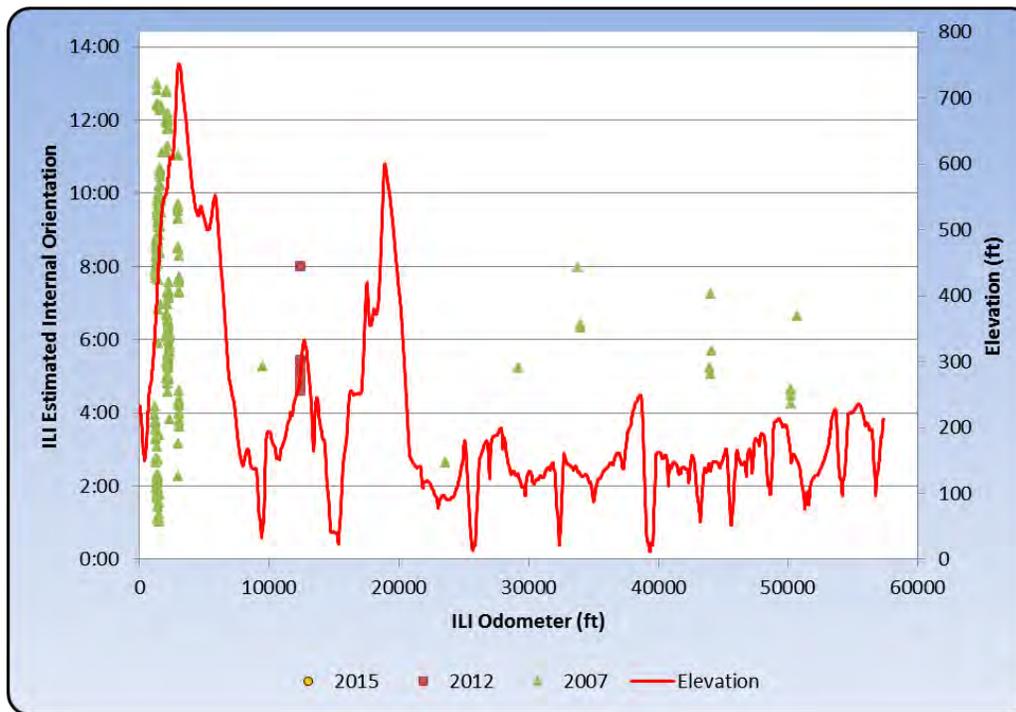
Figure 4. Distribution of internal metal loss anomalies by clock position.

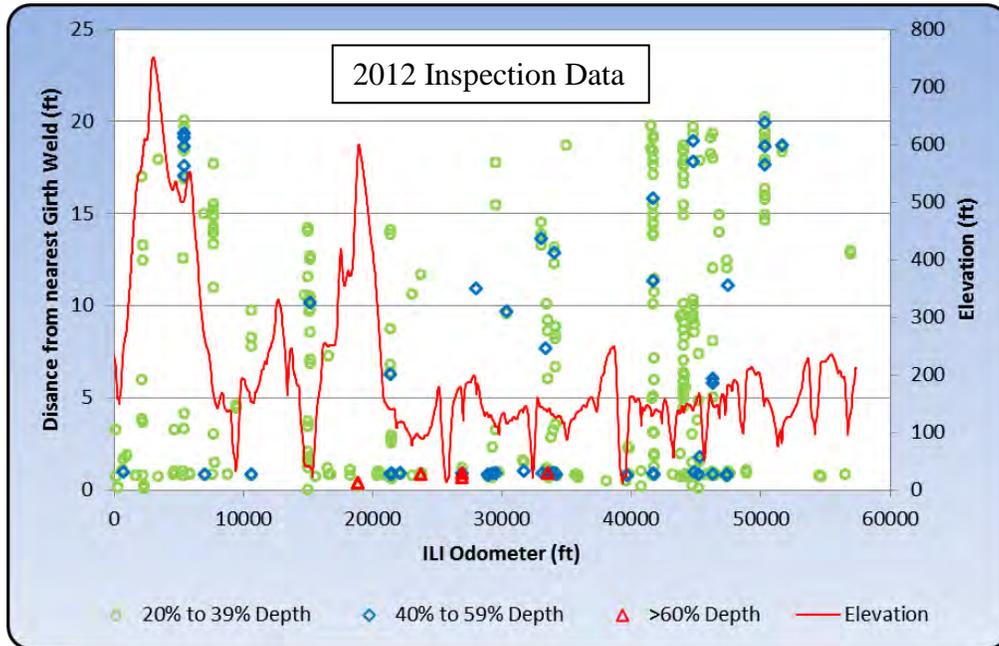
Figure 5. Distance of metal loss to the nearest girth weld in 2012.

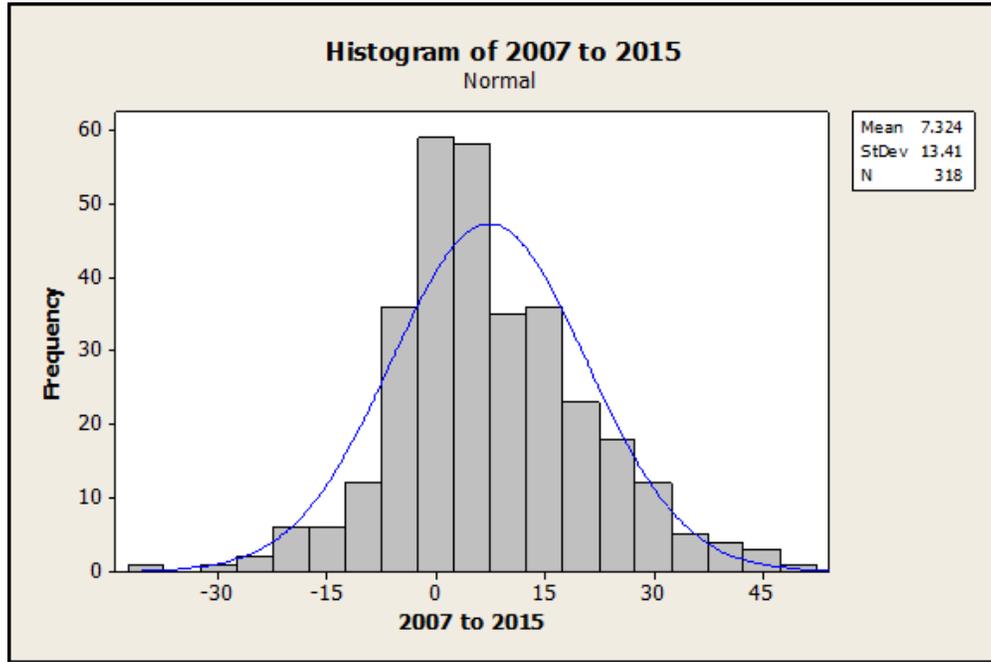
Figure 6. Distribution of growth rates for matching metal loss.

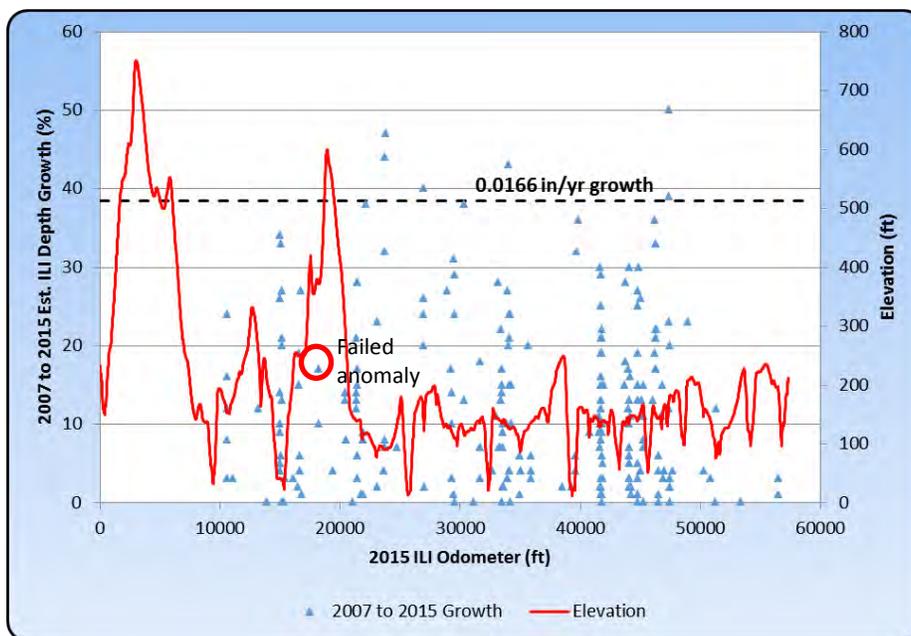
Figure 8. Distribution of external growth by ILI depth variance.

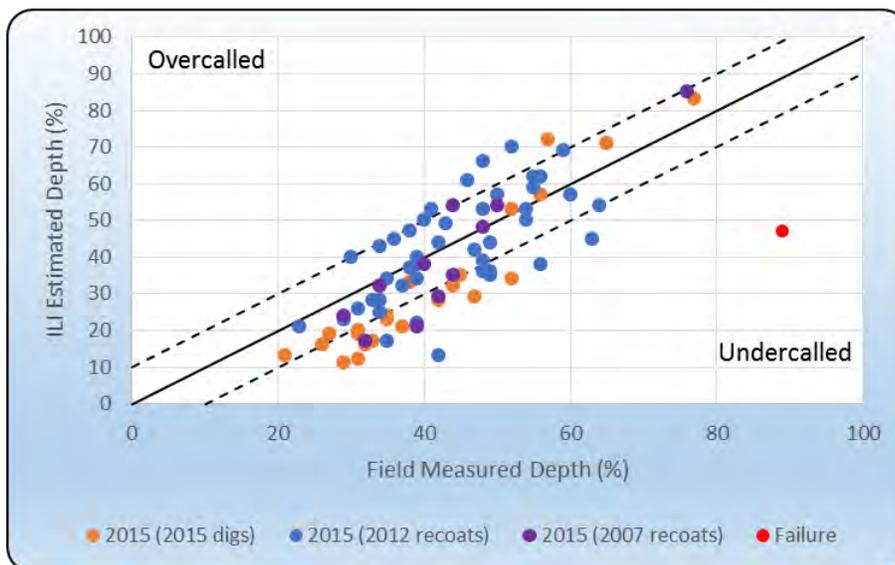
Figure 9. Unity plot for the 2015 MFL inspection.

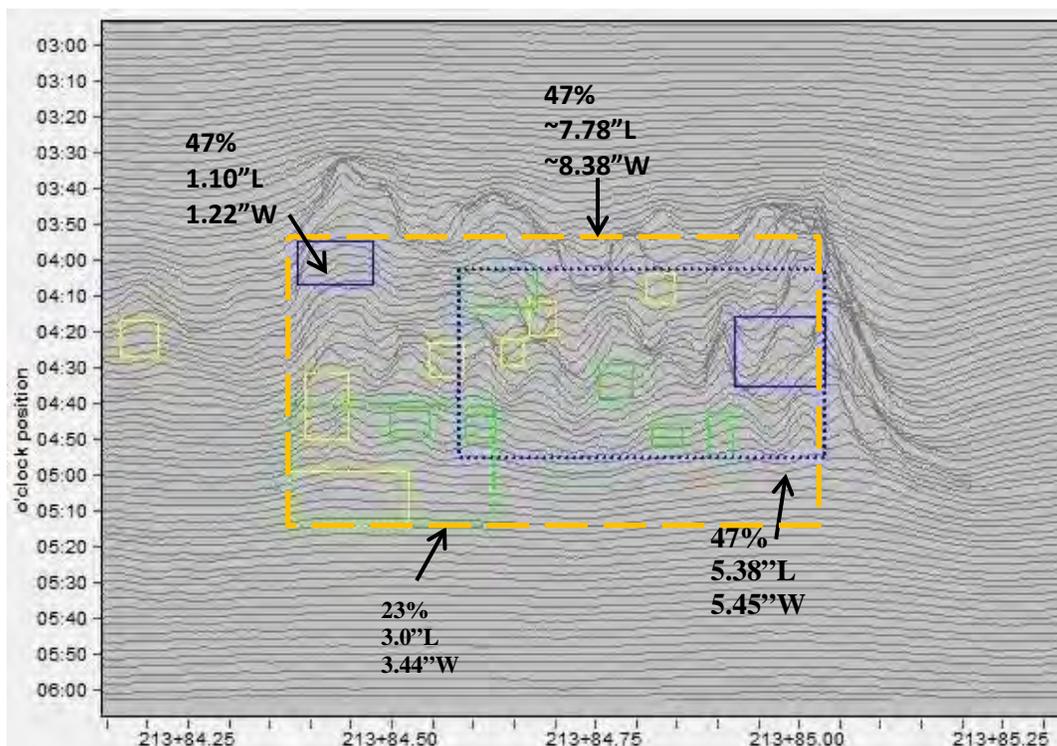
Figure 12. Interacted MFL metal loss in failed anomaly.

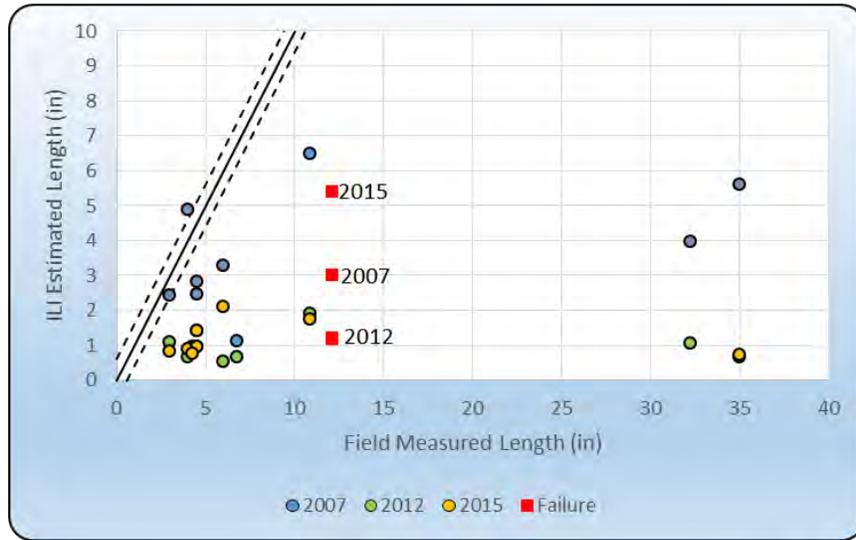
Figure 13. ILI estimated length compared to field measured.

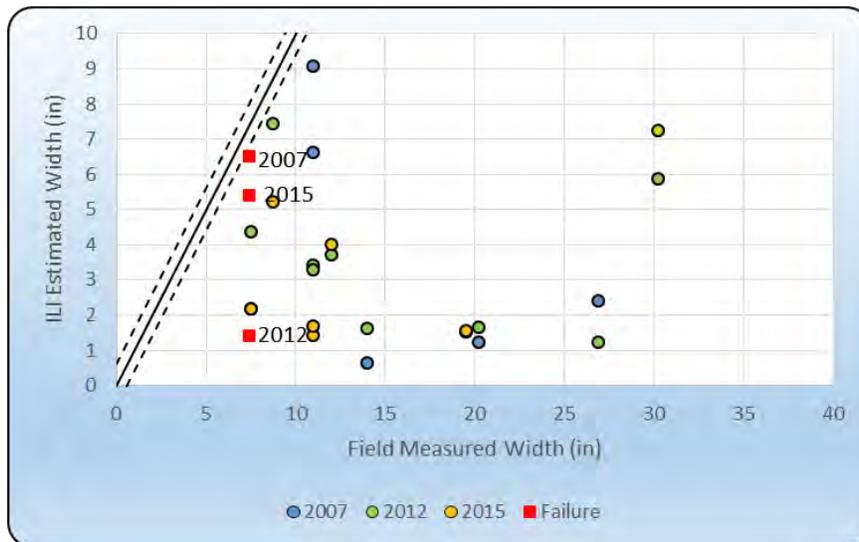
Figure 14. ILI estimated width compared to field measured.

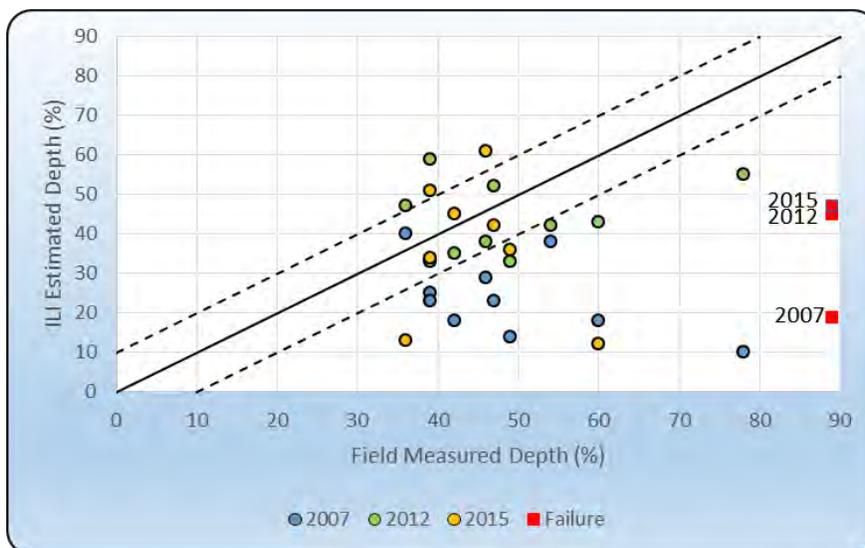
Figure 15. ILI estimated depth compared to field measured.

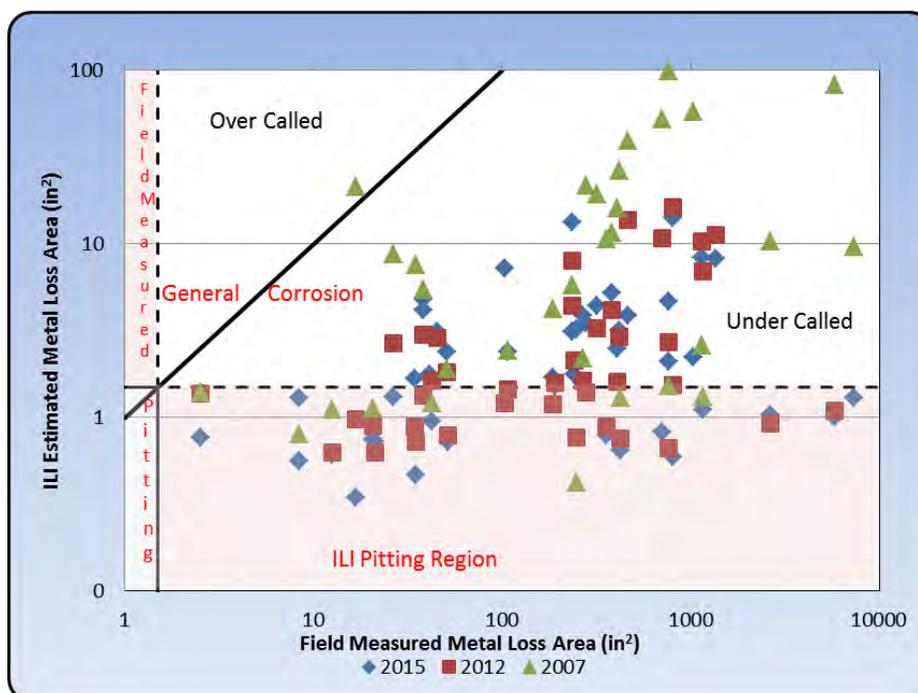
Figure 16. Metal loss area; ILI vs field measurement.

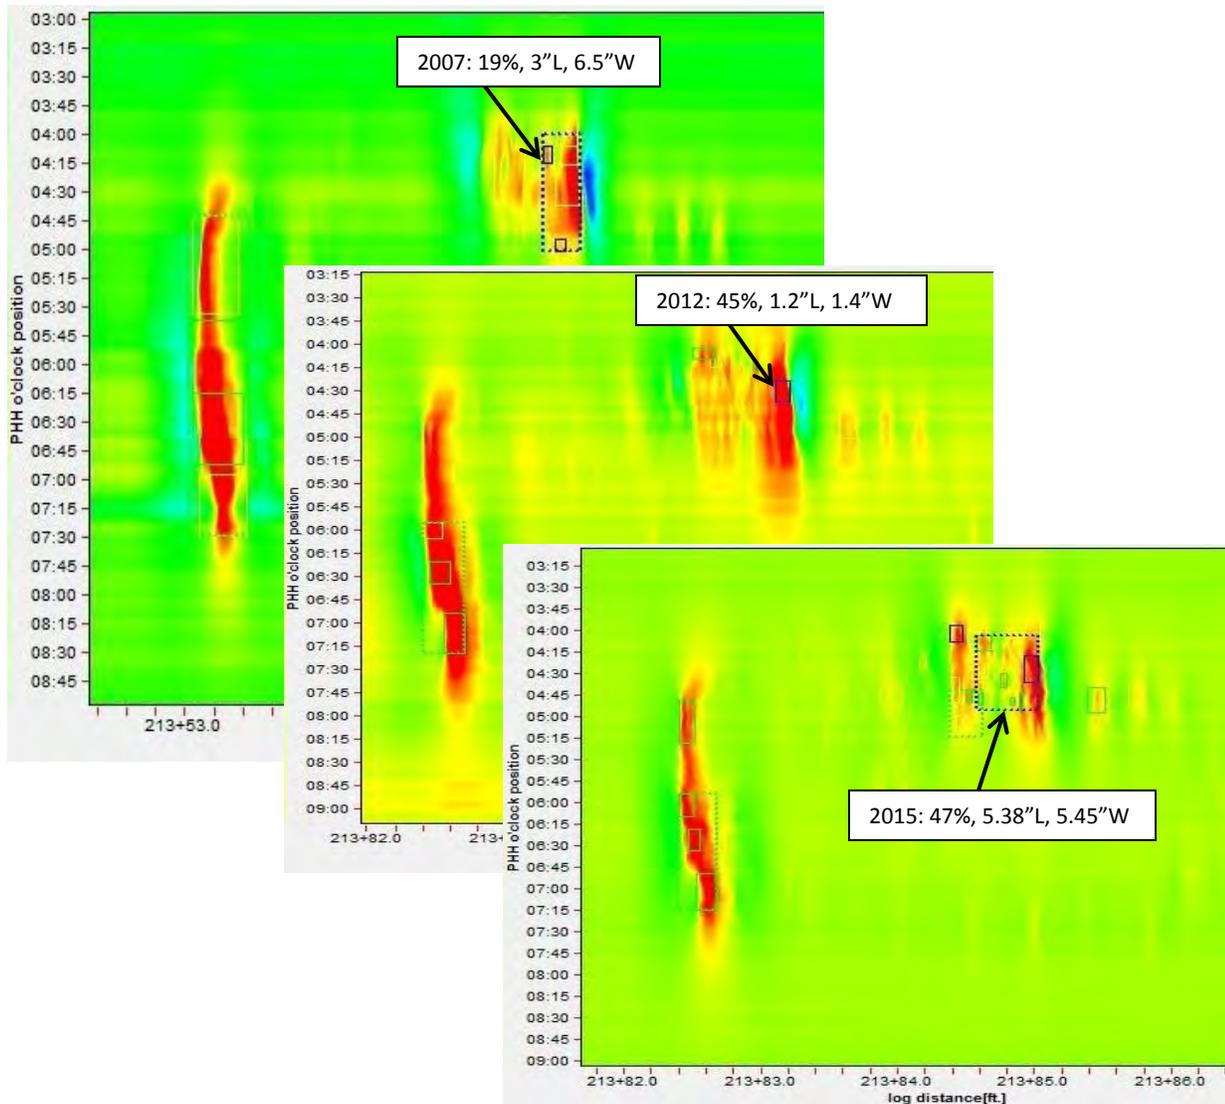
Figure 17. C-Scans with boxes of the failed location as detailed by the 2007, 2012 and 2015 inspections

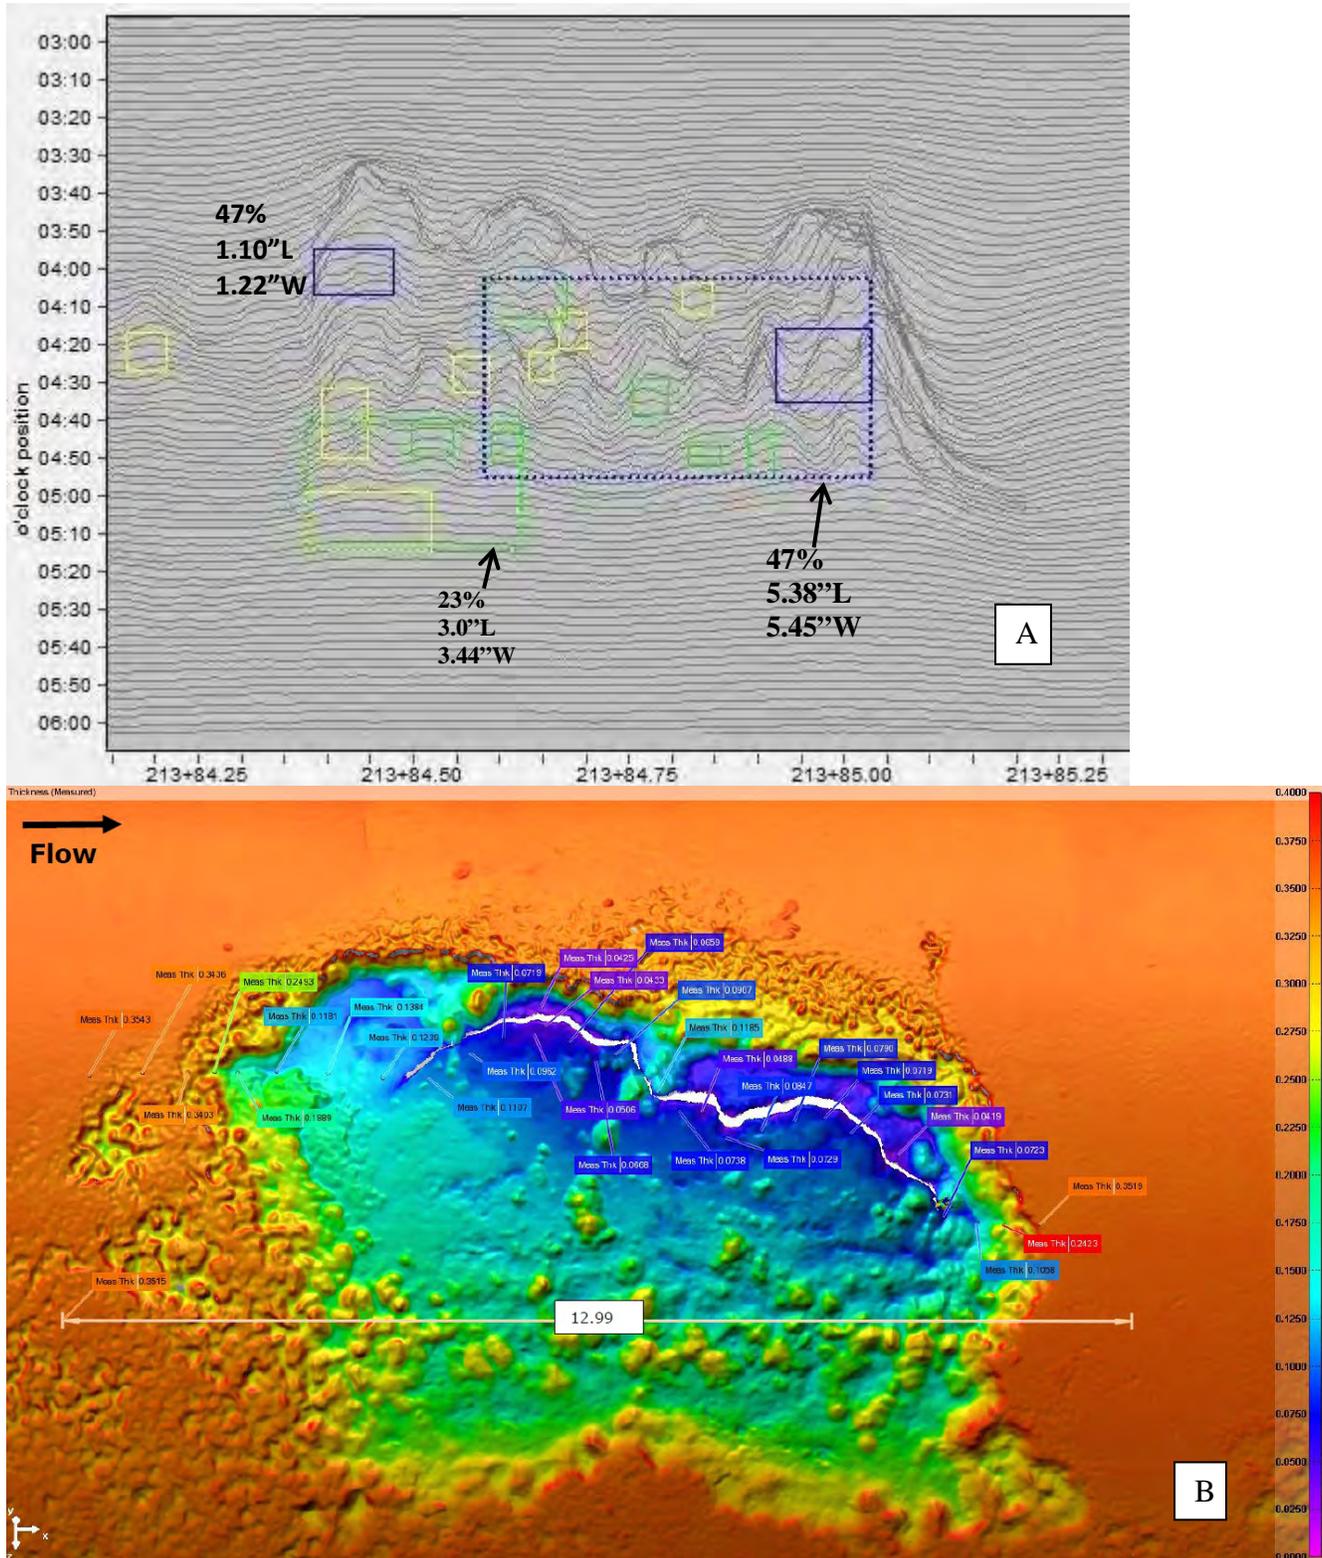
Figure 18. The failed area, A) the Rosen 2015 A-Scan, B) the Laser Scan.

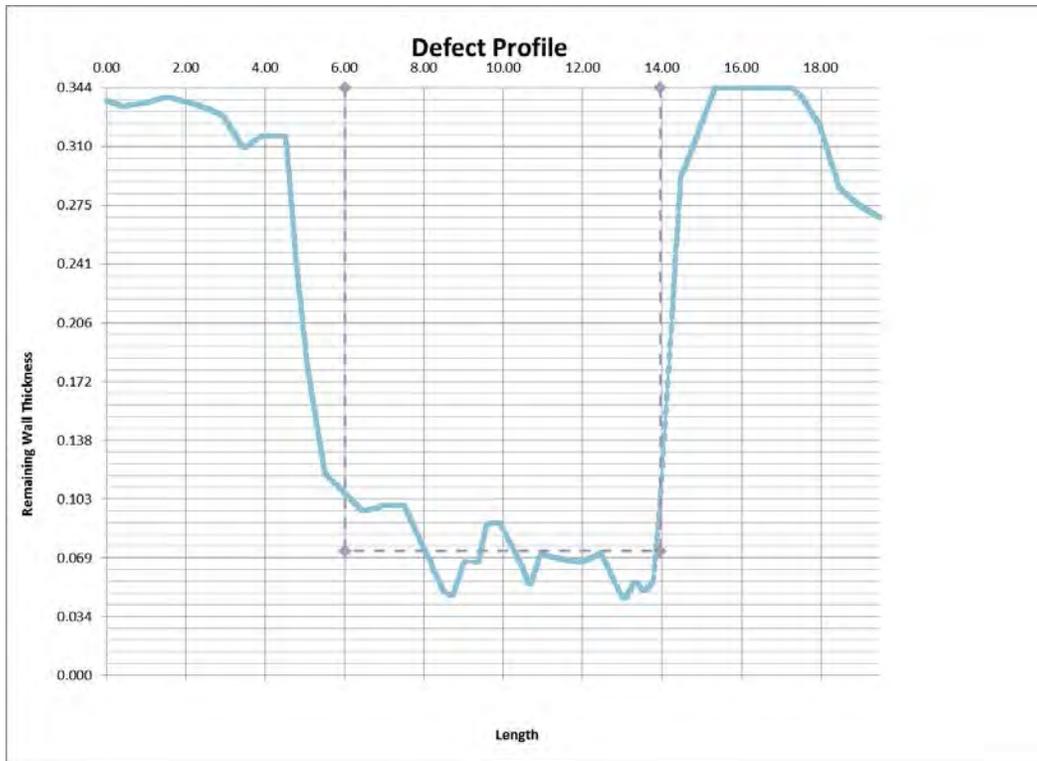
Figure 19. Depth profile of failed anomaly (DNV).

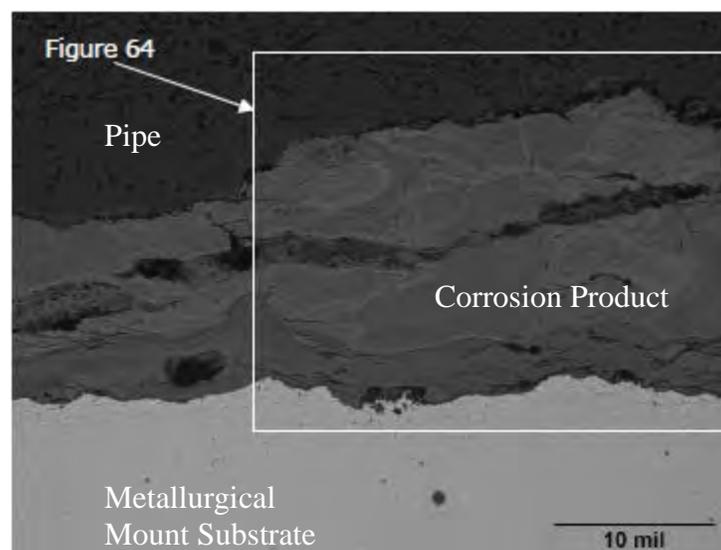
Figure 20. Tightly adhered corrosion product (Fig. 58 from metallurgical report).

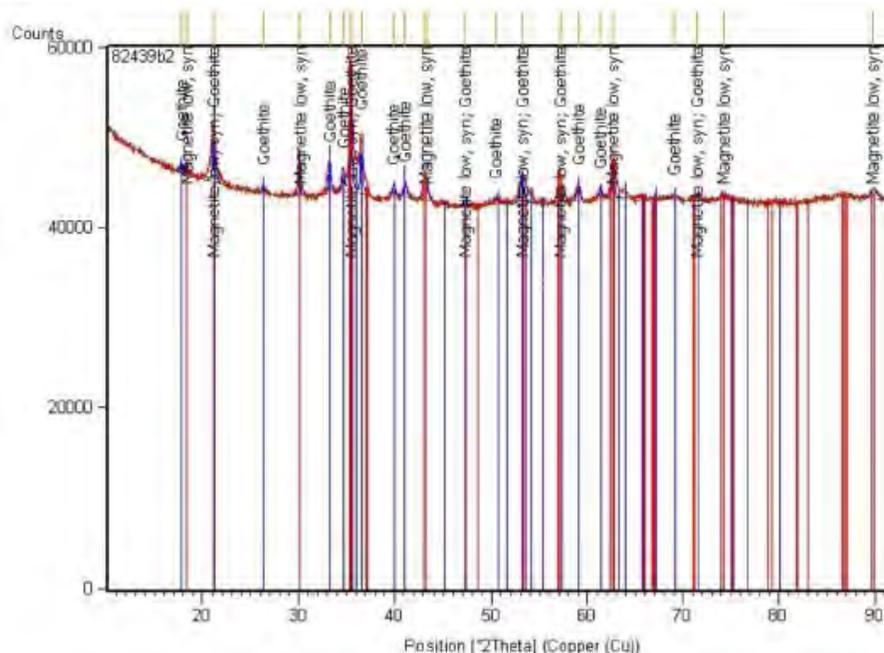
Figure 21. X-Ray Diffraction (XRD) of the corrosion product indicating layering of Magnetite and Goethite (Fig. 62 from metallurgical report).

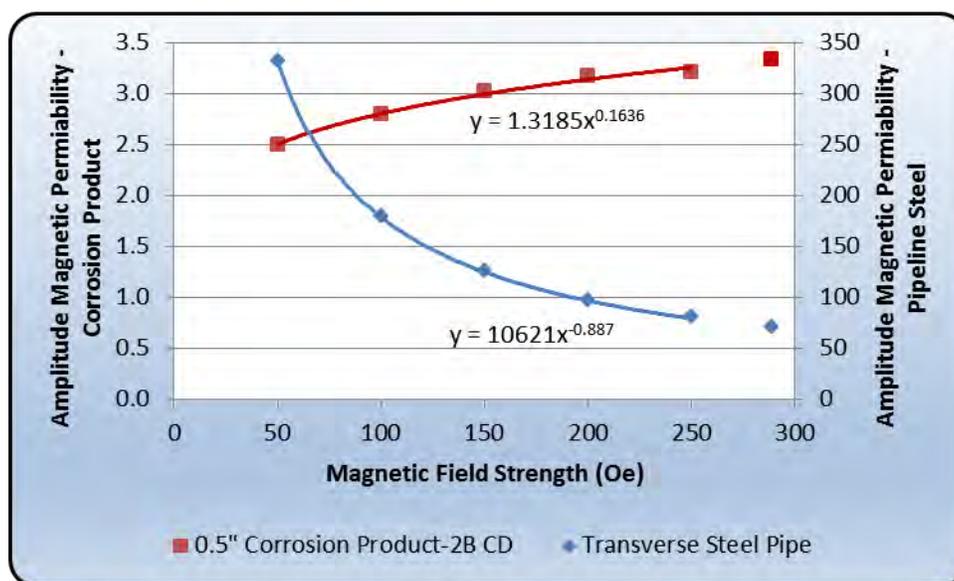
Figure 22. Amplitude magnetic permeability of the pipeline steel and corrosion product (EWI).
